**SUBJECT: Site Investigation Report
 QB Energy Operating, LLC
 Gas Gathering Pipeline System Decommissioning
 Remediation Project Number: 24190
 OP15 to G15OU Pipeline
 Mesa County, Colorado**

**SITE INVESTIGATION REPORT
QB ENERGY OPERATING, LLC
GAS GATHERING PIPELINE SYSTEM DECOMMISSIONING
REMEDATION PROJECT NUMBER: 24190
OP15 TO G15OU PIPELINE
MESA COUNTY, COLORADO**

KLEINFELDER PROJECT NO. 25002443.001A

April 29, 2025

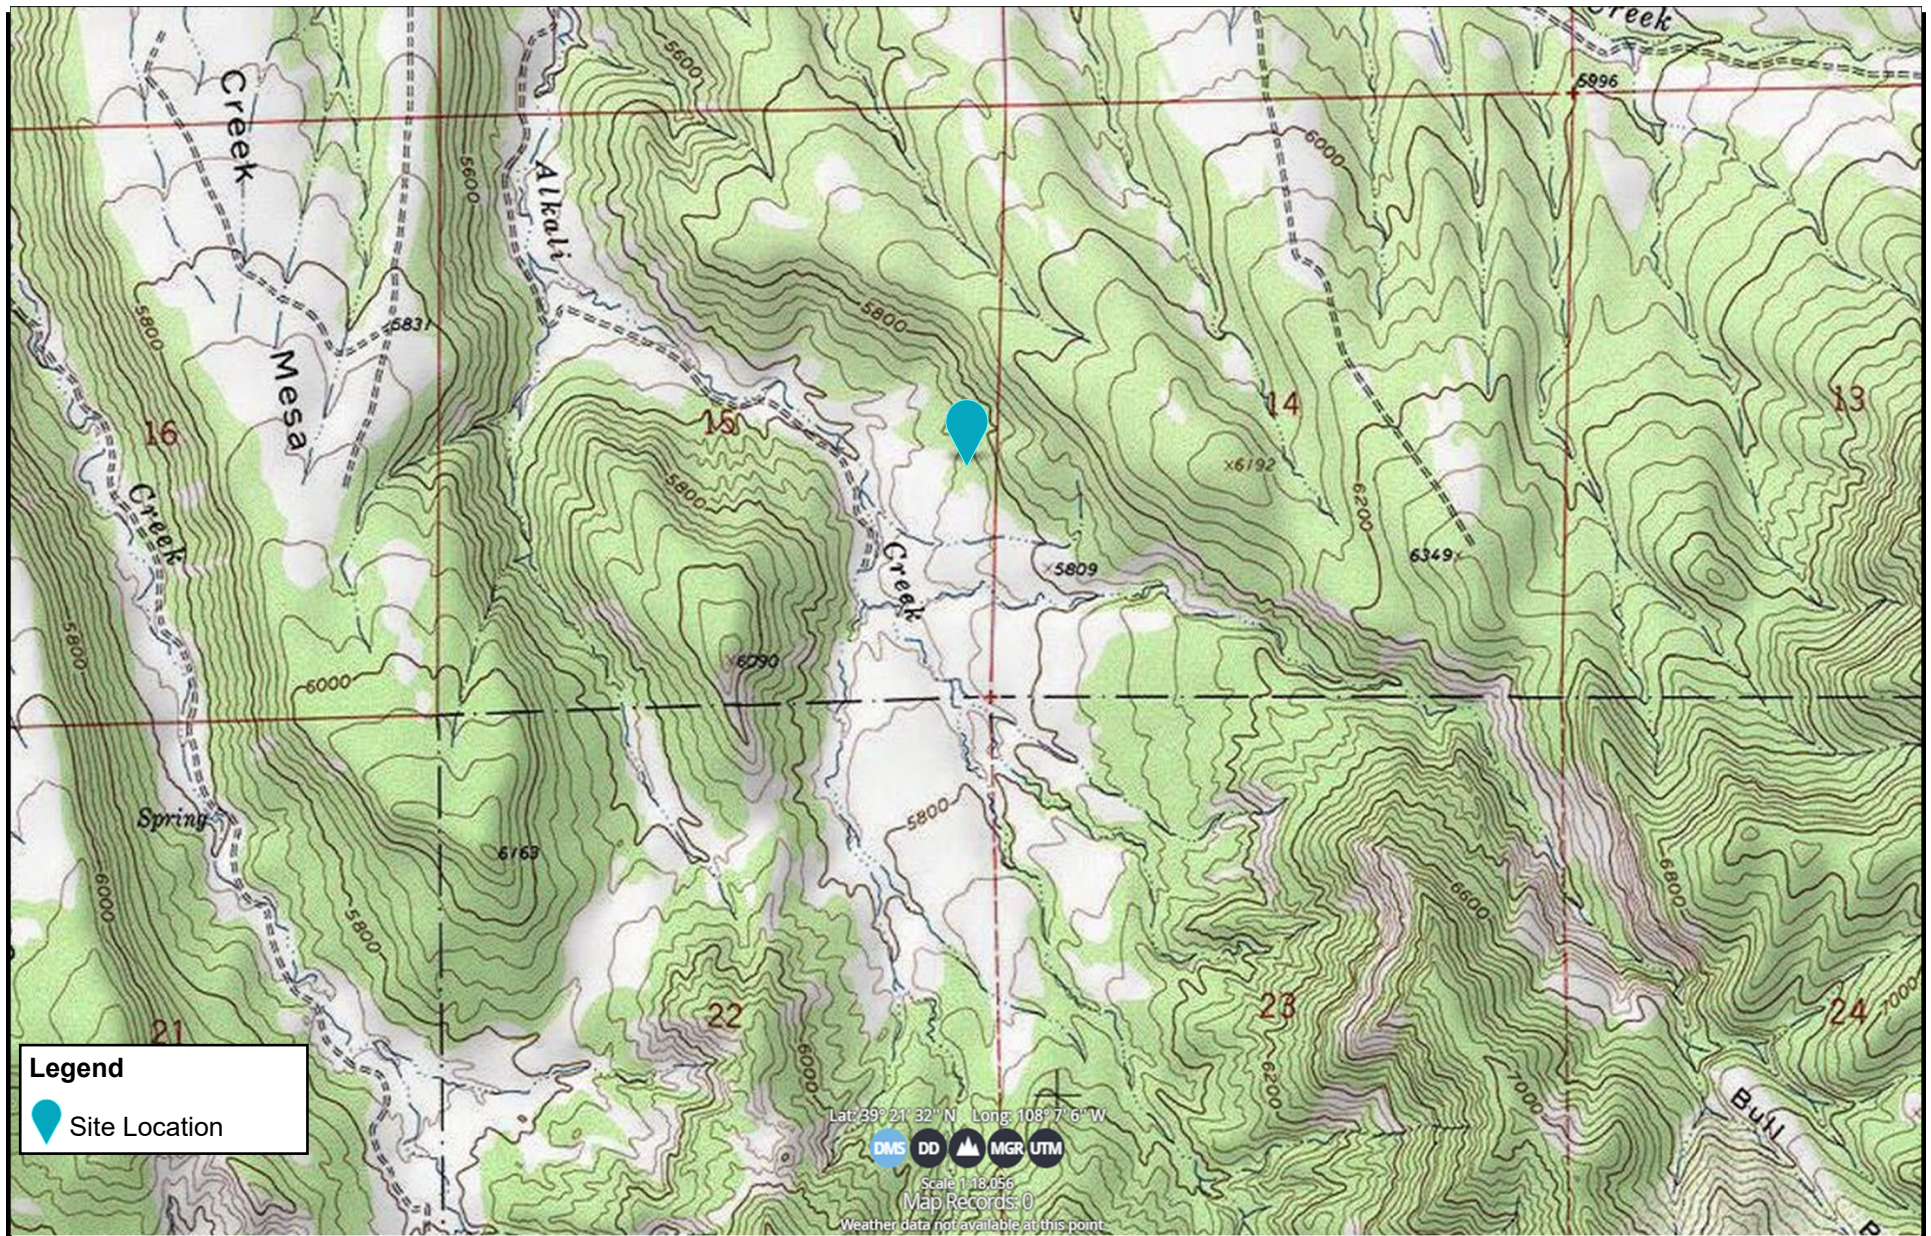
The OP15 to G15OU Pipeline is located within the Piceance Basin in Mesa County, Colorado (SESE, Section 15, Township 8 South, Range 96 West) (**Figure 1**). The Piceance Basin is a geologic structural basin consisting of sandstones and siltstones, containing reserves of coal, natural gas, and oil shale.

No surface water or groundwater were encountered during Kleinfelder's soil sampling activities. Adjacent land was observed to be rangeland. The general soil type within the pipeline removal area was classified based on Kleinfelder's field observations using the Unified Soil Classification System (USCS) and were observed as clayey gravels, gravel-sand-clay mixtures. Topographical information is provided on **Figure 1**.

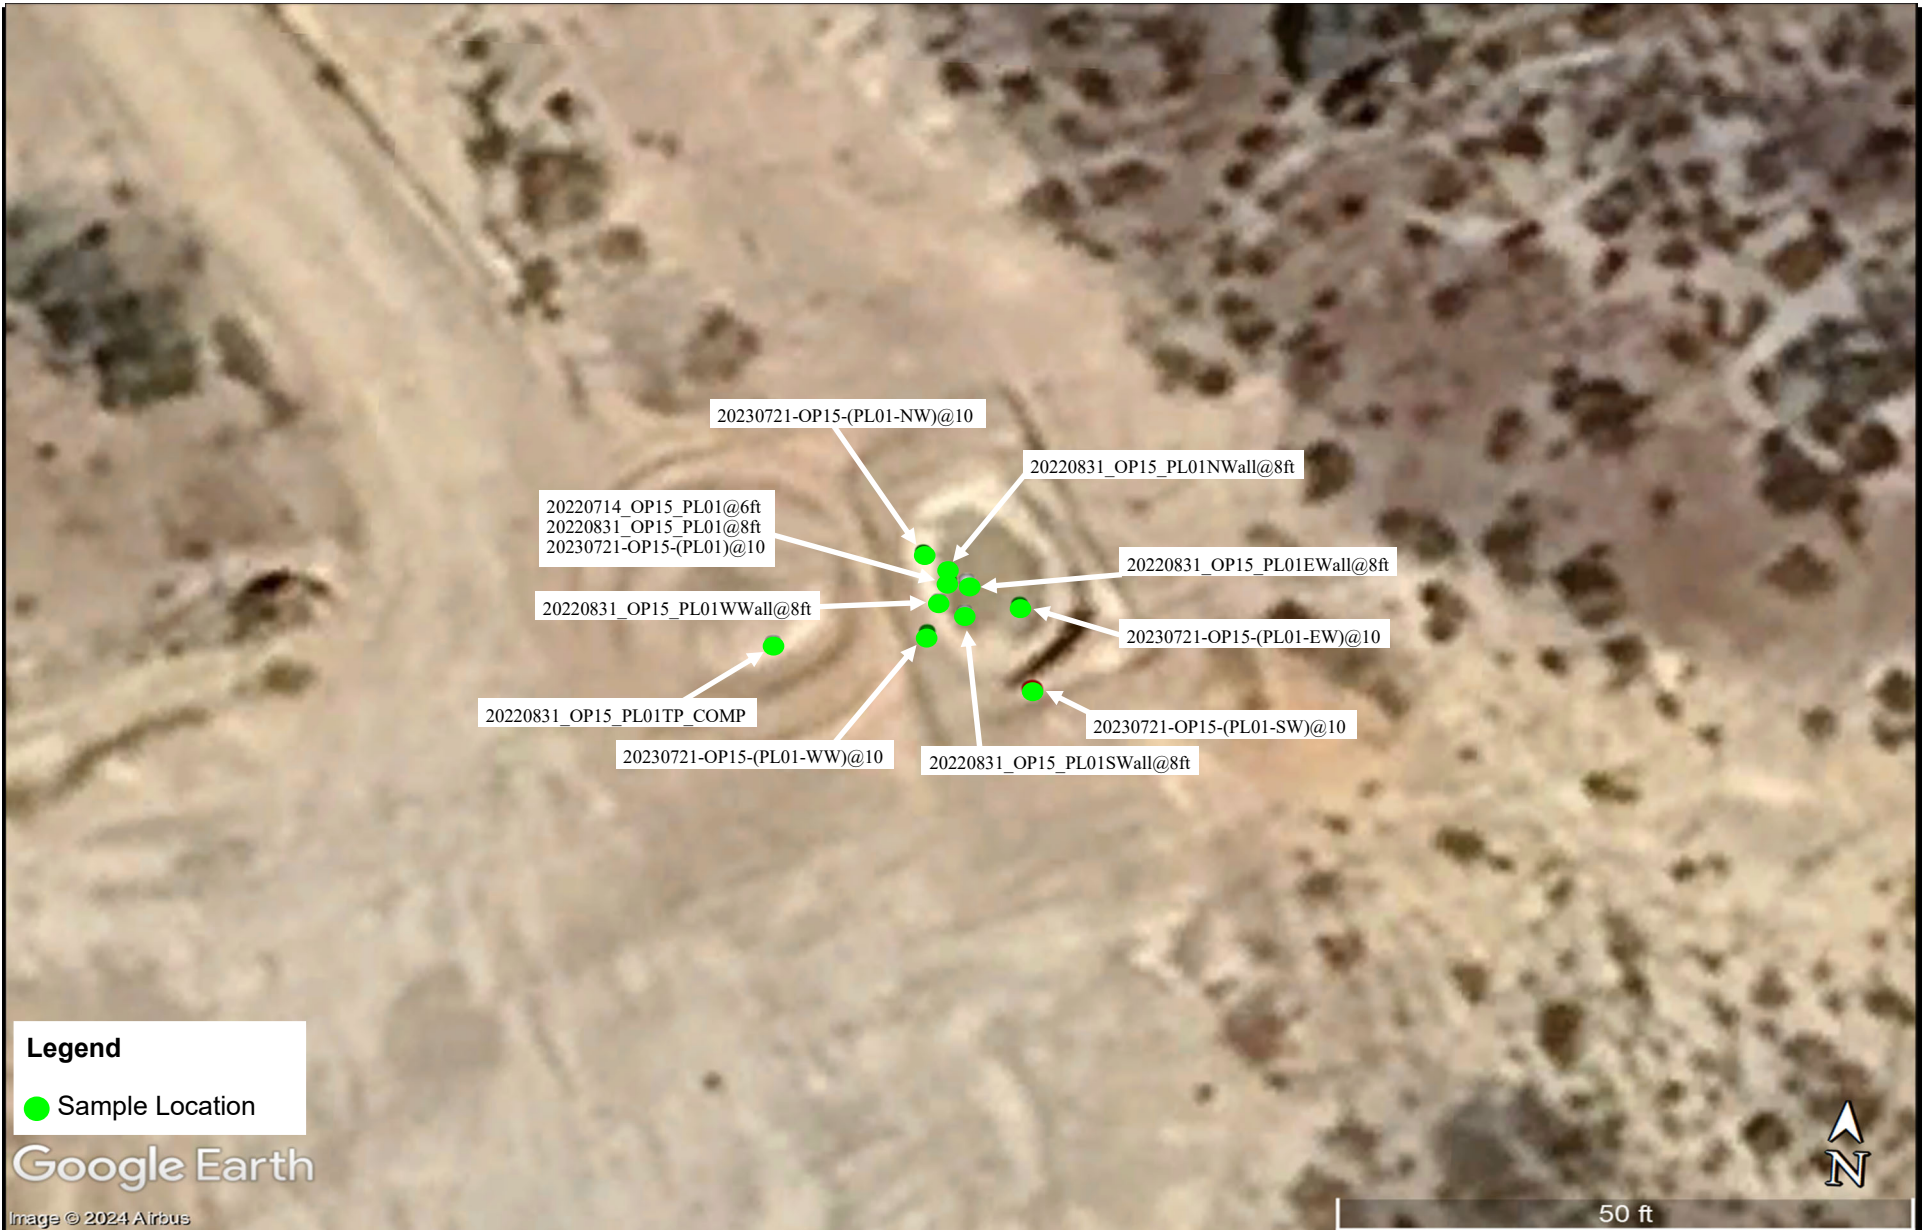
Prior to Kleinfelder's soil screening and sampling activities on July 14, July 27, August 31, and October 5, 2022, as well as July 21 and December 12, 2023, QB Energy identified all sample locations. Soil samples were collected from a stainless-steel hand trowel or stainless-steel hand auger and placed into laboratory-supplied, 9-ounce jars with Teflon lids. Each soil sample was collected directly from the hand trowel or trowel from the appropriate depth and placed into the glass jars. The produced fluid was collected directly from the tank loadout valve into a 1-liter polyethylene collection bottle with the aid of a QB Energy pumper. The samples were immediately placed on ice in a cooler. Standard chain-of-custody (COC) procedures were used during sampling and transportation to Pace in Mount Juliet, Tennessee (via FEDEX). Site soil samples were analyzed for full ECMC Table 915-1 analytes, and the produced fluid sample was analyzed for pH and arsenic. Kleinfelder used an EOS Arrow 100 Submeter Global Navigation Satellite Receiver (GNSS) to record latitude and longitude of the sample locations. Sample locations are shown on **Figures 2-5**.

Analytical results are summarized in **Table 2** and were compared to ECMC Table 915-1 RSSLs as requested by QB Energy. Soil sample locations are provided on **Figures 2-5**.
