# Final Reclamation Inspection

Operator: KERR MCGEE OIL & GAS ONSHORE LP - 47120

Location ID: 331947

Inspection Document #: 718800190

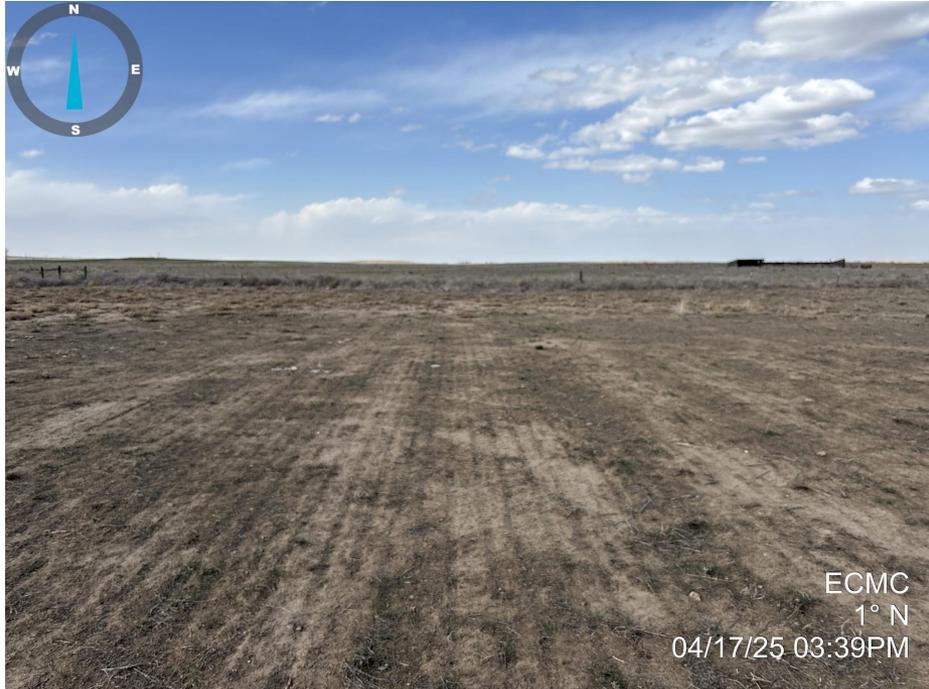
**Photo 1.** Photo taken from the well location, facing North. Operator has performed final reclamation activities with evidence of drill row seeding, however vegetation does not meet Rule 1004 final reclamation standards.

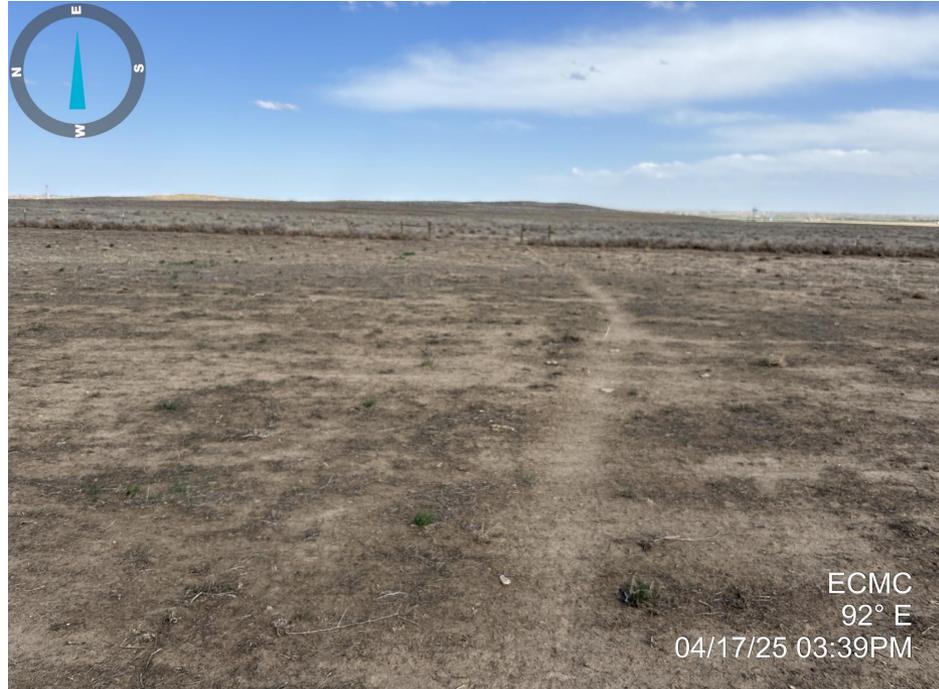
**Photo 2.** Photo taken from the well location, facing East. See comments under Photo 1.

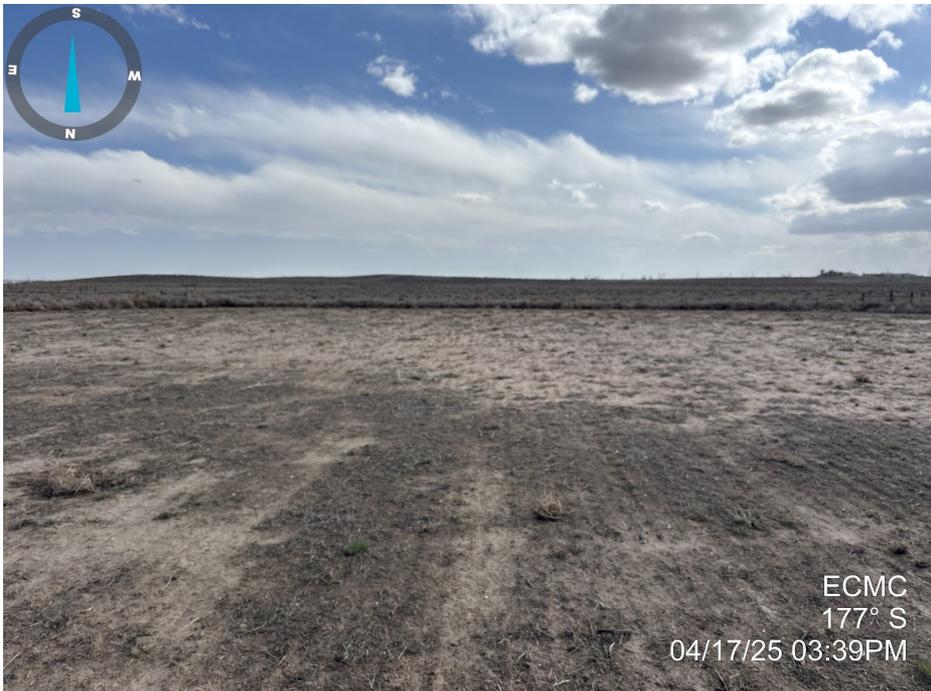
**Photo 3.** Photo taken from the well location, facing South. See comments under Photo 1.

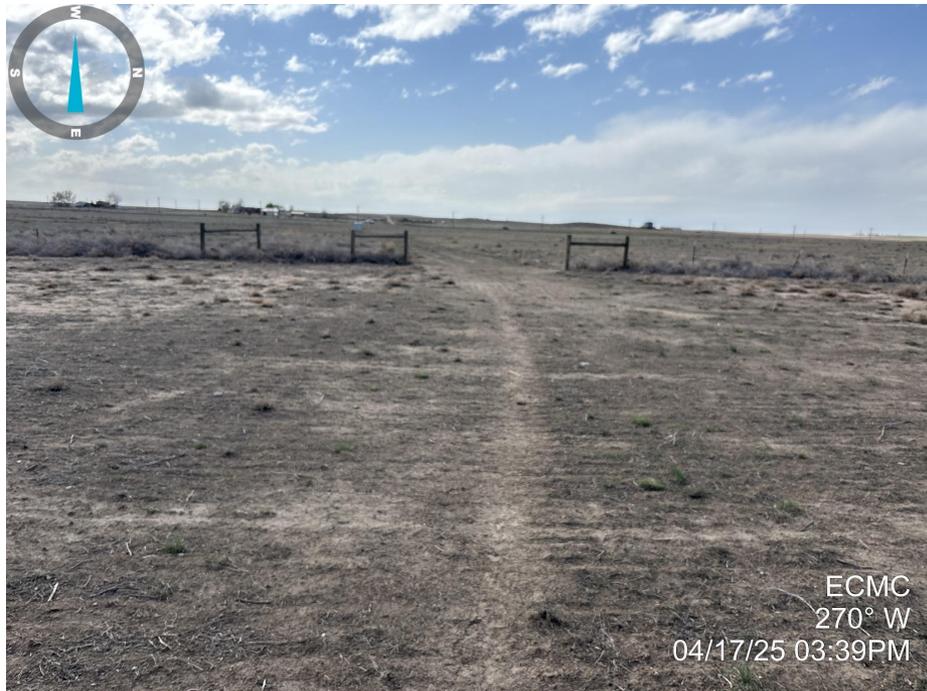
**Photo 4.** Photo taken from the well location, facing West. See comments under Photo 1.

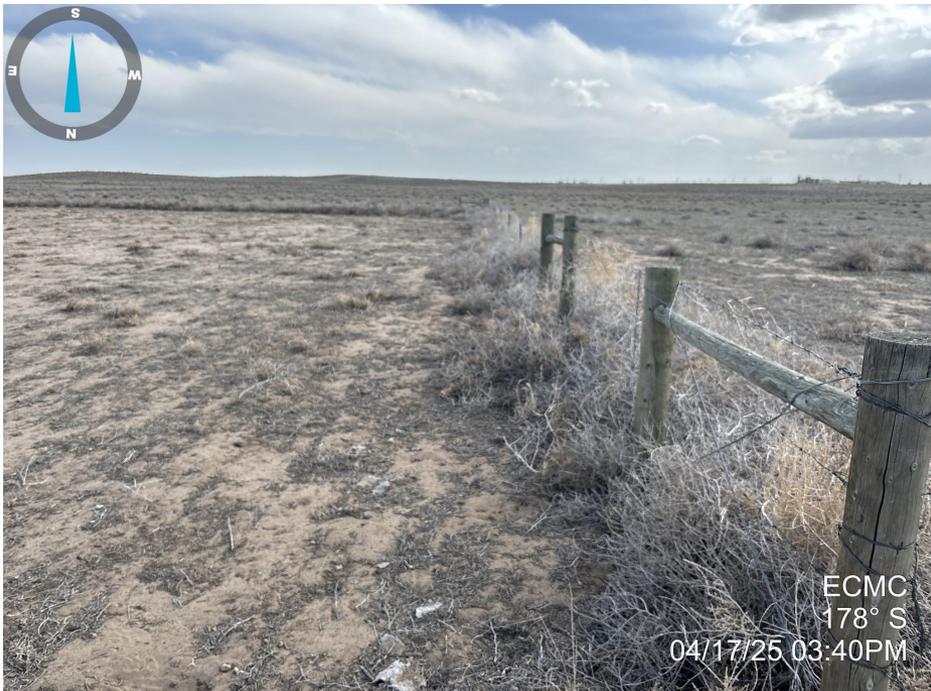
**Photo 5.** Photo taken from the perimeter of the well location, facing South. Photo illustrates barbed wire fencing that remains in place surrounding the well location. Russian thistle (*Salsola tragus*) was observed collected in the fence.

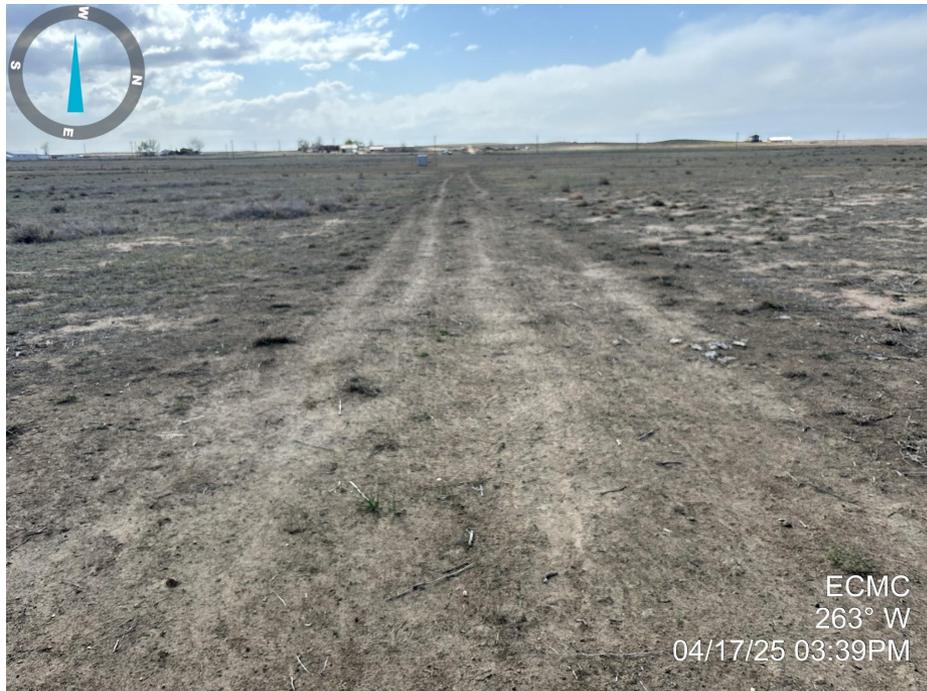
**Photo 6.** Photo taken from the access road, facing west, away from the well location. Photo illustrates that final reclamation activities have taken place, with evidence of drill rows, but vegetation establishment does not meet final reclamation standards.

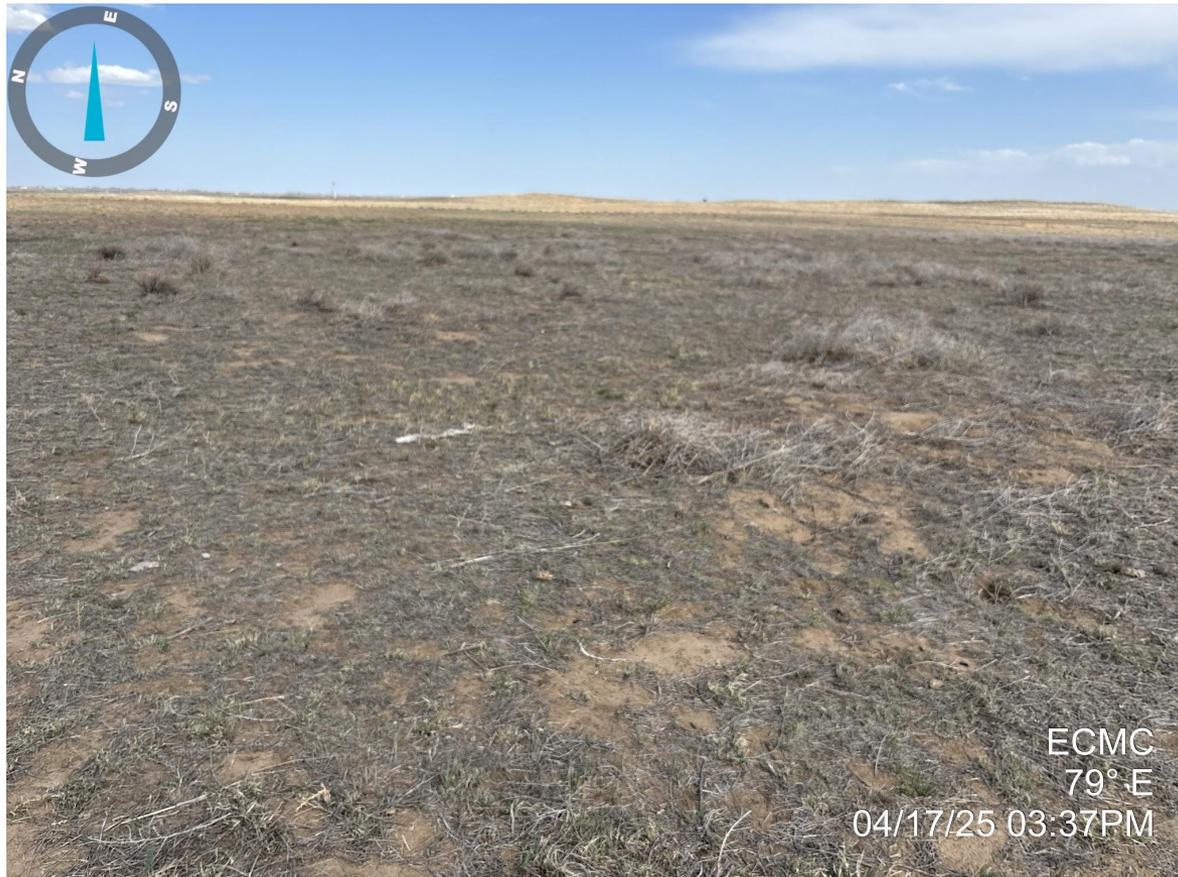
**Photo 7.** Photo taken from the reference area, north of the well location, facing East. Photo illustrates that the reference location is disturbed rangeland with bare ground patches and shrub and perennial grass vegetation.
