Final Reclamation Inspection

Operator: KERR MCGEE OIL & GAS ONSHORE LP - 47120

Location ID: 327880

Inspection Photos
Location Name: UPRC #29-6J
Location ID: 327880

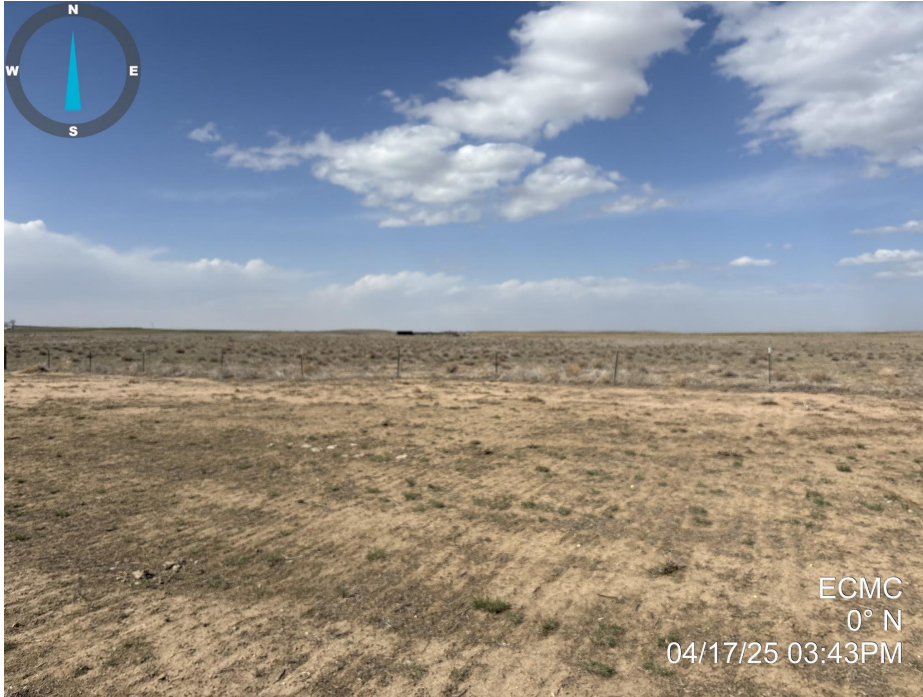
Photo 1. Photo taken from the well location, facing North. Operator has performed final reclamation activities with evidence of drill row seeding, however vegetation does not meet Rule 1004 final reclamation standards.

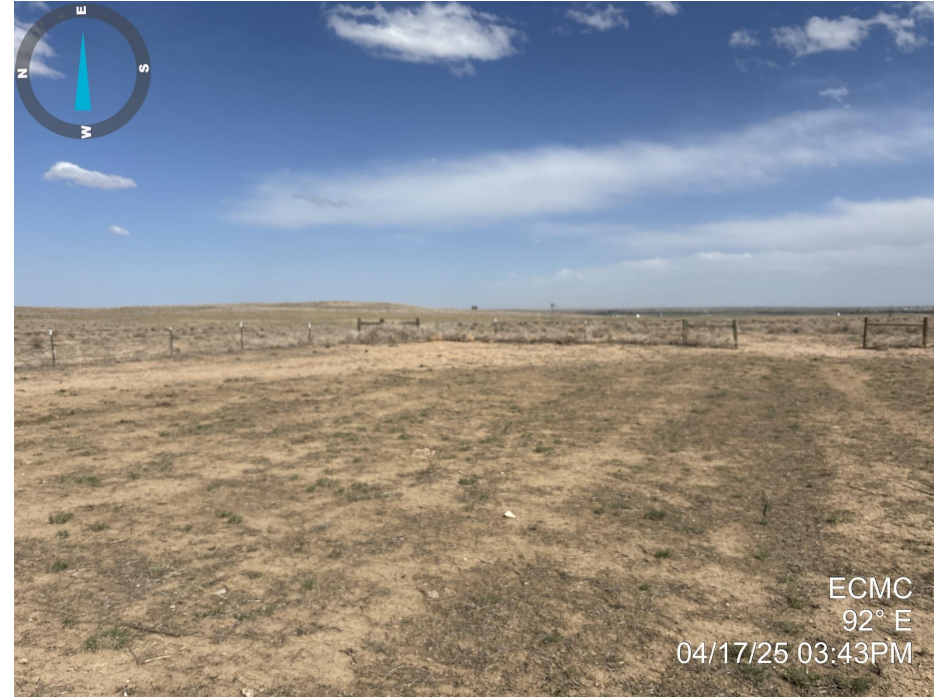
Photo 2. Photo taken from the well location, facing East. See comments under Photo 1.

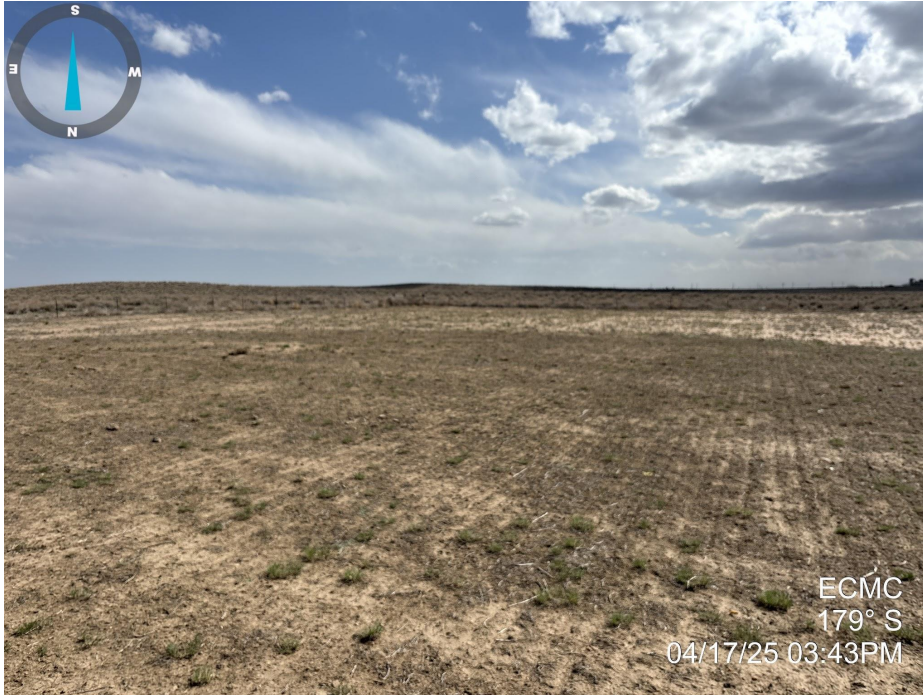
Photo 3. Photo taken from the well location, facing South. See comments under Photo 1.

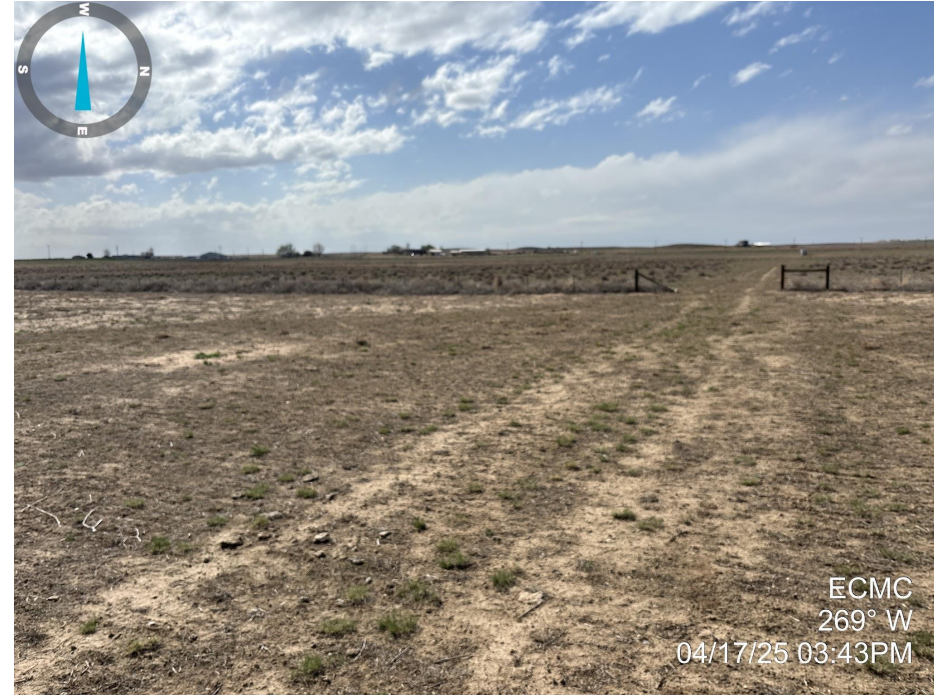
Photo 4. Photo taken from the well location, facing West. See comments under Photo 1.

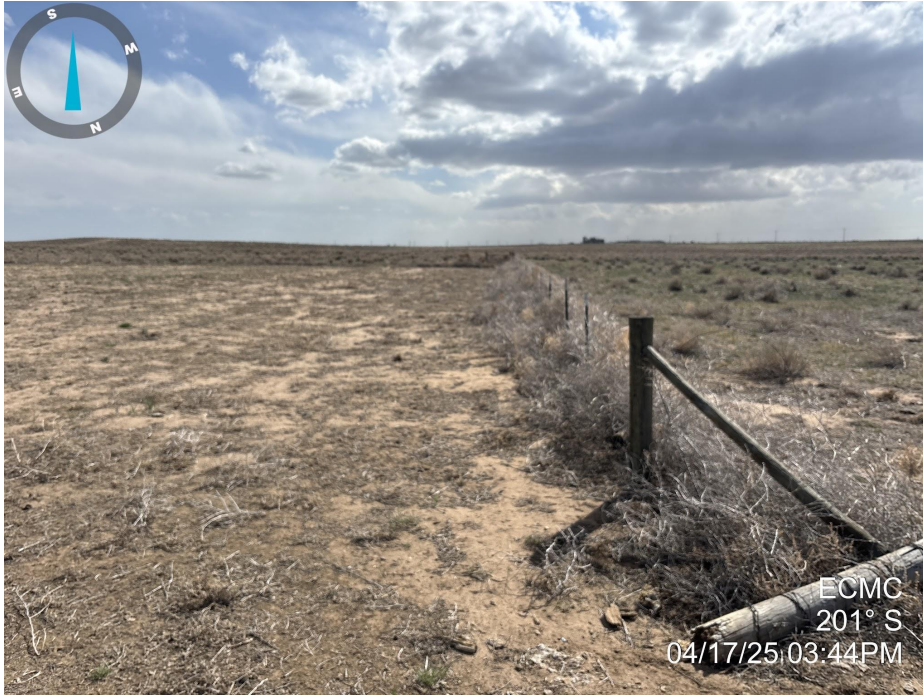
Photo 5. Photo taken from the perimeter of the well location, facing South. Photo illustrates barbed wire fencing in disrepair that remains in place surrounding the well location. Russian thistle (*Salsola tragus*) was observed collected in the fence.

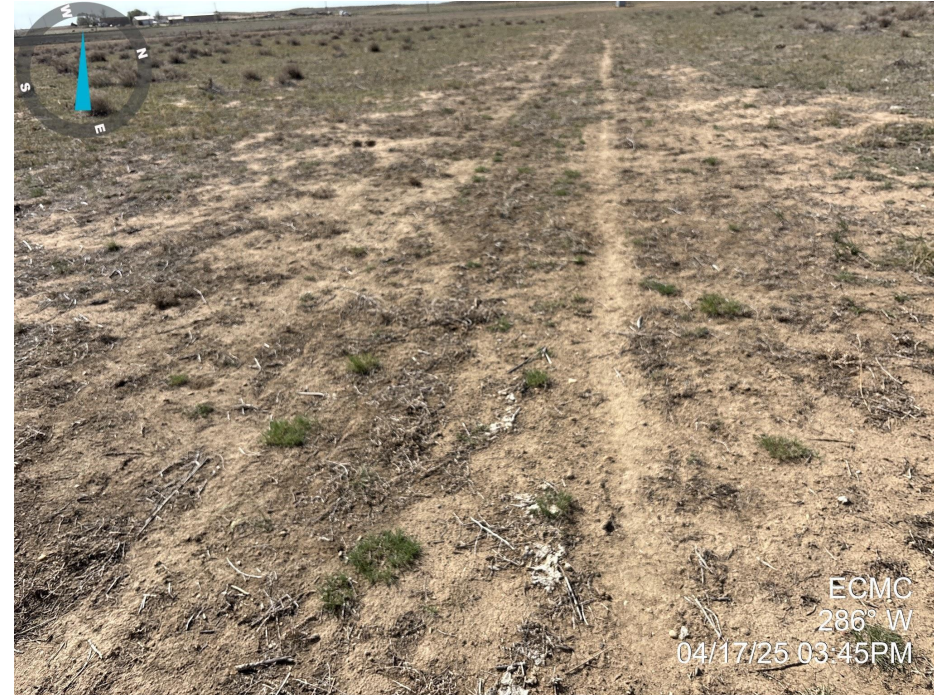
Photo 6. Photo taken from the access road, facing west, away from the well location. Photo illustrates that final reclamation activities have taken place, with evidence of drill rows, but vegetation establishment does not meet final reclamation standards.

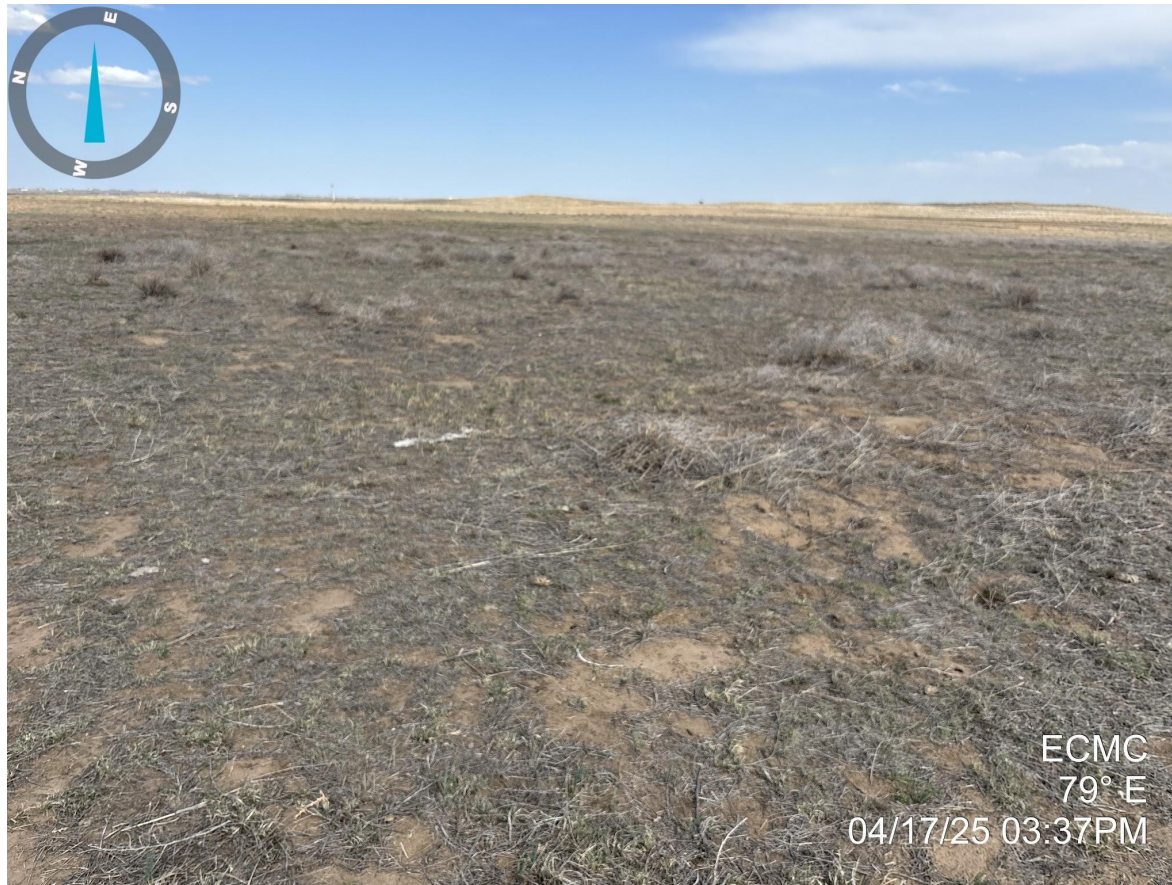
Photo 7. Photo taken from the reference area, north of the well location, facing East. Photo illustrates that the reference location is rangeland with bare ground patches and shrub and perennial grass vegetation.
