Final Reclamation Inspection

Location ID: 417179

Inspection Document #: 718800230

Inspection Photos
Location Name: COTTONWOOD TANK
BATTERY #12-33
Location ID: 417179

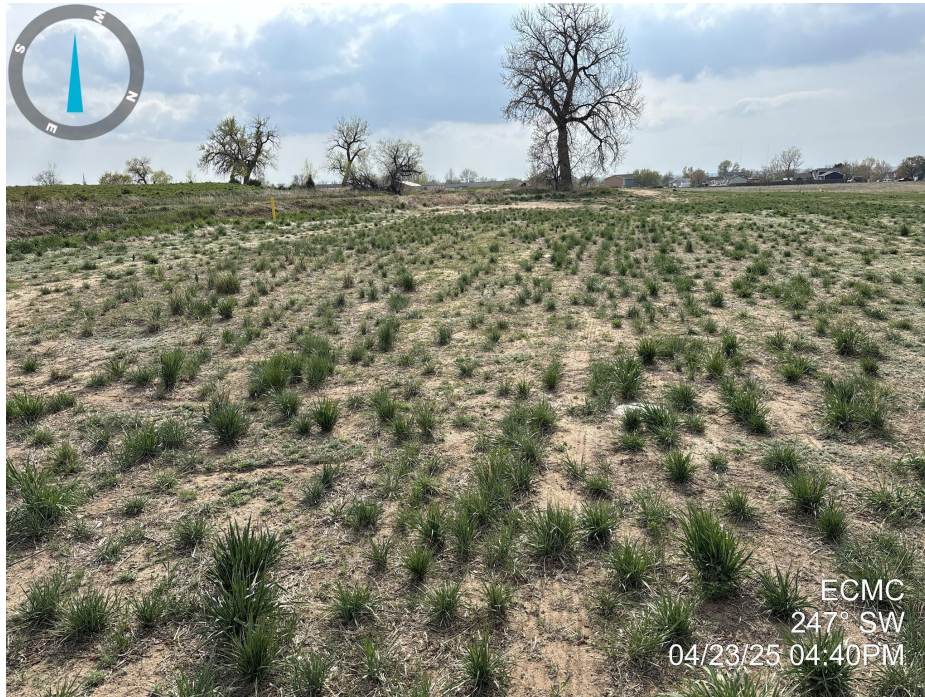
Photo 1. Photo taken from the tank battery location, facing Southwest. Photo illustrates that final reclamation has taken place, with evidence of drill rows from reseeded.

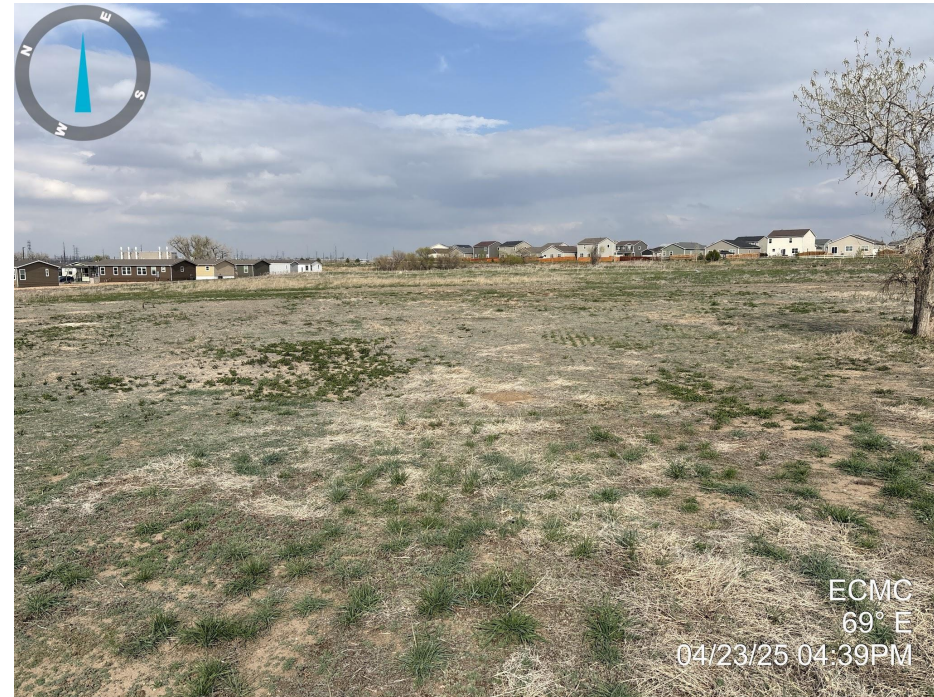
Photo 2. Photo taken from the tank battery location, facing East. See comments under Photo 1.

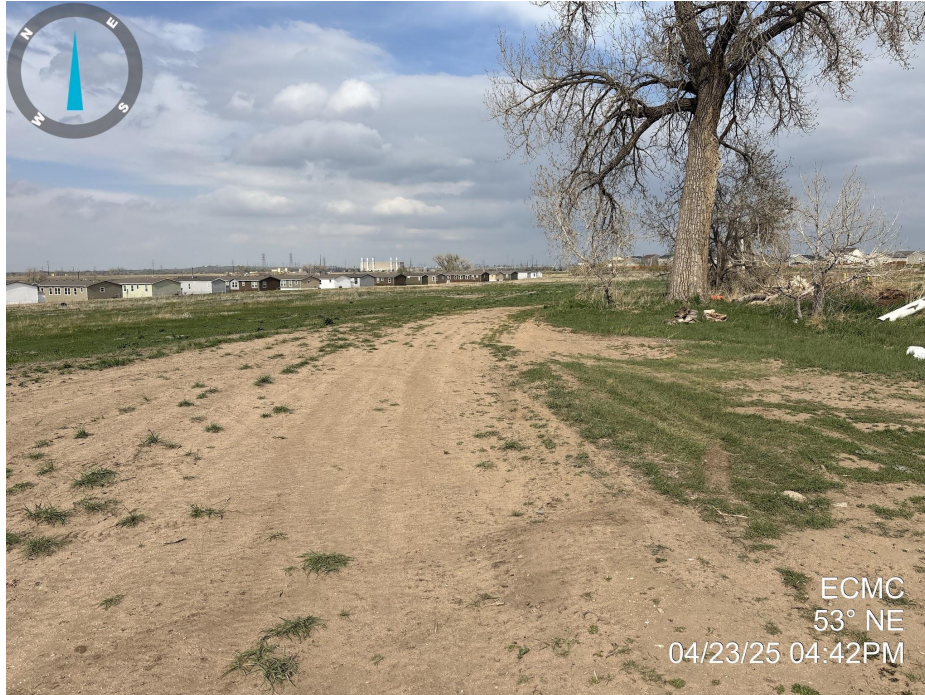
Photo 3. Photo taken from the access road, facing northeast, towards the location. Photo illustrates that access road has not been reclaimed.

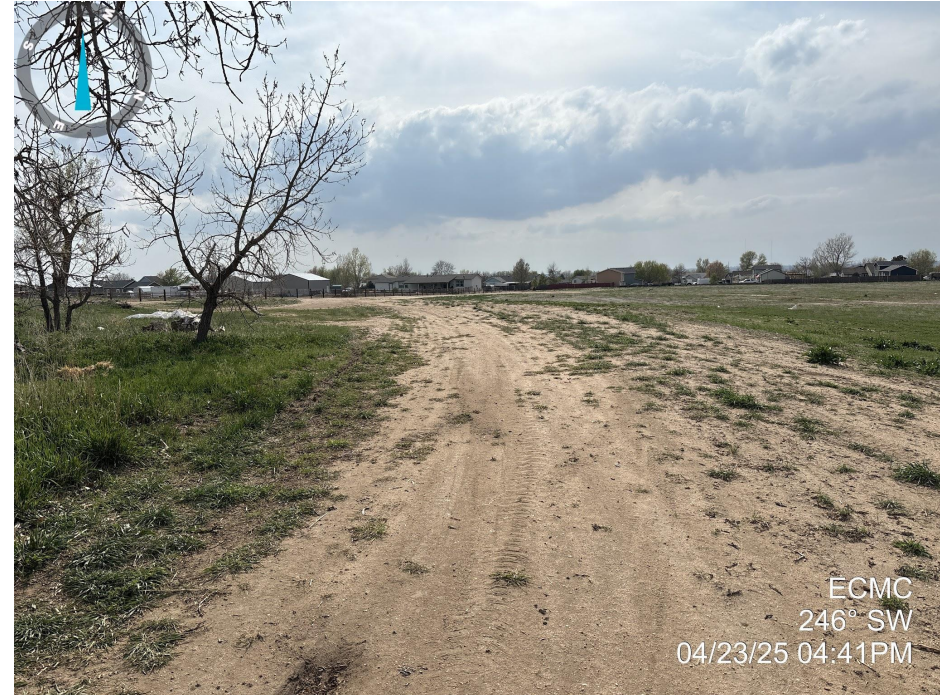
Photo 4. Photo taken from the access road, facing Southwest, away from the location. See comments under Photo 3.

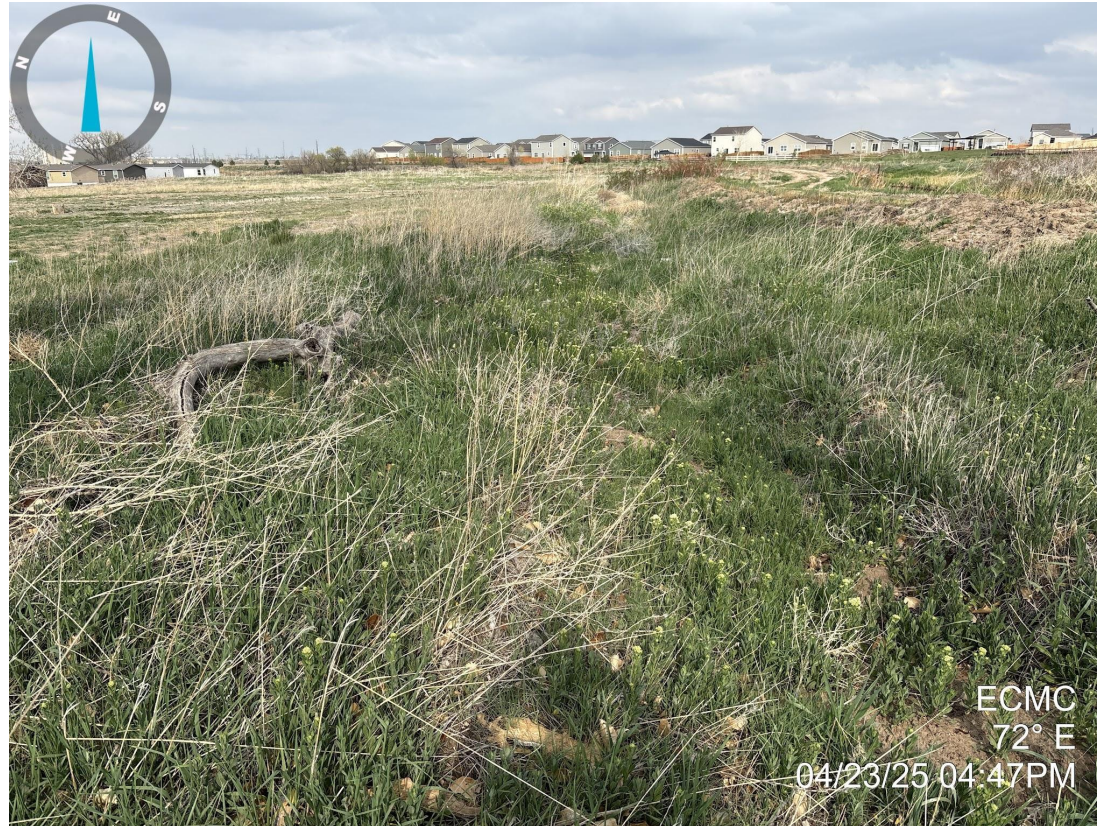
Photo 5. Photo taken of the reference area, south of the location, facing East. Photo illustrates area is dominated by perennial grass vegetation.
