WELL NAME: BURRO CANYON 34-28, API #: 071-06112, INSP. # 716300978

COLORADO
Energy & Carbon Management
Commission
Department of Natural Resources

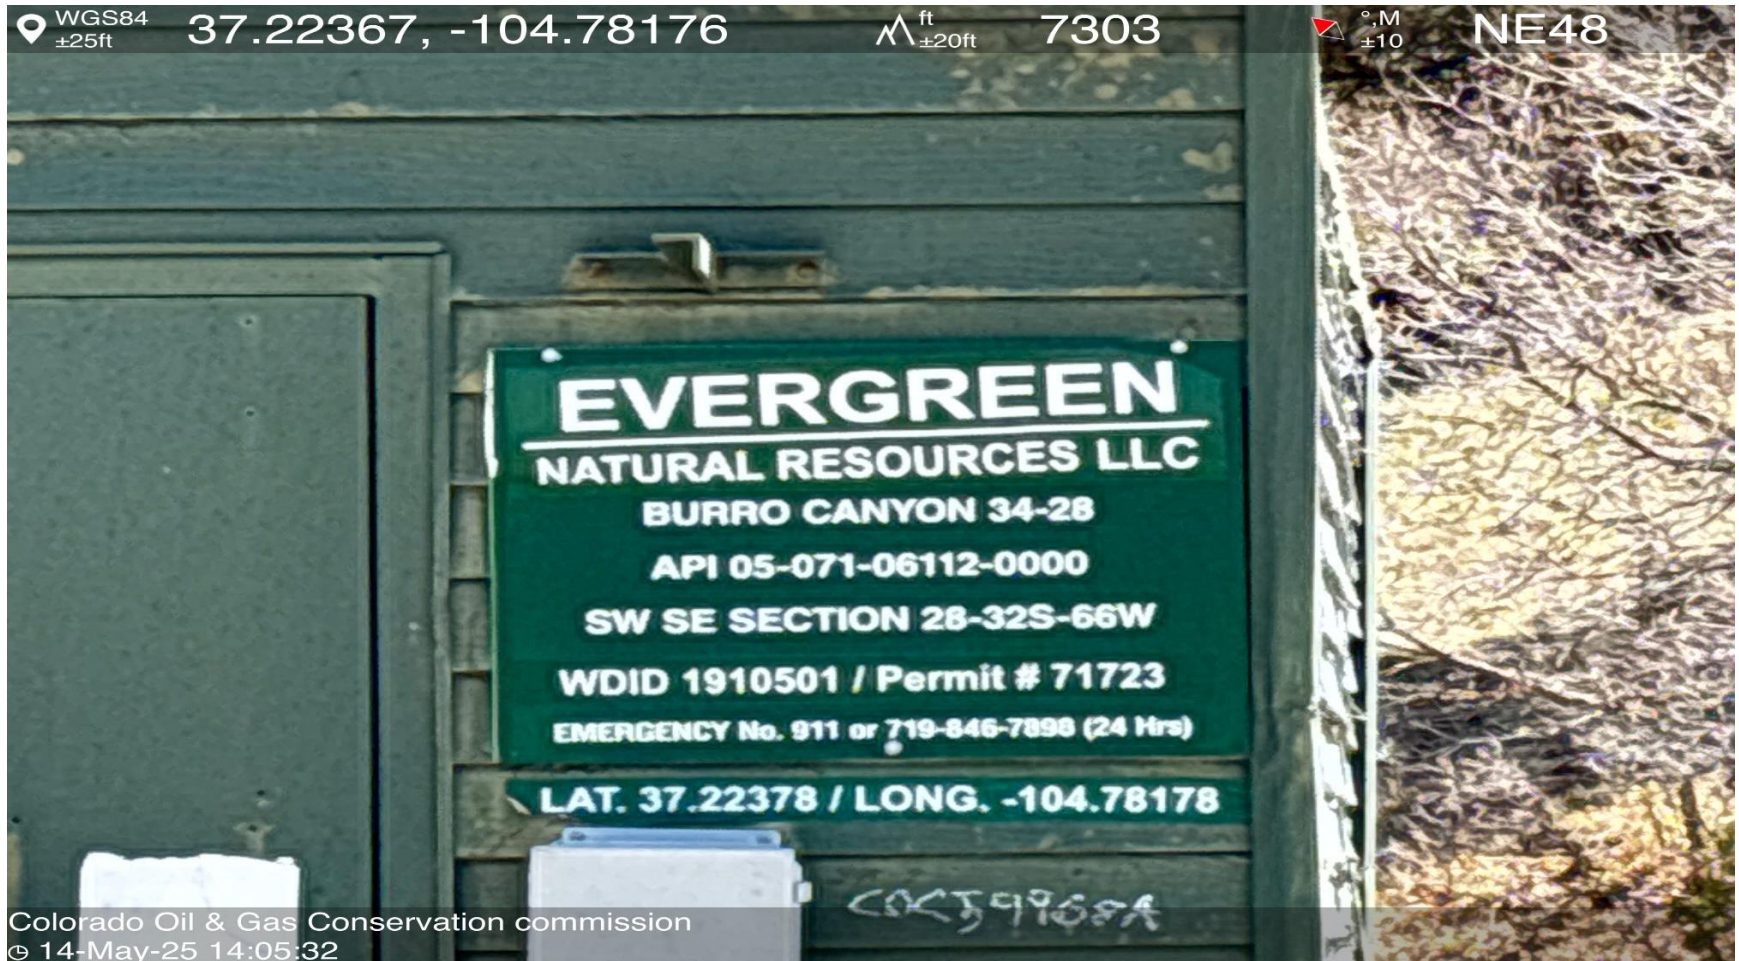
PHOTO 1: WELL SIGN

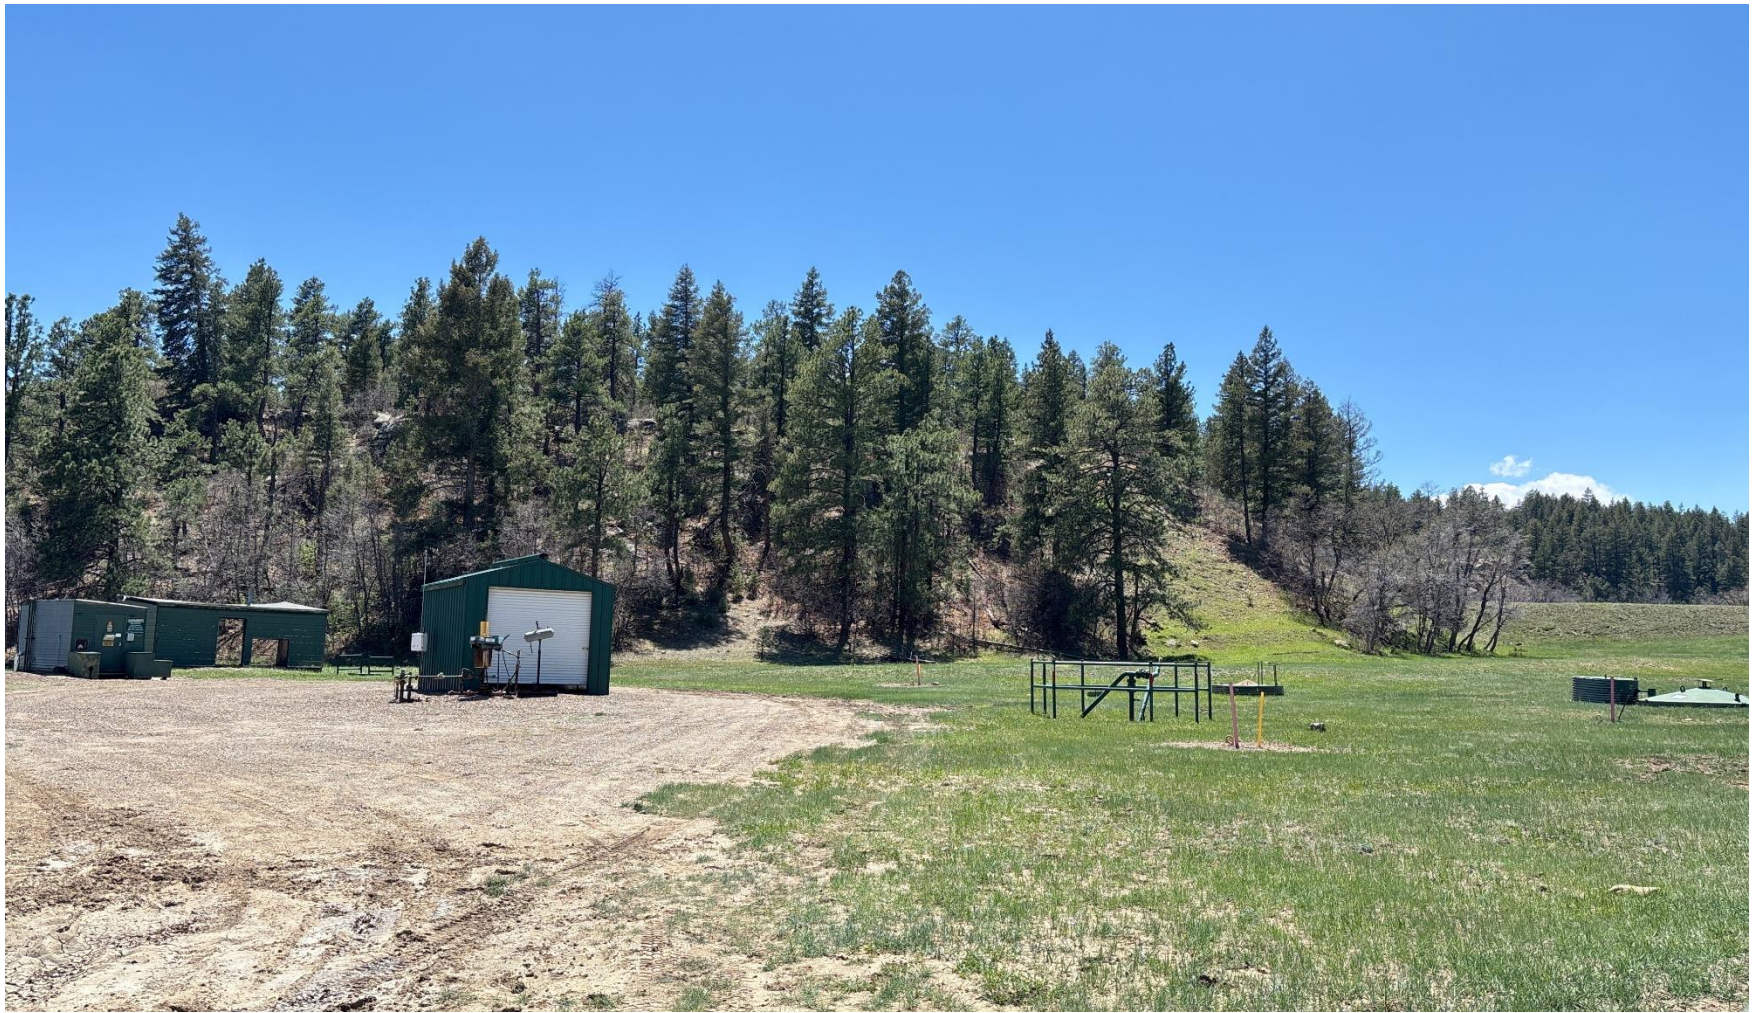
PHOTO 2: LOCATION.

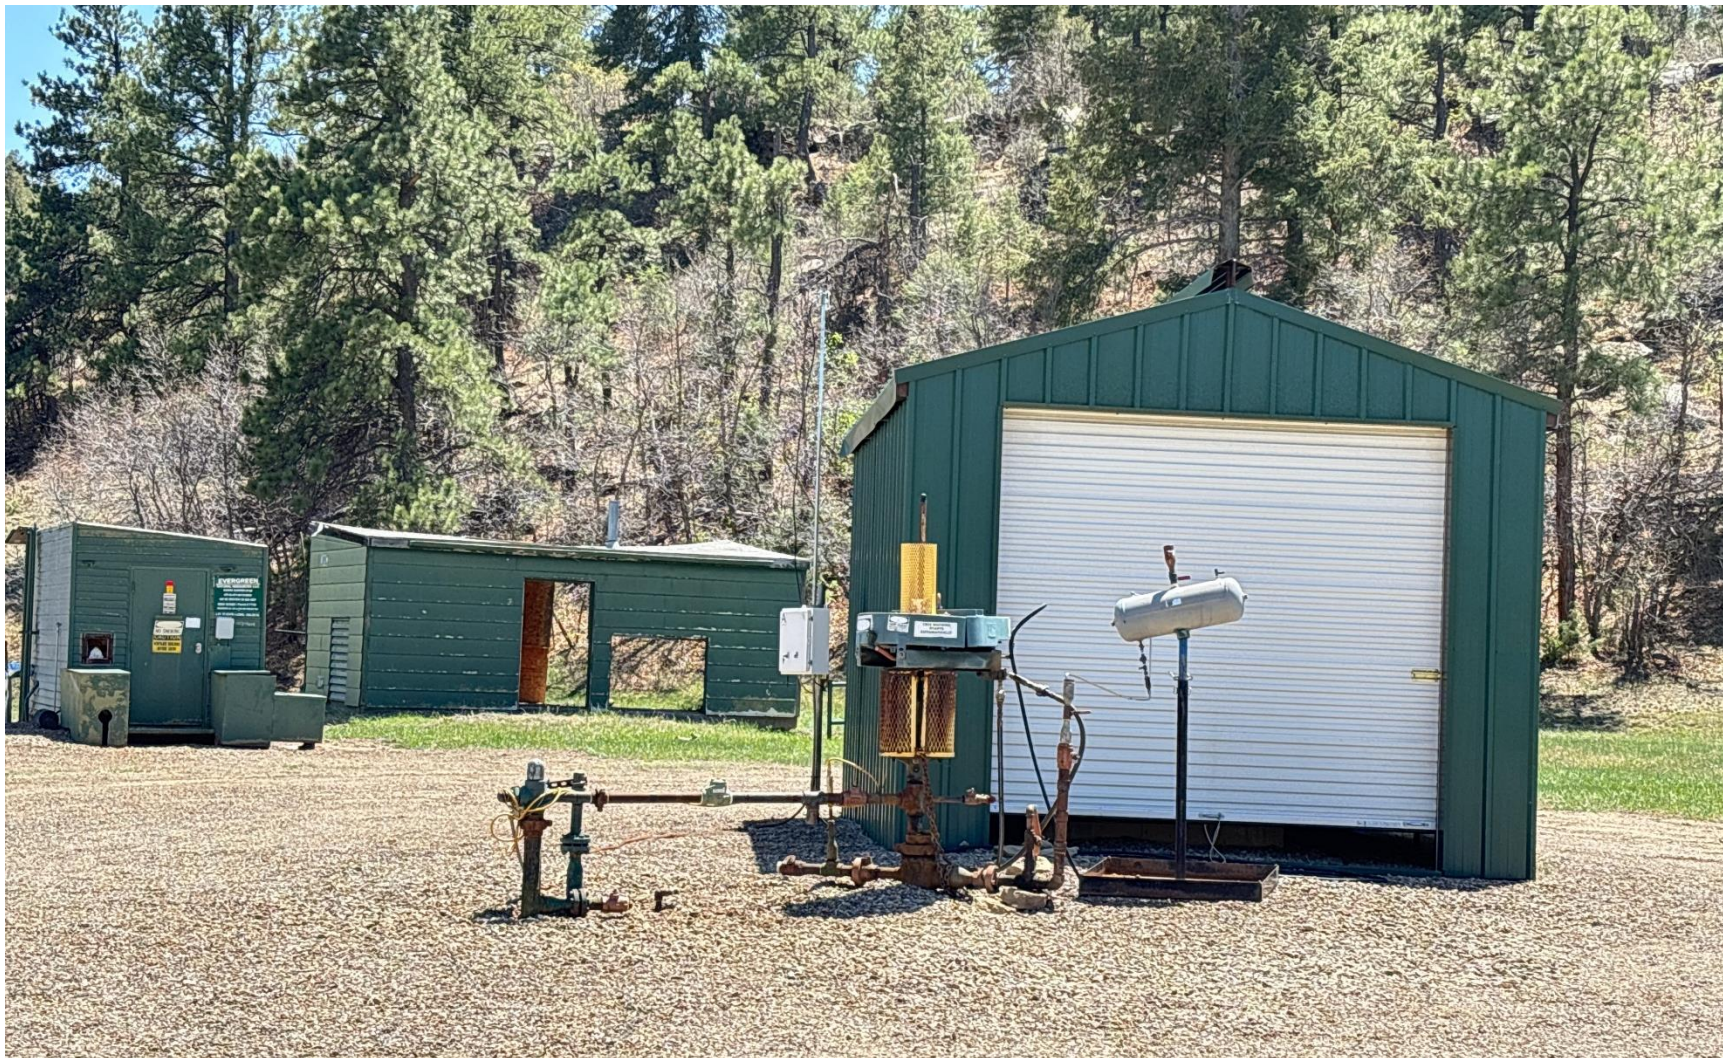
PHOTO 3: WELLHEAD AND EQUIPMENT.

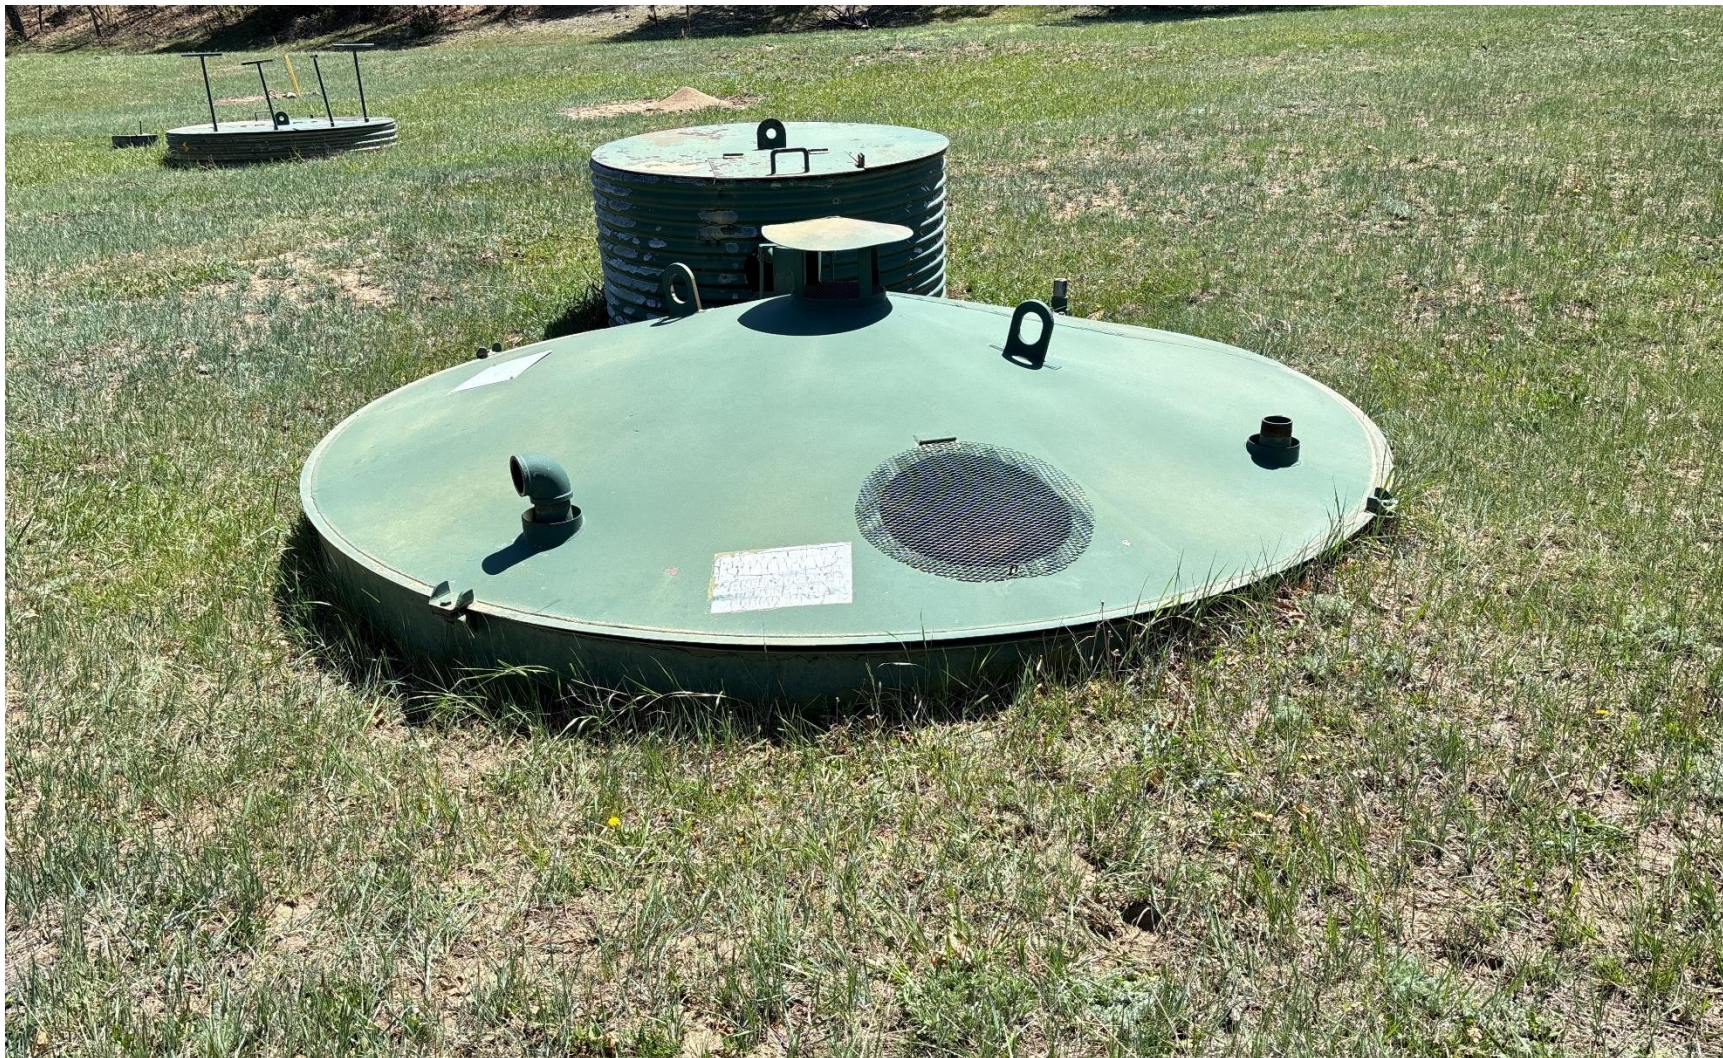
PHOTO 4: PRODUCED WATER TANK BATTERY. NFPA, CAPACITY AND CONTENTS NOT LABELED ON TANK. Install sign to comply with Rule 605.h. CA DATE 5/19/2025.

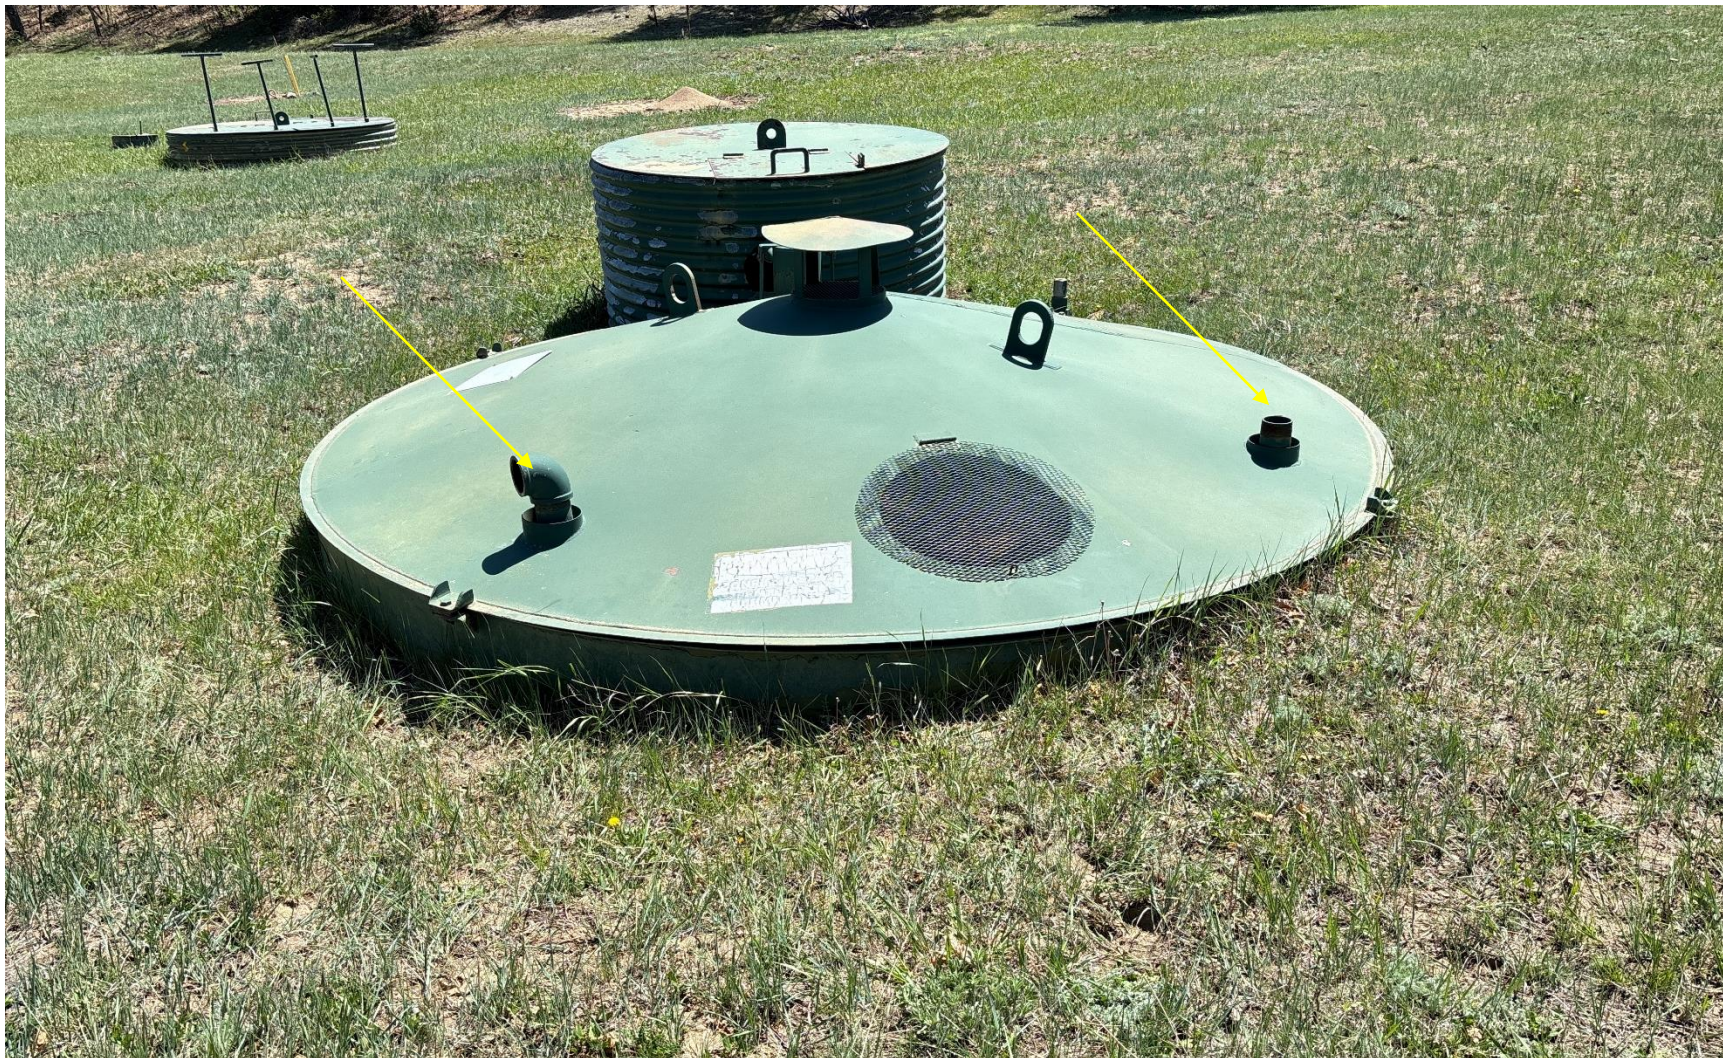
PHOTO 5: BIRD PROTECTORES MISSING OR NOT INSTALLED ON TWO PIPES IN TOP OF TANK. **INSTALL BIRD PROTECTORS. CA**
DATE 5/19/2025.

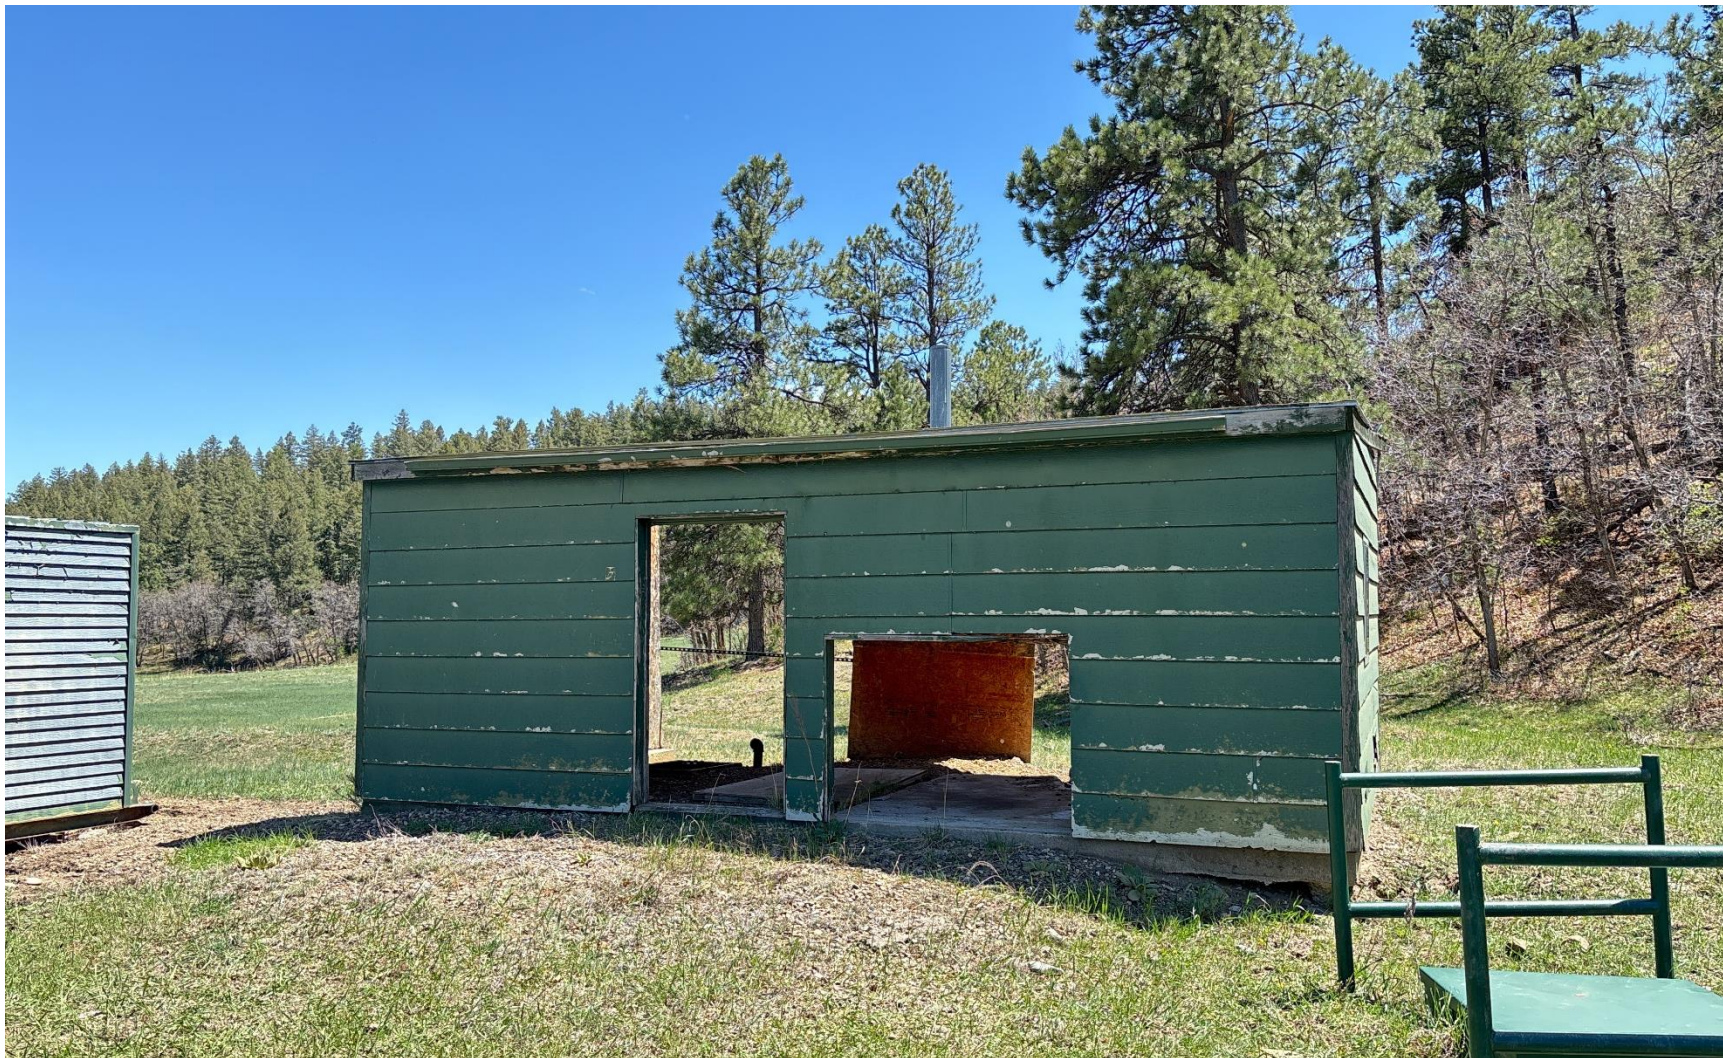
PHOTO 6: UNUSED EQUIPMENT (SHED DOES NOT APPEAR TO BE IN USE OR USEFUL TO THE OPERATION OF THIS FACILITY, SHED IS DETERIORATING AND TRASH AND DEBREE FROM SHED IS ON AND AROUND LOCATION). REMOVE UNUSED EQUIPMENT PER RULE 606. CA DATE 6/14/2025.

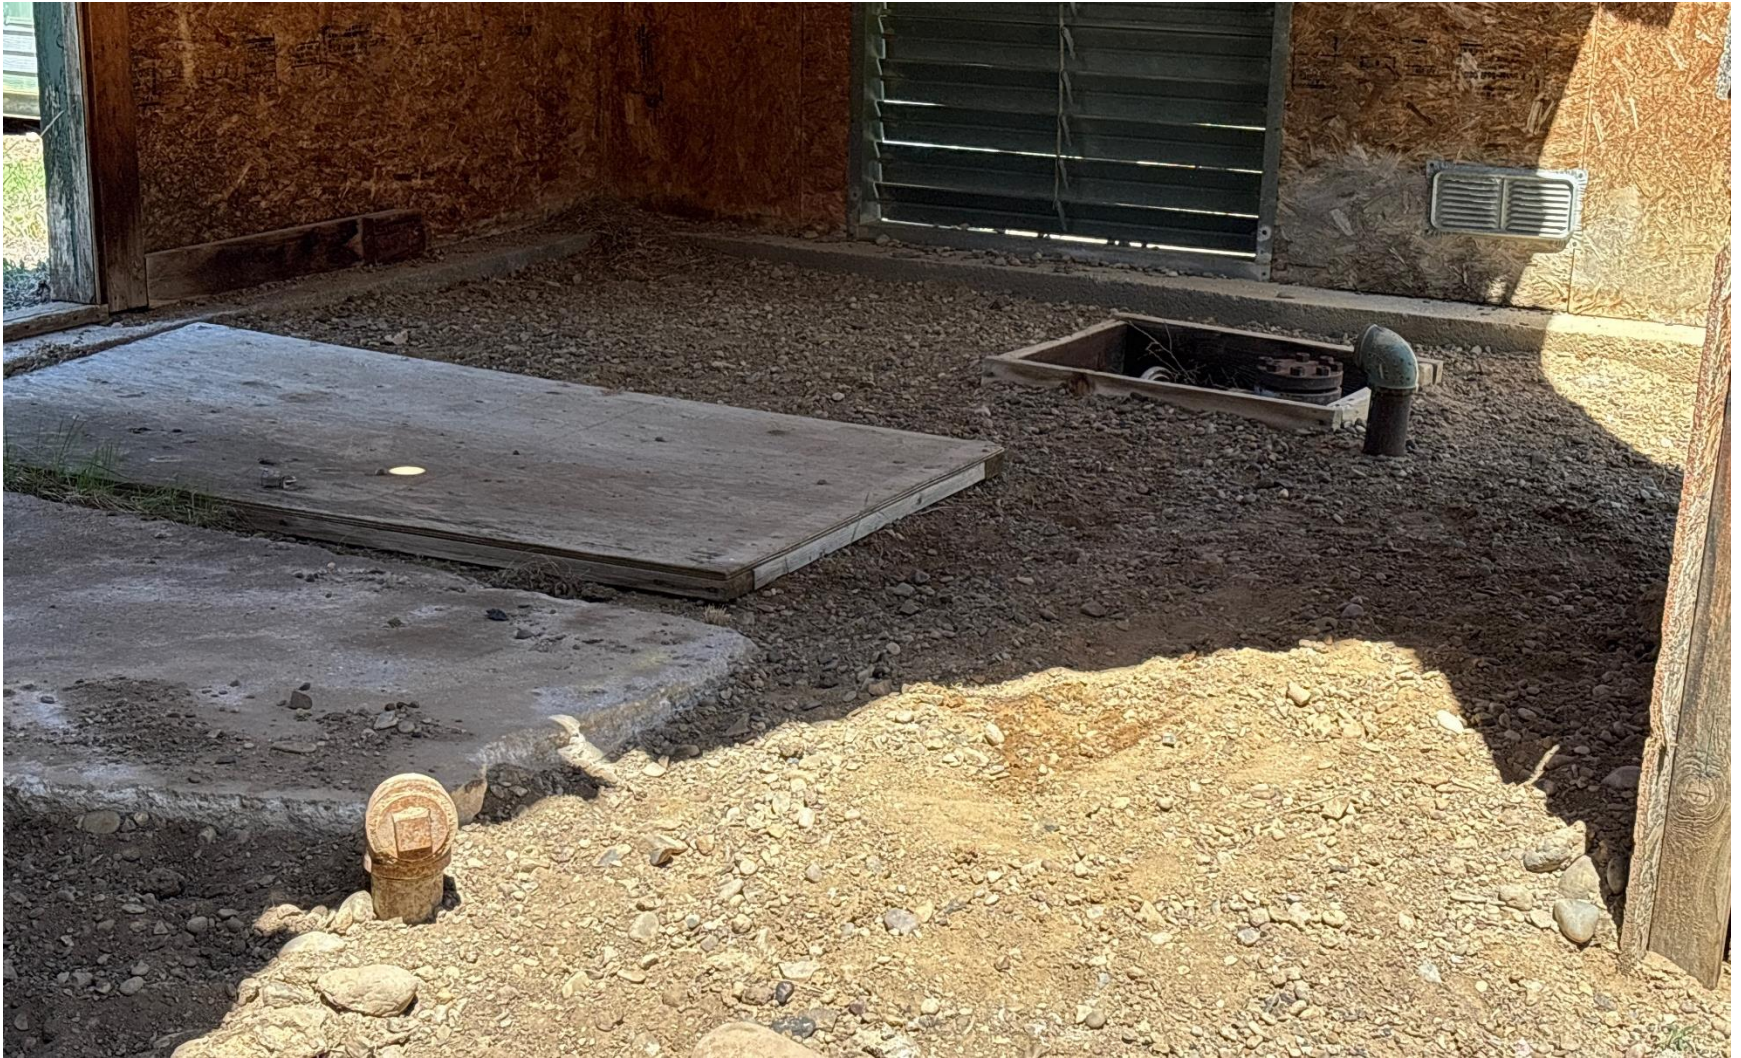
**PHOTO 7: UNUSED EQUIPEMENT (UNUSED RISERS NOT MARKED OR LABELED INSIDE UNUSED SHED). MARK OR REMOVE
UNUSED AND OR UNNESSESARY RISERS PER RULE 606. CA DATE 6/14/2025.**

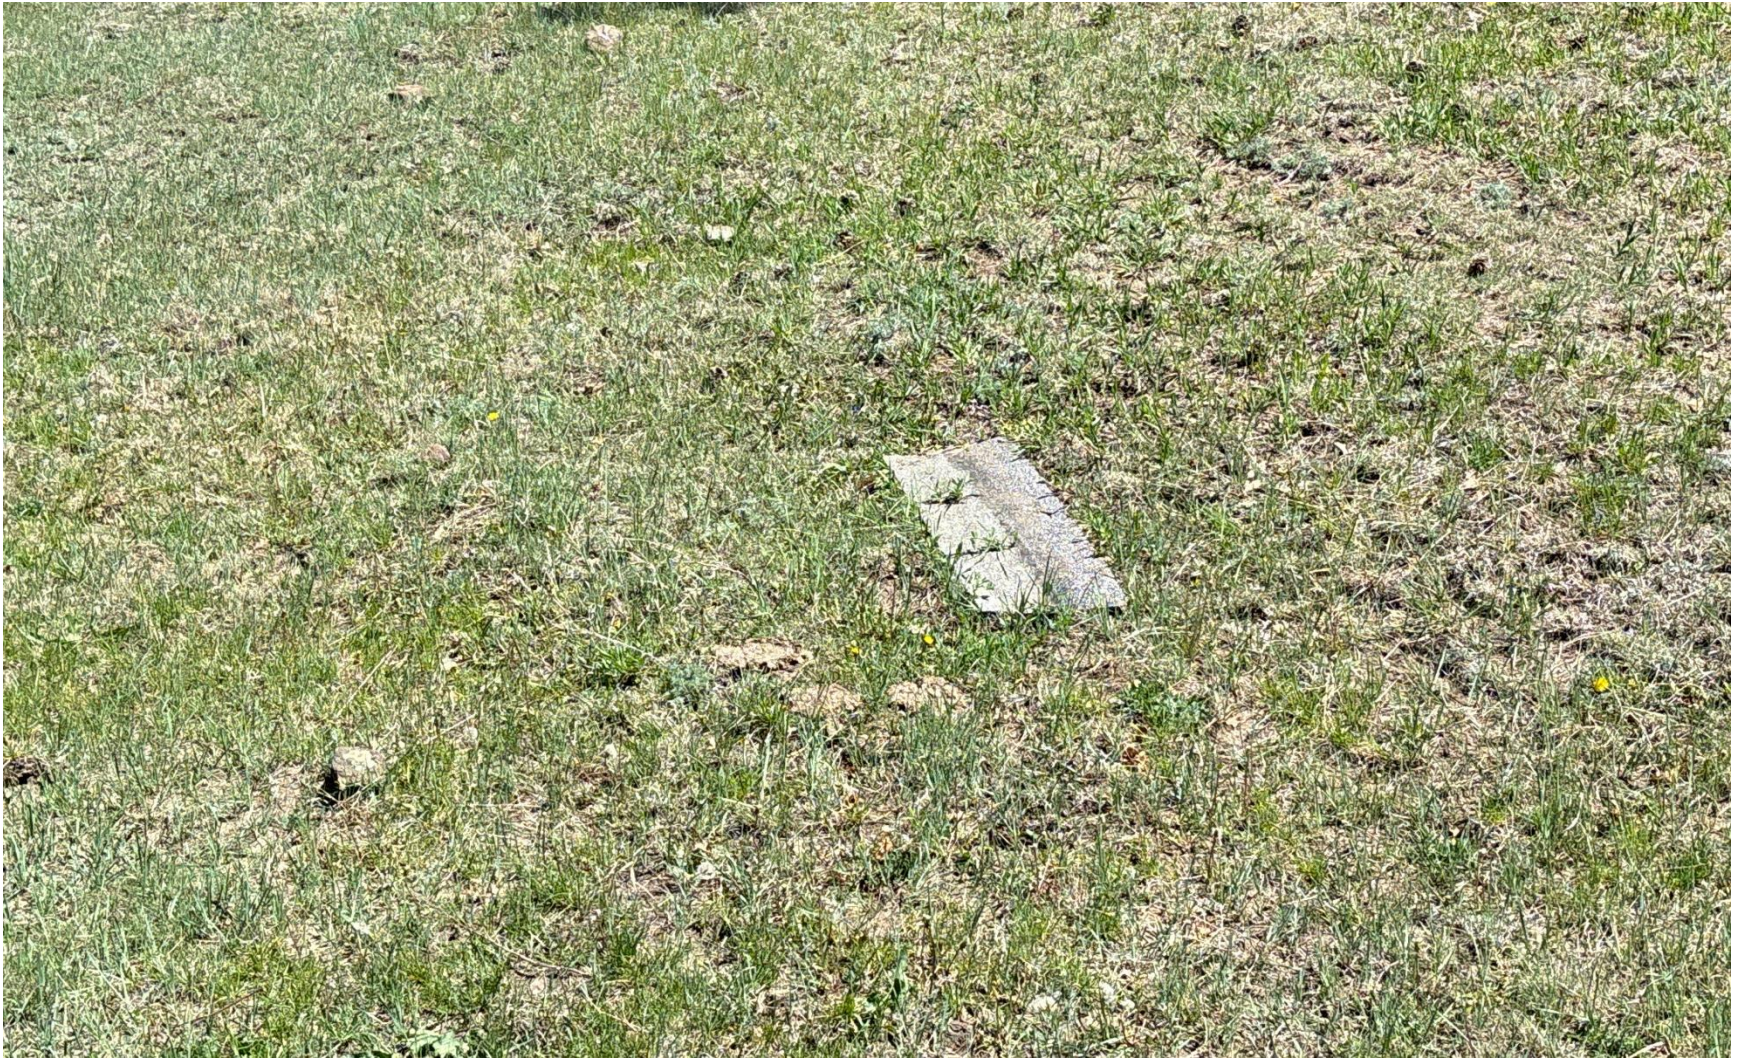
PHOTO 8: TRASH AND OR DEBREE FROM DETERIORATING SHED ON AND AROUND LOCATION MOSTELY TO THE SOUTH AND SOUTHEAST OF SHED. INSPECT AND REMOVE ALL TRASH AND DEBREE FROM LOCATION AND SURROUNDING AREA PER RULE 606. CA DATE 5/19/2025.

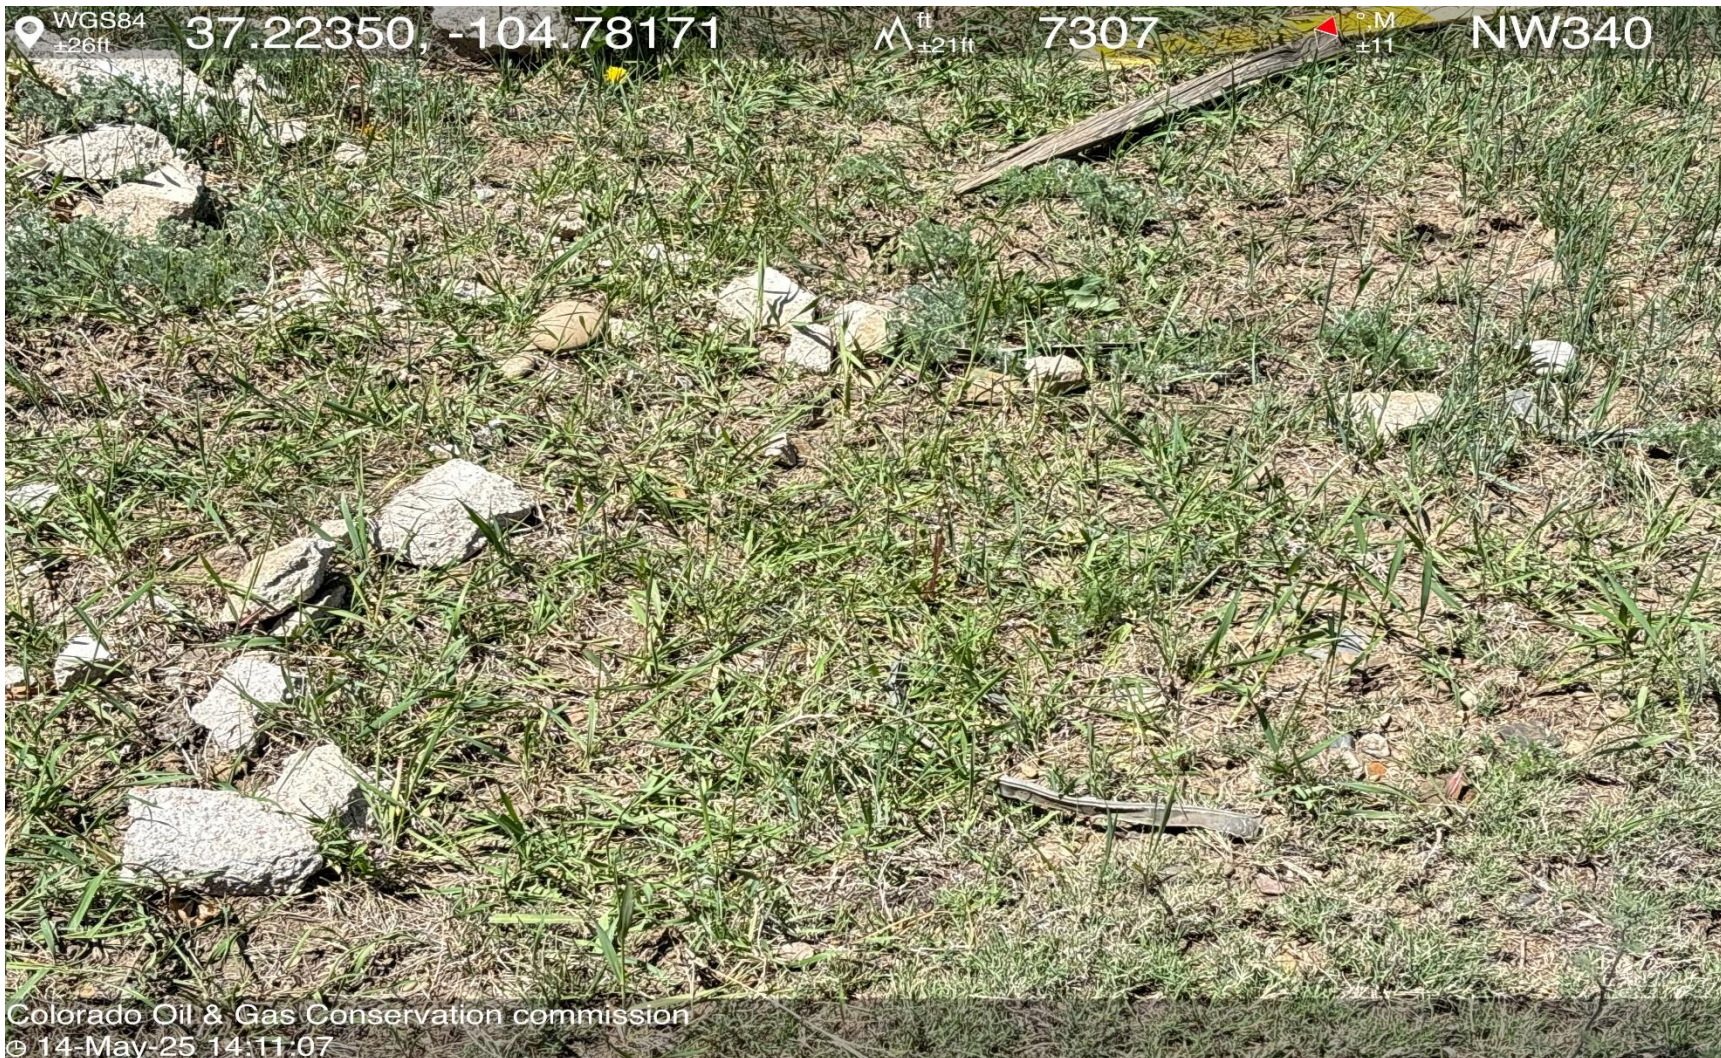
PHOTO 9: TRASH AND OR DEBREE FROM DETERIORATING SHED ON AND AROUND LOCATION MOSTELY TO THE SOUTH AND SOUTHEAST OF SHED. INSPECT AND REMOVE ALL TRASH AND DEBREE FROM LOCATION AND SURROUNDING AREA PER RULE 606. CA DATE 5/19/2025.

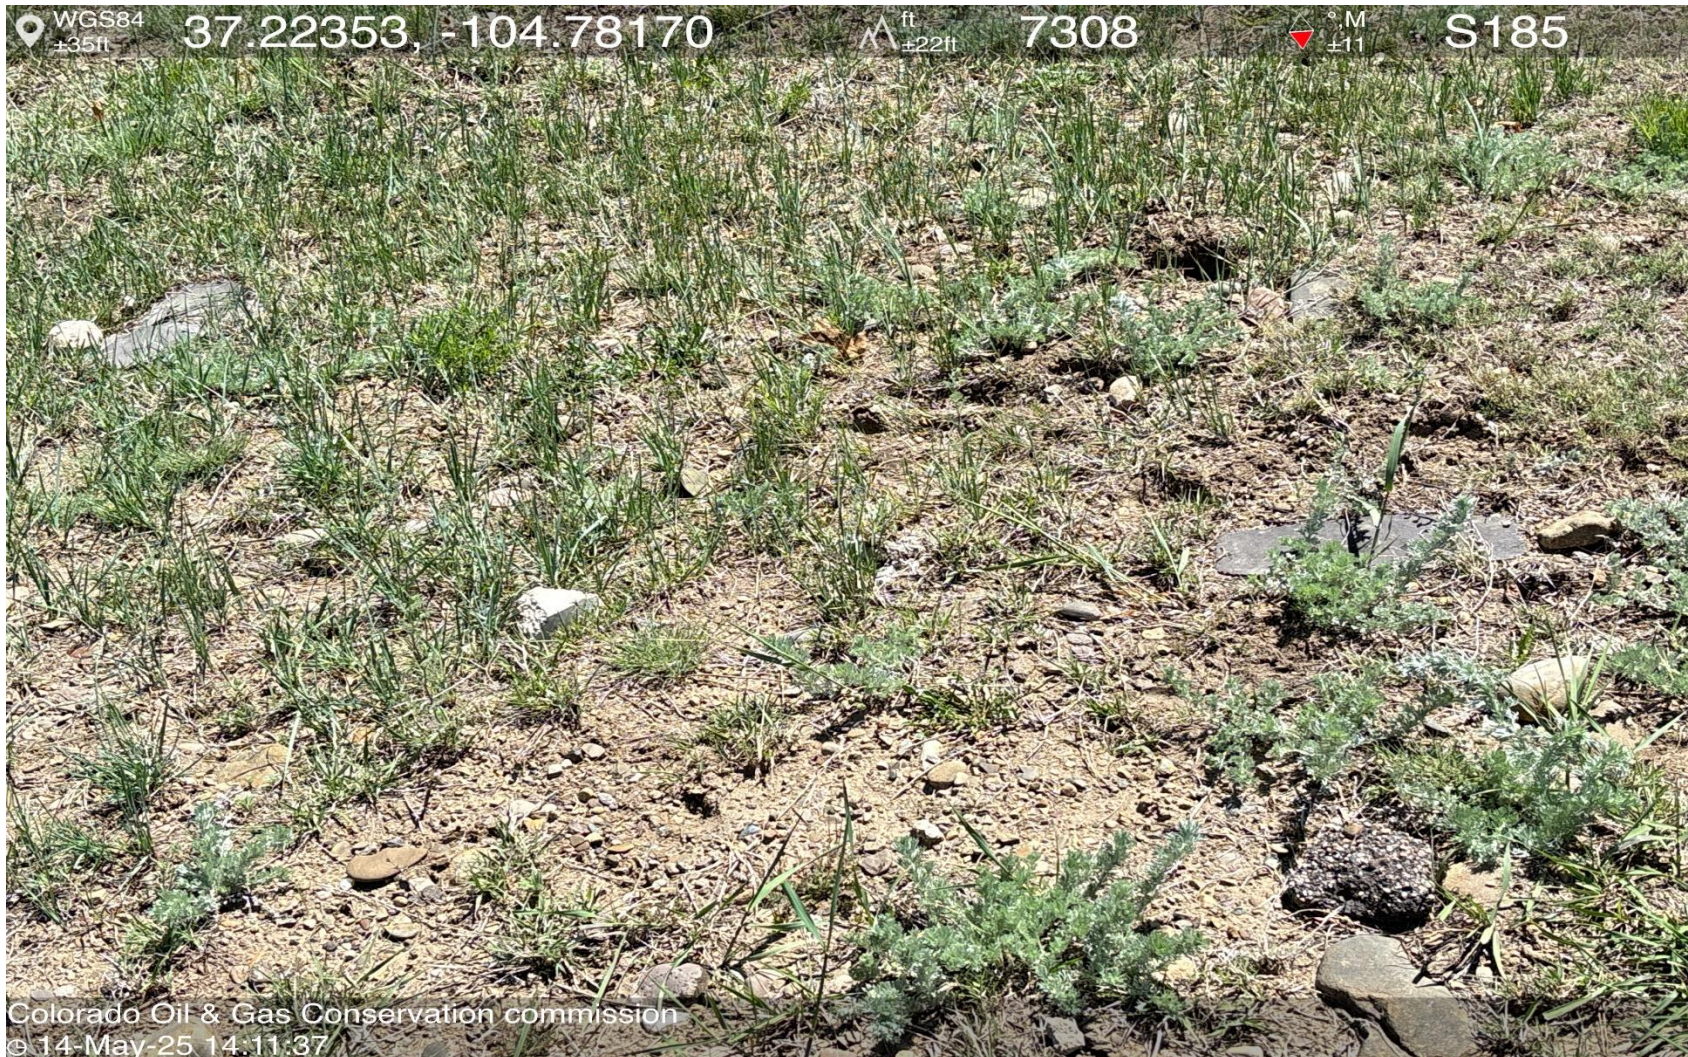
PHOTO 9: TRASH AND OR DEBREE FROM DETERIORATING SHED ON AND AROUND LOCATION MOSTELY TO THE SOUTH AND SOUTHEAST OF SHED. INSPECT AND REMOVE ALL TRASH AND DEBREE FROM LOCATION AND SURROUNDING AREA PER RULE 606. CA DATE 5/19/2025.

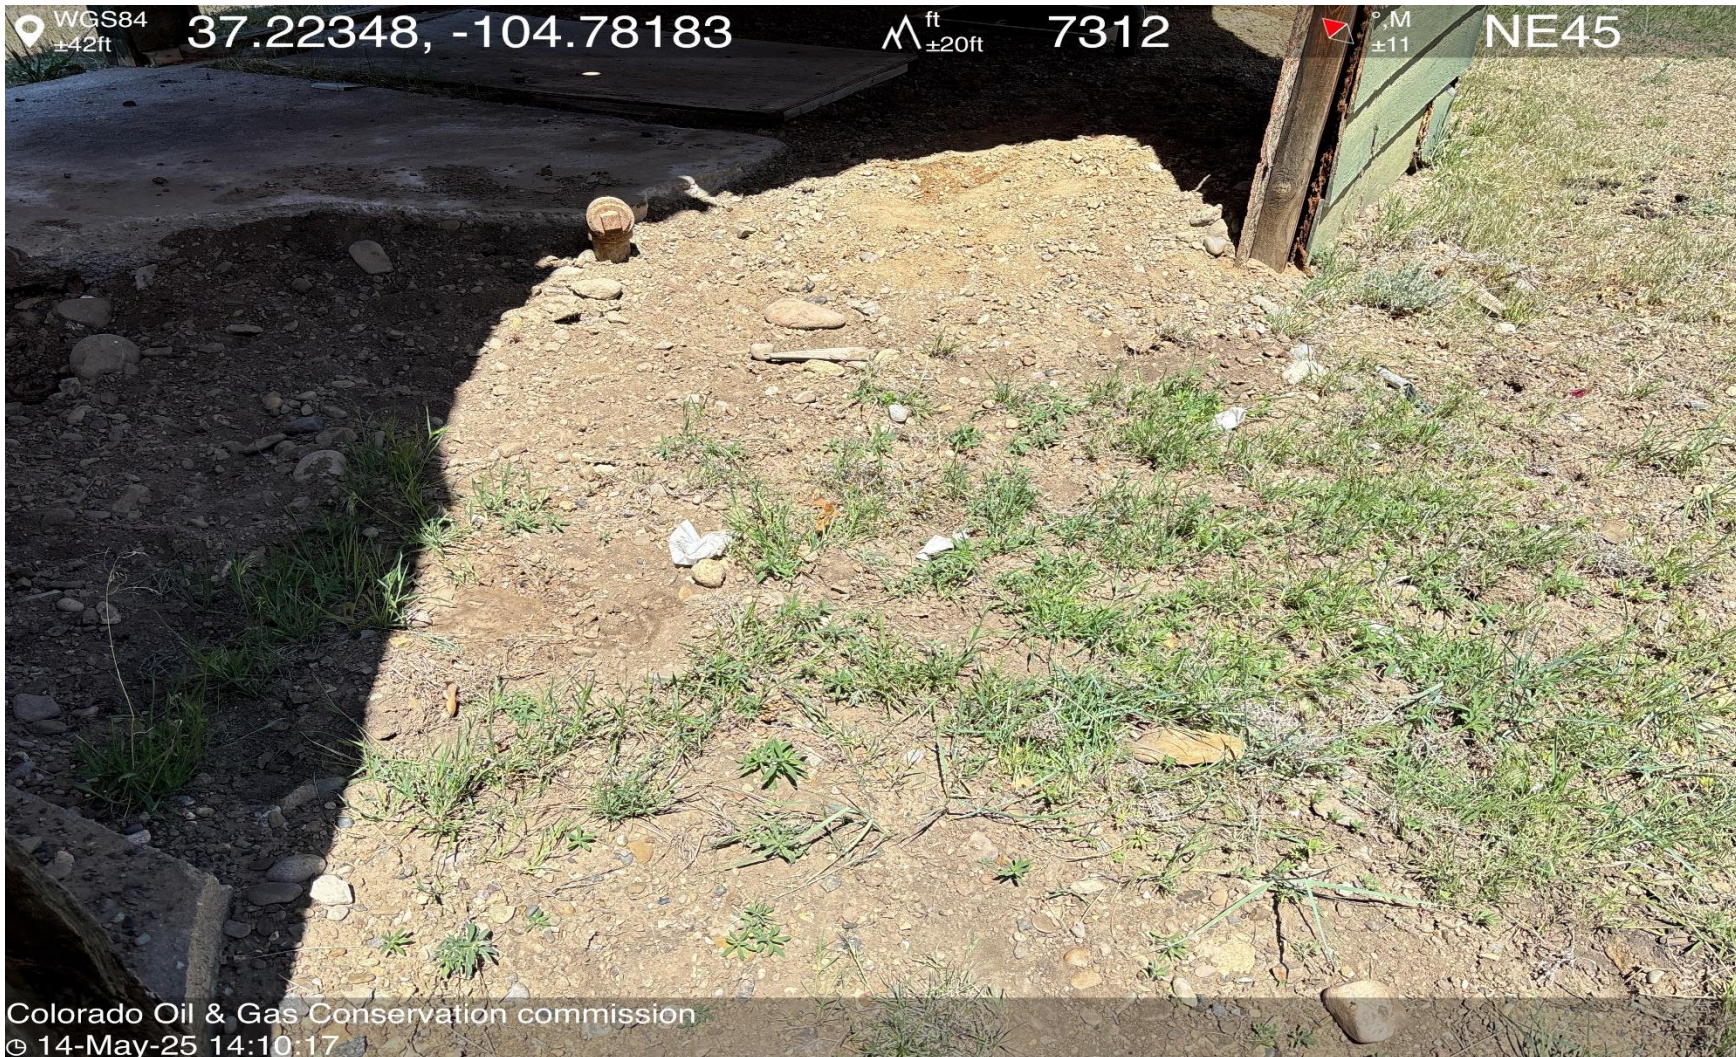
PHOTO 10: TRASH AND OR DEBREE FROM DETERIORATING SHED ON AND AROUND LOCATION MOSTELY TO THE SOUTH AND SOUTHEAST OF SHED. INSPECT AND REMOVE ALL TRASH AND DEBREE FROM LOCATION AND SURROUNDING AREA PER RULE 606. CA DATE 5/19/2025.

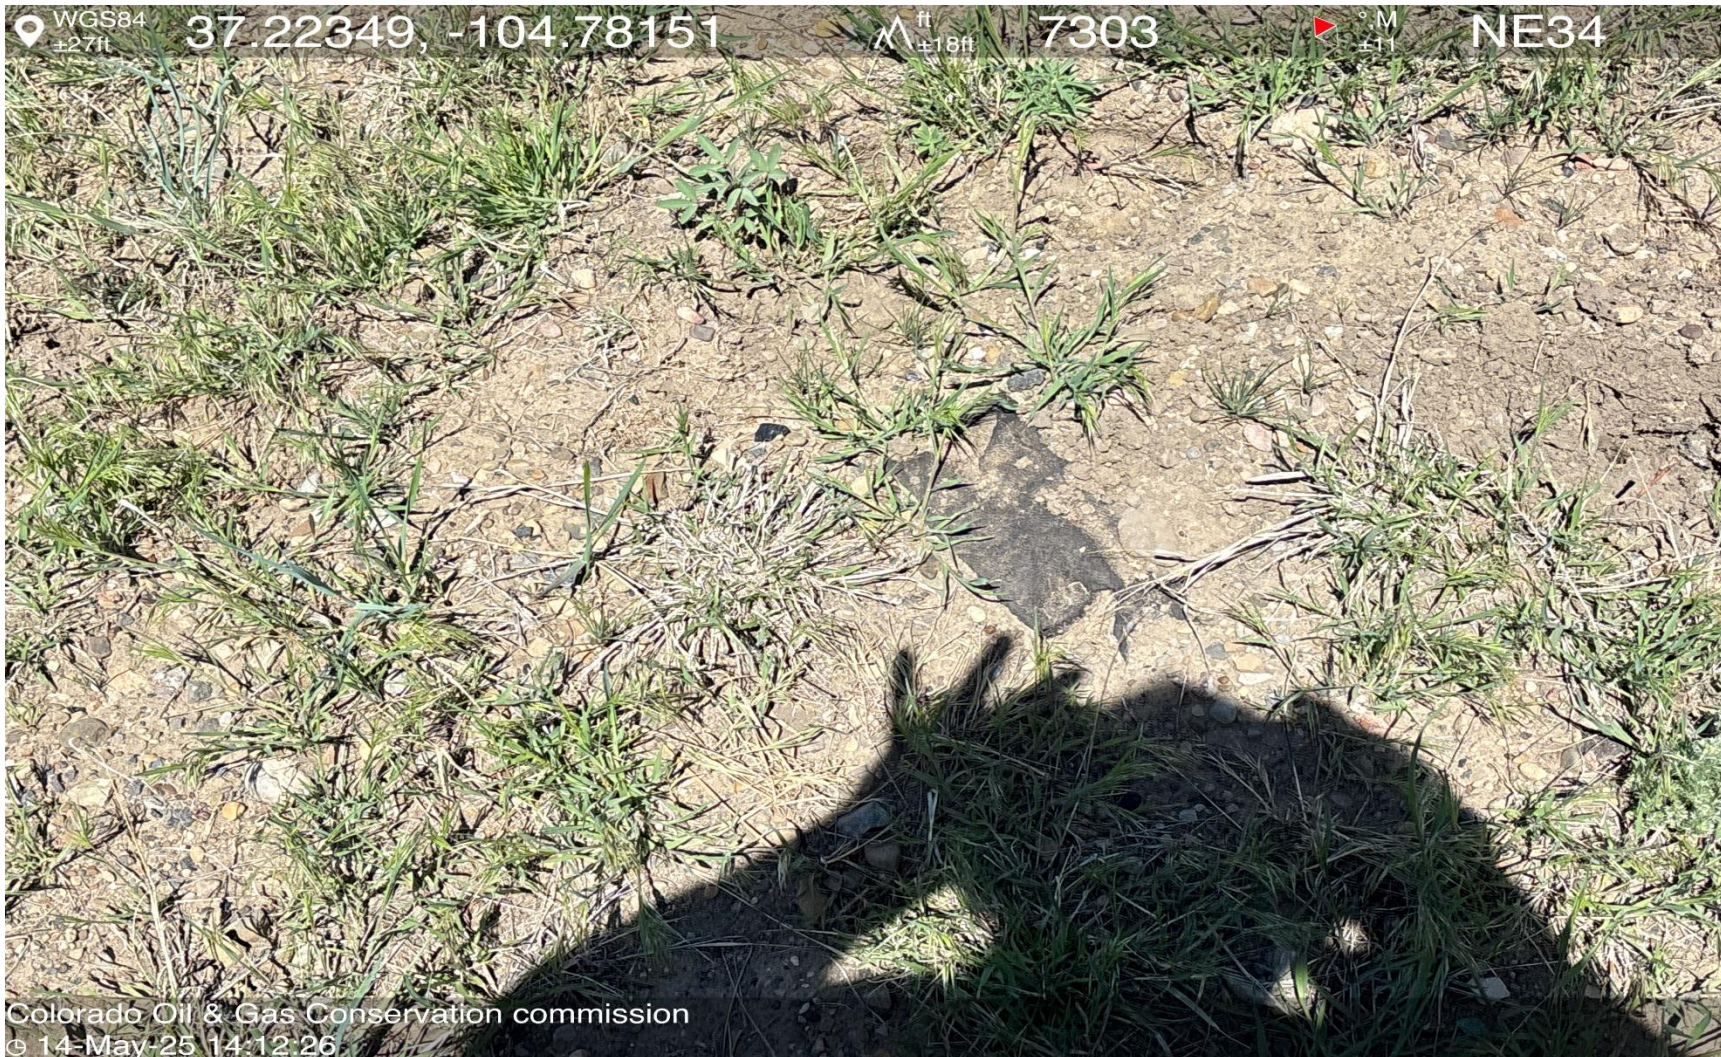
PHOTO 11: TRASH AND OR DEBREE FROM DETERIORATING SHED ON AND AROUND LOCATION MOSTELY TO THE SOUTH AND SOUTHEAST OF SHED. **INSPECT AND REMOVE ALL TRASH AND DEBREE FROM LOCATION AND SURROUNDING AREA PER RULE 606. CA DATE 5/19/2025.**
