WELL NAME: BURRO CANYON 34-28, API #: 071-06112, INSP. # 716300978

COLORADO
Energy & Carbon Management
Commission
Department of Natural Resources

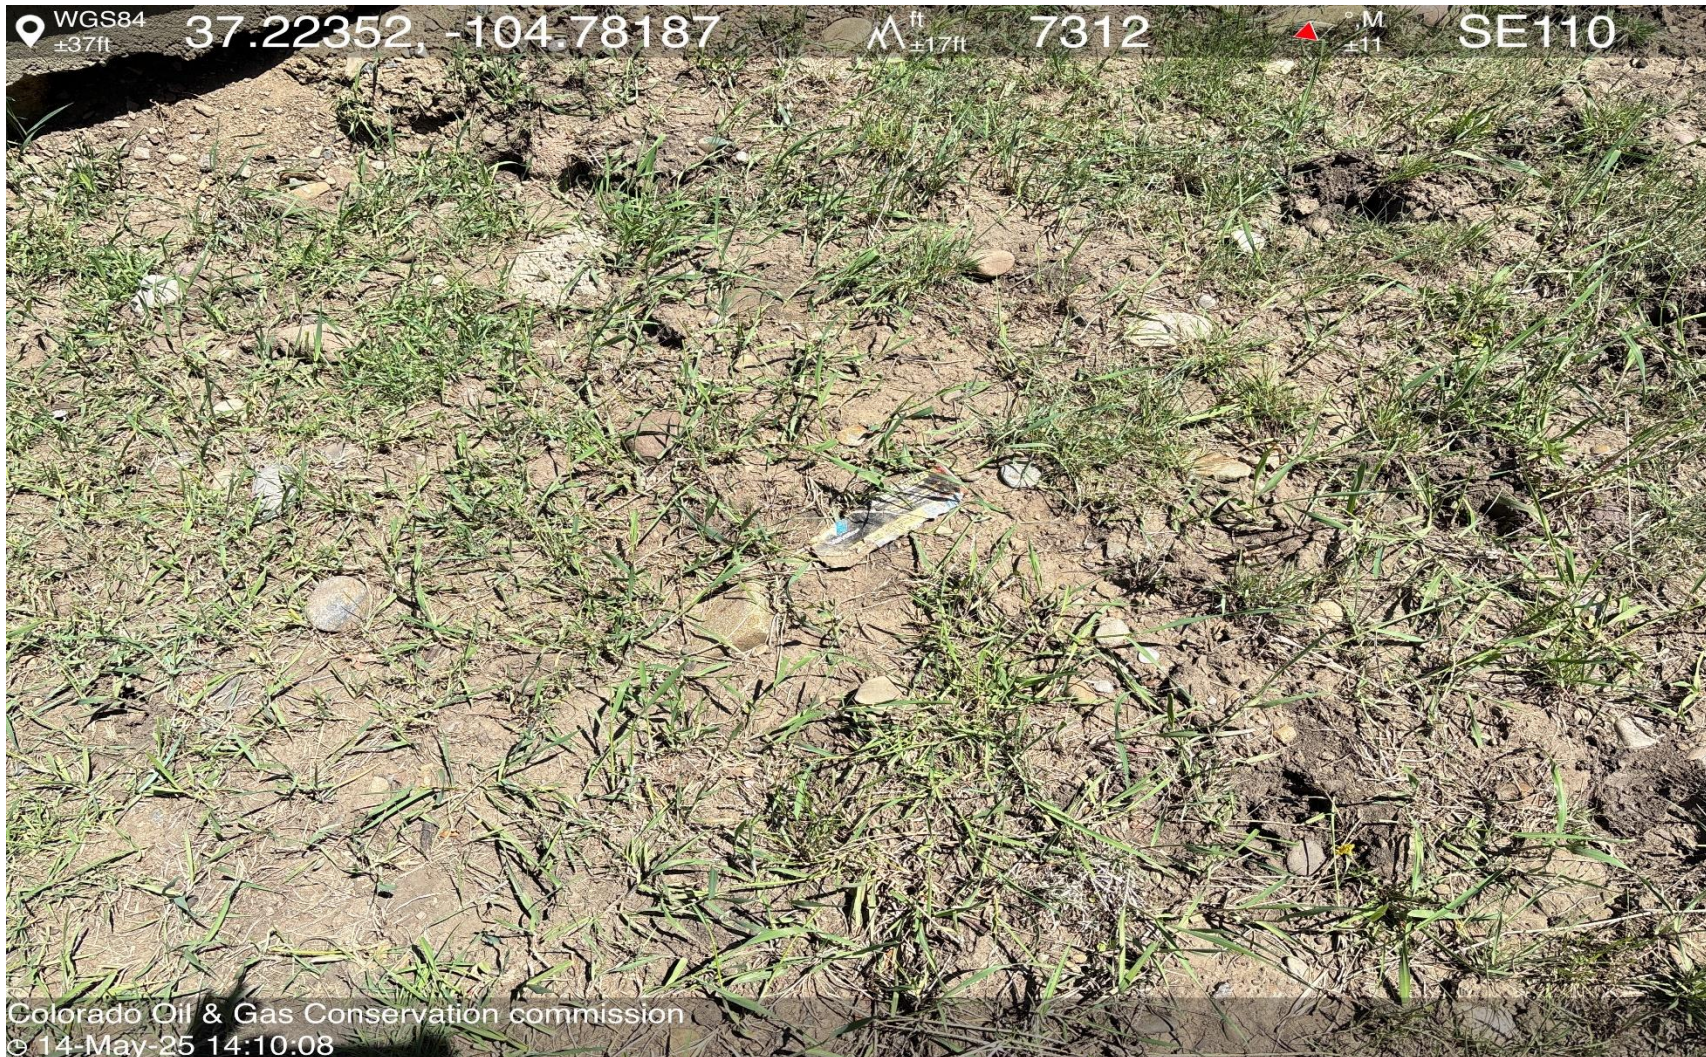
PHOTO 12: TRASH AND OR DEBREE FROM DETERIORATING SHED ON AND AROUND LOCATION MOSTELY TO THE SOUTH AND SOUTHEAST OF SHED. INSPECT AND REMOVE ALL TRASH AND DEBREE FROM LOCATION AND SURROUNDING AREA PER RULE 606. CA DATE 5/19/2025.
