Interim Reclamation and Stormwater Inspection

Location ID: 462908

Inspection Document #: 697505906

Location Name: Little Lady 21/South Well Pad

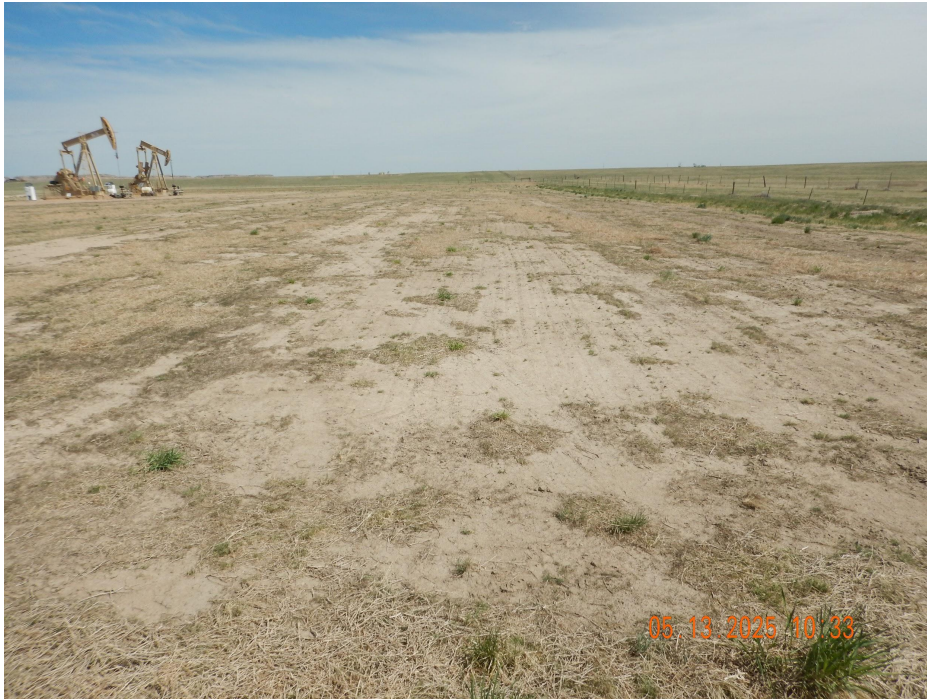
Photo 1. Photo taken from the southeastern location, facing North. Photo illustrates interim reclamation areas that were dominated by weedy, annual vegetation consisting of Russian thistle have been mowed. Desirable germination was observed throughout most areas but is lacking some along the eastern area.

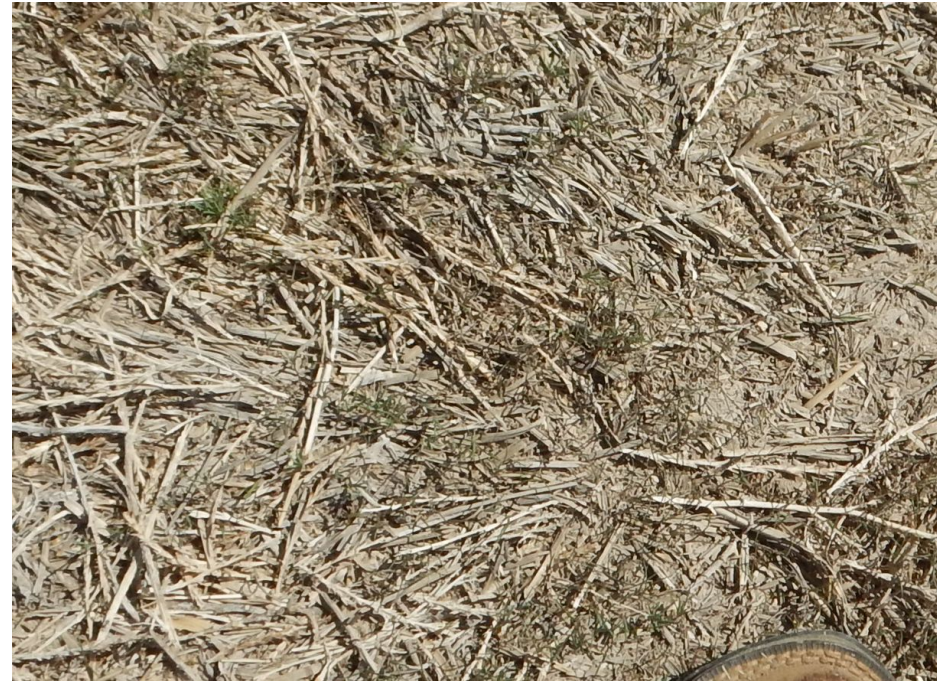
Photo 2. Close up photo illustrating the Russian thistle growth.

Note- Russian thistle growth was observed throughout the interim area and in need of weed management.

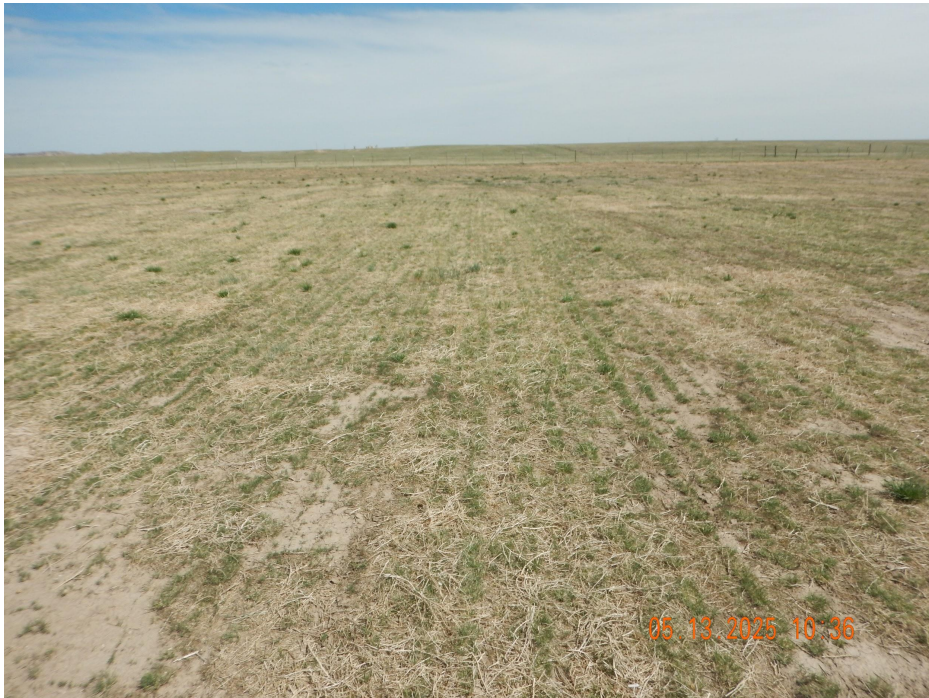
Photo 3. Photo taken from the northern location, facing North.
See comments under Photo 1.

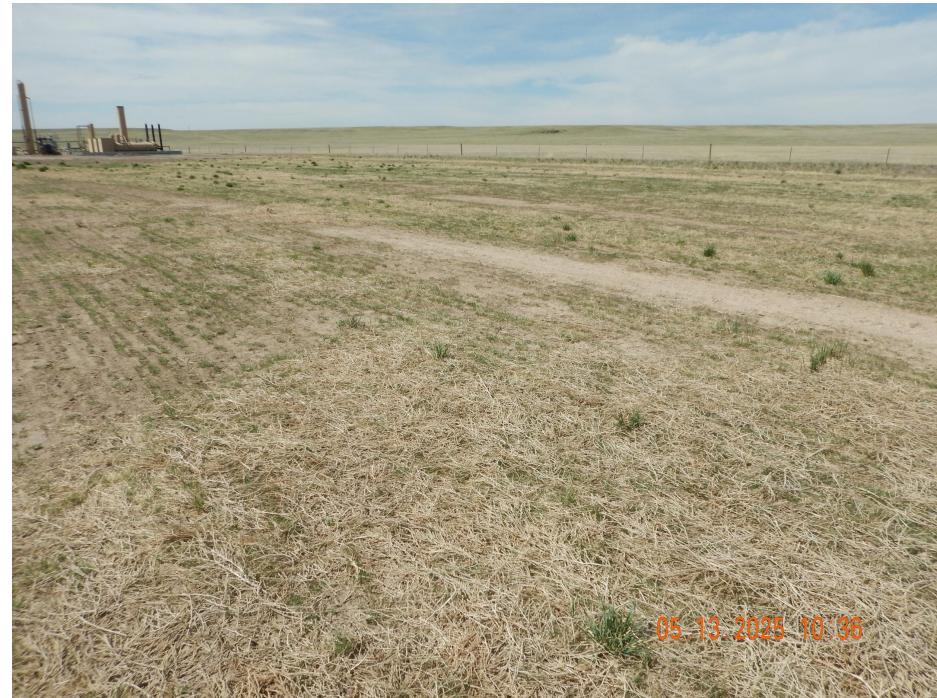
Photo 4. Photo taken from the western location, facing Southwest.
See comments under Photo 1.

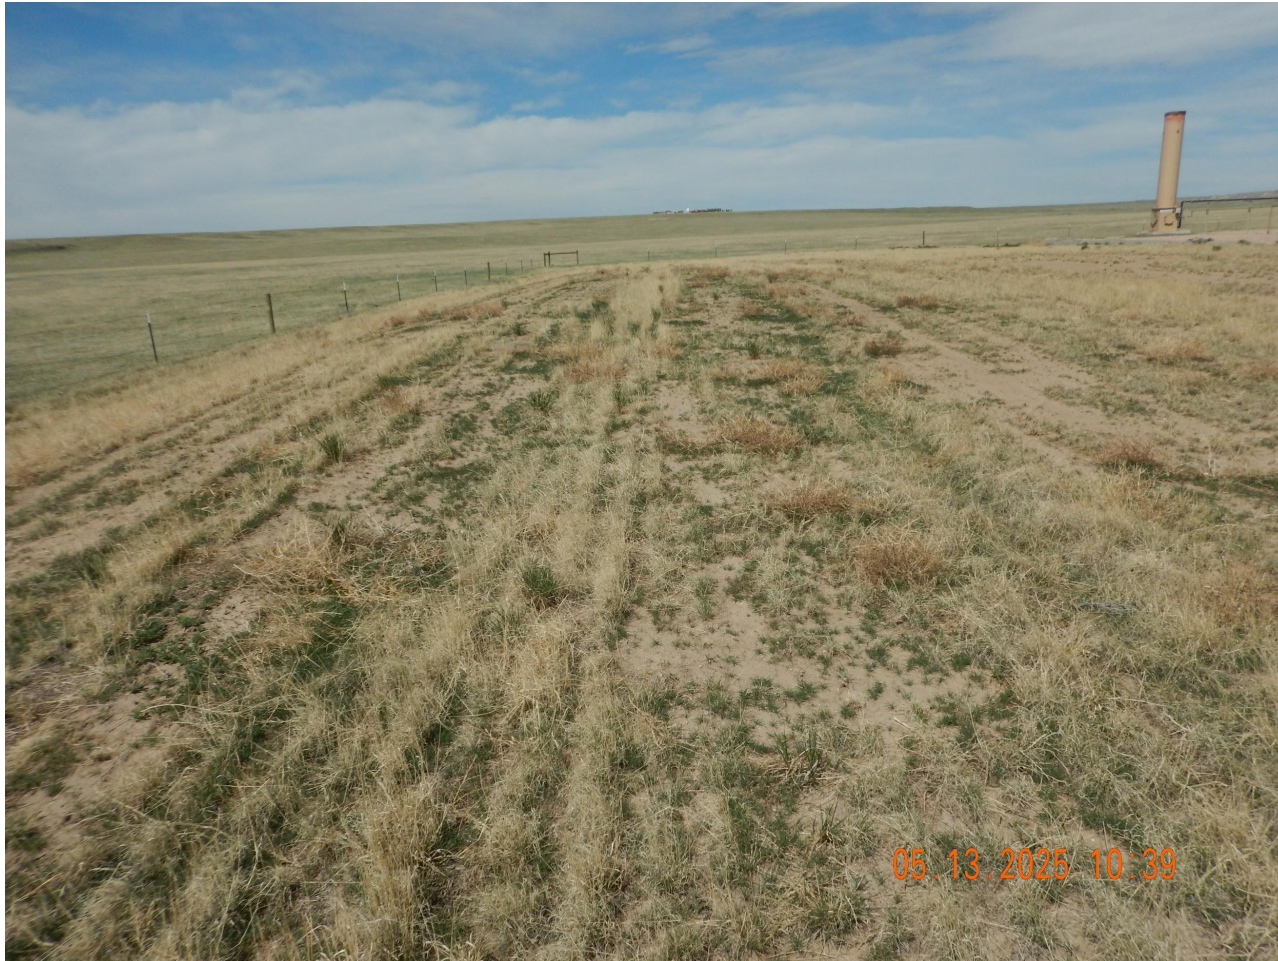
Photo 5. Photo taken from the topsoil stockpile, facing West. Photo illustrates desirable vegetation is in process with the composition of weedy, annual vegetation.
