Interim Reclamation and Stormwater Inspection

Operator: BISON IV OPERATING LLC- #10670

Location ID: 454351

Inspection Photos
Location Name: SALT RANCH FEE 10 East
Location ID: 454351

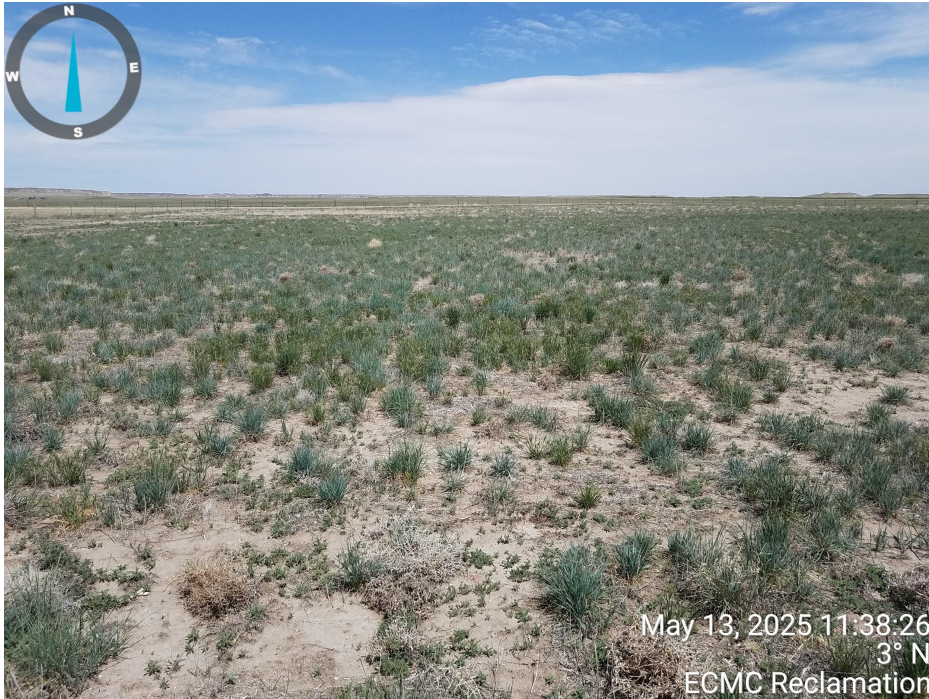
Photo 1. Photo taken from the western interim area, facing North. Photo illustrates interim reclamation areas are a mix of annual wheat grass (not desirable), western wheatgrass (desirable), and weedy, annual vegetation which includes cheatgrass. Desirable germination was mostly observed along the western area, while the north and east were predominantly weedy, annual vegetation.

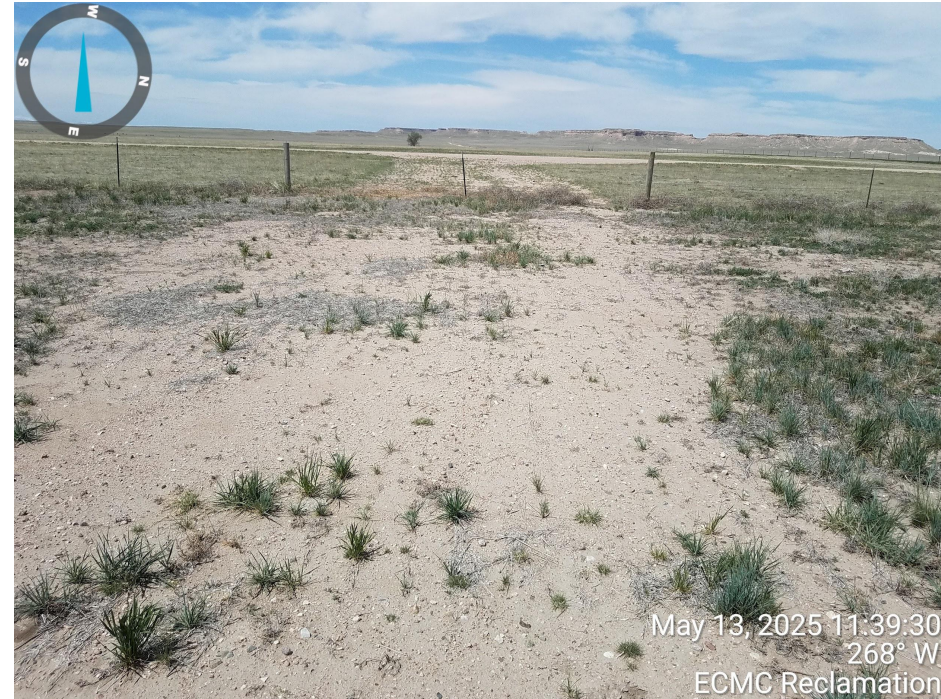
Photo 2. Photo taken along the northwestern interim area, facing West. Photo illustrates where a previous access road was removed with sparse desirable germination.

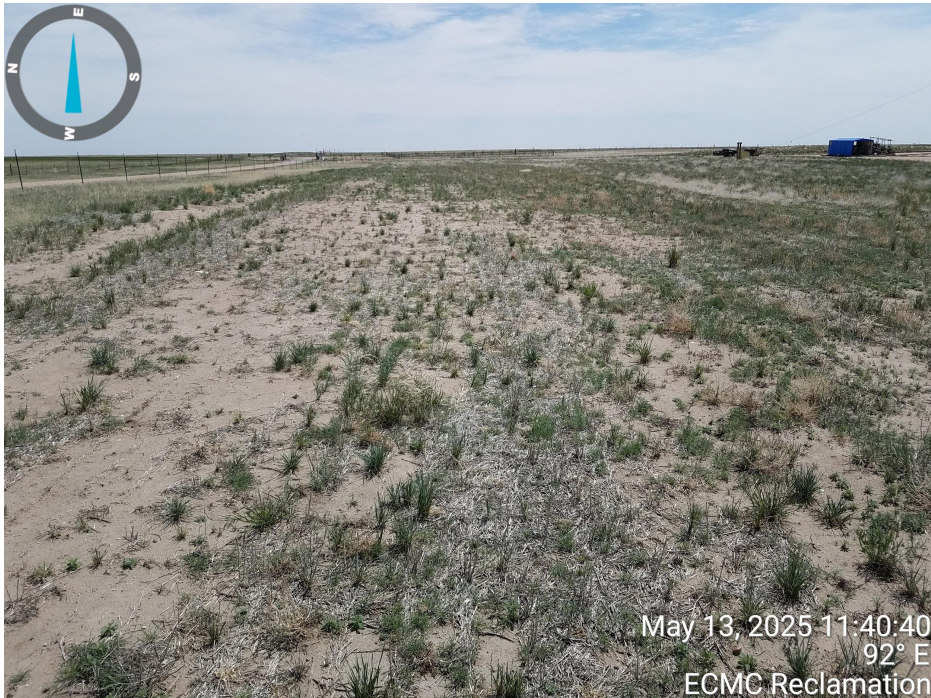
Photo 3. Photo taken from the northwestern interim area, facing East. See comments under Photo 1.

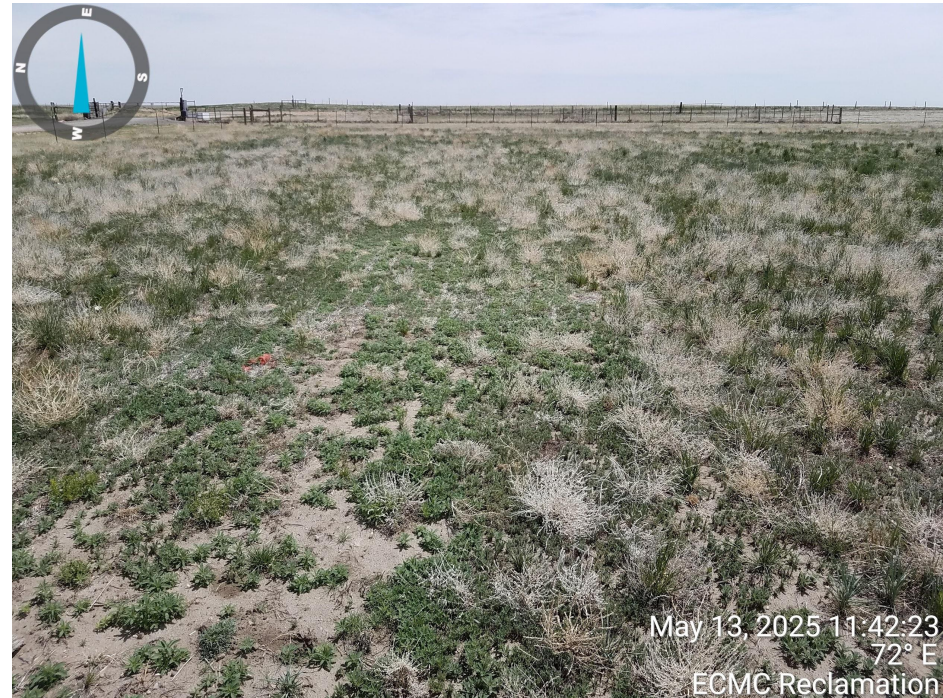
Photo 4. Photo taken from the northeastern interim area, facing East. Photo illustrates weedy, annual vegetation.

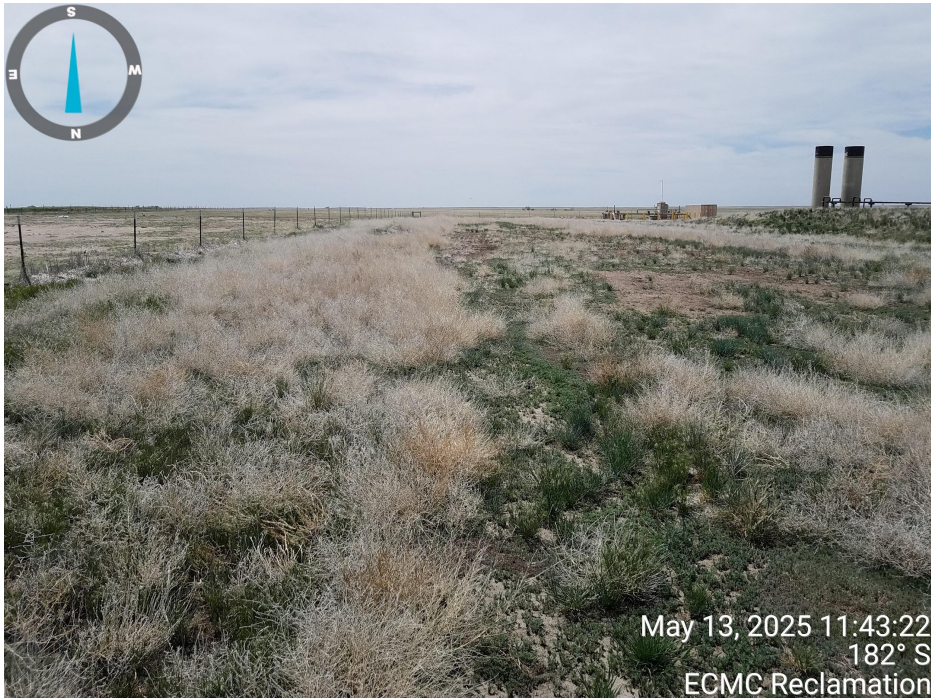
Photo 5. Photo taken from the northeastern interim area, facing South. See comments under Photo 4.

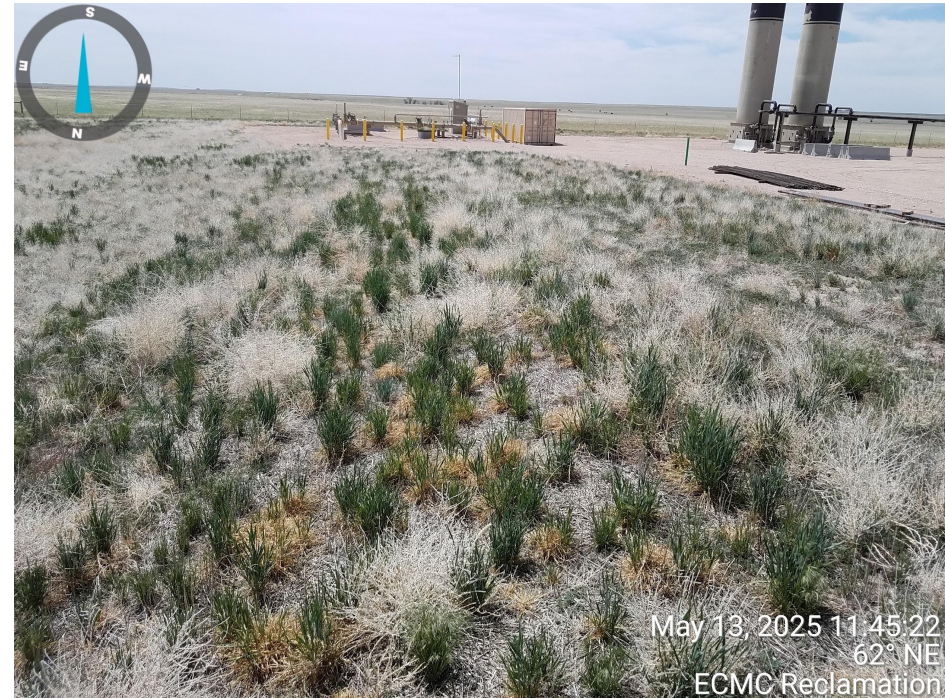
Photo 6. Photo taken from the topsoil stockpile, facing South. Photo illustrates weedy, annual vegetation consisting of annual wheat grass, tumbleweeds and cheatgrass.
