Final Reclamation Inspection

Operator: KERR MCGEE OIL & GAS ONSHORE LP - 47120

Location ID: 319288

Inspection Photos
Location Name: BERNARD E. TEETS #2
Location ID: 319288

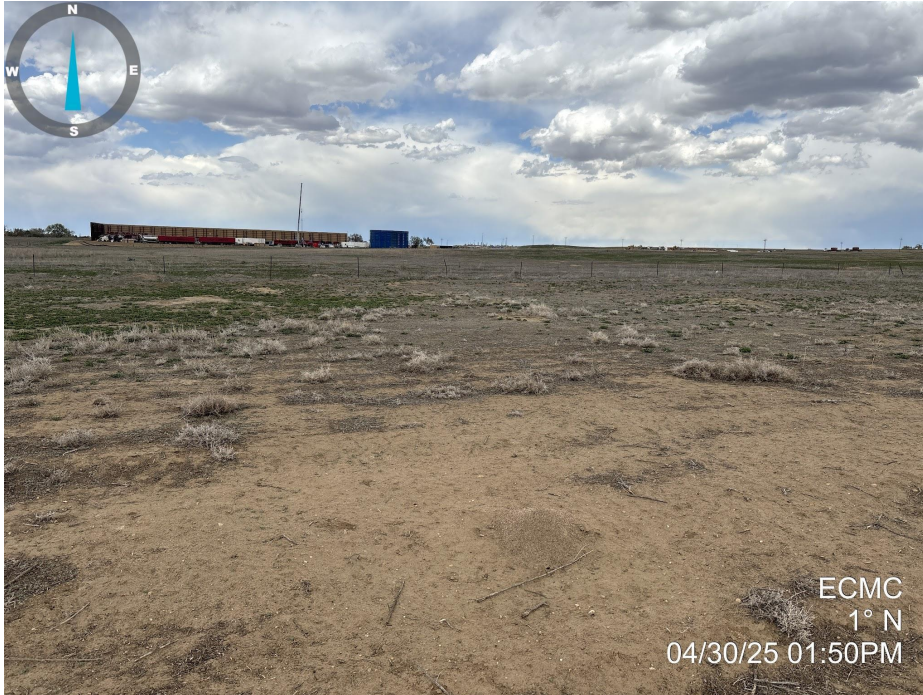
Photo 1. Photo taken from the well location, facing North. Photo illustrates that final reclamation activities have taken place, with evidence of drill row seeding, but bare ground and weedy annual vegetation remains at the site.

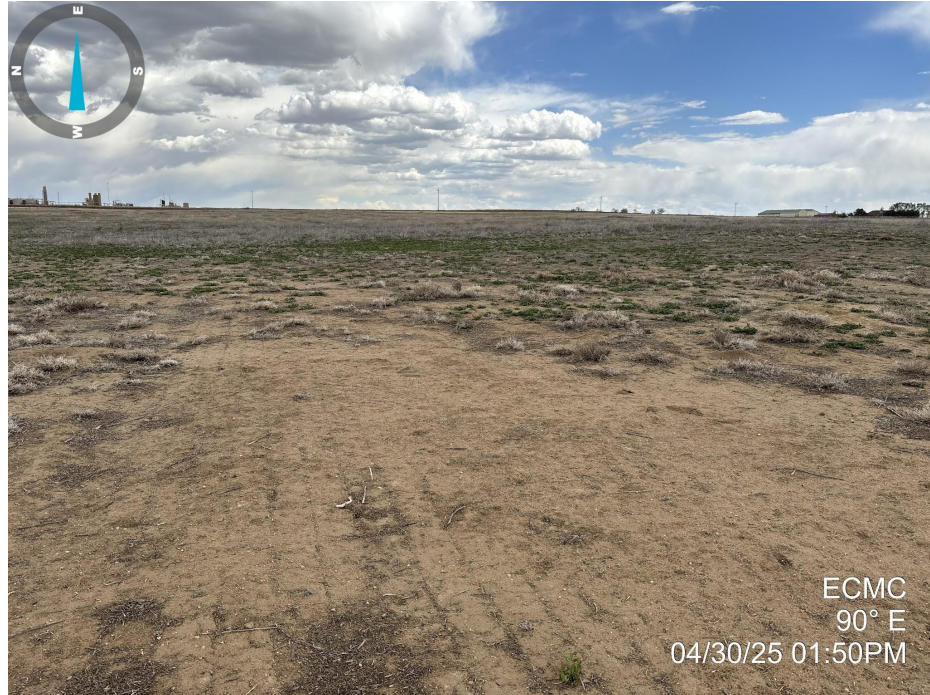
Photo 2. Photo taken from the well location, facing East. See comments under Photo 1.

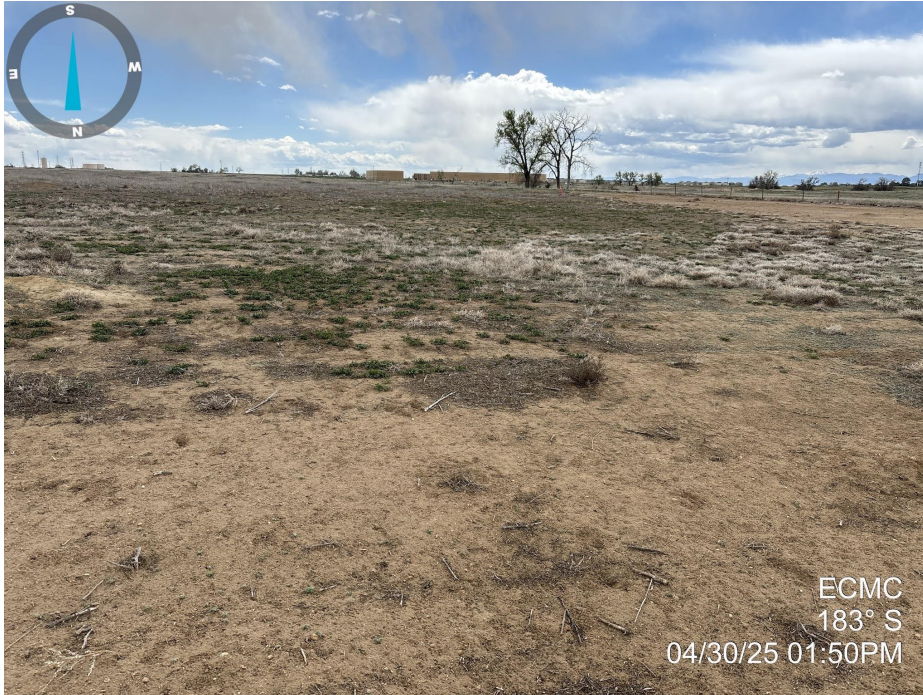
Photo 3. Photo taken from the well location, facing South. See comments under Photo 1.

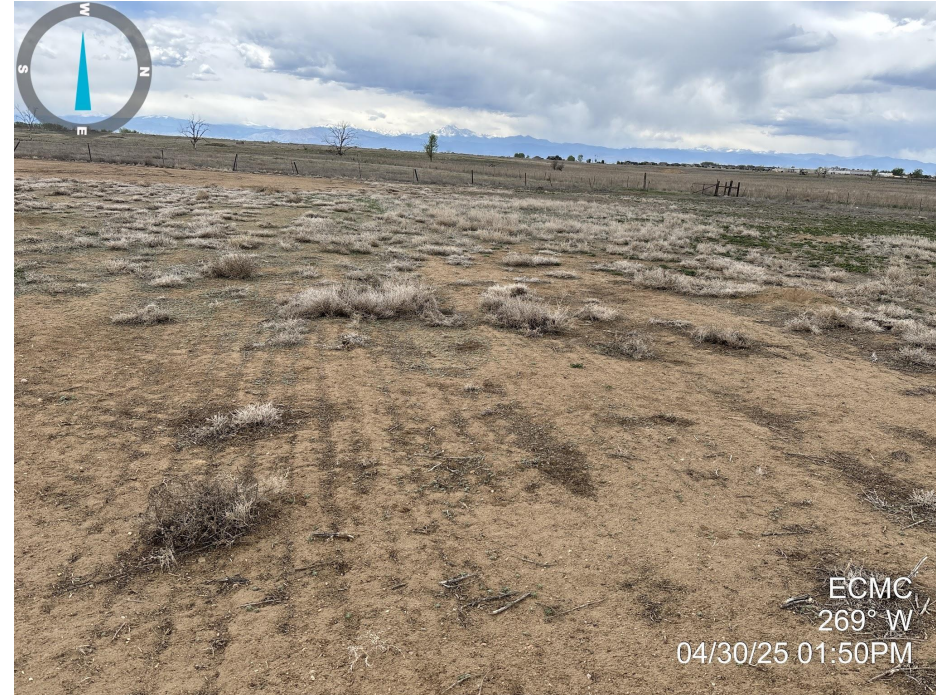
Photo 4. Photo taken from the well location, facing West. See comments under Photo 1.

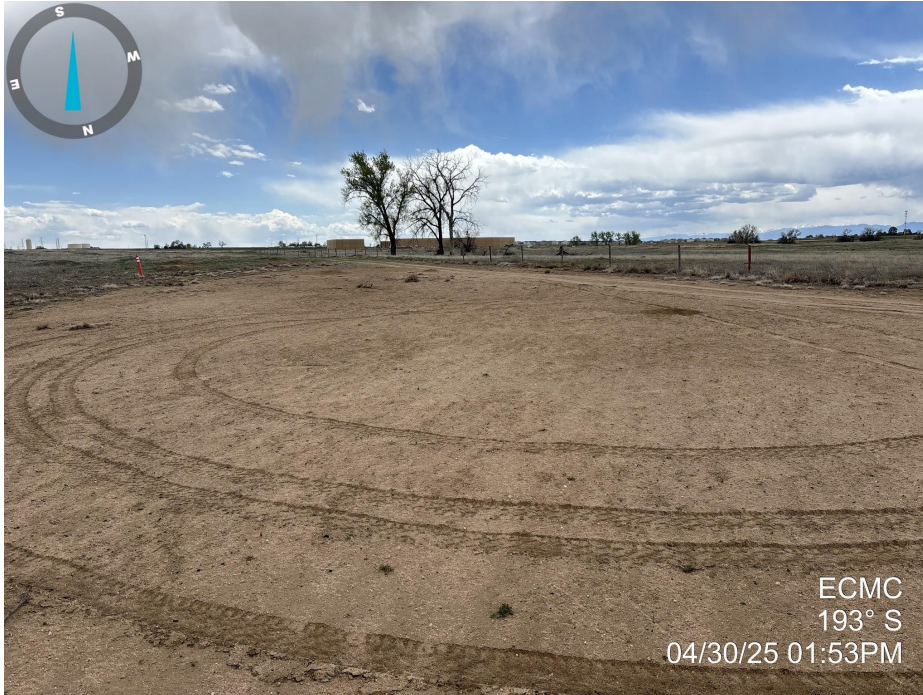
Photo 5. Photo taken of the tank battery location, facing South. Photo illustrates that bare ground remains at the tank battery location and vegetation has not established from final reclamation activities.

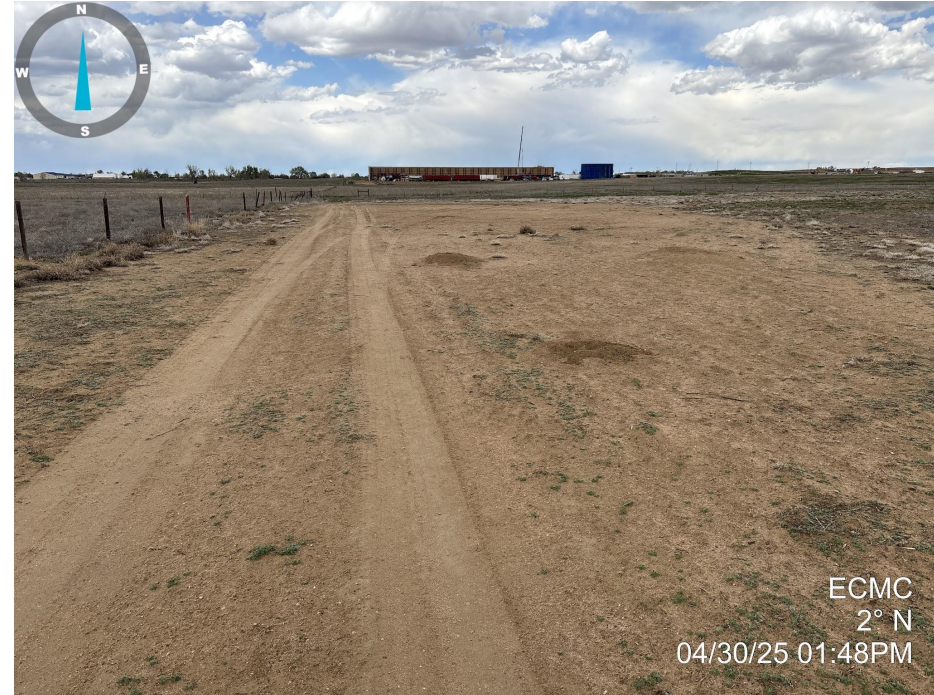
Photo 6. Photo taken of the tank battery location, facing North. See comments under Photo 5.

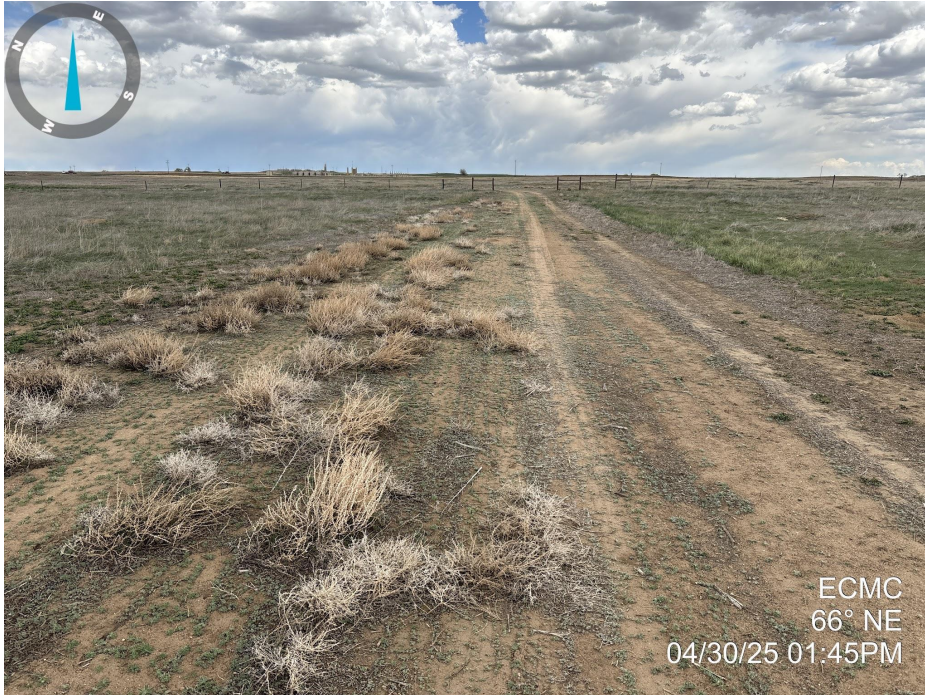
Photo 7. Photo taken from the access road, southwest of the location, facing Northeast. Photo illustrates that disturbance remains along the access road.

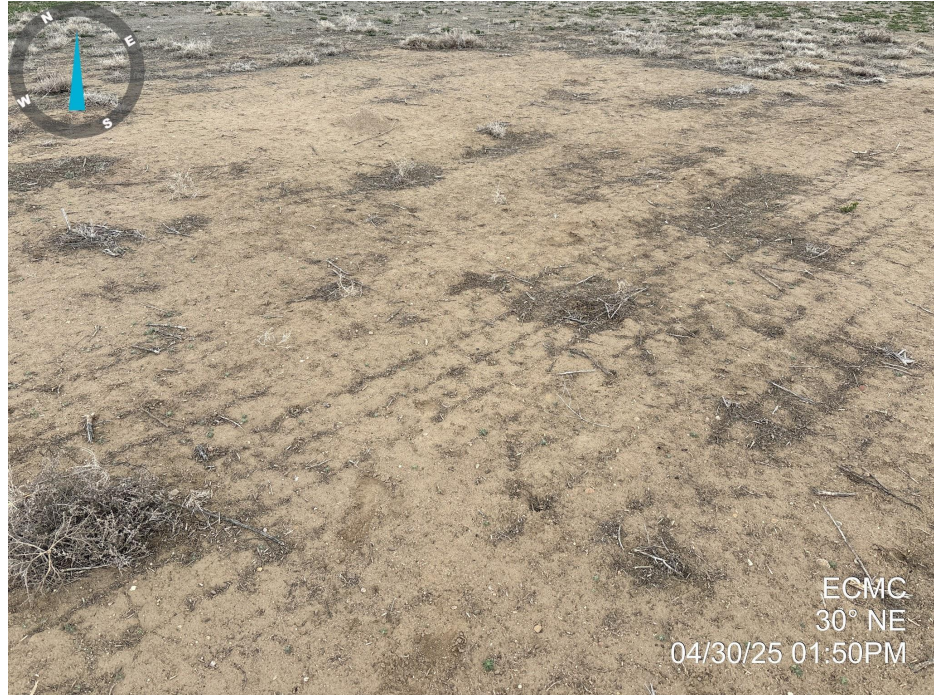
Photo 8. Photo taken of the well location. Photo illustrates that bare ground remains at the location.

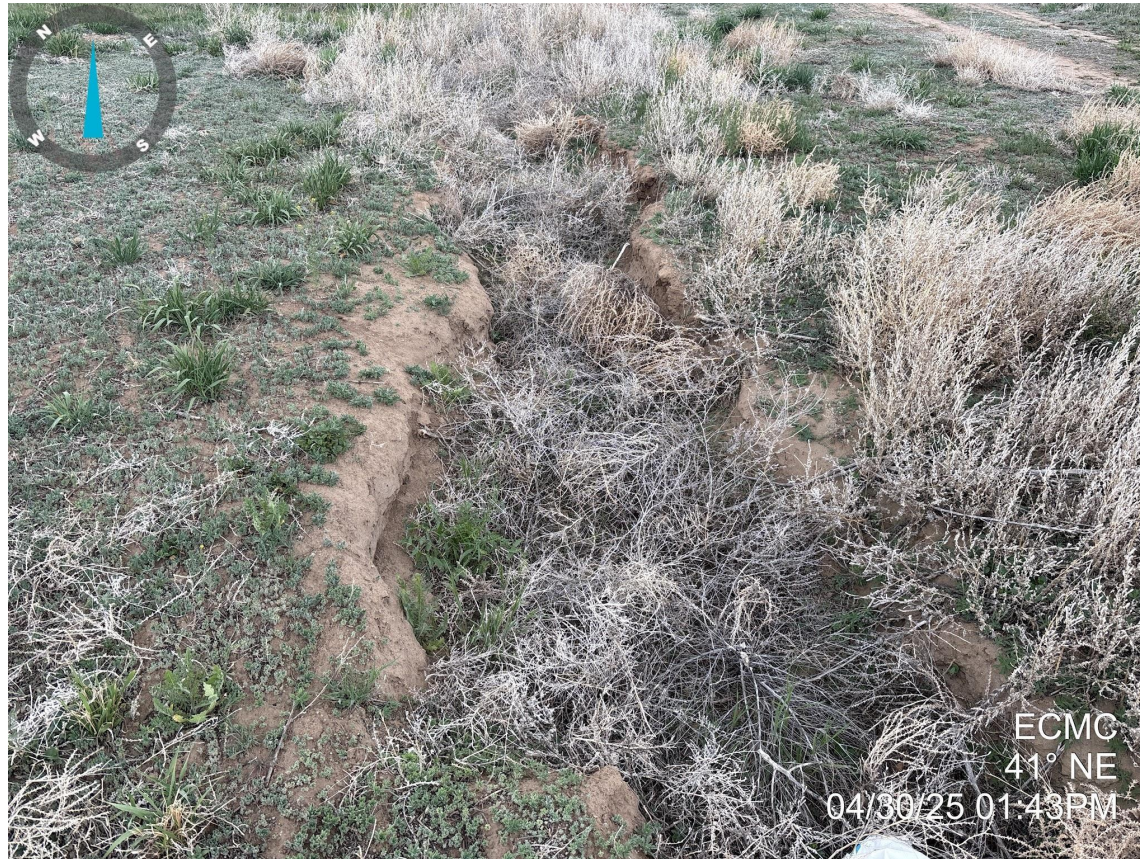
Photo 9. Photo taken of erosion north of the access road, directly east of Location ID # 331225. A small gully, approximately one foot across and 8 feet in length has formed. The access road is located to the top right corner of the image.

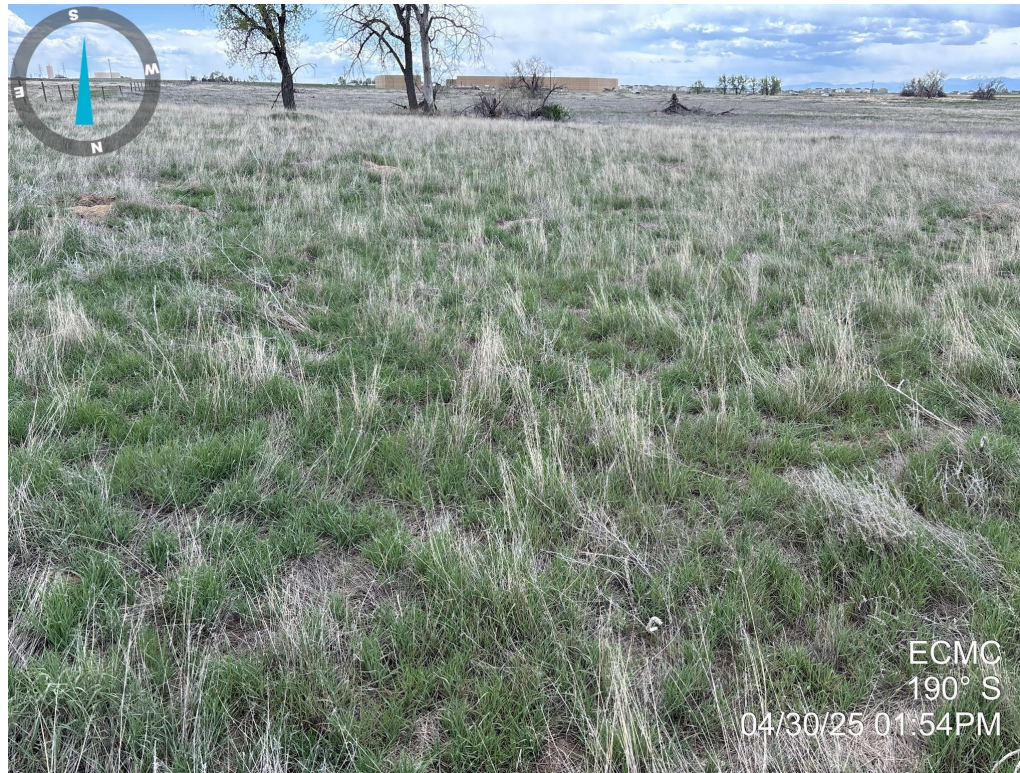
Photo 10. Photo taken of the reference area, south of the location, facing South. Photo illustrates perennial grass vegetation.
