Final Reclamation Inspection

Operator: KERR MCGEE OIL & GAS ONSHORE LP - 47120

Location ID: 336158

Inspection Document #: 718800279

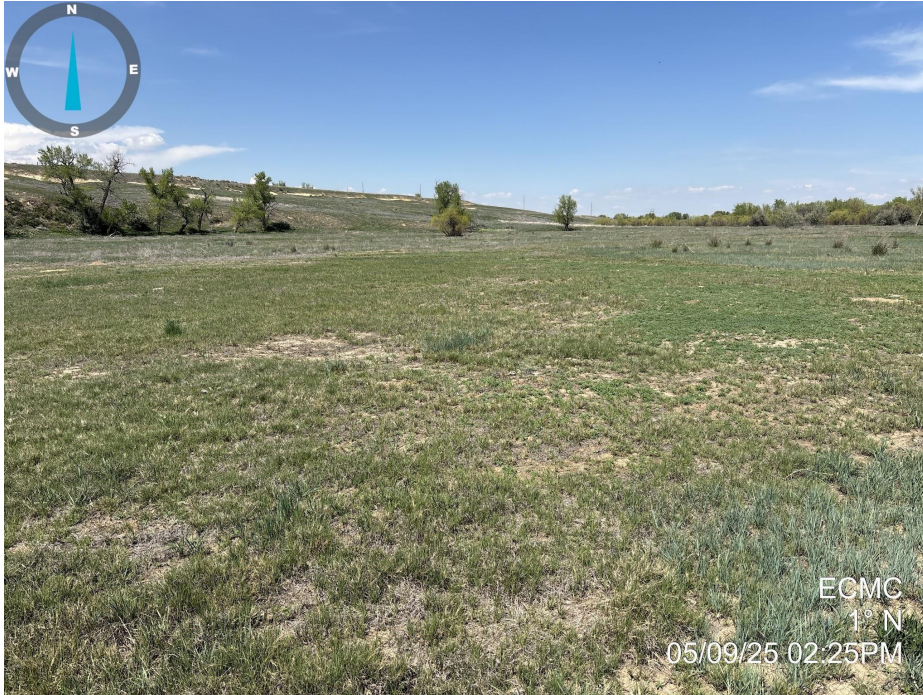
Photo 1. Photo taken from the multi-well location, facing North. Photo illustrates that the well site meets Rule 1004 requirements.

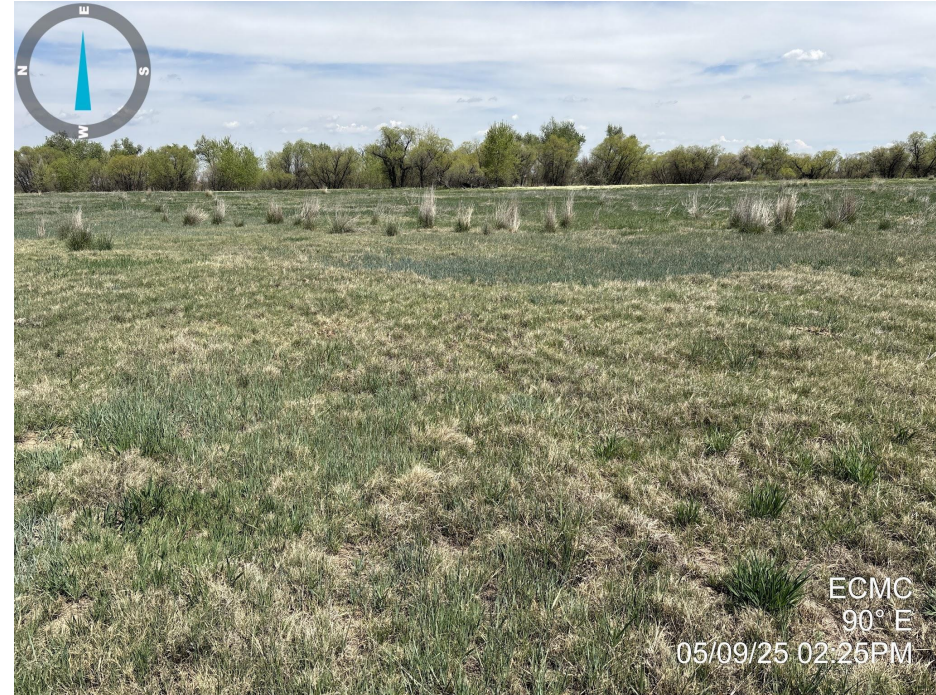
Photo 2. Photo taken from the multi-well location, facing East. See comments under Photo 1.

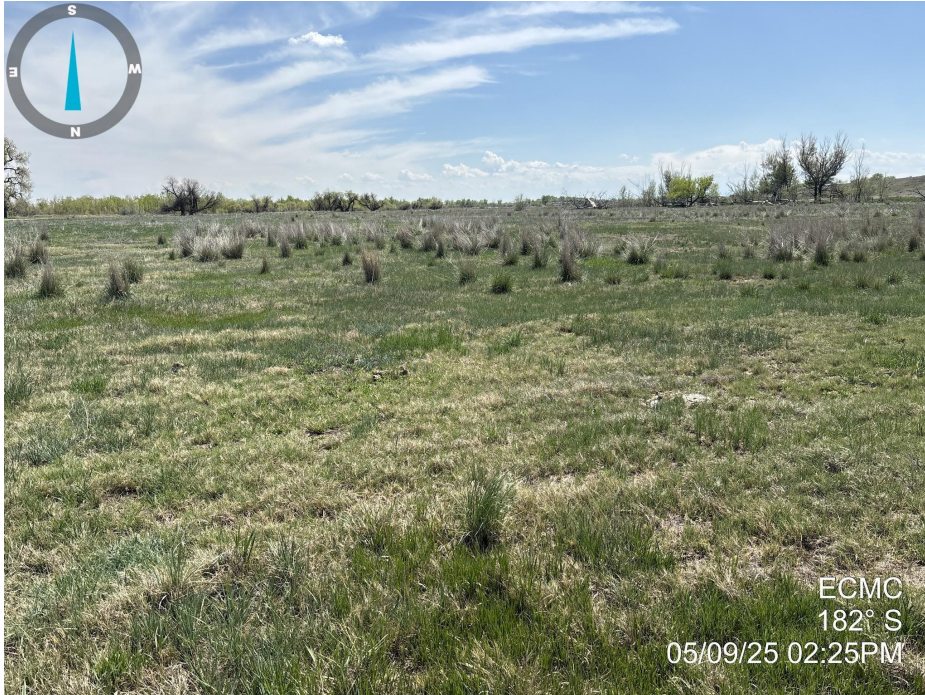
Photo 3. Photo taken from the multi-well location, facing South. See comments under Photo 1.

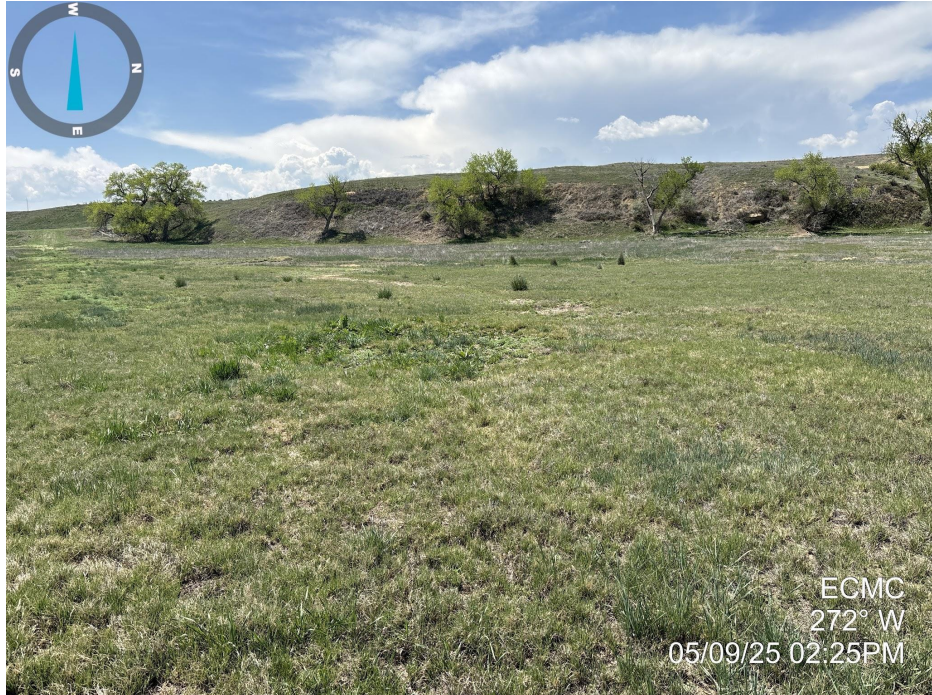
Photo 4. Photo taken from the multi-well location, facing West. See comments under Photo 1.

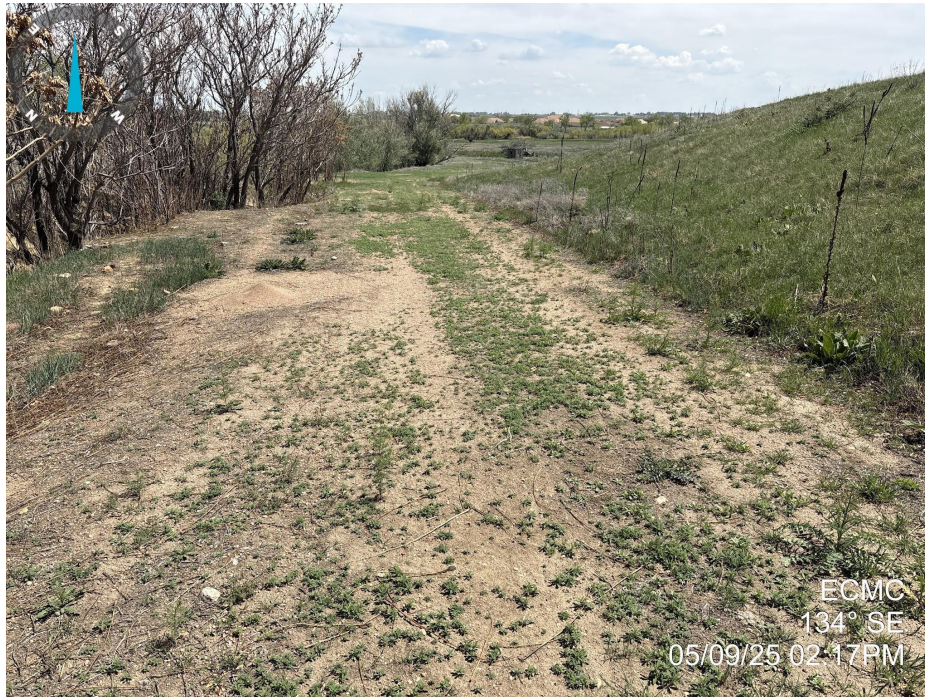
Photo 5. Photo taken from the access road, facing Southeast towards the location. Photo illustrates that the access road has not been reclaimed. Gravel remains on the road and weedy annual vegetation dominates the location.

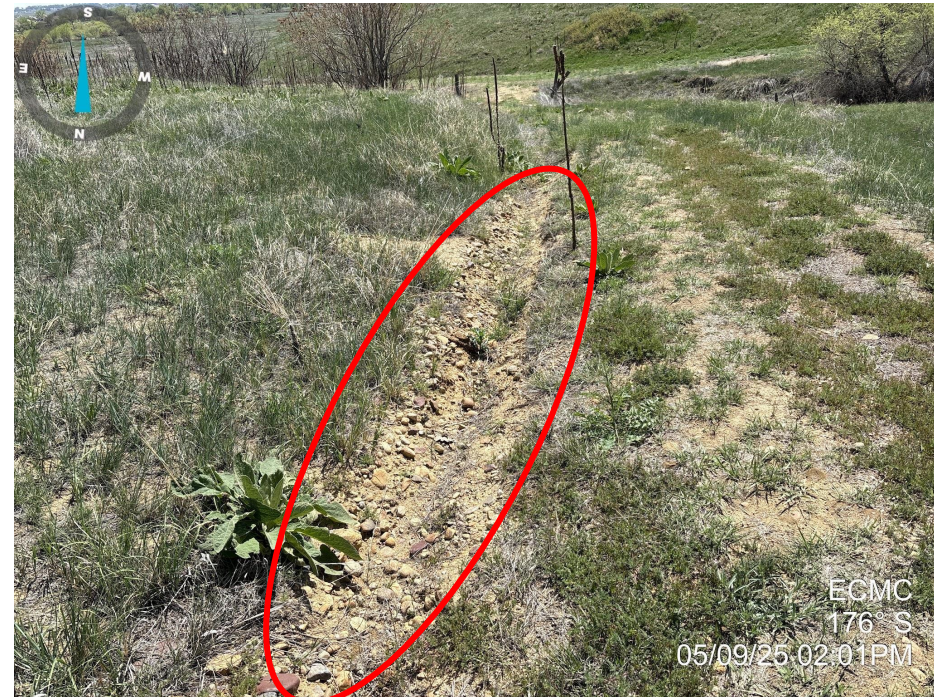
Photo 6. Photo taken of the access road, facing South. Photo illustrates that erosion is present along the side of the road (highlighted in red).

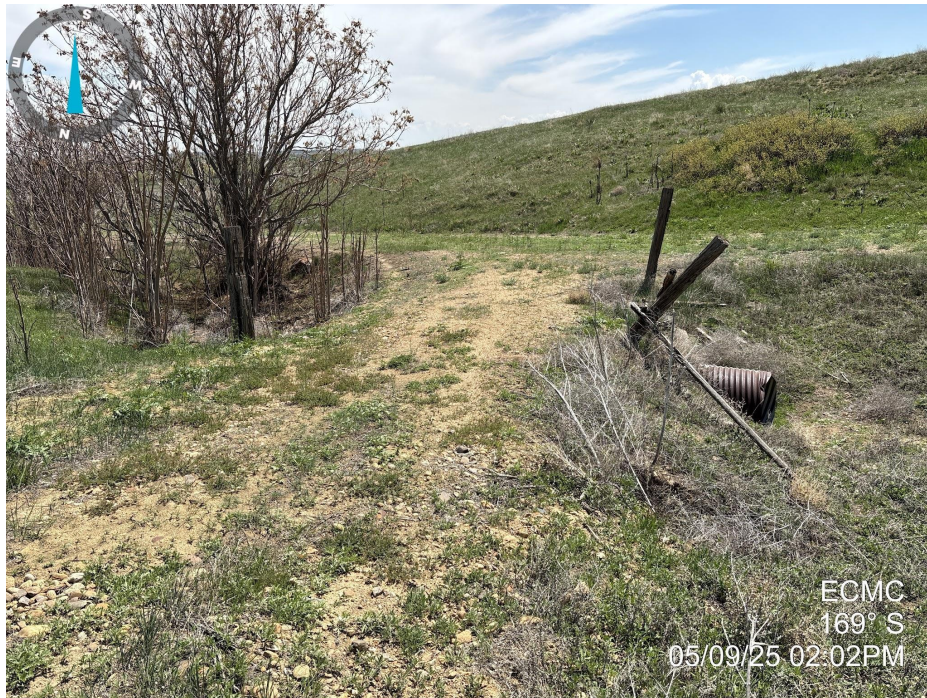
Photo 7. Photo taken of the access road, facing South. Photo illustrates that the access road has not been reclaimed and culverts remain along the road.

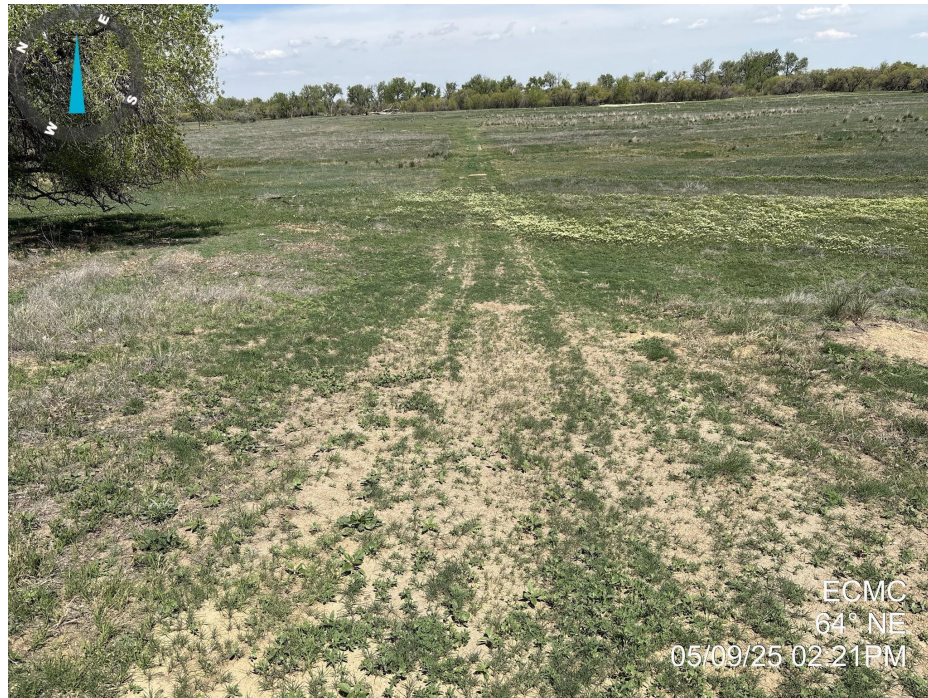
Photo 8. Photo taken of the access road, facing Northeast, towards the multi-well location. See comments under Photo 5.

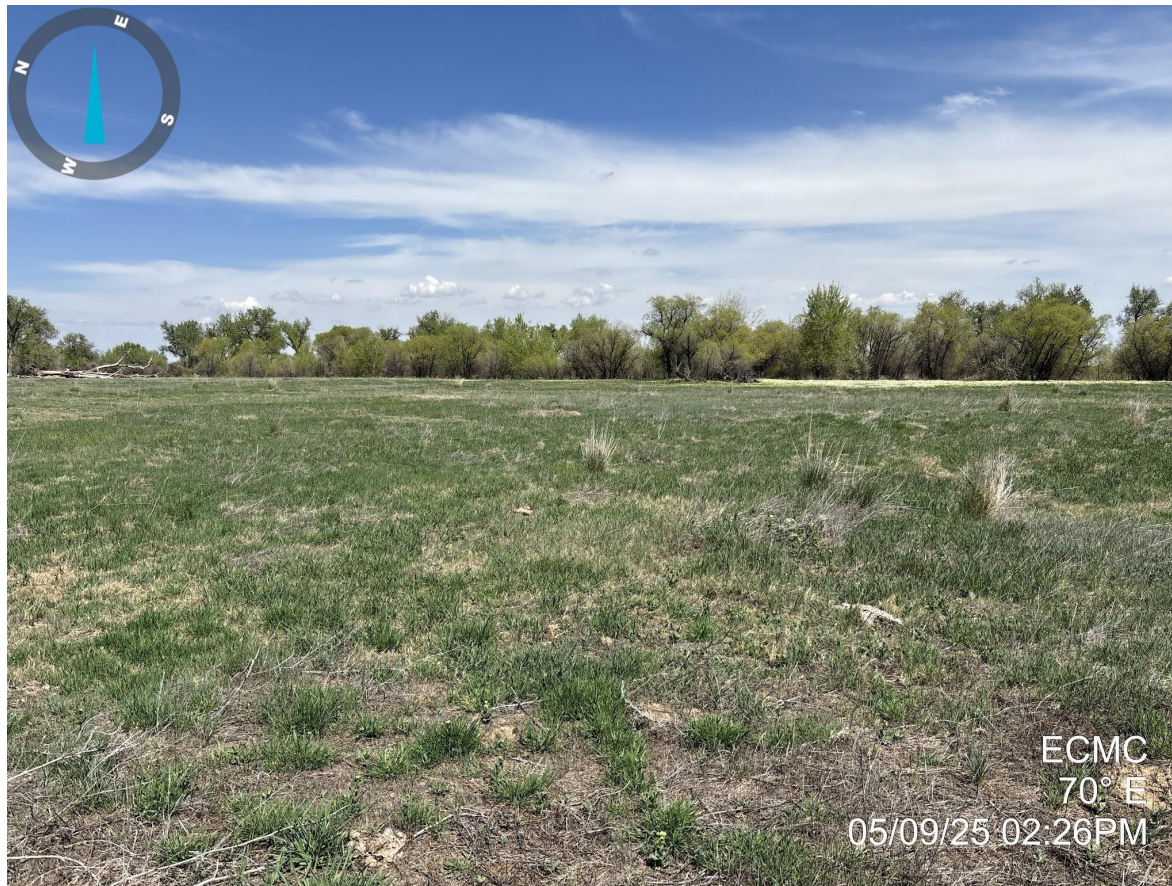
Photo 9. Photo taken of the reference area, south of the multi-well location, facing East. Photo illustrates perennial grass vegetation.
