Final Reclamation Inspection

Operator: KERR MCGEE OIL & GAS ONSHORE LP - 47120

Location ID: 329337

Inspection Photos
Location Name: HSR-REDMOND #12-21
Location ID: 329337

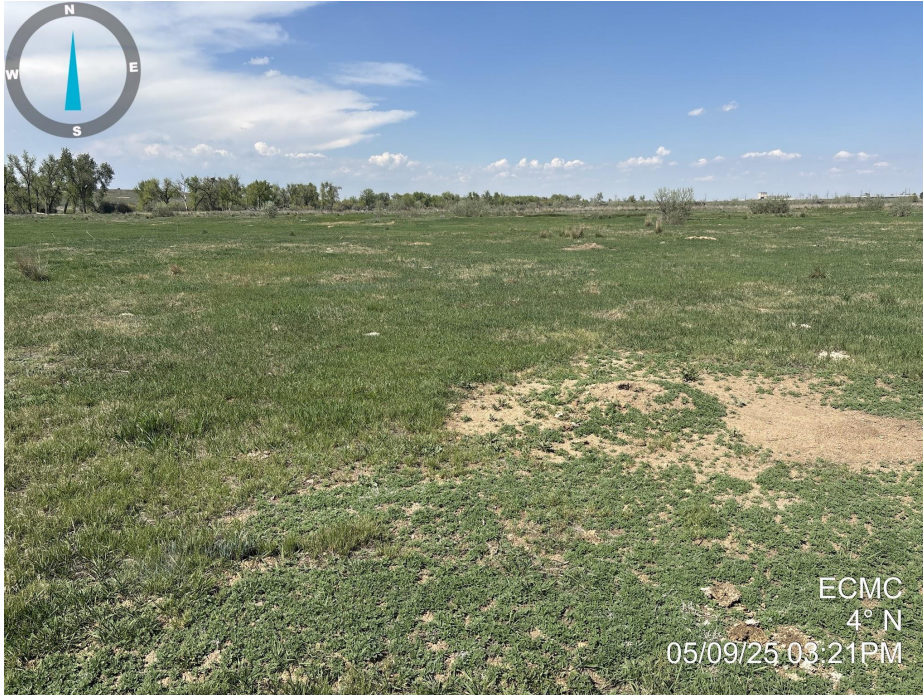
Photo 1. Photo taken from the well location, facing North. Photo illustrates that the well site meets Rule 1004 requirements.

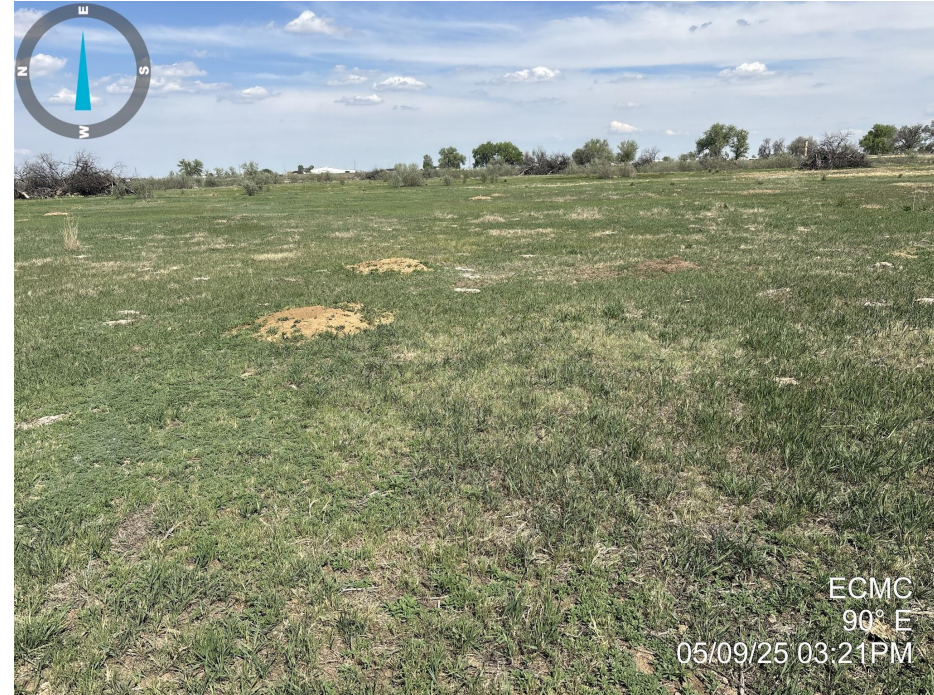
Photo 2. Photo taken from the well location, facing East. See comments under Photo 1.

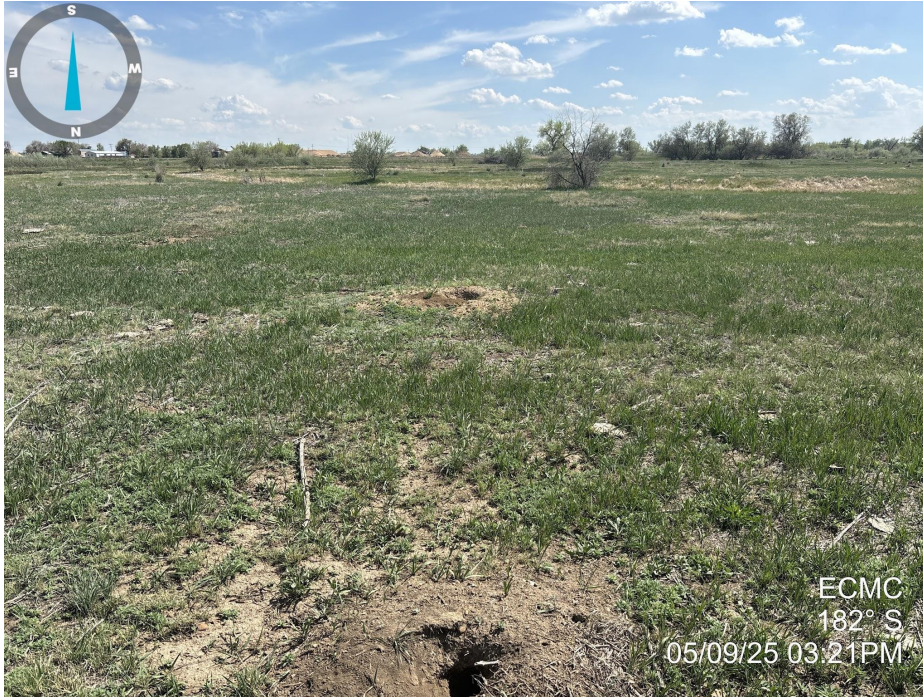
Photo 3. Photo taken from the well location, facing South. See comments under Photo 1.

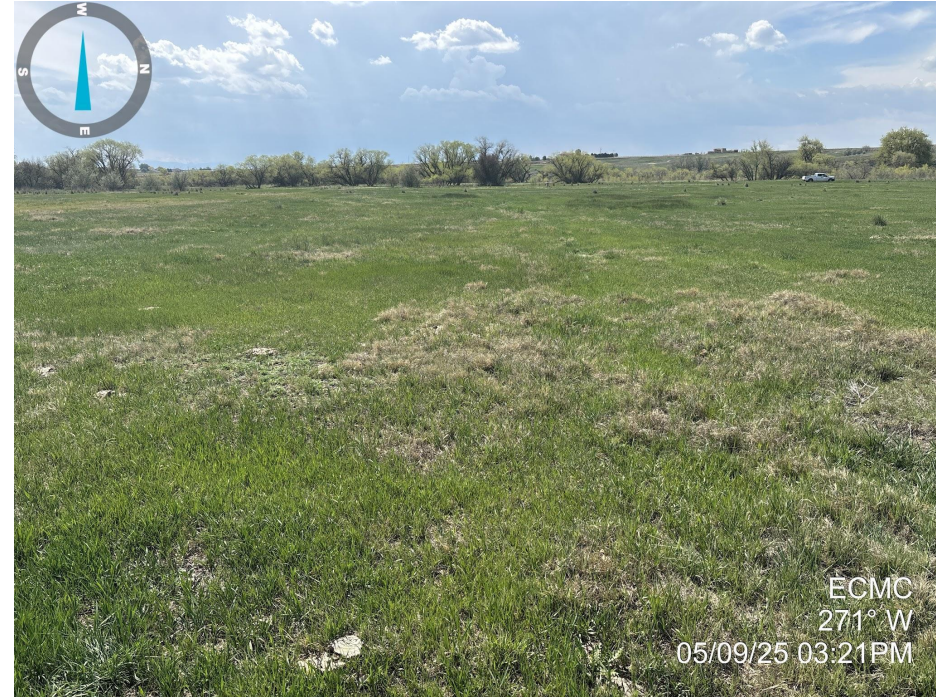
Photo 4. Photo taken from the well location, facing West. See comments under Photo 1.

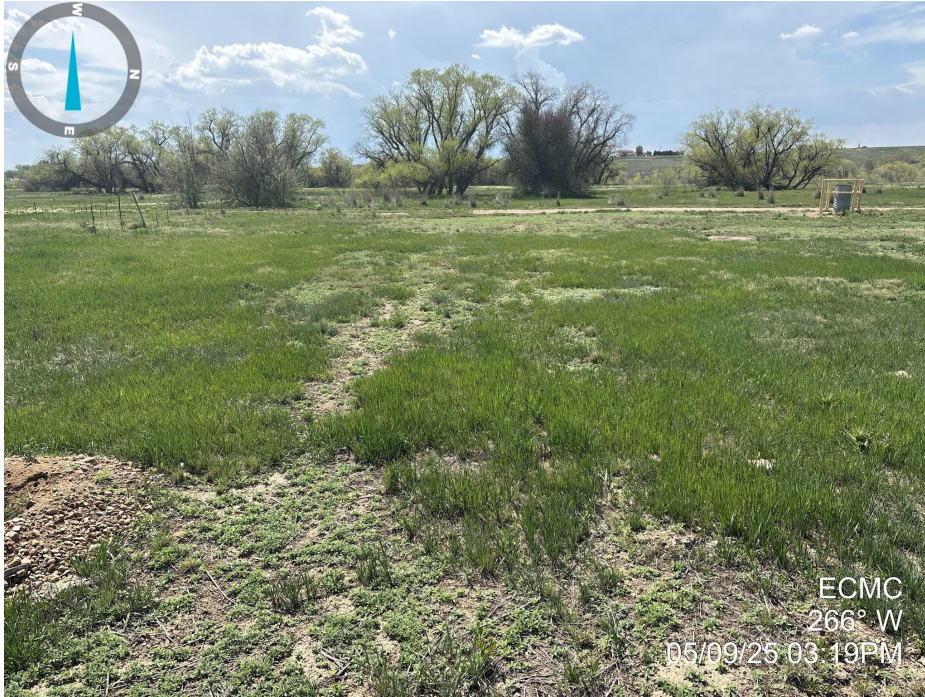
Photo 5. Photo taken from the access road, facing West. Photo illustrates that the access road has been reclaimed, but patches of weedy growth remain and vegetation establishment does not meet Rule 1004 standards.

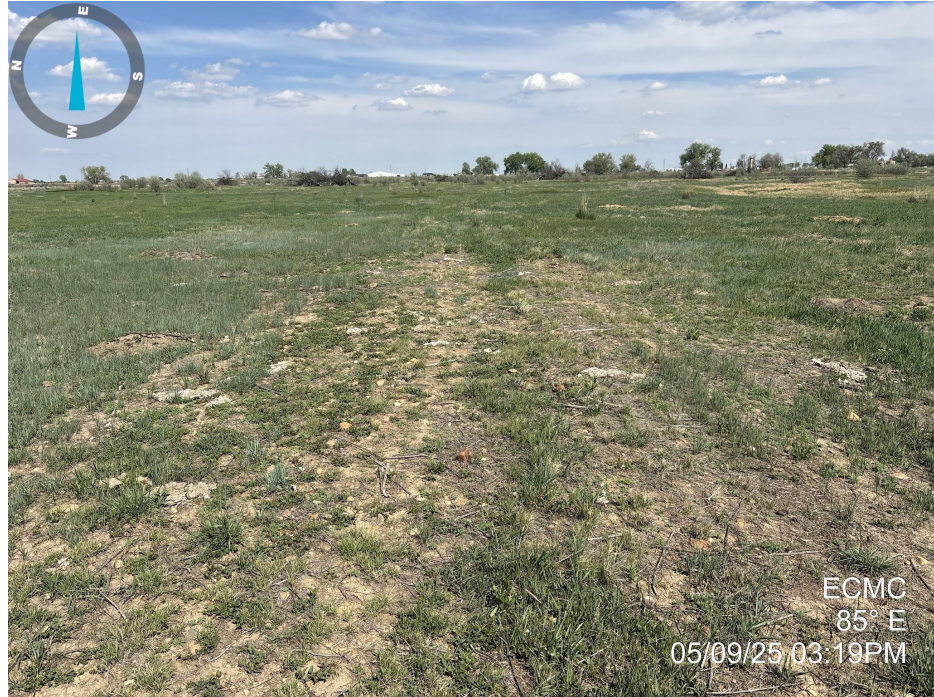
Photo 6. Photo taken of the access road, facing East towards the well site. See comments under Photo 5.

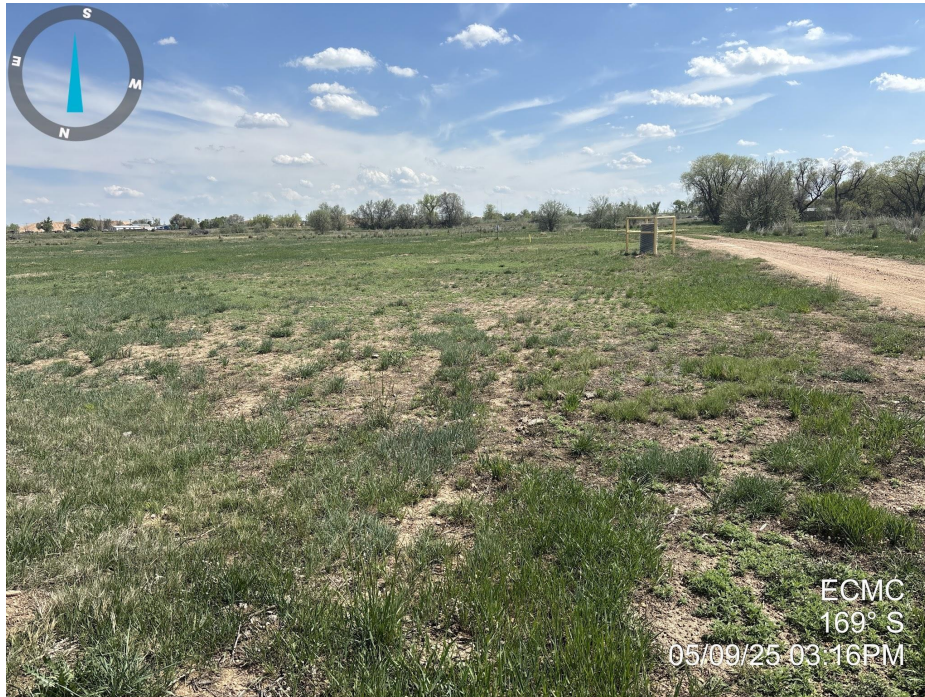
Photo 7. Photo taken of the tank battery location, facing South. Photo illustrates that final reclamation activities have taken place, but vegetation has not established to Rule 1004 standards.

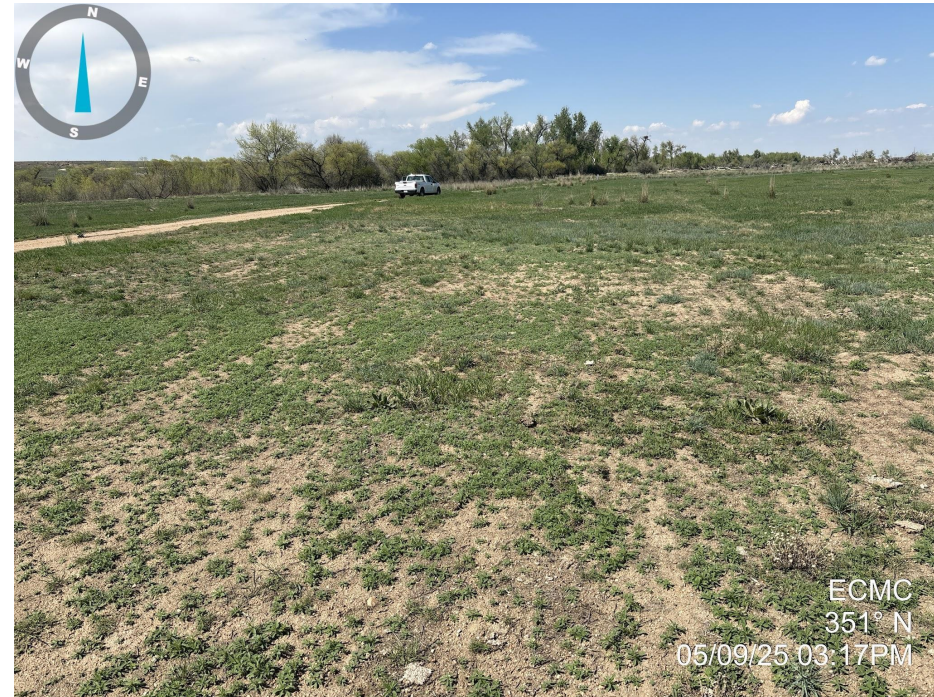
Photo 8. Photo taken of the tank battery location, facing North. See comments under Photo 7.

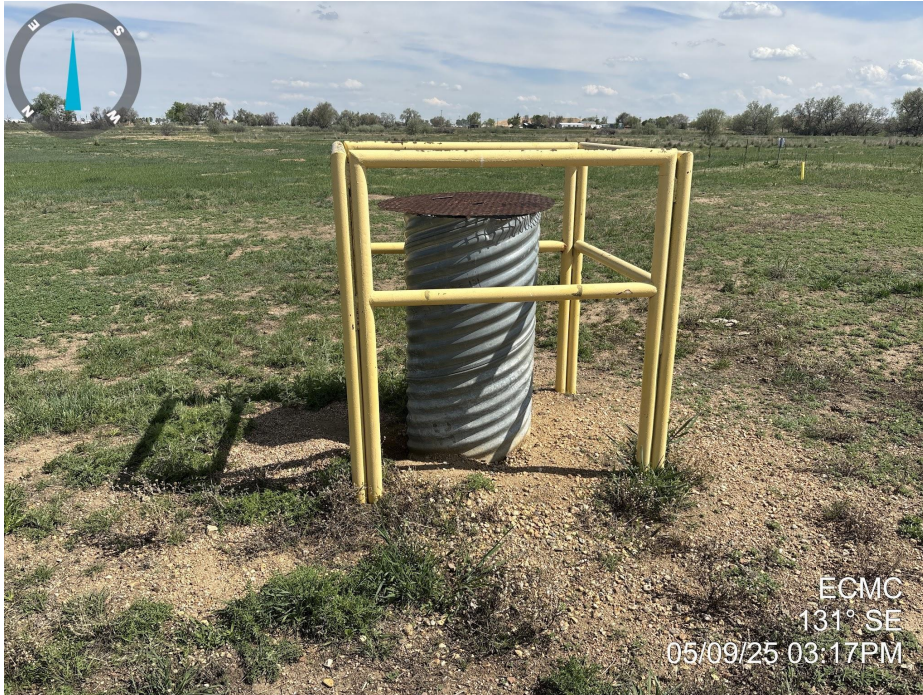
Photo 9. Photo taken of the tank battery location, facing Southeast. Photo illustrates that a buried valve set for midstream equipment remains on location.

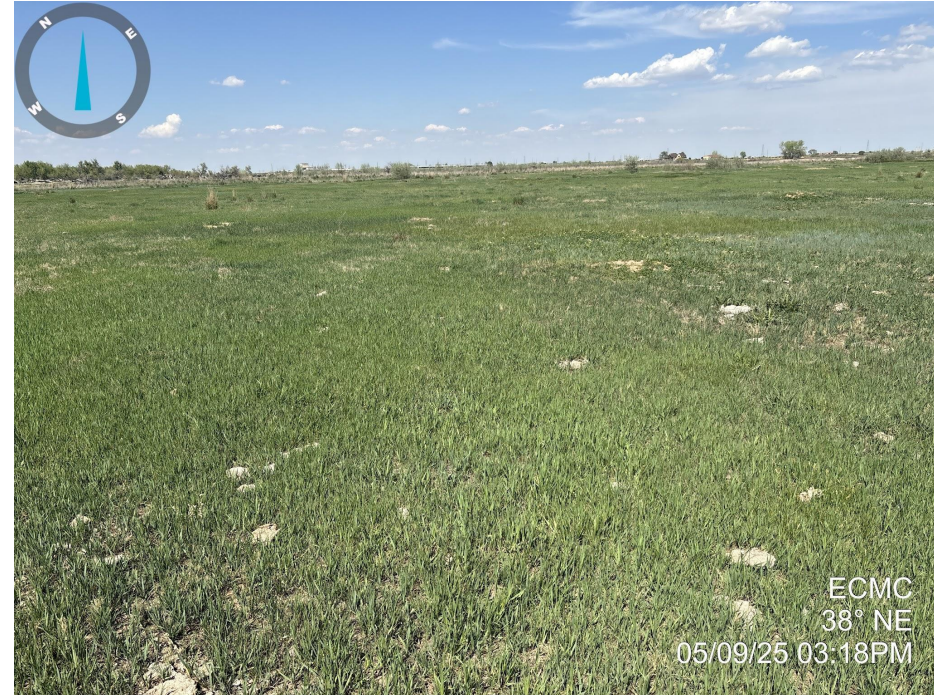
Photo 10. Photo taken of the reference area, northeast of the well site, facing Northeast. Photo illustrates perennial grass vegetation.
