# Final Reclamation Inspection

Operator: KERR MCGEE OIL & GAS ONSHORE LP - 47120

Location ID: 329343

Inspection Photos  
Location Name: HSR-WEIS #5-21  
Location ID: 329343

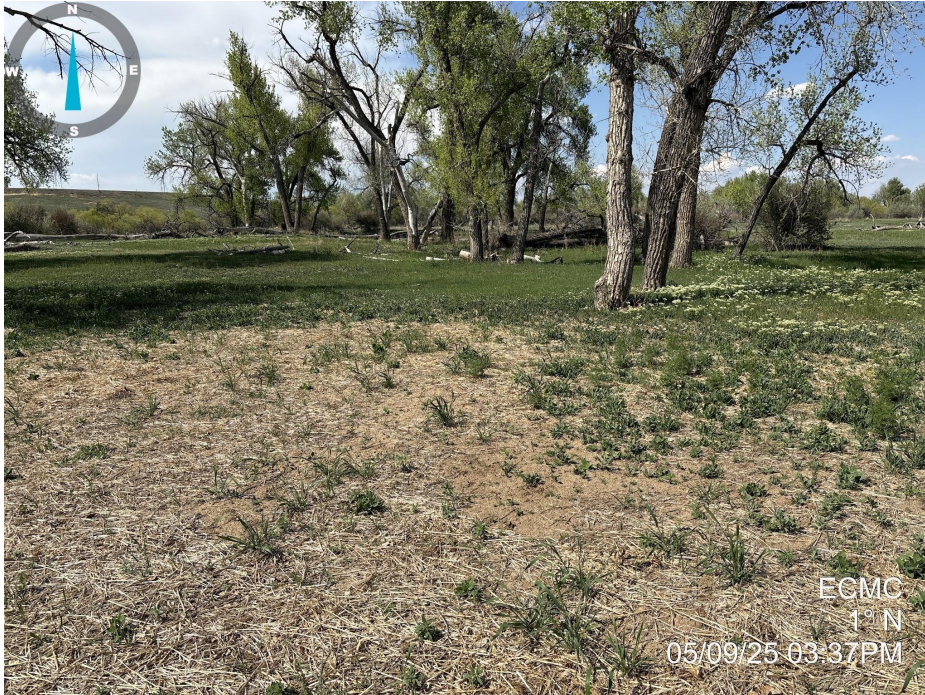
**Photo 1.** Photo taken from the well location, facing North. Photo illustrates that final reclamation activities have taken place, with evidence of drill rows from seeding and straw mulch, but vegetation has not yet established to Rule 1004 standards.

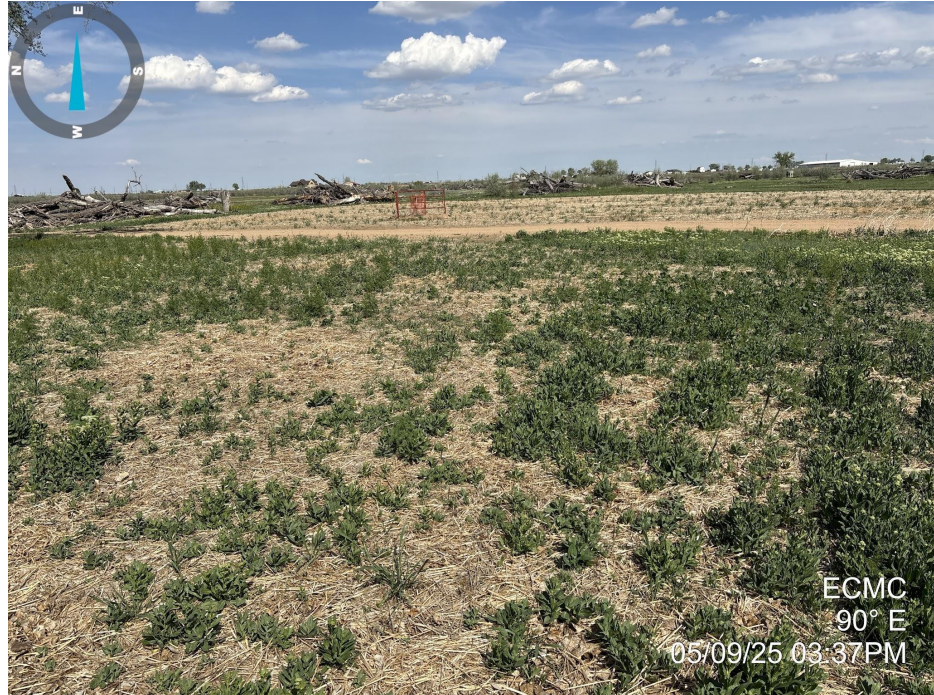
**Photo 2.** Photo taken from the well location, facing East. See comments under Photo 1.

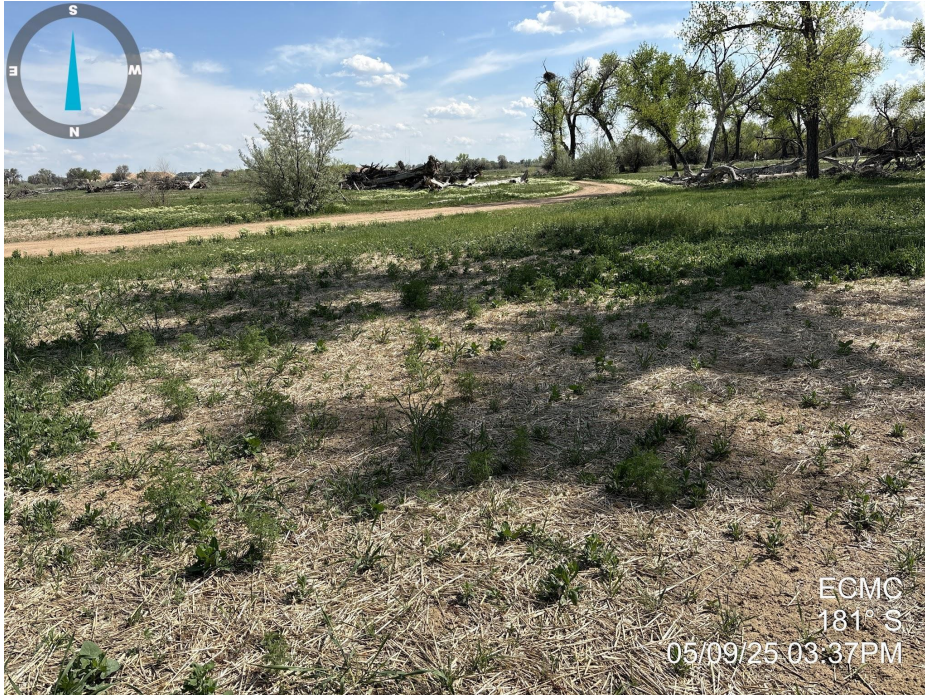
**Photo 3.** Photo taken from the well location, facing South. See comments under Photo 1.

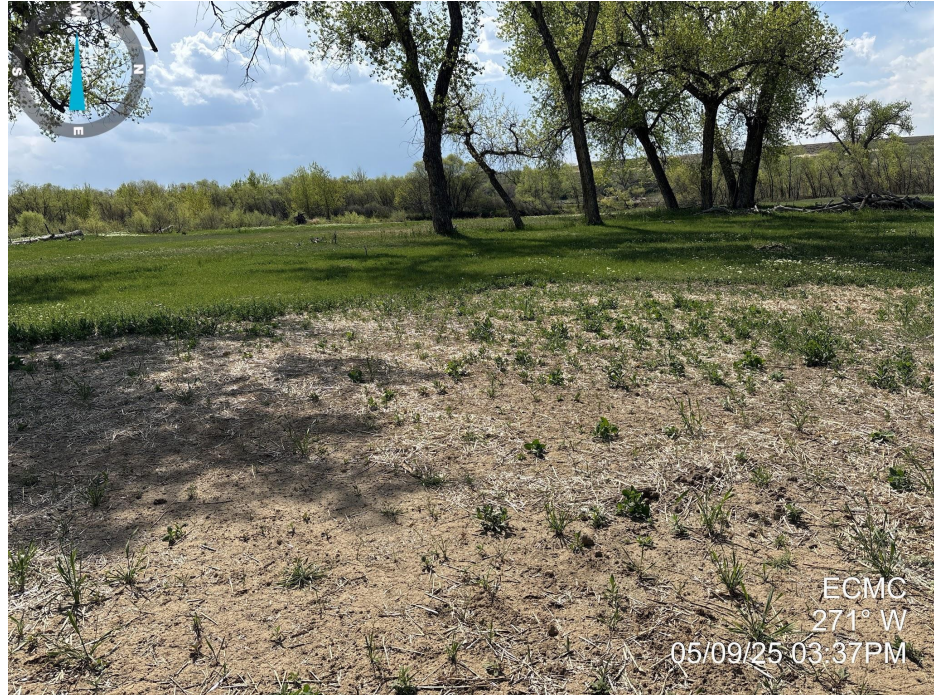
**Photo 4.** Photo taken from the well location, facing West. See comments under Photo 1.

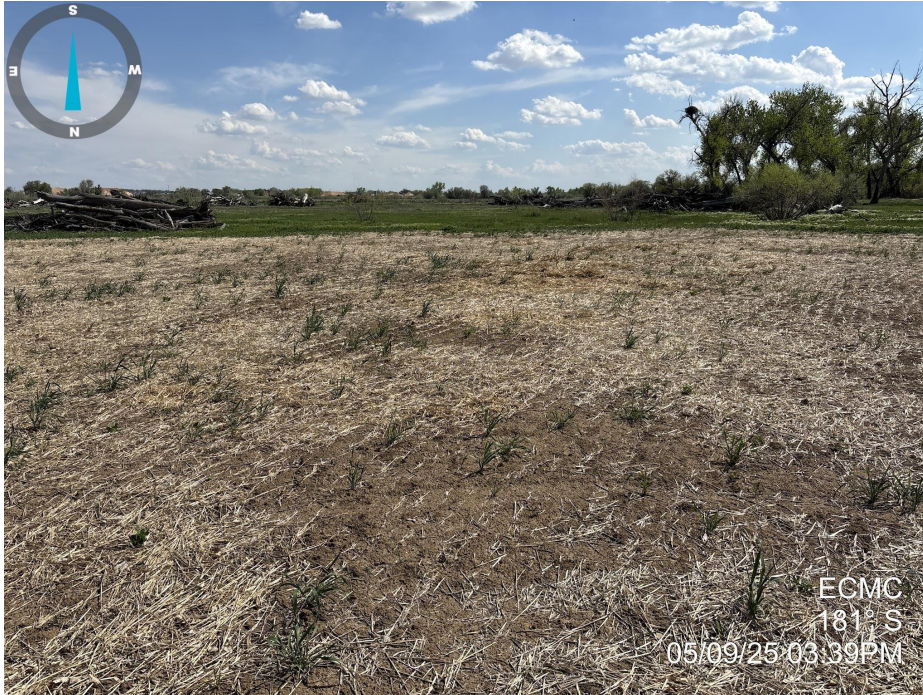
**Photo 5.** Photo taken from the tank battery location, facing South. Photo illustrates the operator has performed reclamation, with evidence of drill row seeding and straw mulch, but vegetation has not yet established to Rule 1004 standards.

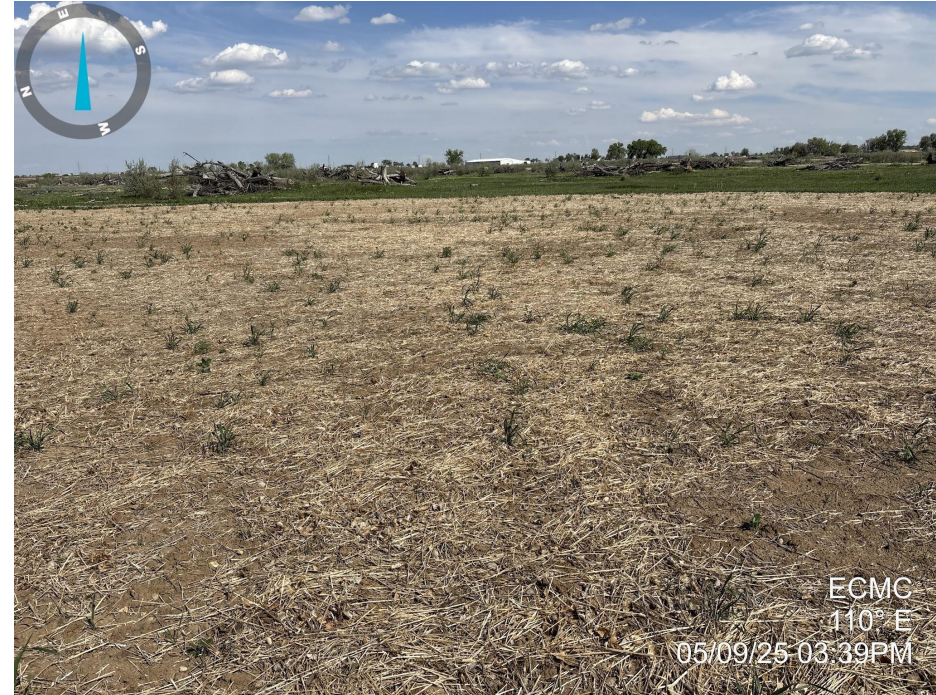
**Photo 6.** Photo taken of the tank battery location, facing East. See comments under Photo 5.

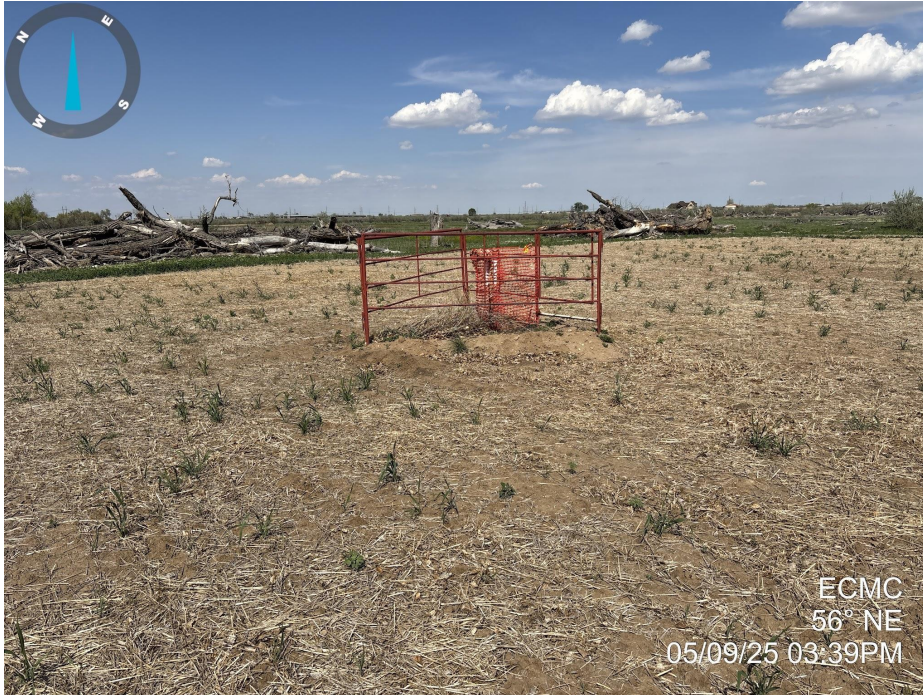
**Photo 7.** Photo taken of the tank battery location, facing Northeast. Photo illustrates midstream equipment remains on location.

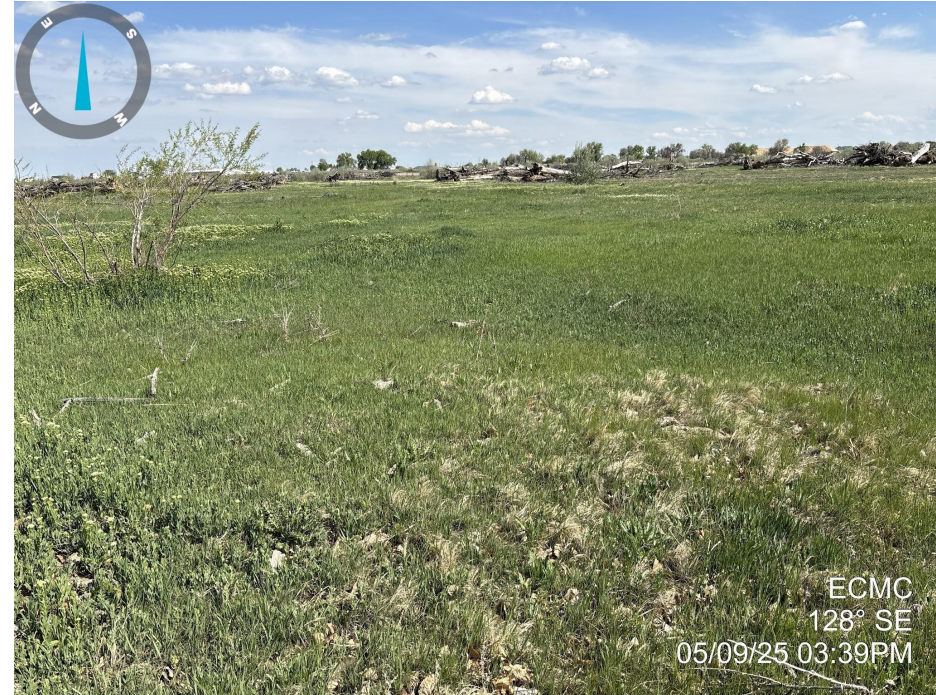
**Photo 8.** Photo taken of the reference area, south of the location, facing Southeast. Photo illustrates perennial grass vegetation.
