Final Reclamation Inspection

Operator: NOBLE ENERGY INC - 100322

Location ID: 329239

Inspection Photos
Location Name: HSR-PETRIE #3-7
Location ID: 329239

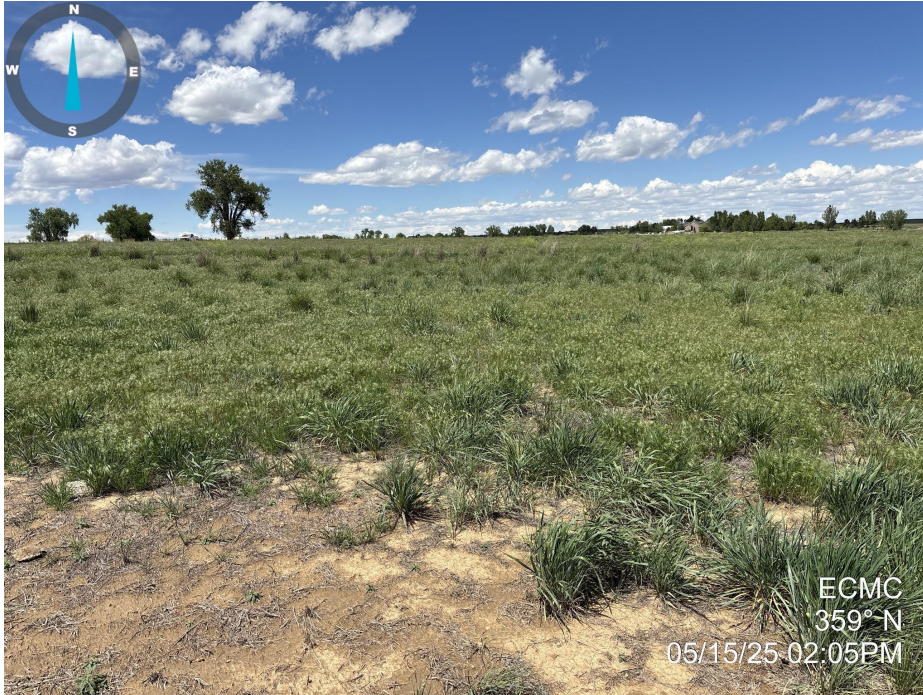
Photo 1. Photo taken from the well location, facing North. Photo illustrates that final reclamation activities have taken place, but vegetation has not established to Rule 1004 standards.

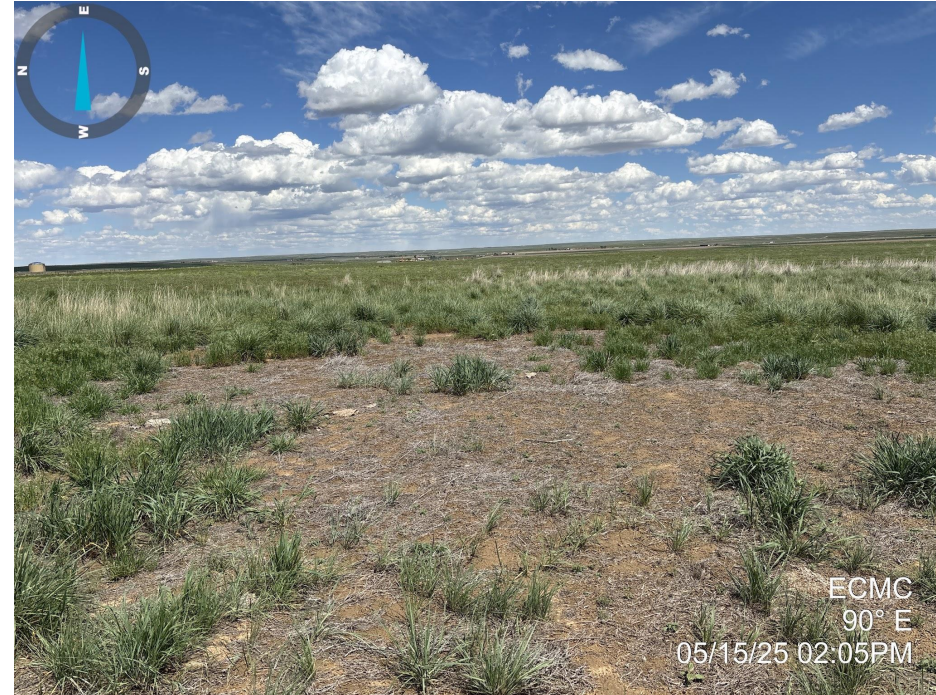
Photo 2. Photo taken from the well location, facing East. See comments under Photo 1.

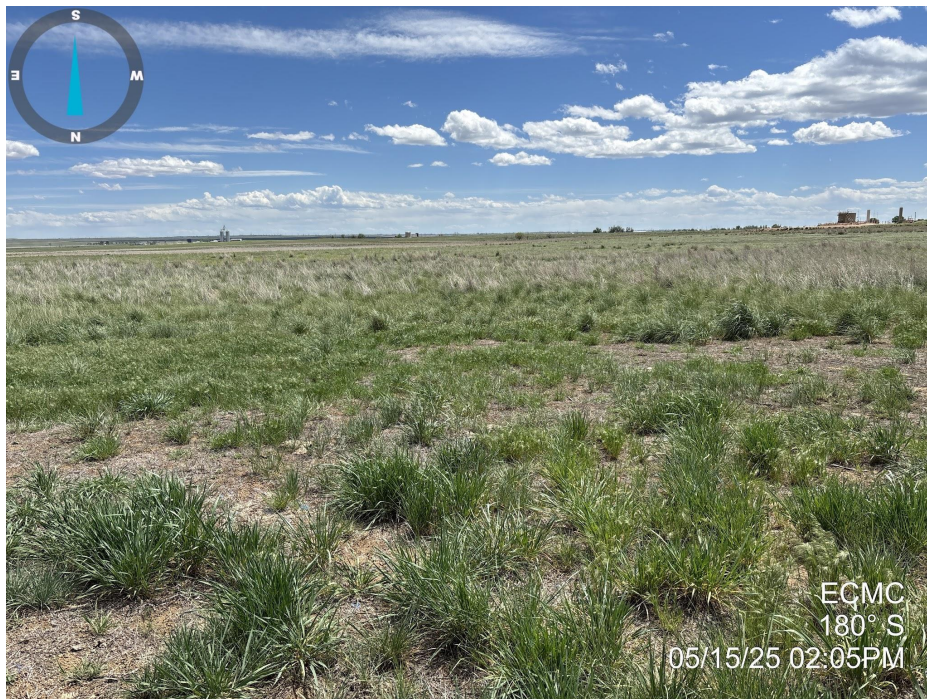
Photo 3. Photo taken from the well location, facing South. See comments under Photo 1.

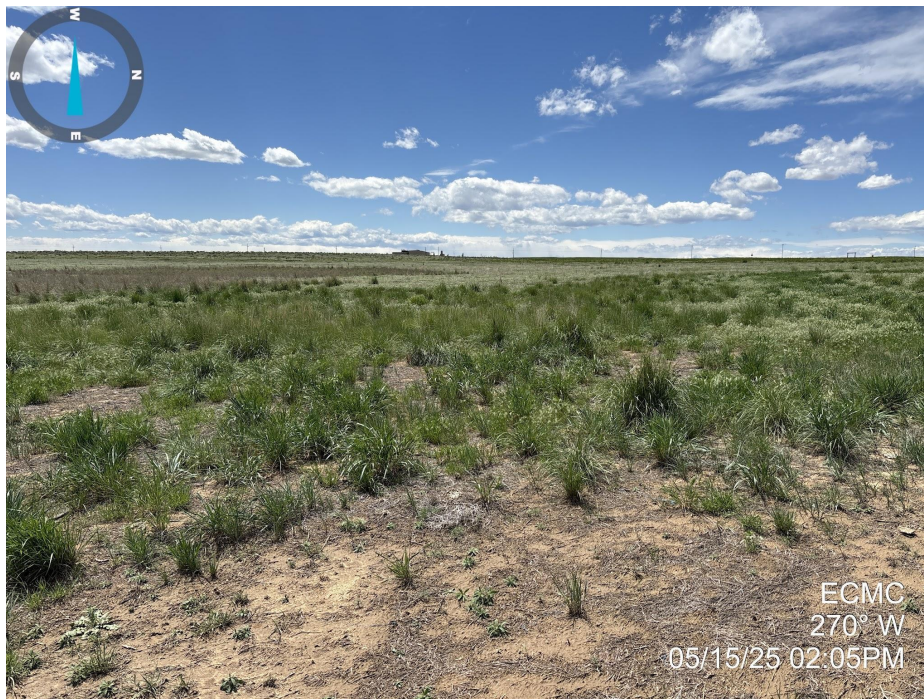
Photo 4. Photo taken from the well location, facing West. See comments under Photo 1.

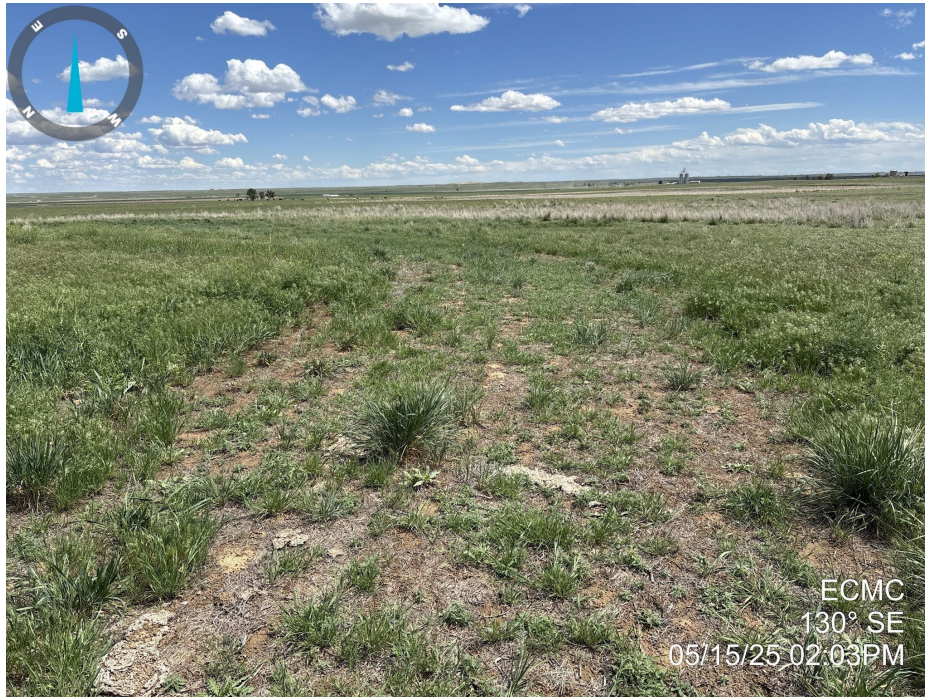
Photo 5. Photo taken from the access road, facing Southeast towards the well location. Photo illustrates that vegetation has not established to Rule 1004 standards along the access road.

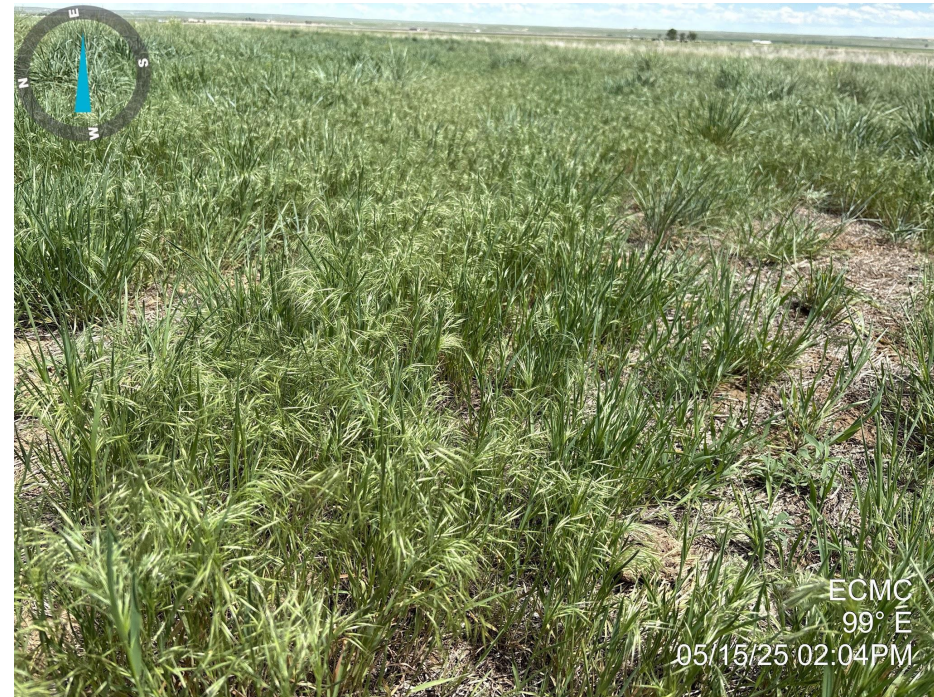
Photo 6. Photo taken of vegetation along the access road. Photo illustrates that cheatgrass (*Bromus tectorum*) is present across the location and is a List C noxious weed species.

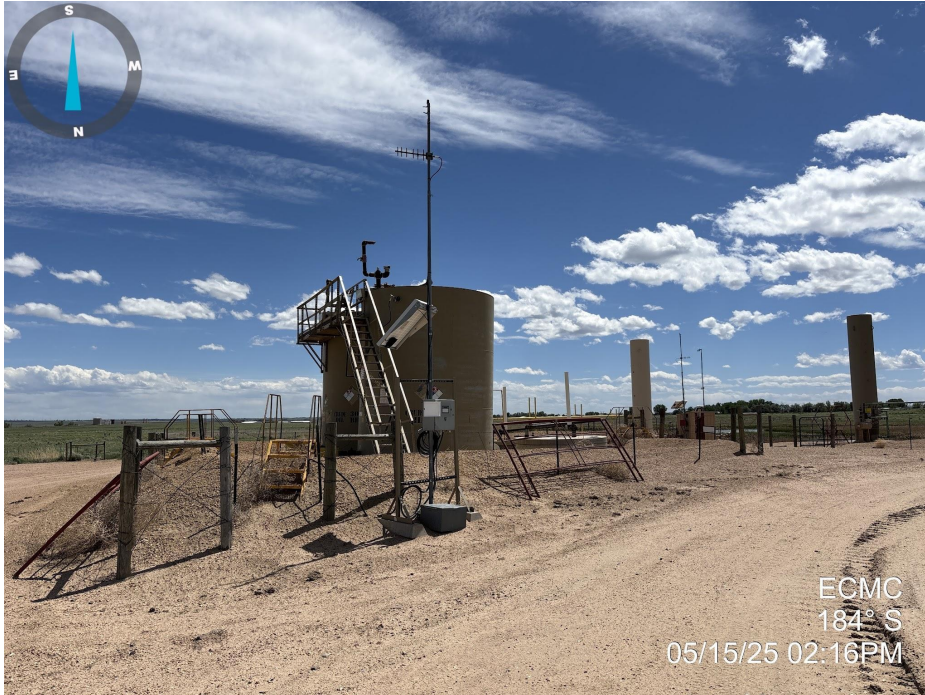
Photo 7. Photo taken of the tank battery location, facing South. Photo illustrates that the tank battery remains in use for another TA well site.

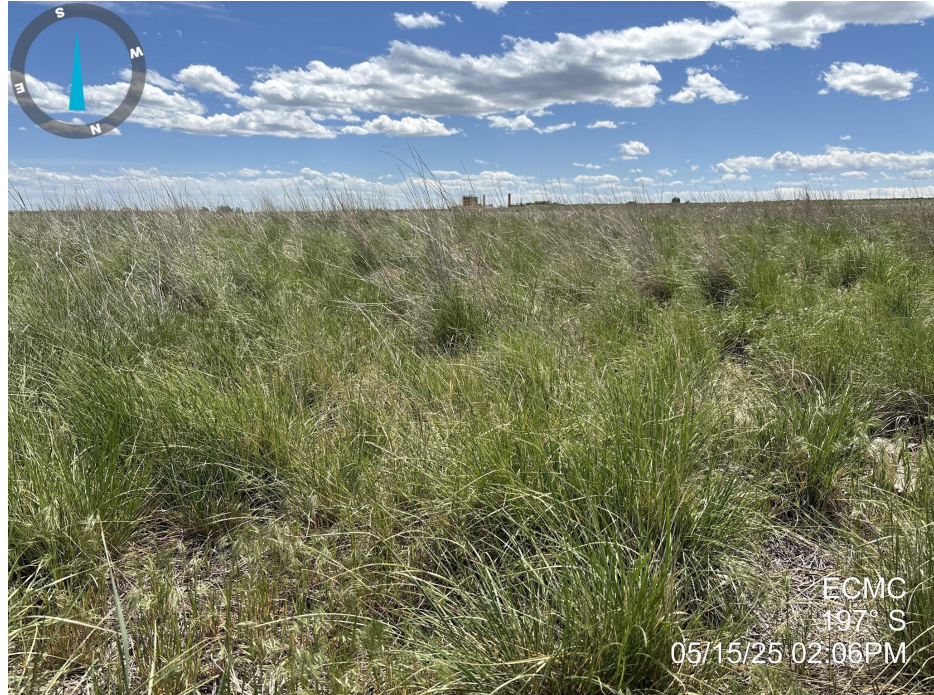
Photo 8. Photo taken of the reference area, south of the well site, facing South. Photo illustrates the site is dominated by perennial grass vegetation and cheatgrass (*Bromus tectorum*).
