Final Reclamation Inspection

Operator: NOBLE ENERGY INC - 100322

Location ID: 329223

Inspection Photos
Location Name: HSR-PARKMAN #6-7
Location ID: 329223

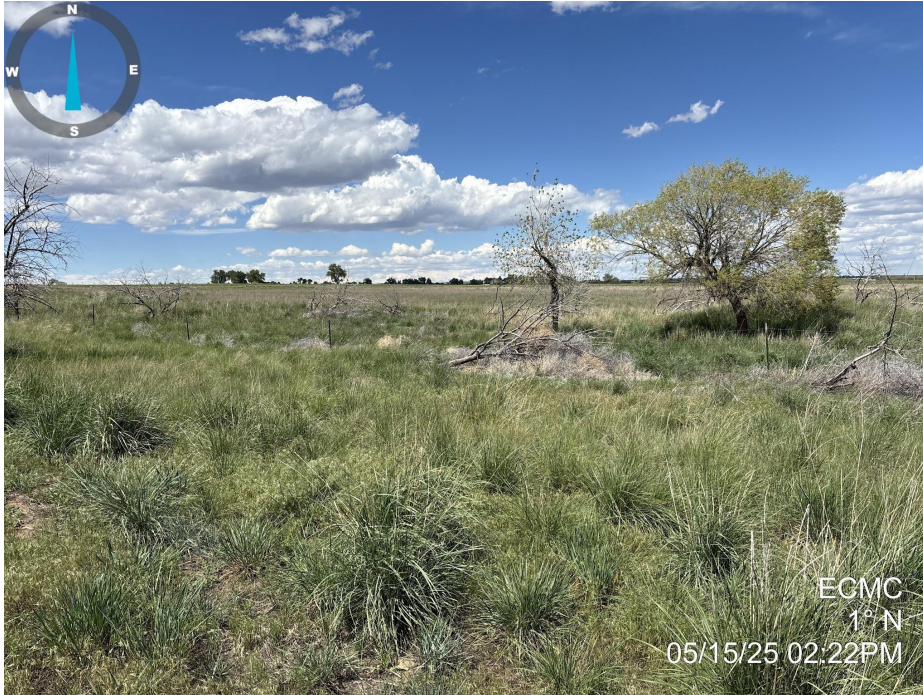
Photo 1. Photo taken from the well location, facing North. Photo illustrates final reclamation has taken place, but cheatgrass (*Bromus Tectorum*) is present and must be managed on the site (see Photo 5).

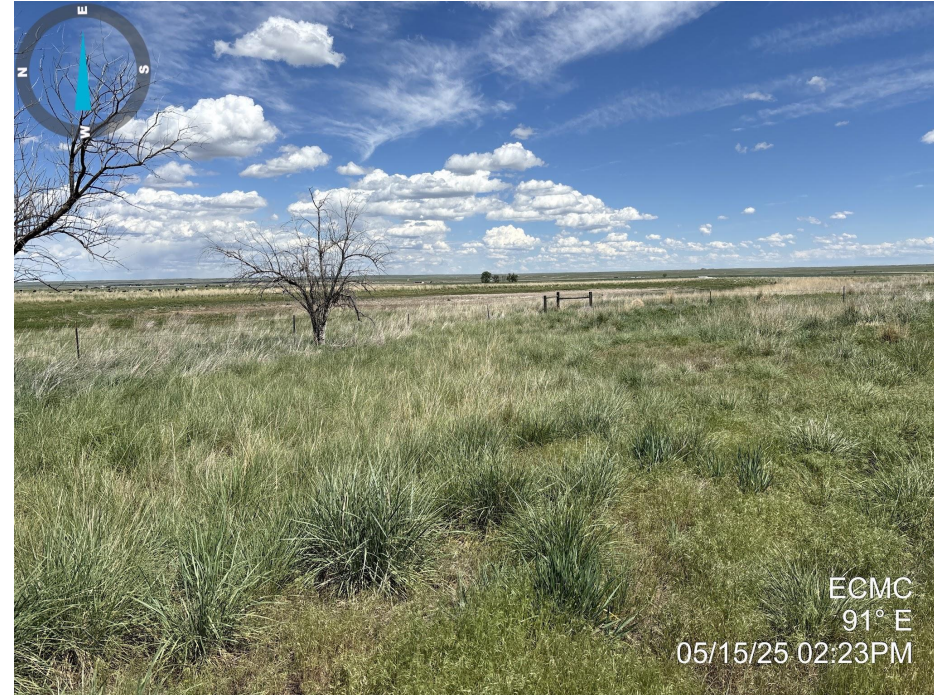
Photo 2. Photo taken from the well location, facing East. See comments under Photo 1.

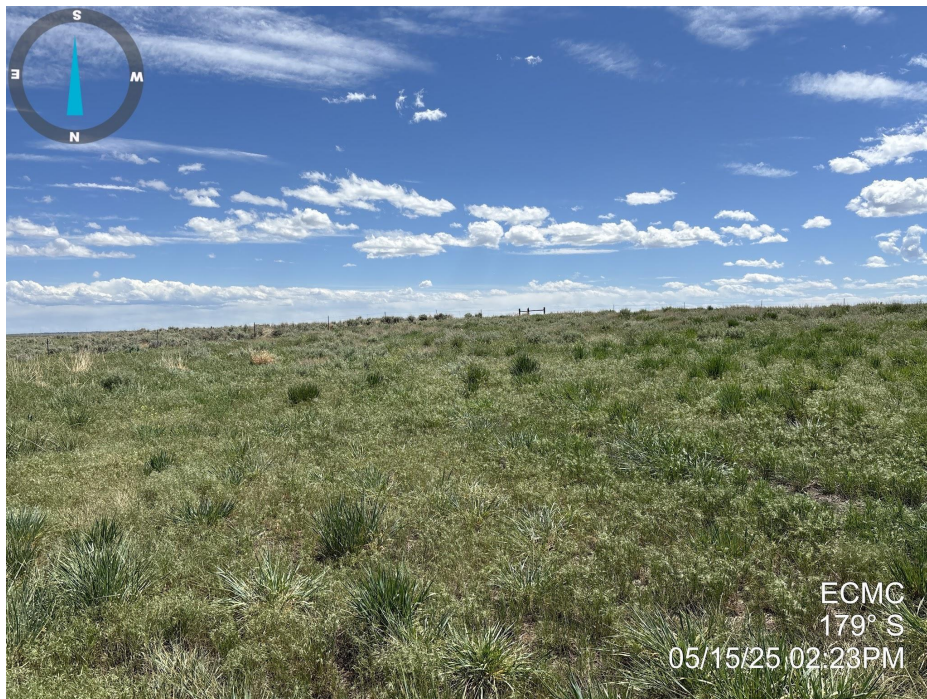
Photo 3. Photo taken from the well location, facing South. See comments under Photo 1.

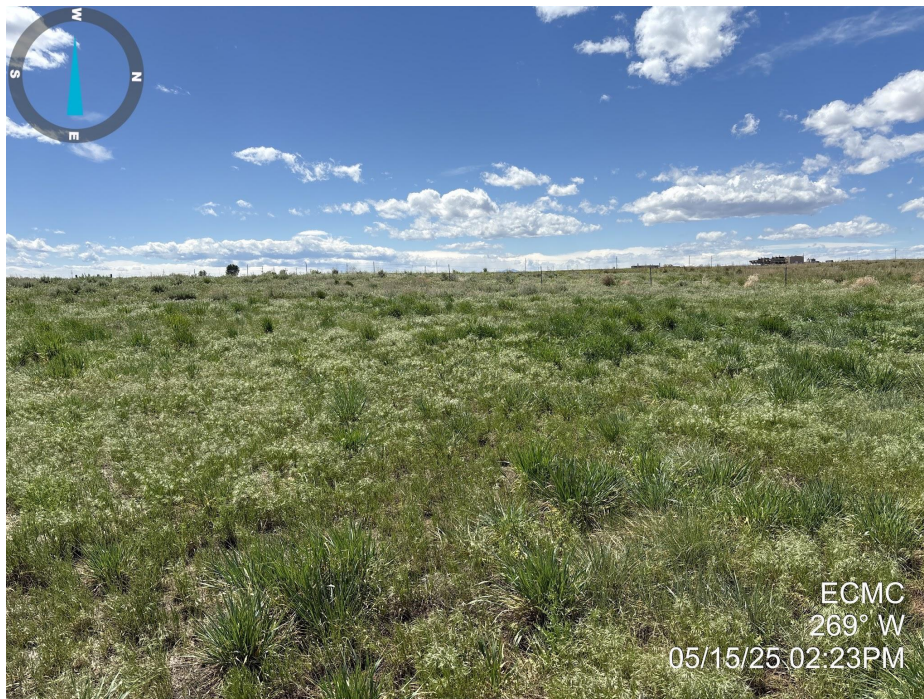
Photo 4. Photo taken from the well location, facing West. See comments under Photo 1.

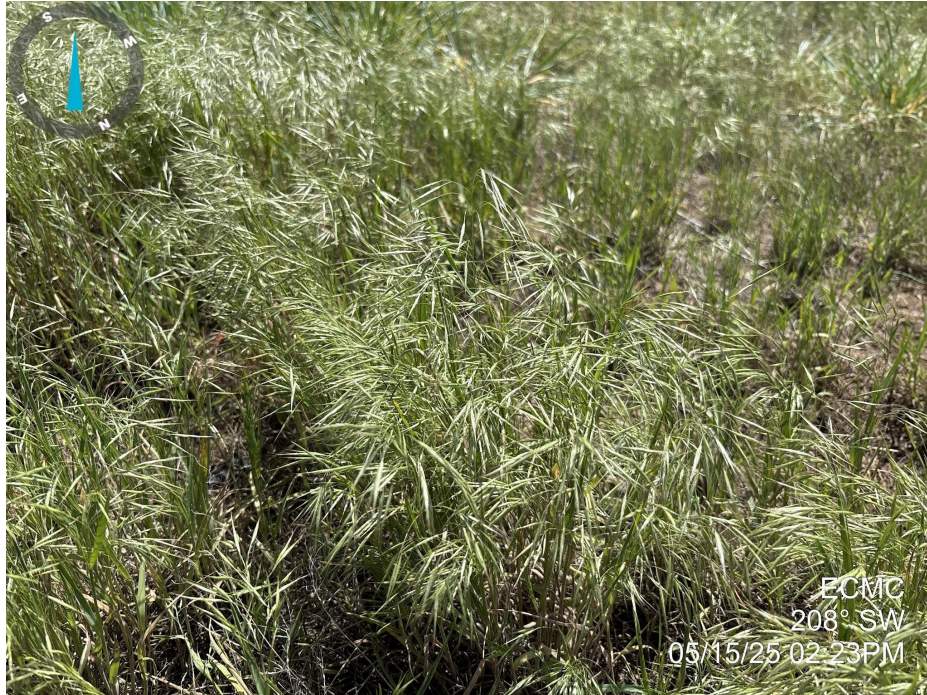
Photo 5. Photo taken of vegetation at the well site. Photo illustrates that cheatgrass (*Bromus tectorum*) is present across the location and is a List C noxious weed species.

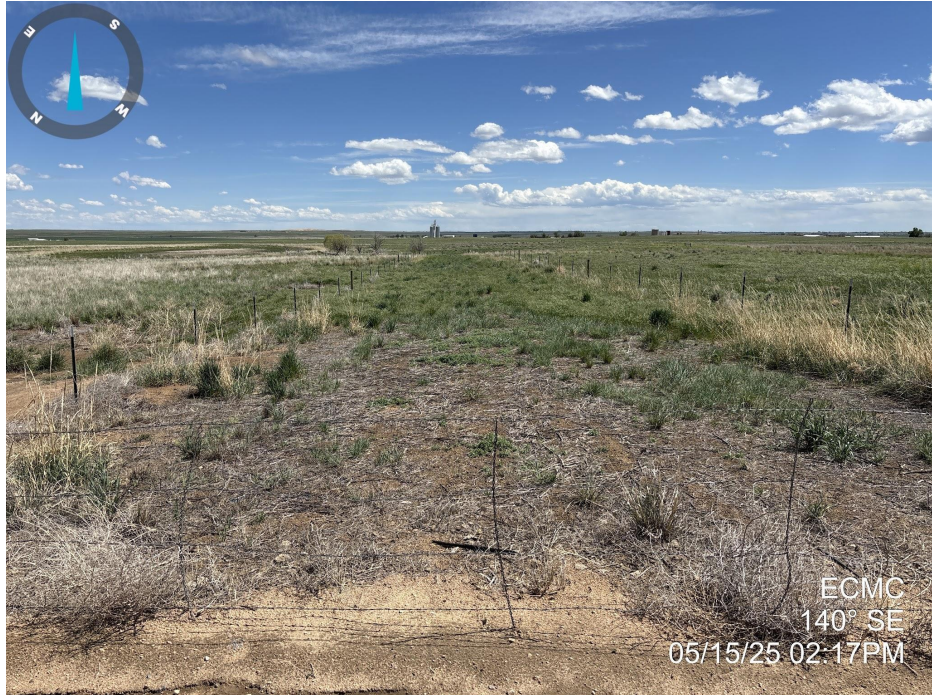
Photo 6. Photo taken from the access road, facing West towards the well location. Photo illustrates that vegetation has not established to Rule 1004 standards along portions of the access road.

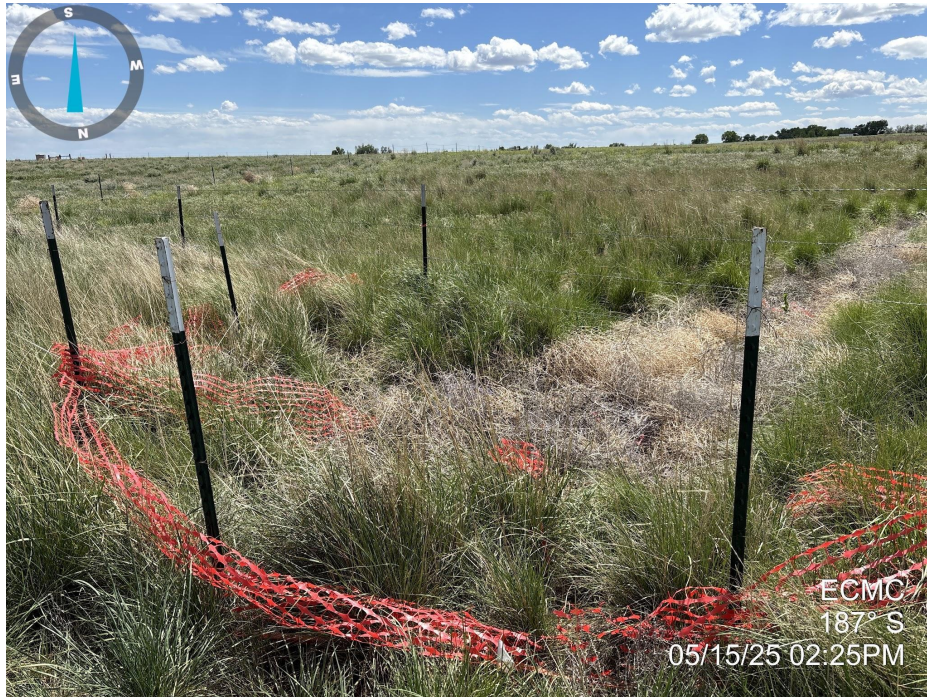
Photo 7. Photo taken from the southern edge of the access road, facing South. Photo illustrates that there is stormwater erosion running along the edge of the access road and fencing is in place and in disrepair.

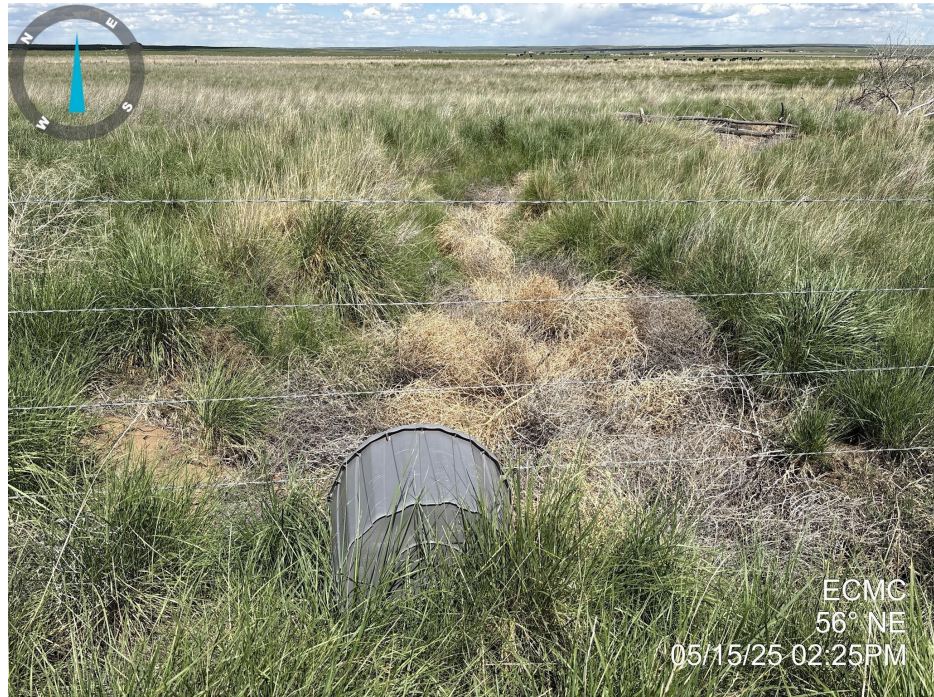
Photo 8. Photo taken of the northern edge of the access road, facing northeast. See comments under Photo 7.

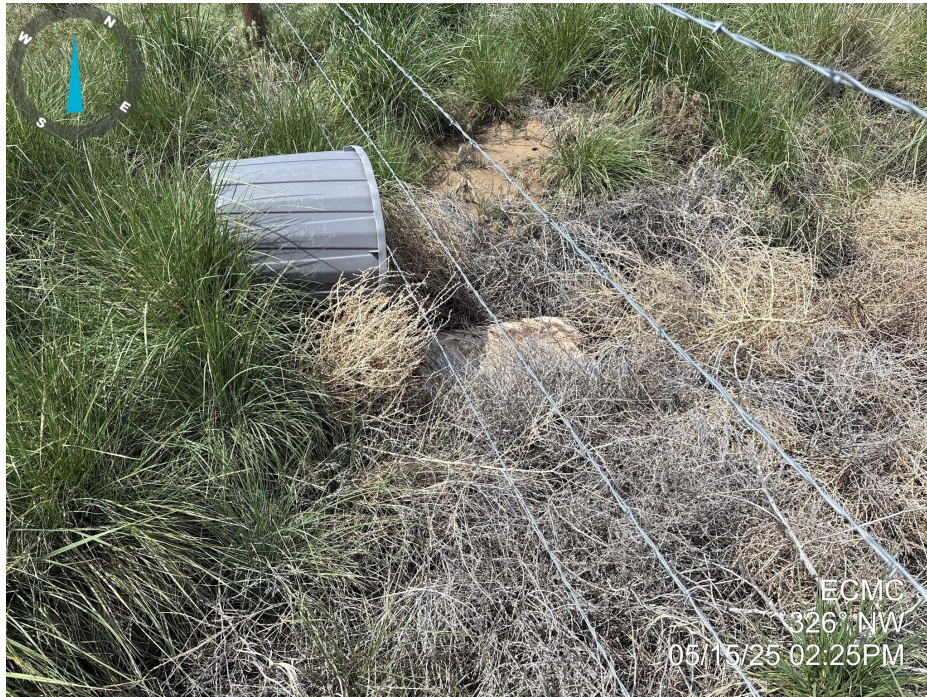
Photo 9. Photo taken from the access road, facing northwest, along the Northern edge of the road. Photo illustrates weedy annual vegetation (*Salsola tragus*) and erosion along the edge of a portion of the access road.

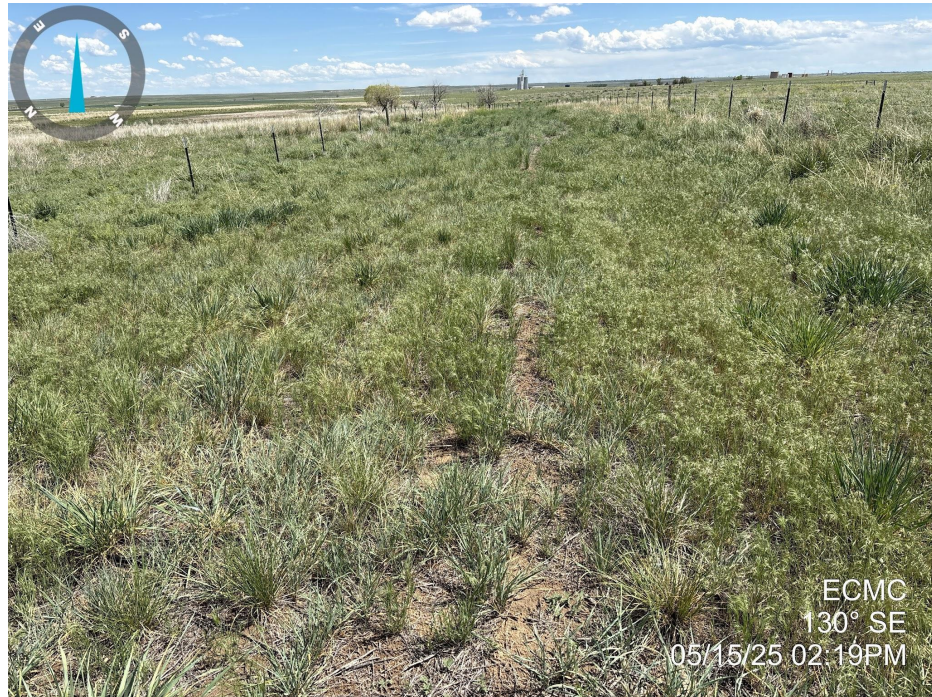
Photo 10. Photo taken of vegetation along the access road. Photo illustrates that cheatgrass (*Bromus tectorum*) is present across the location and is a List C noxious weed species.

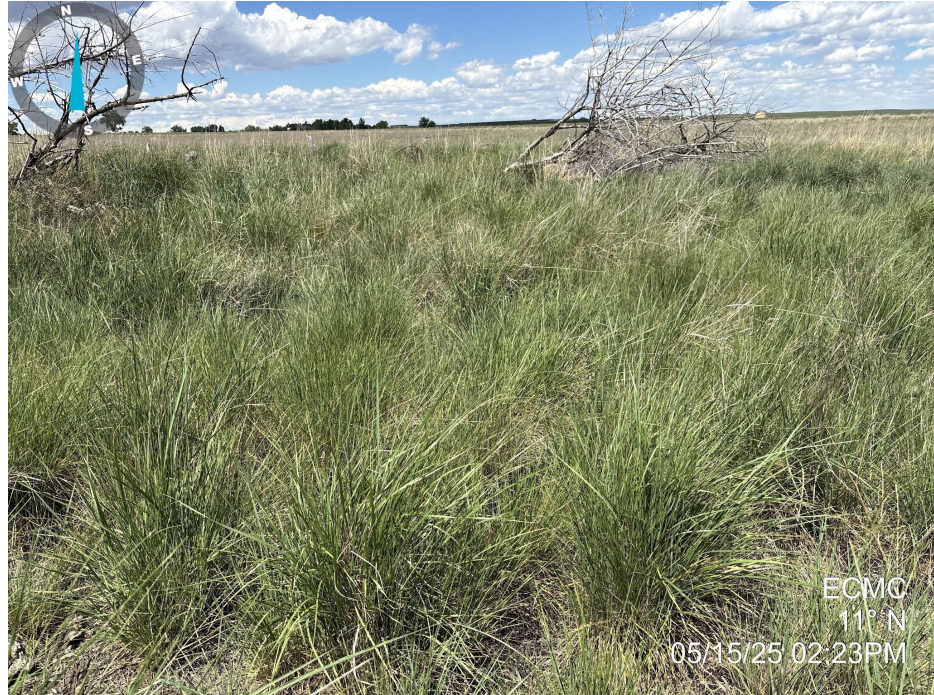
Photo 12. Photo taken of the reference area, north of the well site, facing North. Photo illustrates the site is dominated by perennial grass vegetation.
