Final Reclamation Inspection

Operator: NOBLE ENERGY INC - 100322

Location ID: 460860

Inspection Document #: 718800352

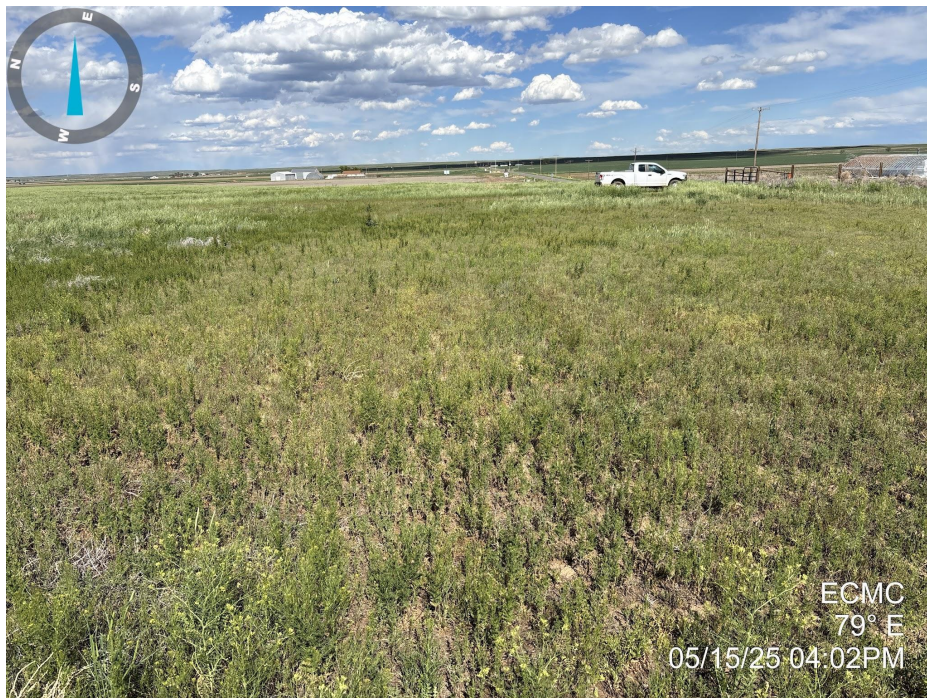
Photo 1. Photo taken from the tank battery location, facing East. Photo illustrates that the location does not meet Rule 1004 reclamation standards as weedy annual vegetation and cheatgrass (*Bromus tectorum*) dominates the location.

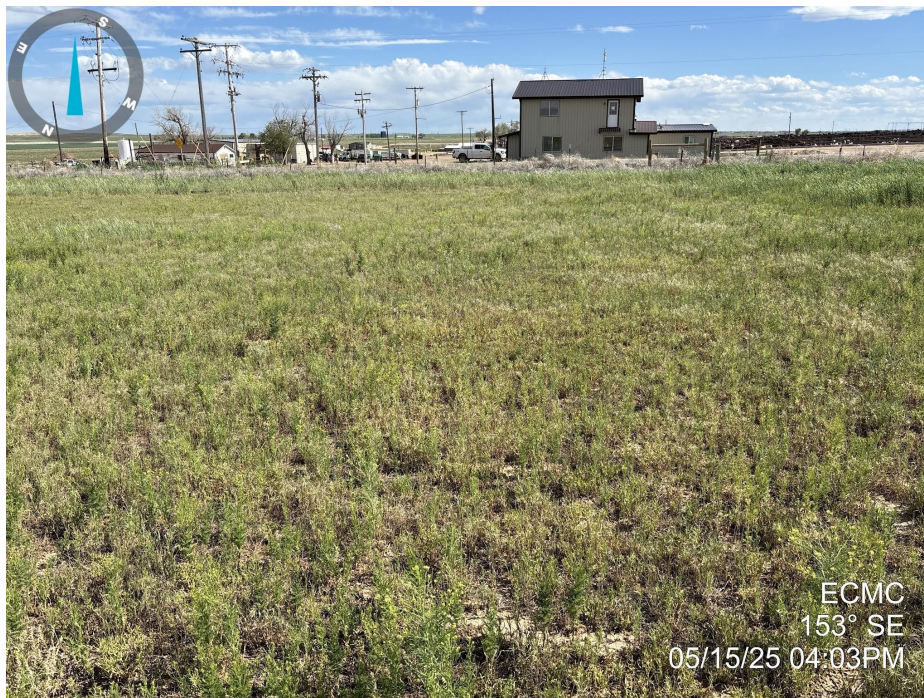
Photo 2. Photo taken from the tank battery location, facing Southeast. See comments under Photo 1.

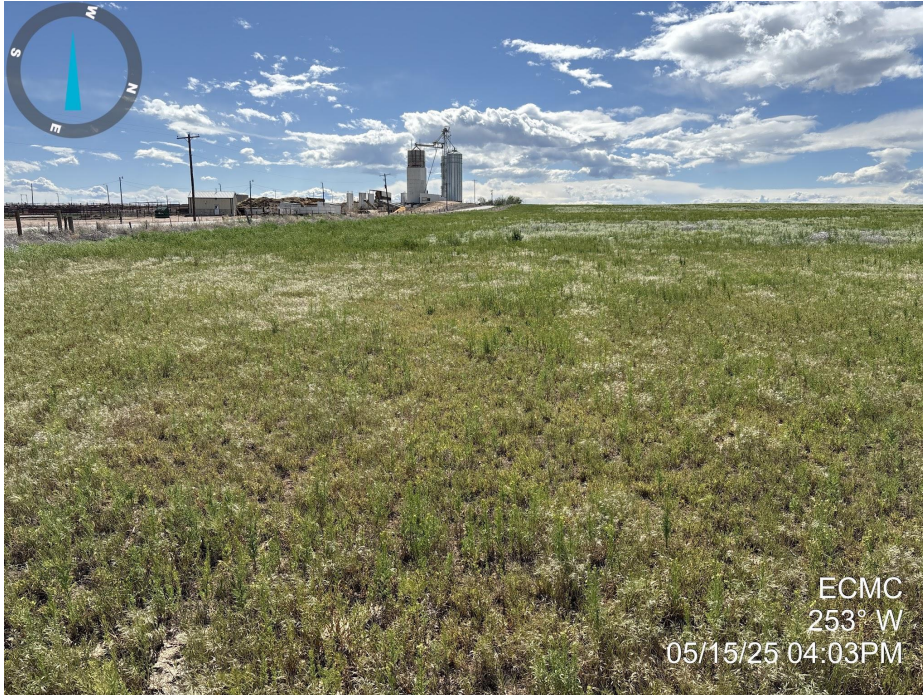
Photo 3. Photo taken from the tank battery location, facing West. See comments under Photo 1.

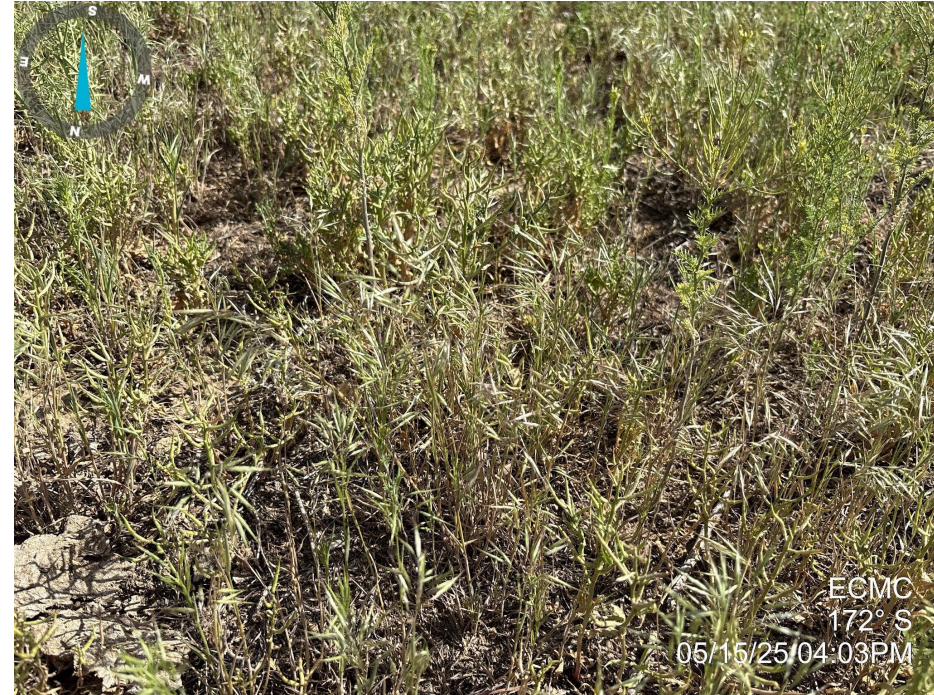
Photo 4. Photo taken of vegetation at the tank battery location. Photo illustrates cheatgrass (*Bromus tectorum*) is present at the location and is a List C noxious weed species.

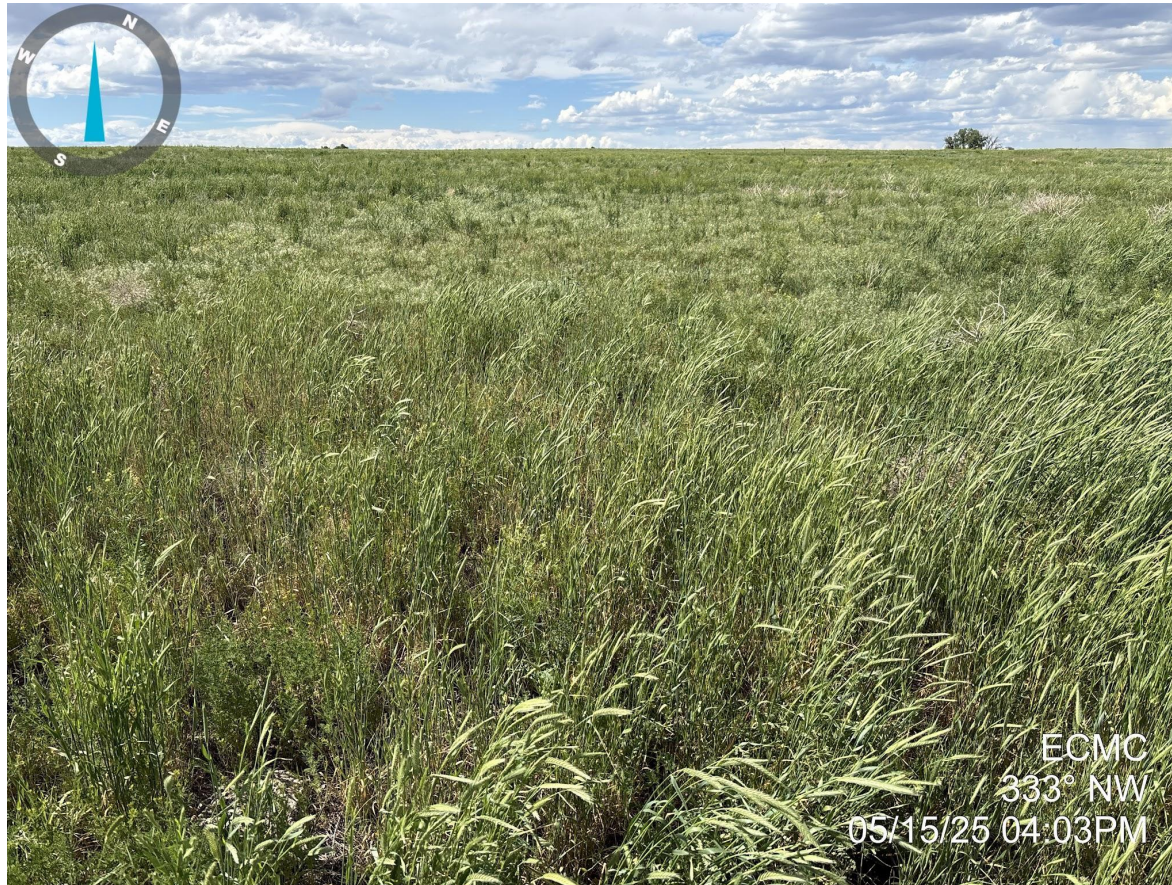
Photo 5. Photo taken from the reference area, east of the location, facing Northwest. Photo illustrates perennial grass vegetation with some cheatgrass encroachment.
