ECMC  
Environmental  
Field Inspection

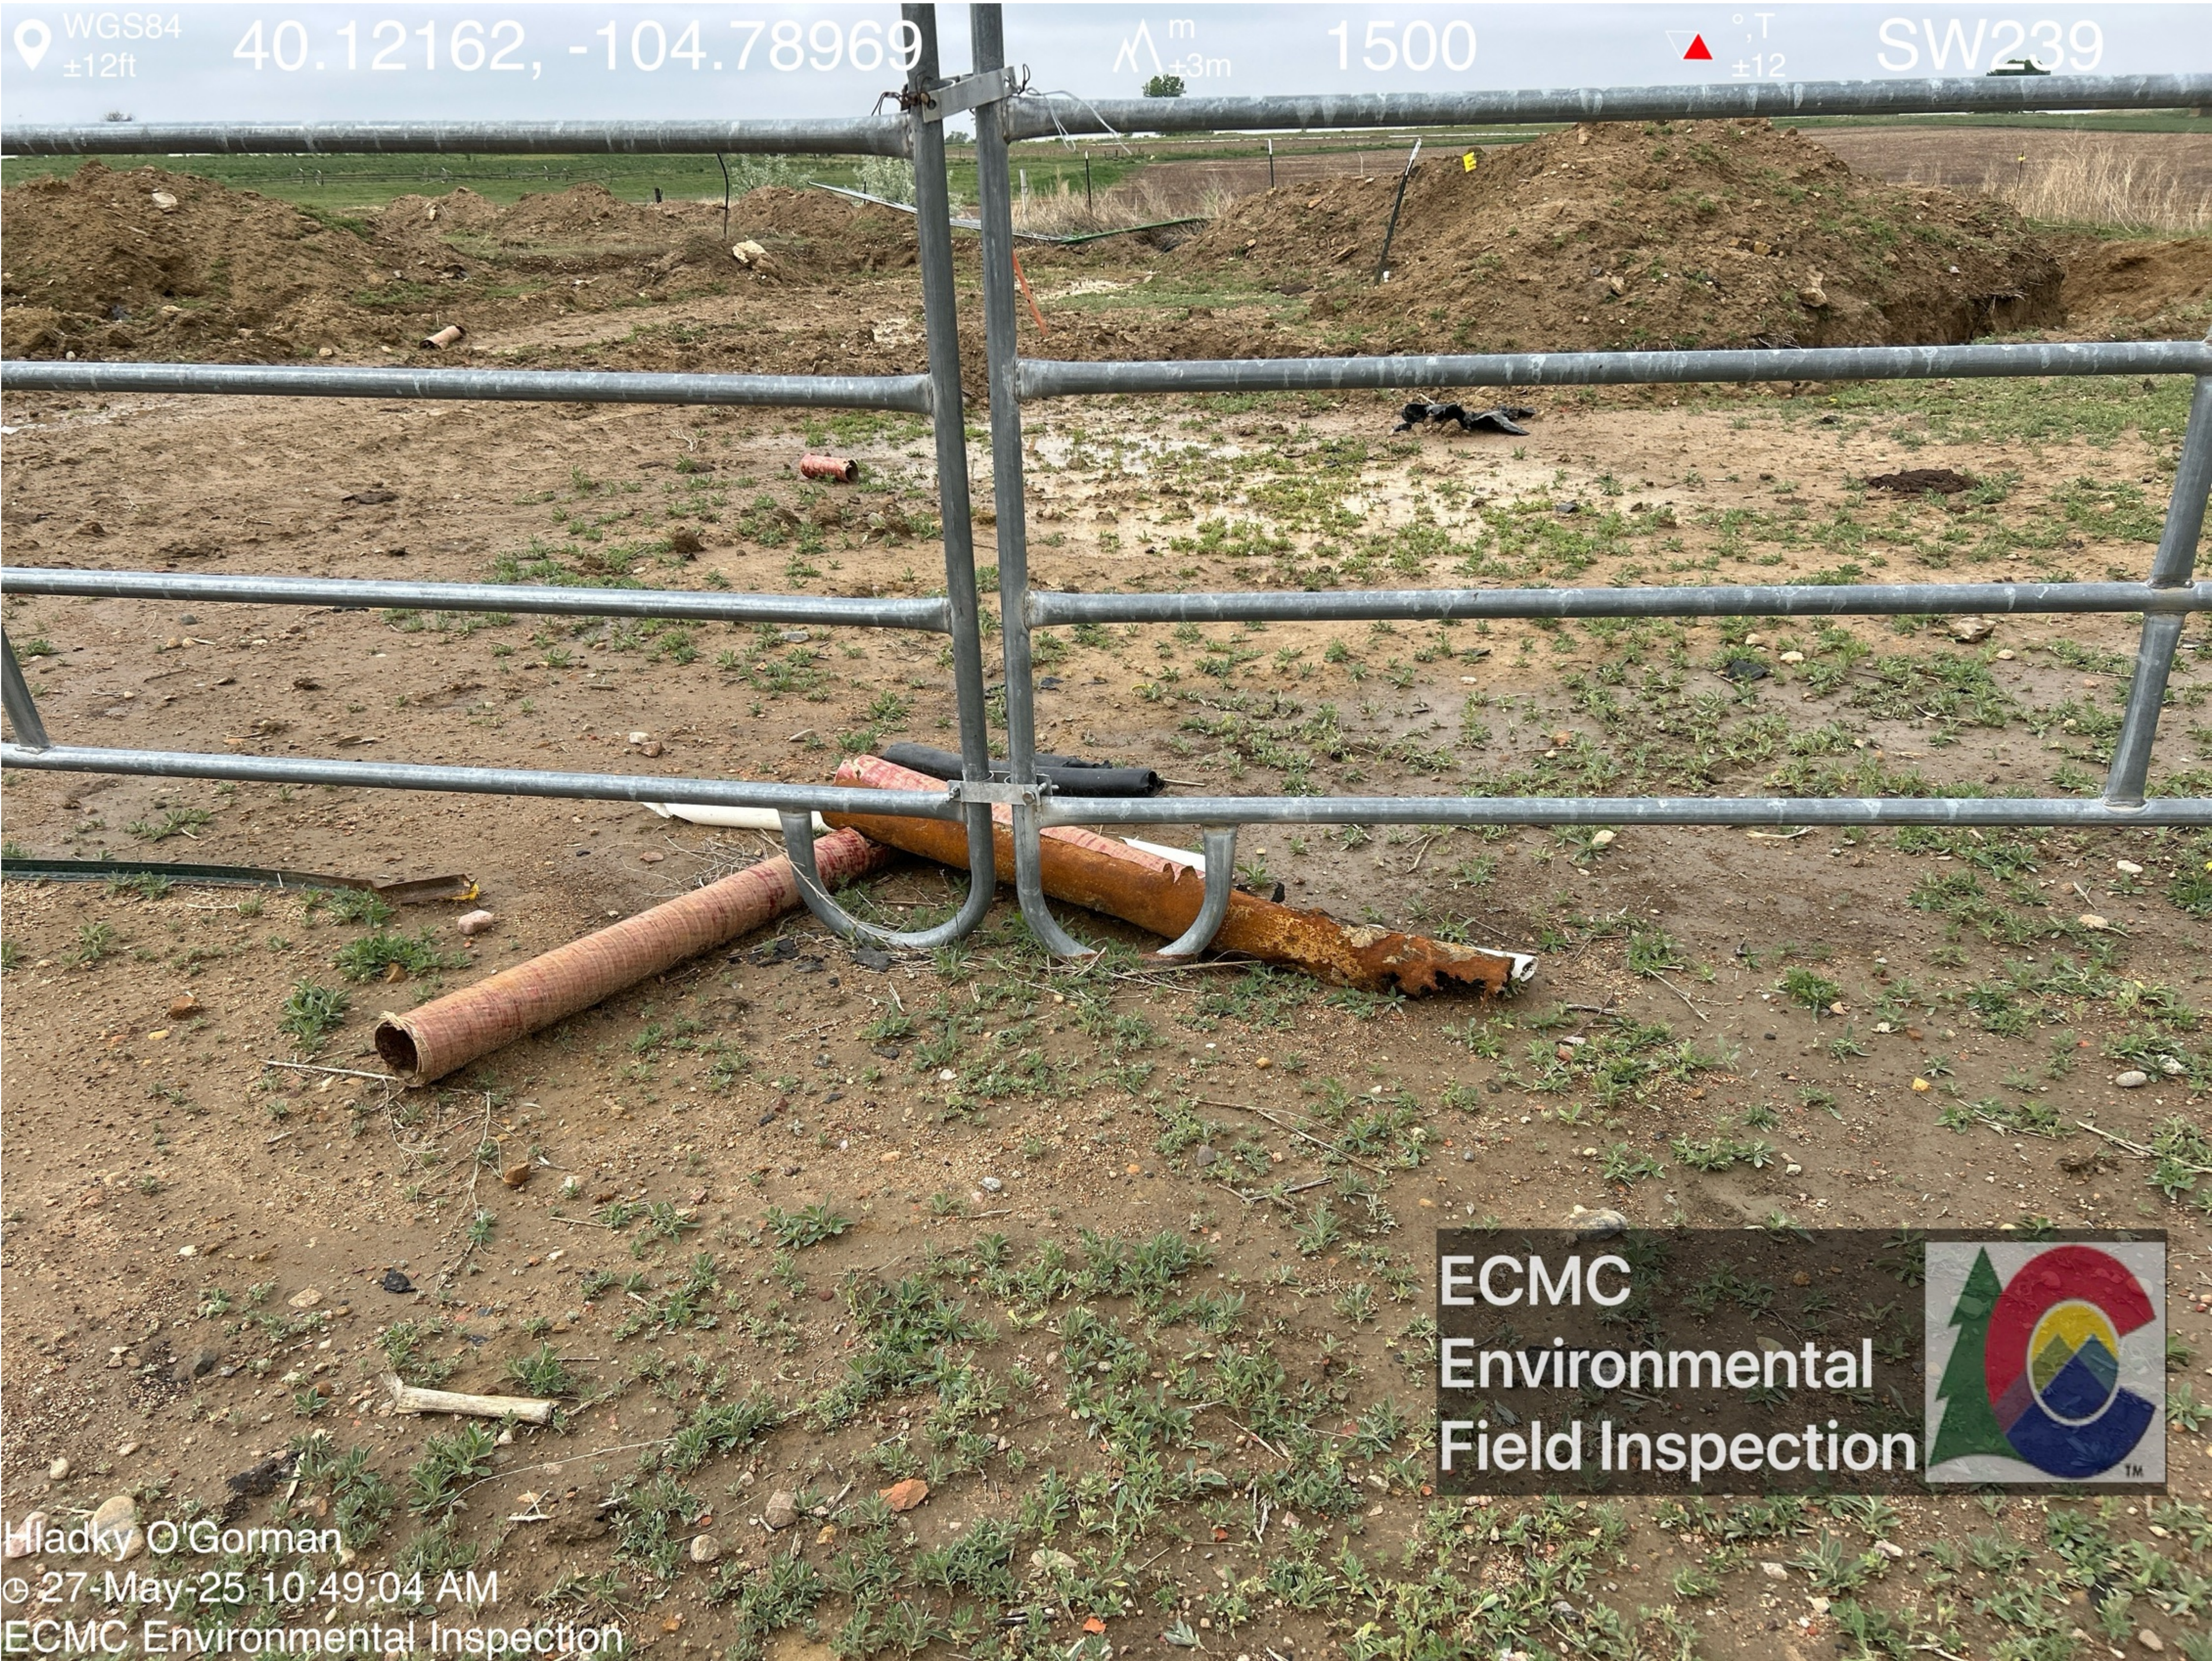
Trash (cans) and E&P waste (pieces of flowline) were visible on location.

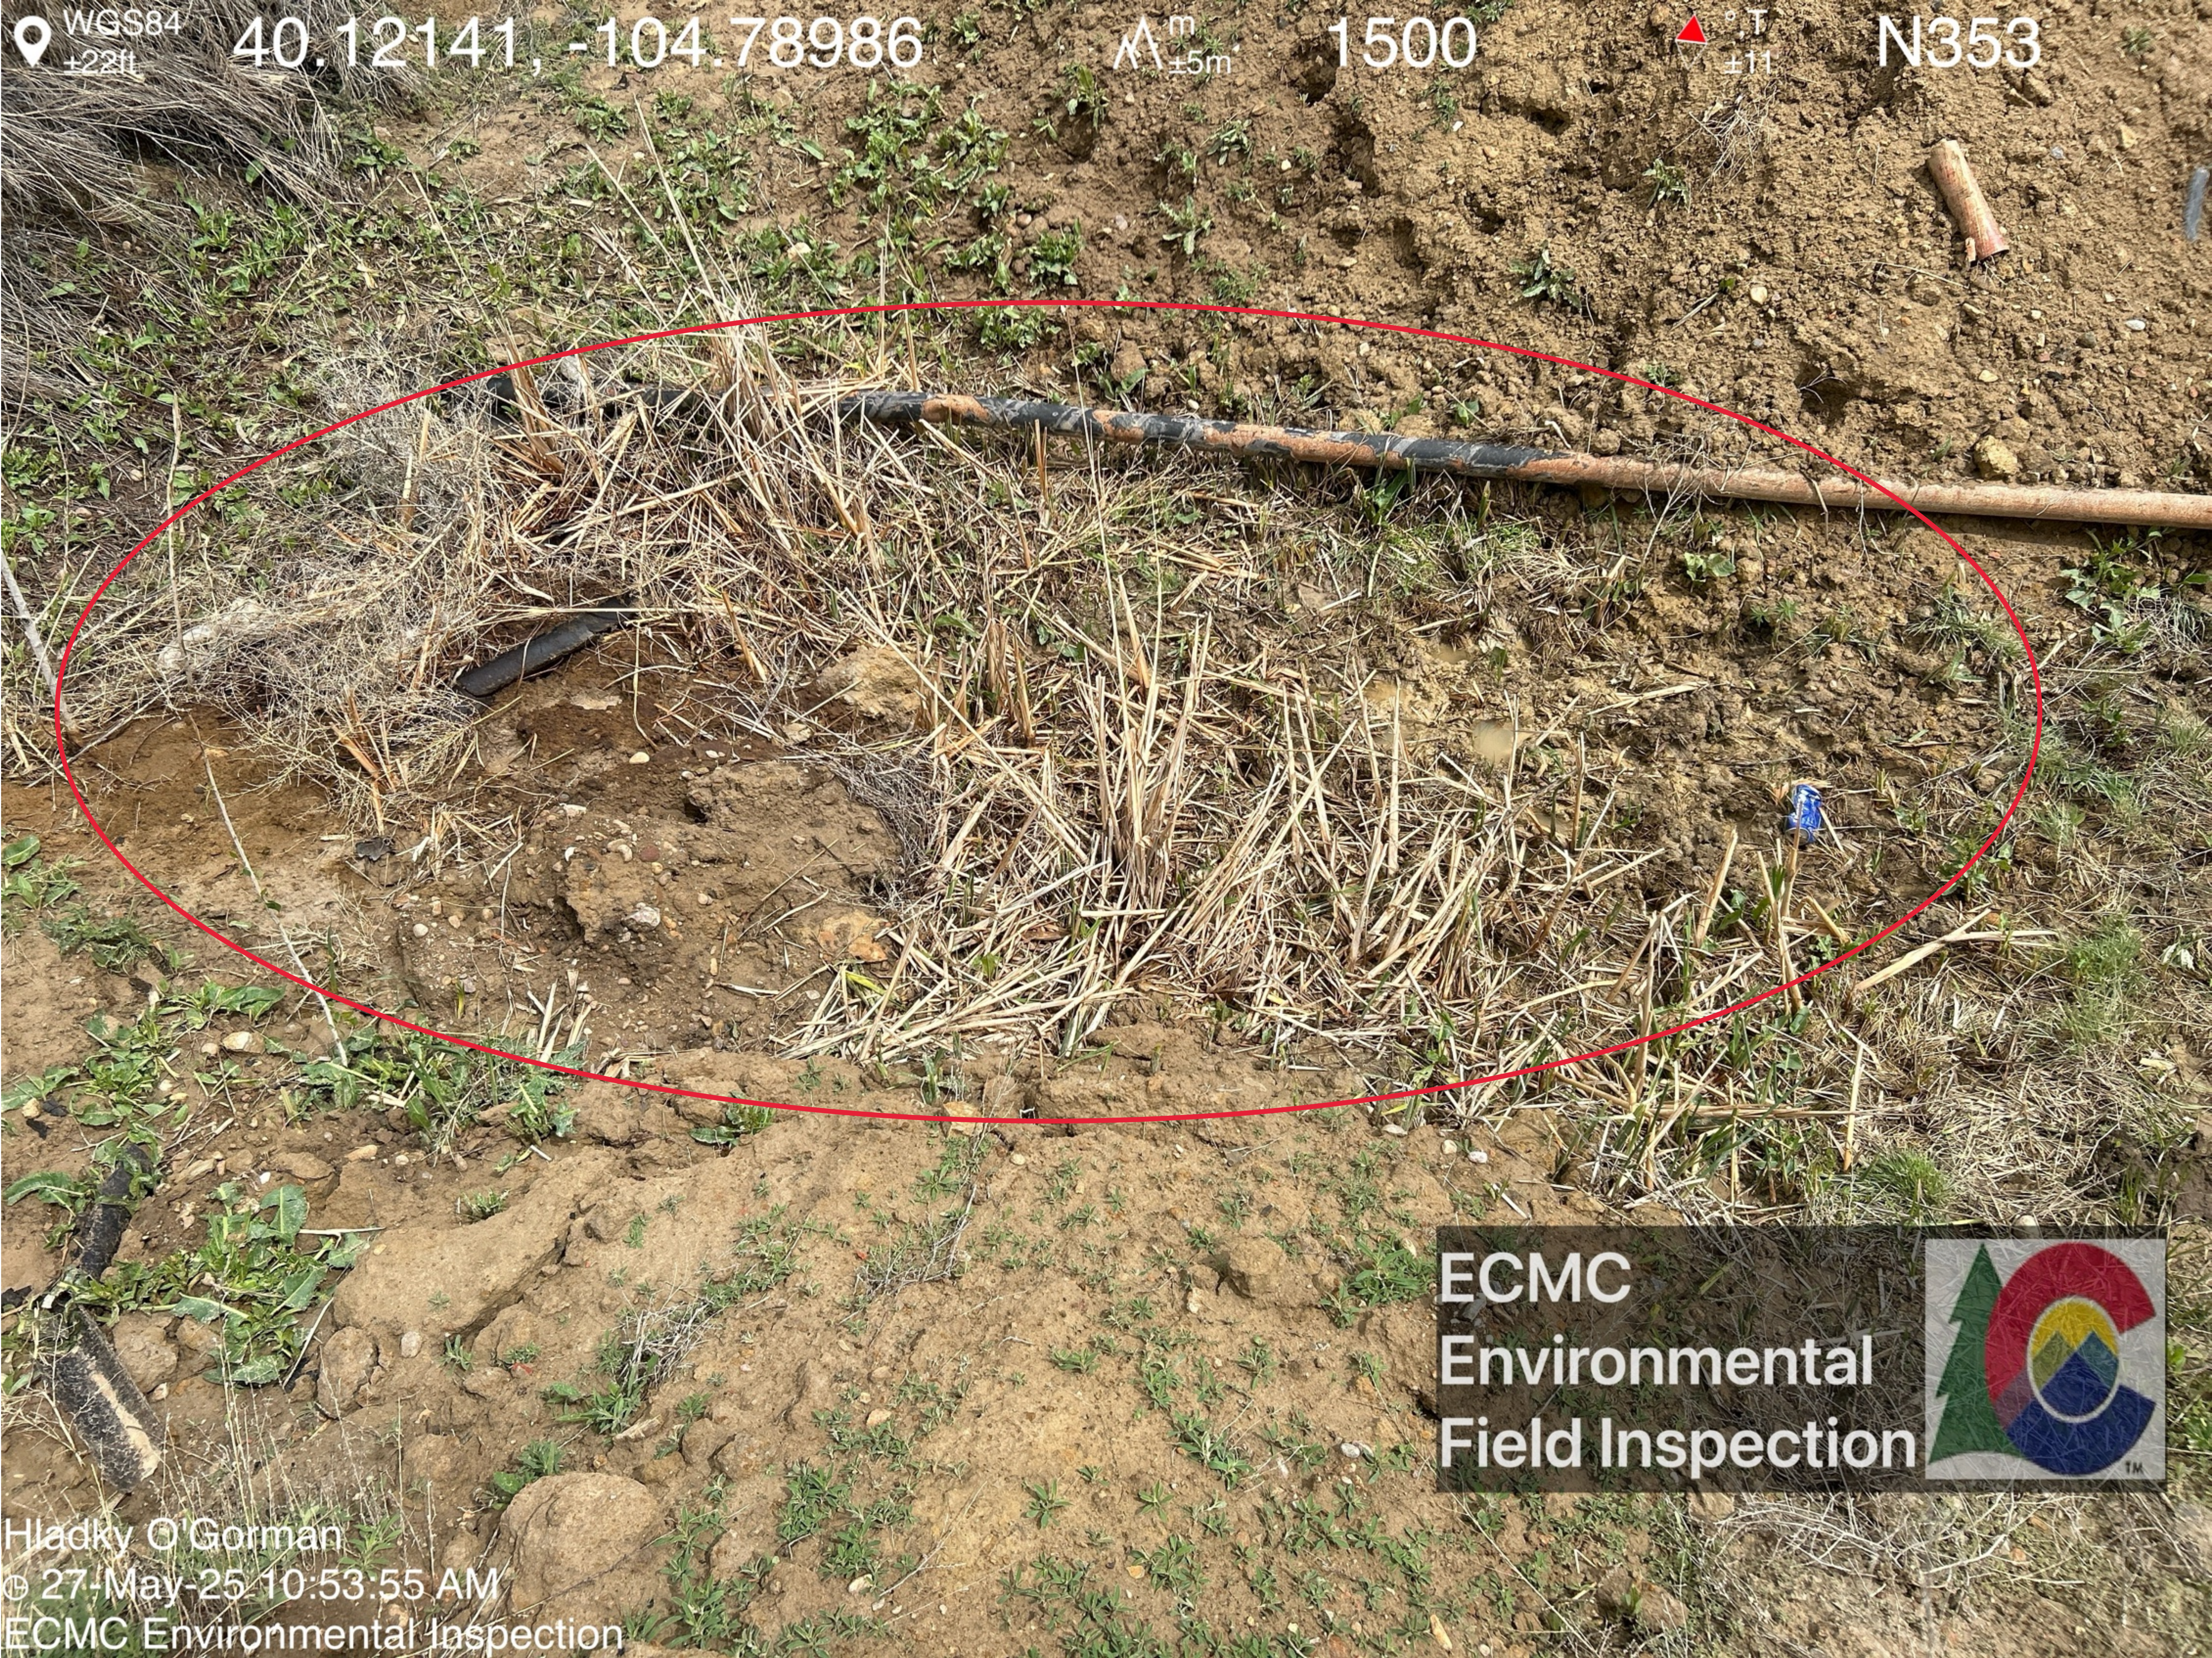
Petroleum hydrocarbon staining is visible within the excavation.
