Final Reclamation and Stormwater Inspection

Operator: KP KAUFFMAN COMPANY INC - 46290

Location ID: 320457

Location Name: MCELWAIN #11-17

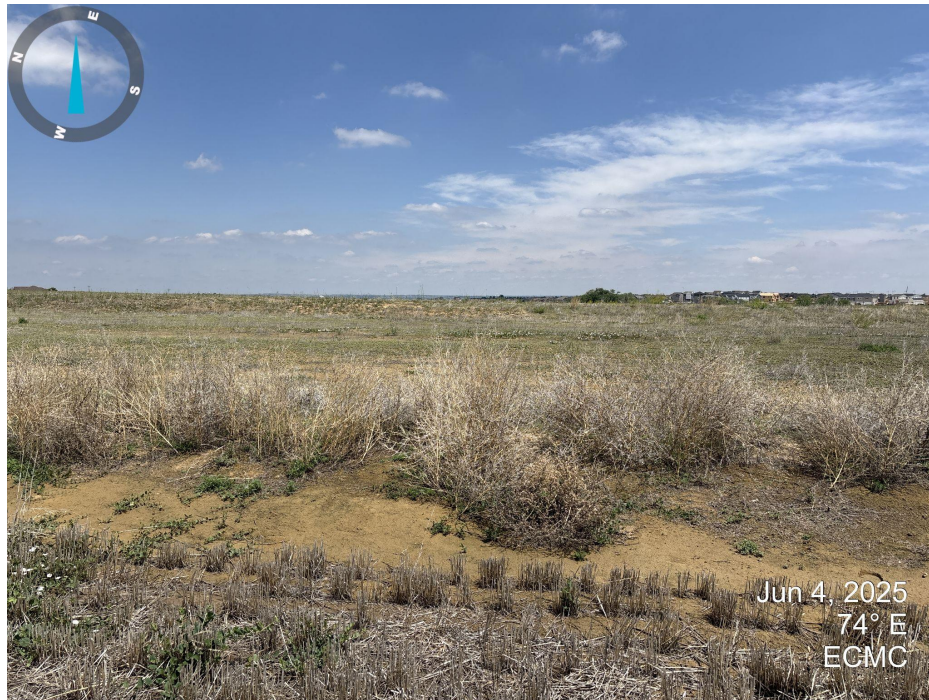
Photo 1. Looking east from fallow cropland across cogis location.

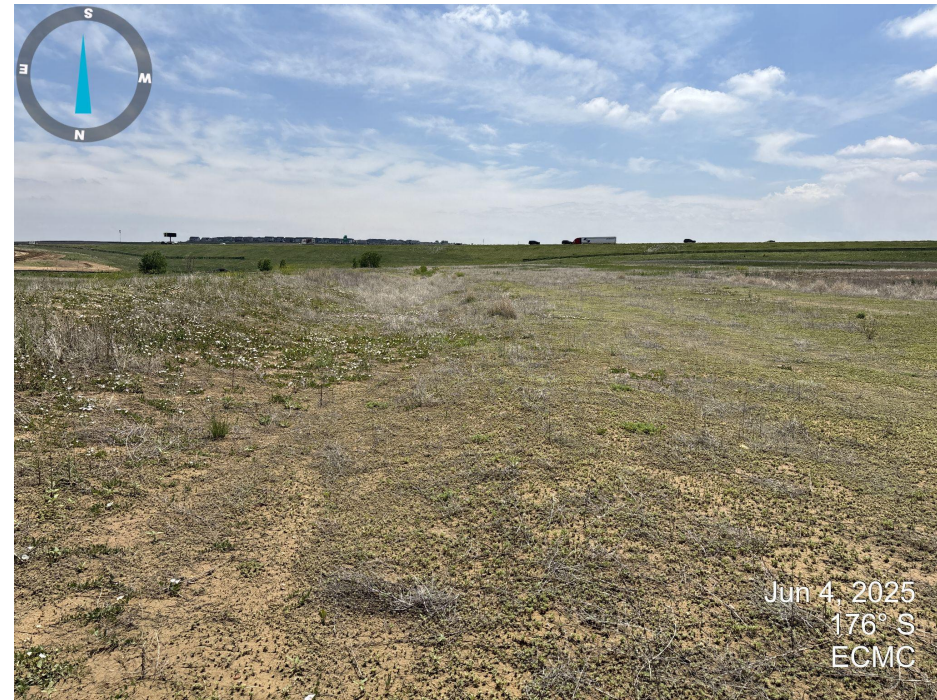
Photo 2. Looking from cogis location. The gps location appears to be incorrect. It appears that significant earthworks were conducted over the location.

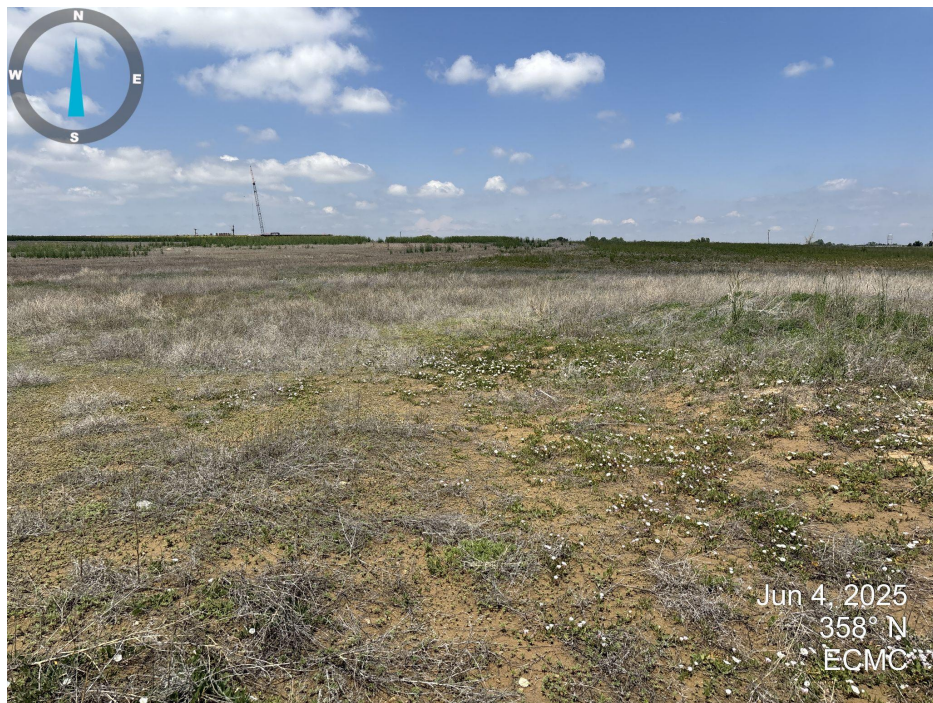
Photo 3. Looking north from the cogis location towards the actual location.

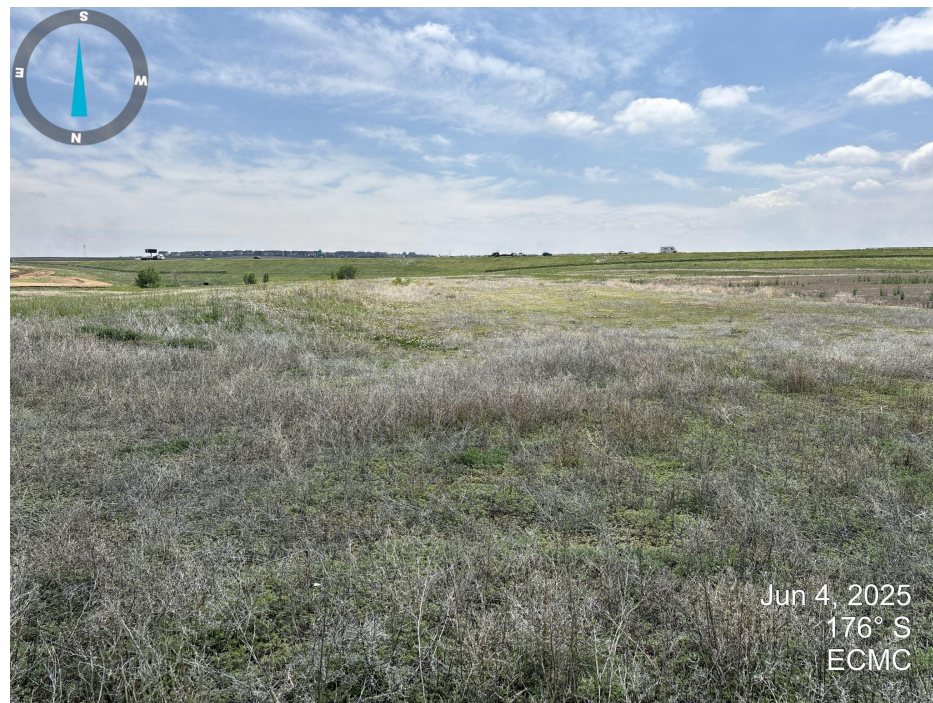
Photo 4. Looking south from the west side of wellbore location.

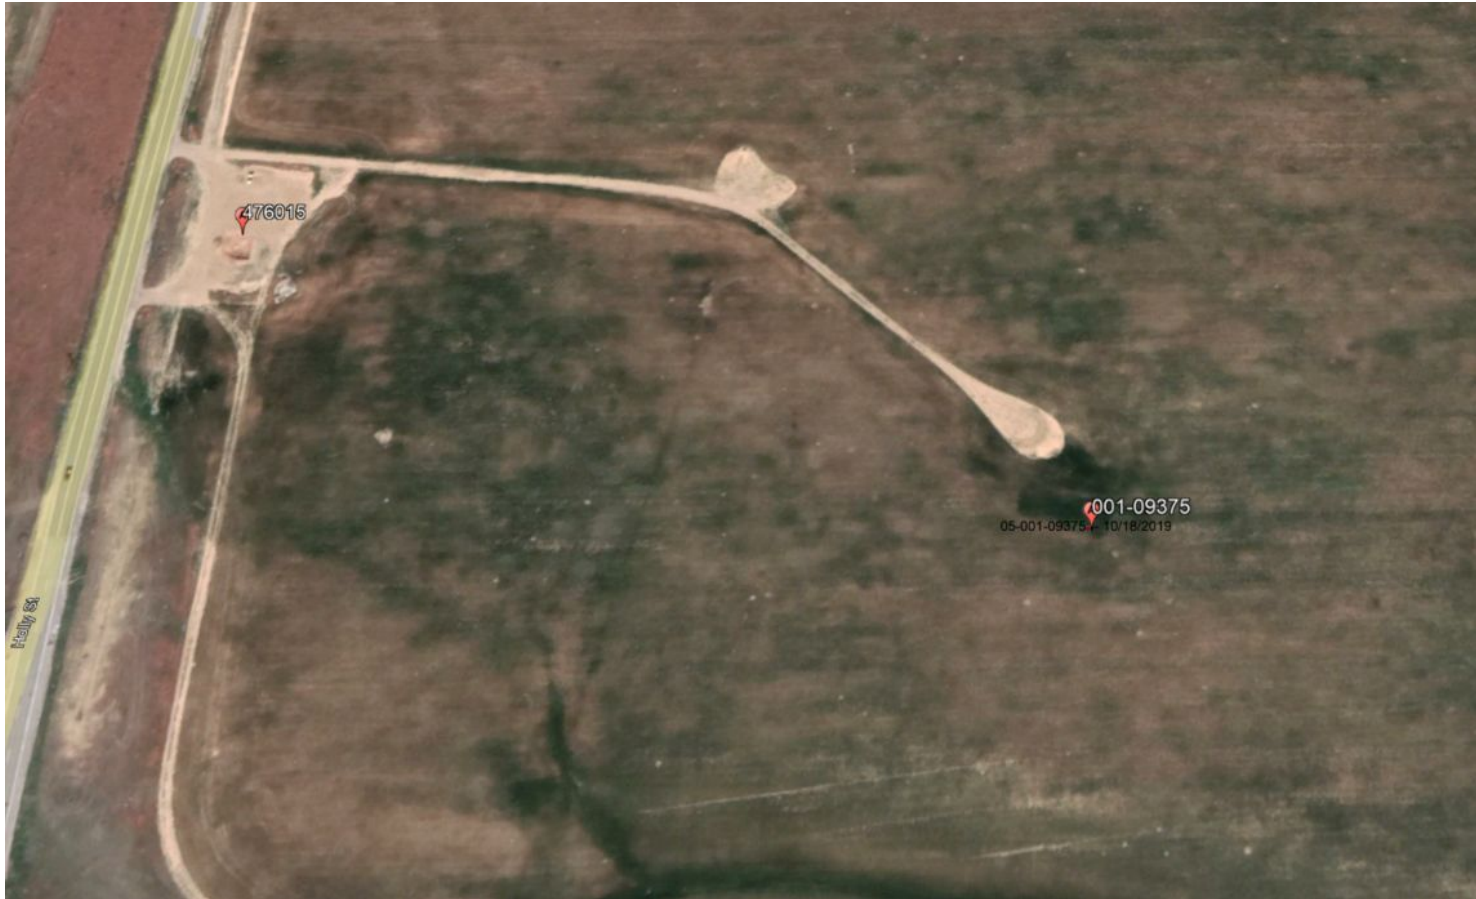
Photo 5. Google earth aerial photo taken 06/2020. Access road and well location are in cropland. GPS data of wellbore location appears to be 125 ft off from imagery.

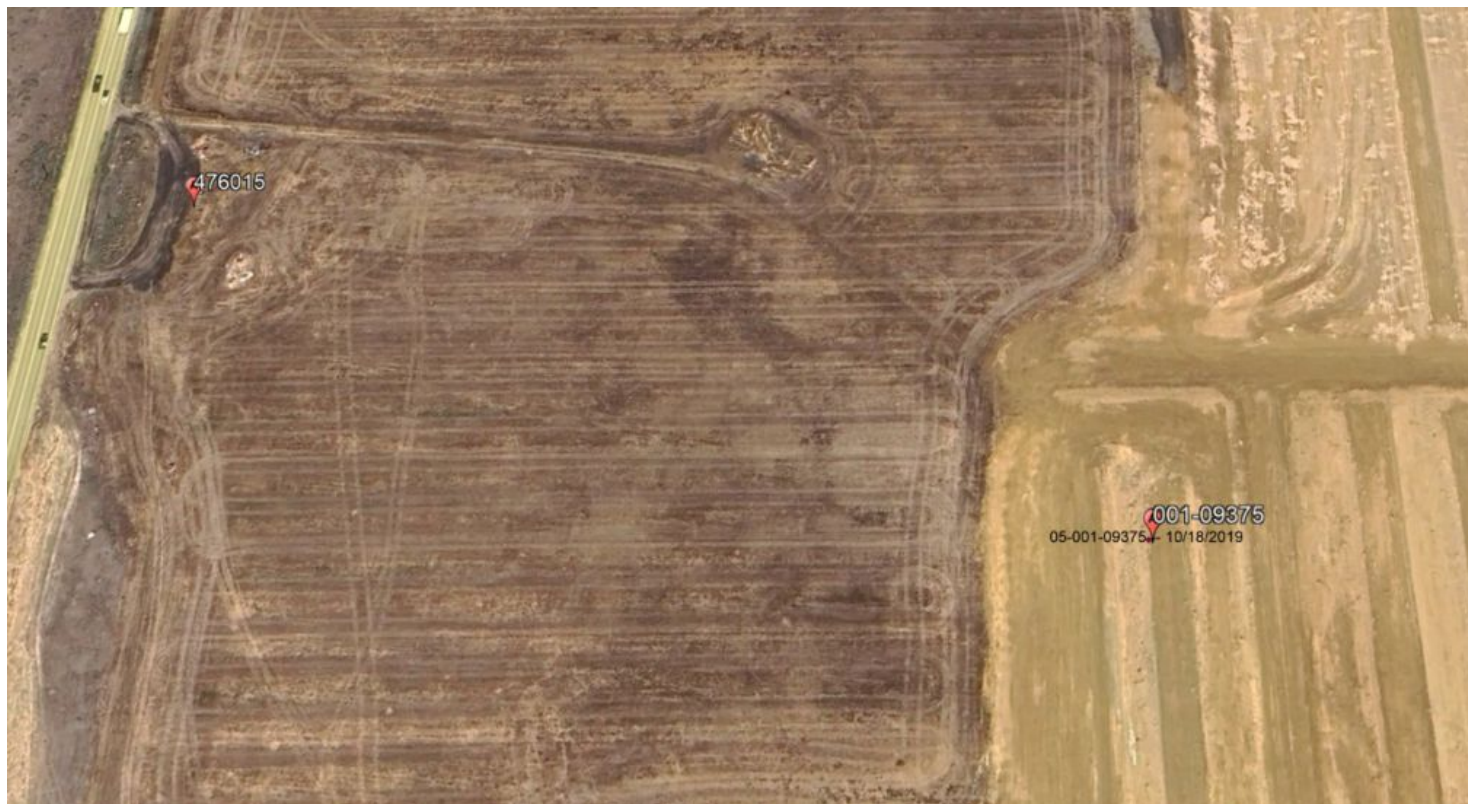
Photo 6. Google earth aerial photo taken 03/2025. Location appears to be located in land use change with significant earthworks conducted. Access road is present in cropland.
