Final Reclamation and Stormwater Inspection

Location ID: 317112

Well Name: GULLEY #1-D

Inspection Document #: 718600676

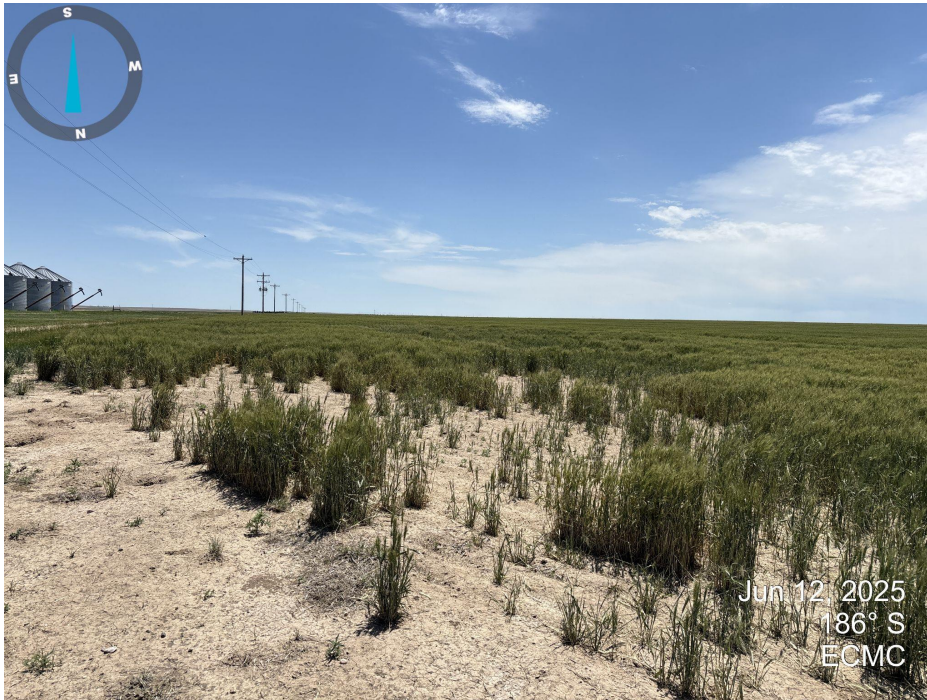
Photo 1. Looking south across the tank battery location. Bare patches and stunted crop growth is present on the former tank battery location.

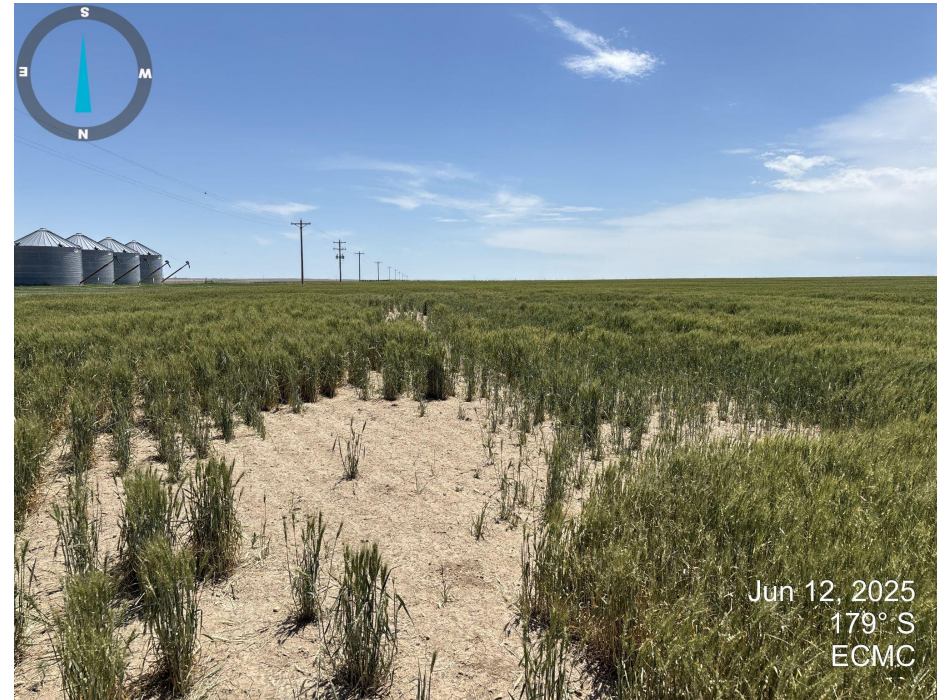
Photo 2. Looking south from the center of the tank battery location. Bare soil is present within active cropland.

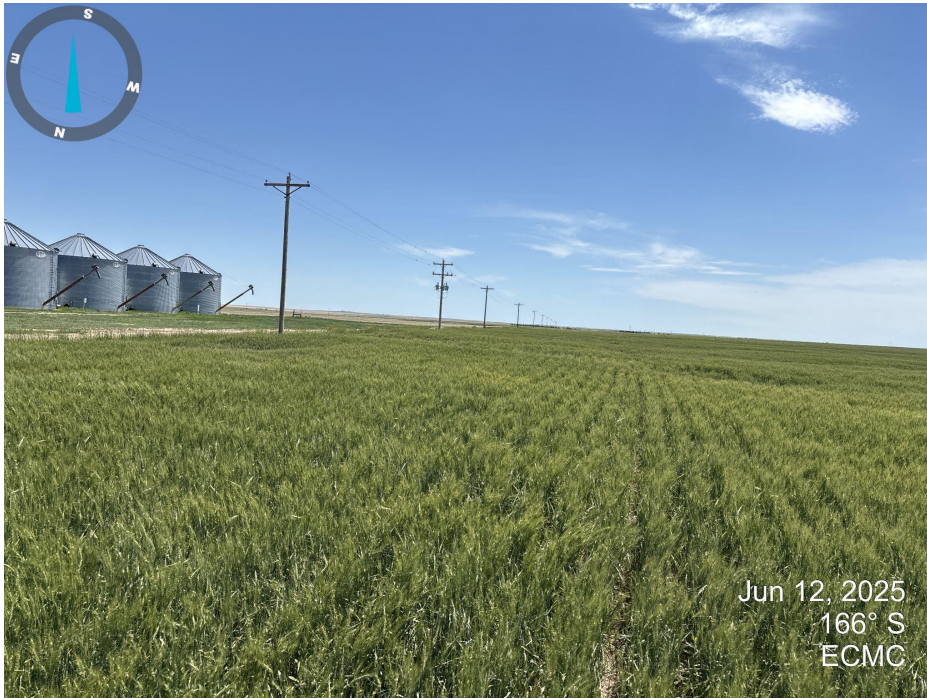
Photo 3. Looking from the south side of the tank battery down the former access road. Vegetation on the tank battery access road appears reflective of surrounding cropland.

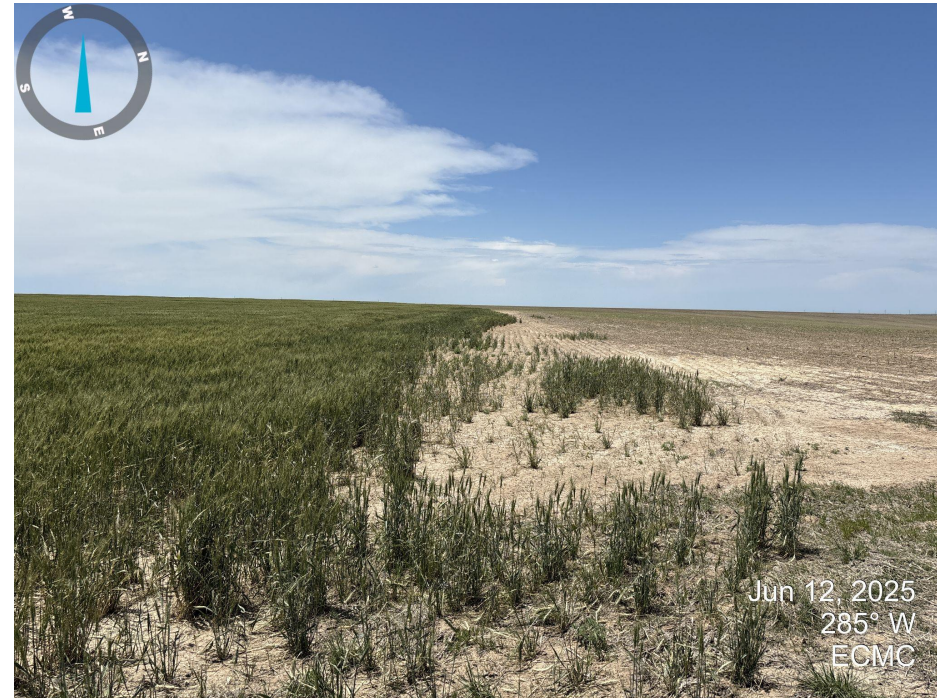
Photo 4. Looking west down the access road towards the well location. The access road appears to have been planted but poor crop growth/ bare soil is present.

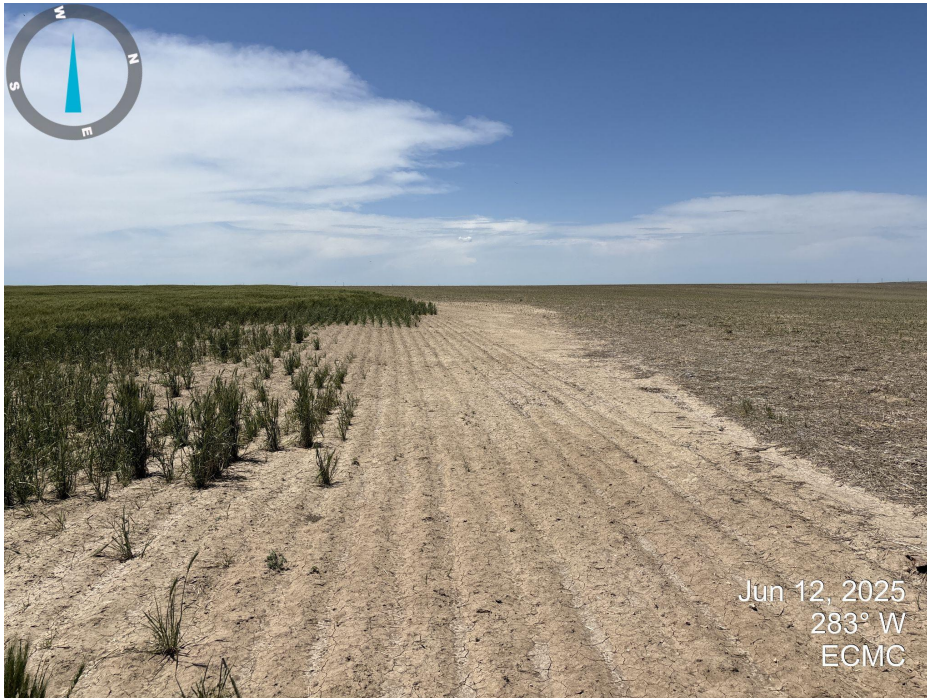
Photo 5. Looking west towards the well location. See photo 4 comments.

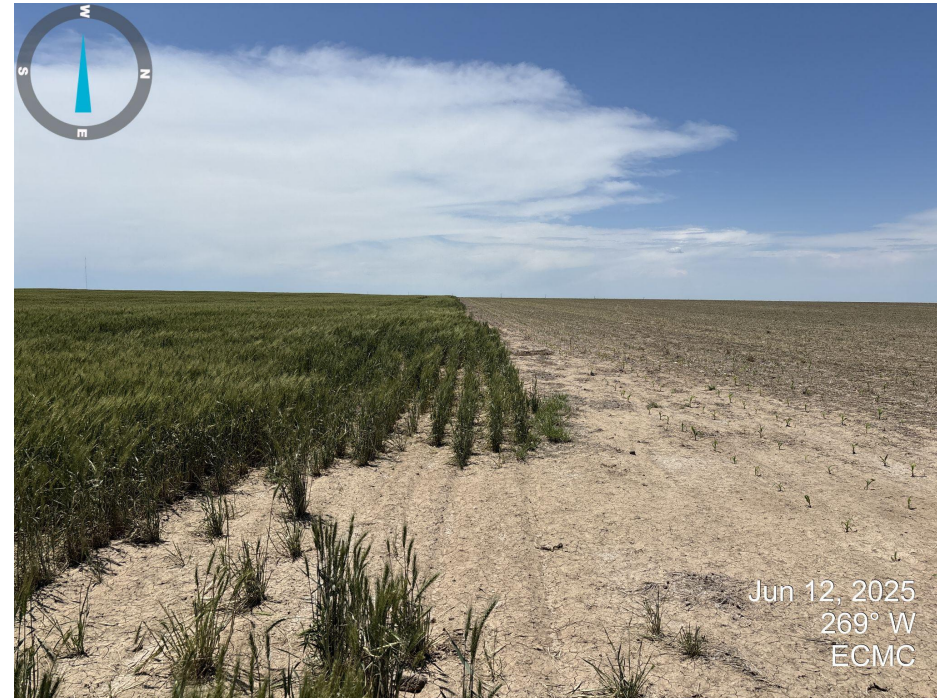
Photo 6. Looking west from the wellbore. No oil and gas equipment is present. Crop coverage is absent or stunted on the well location.

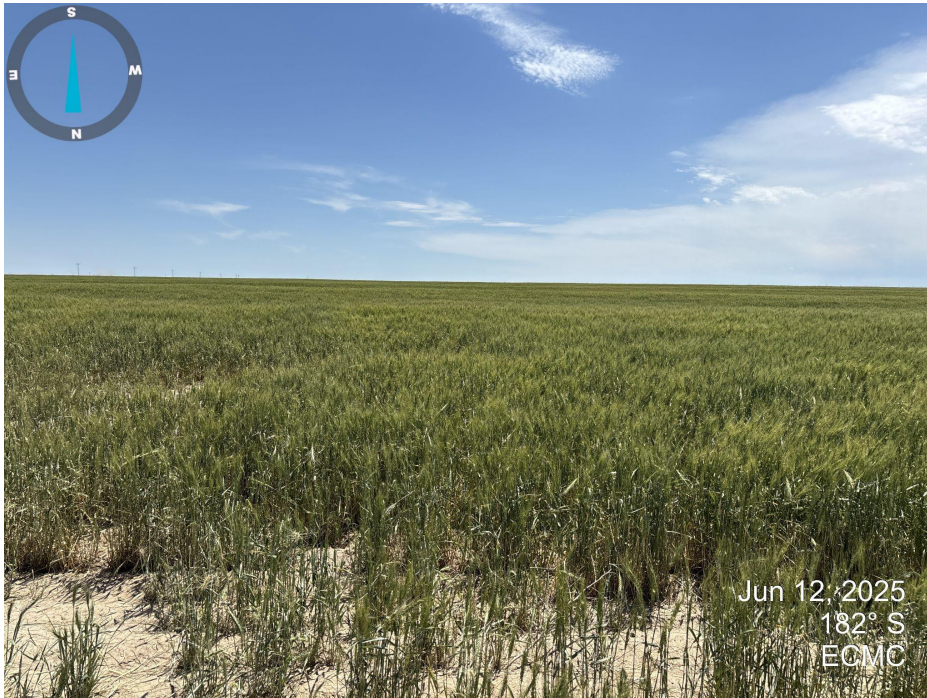
Photo 7. Looking south from the well location. See photo 6 comments.

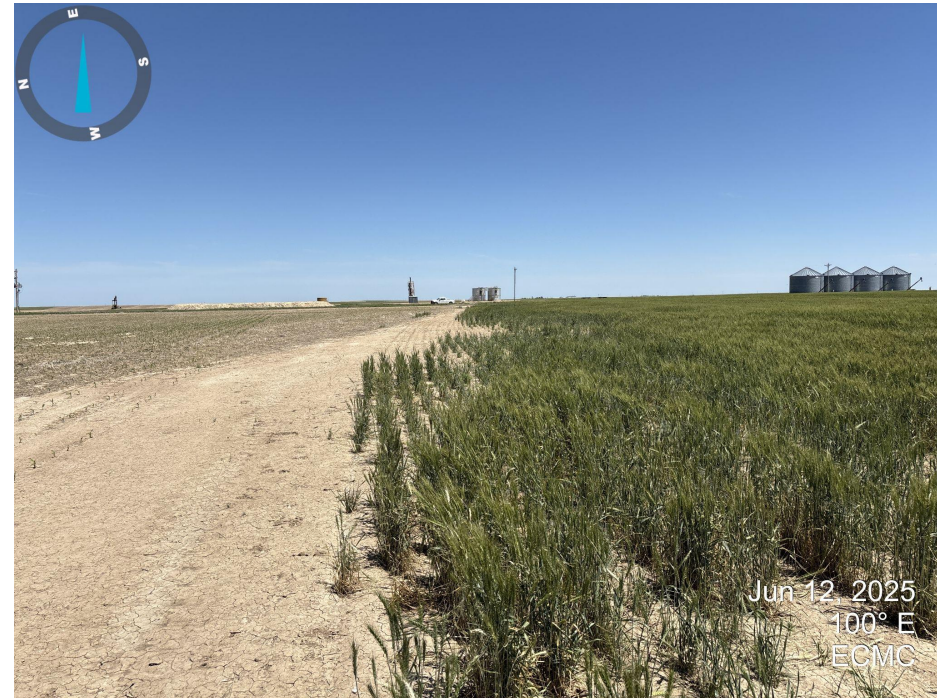
Photo 8. Looking east from the well location. See photo 6 comments.

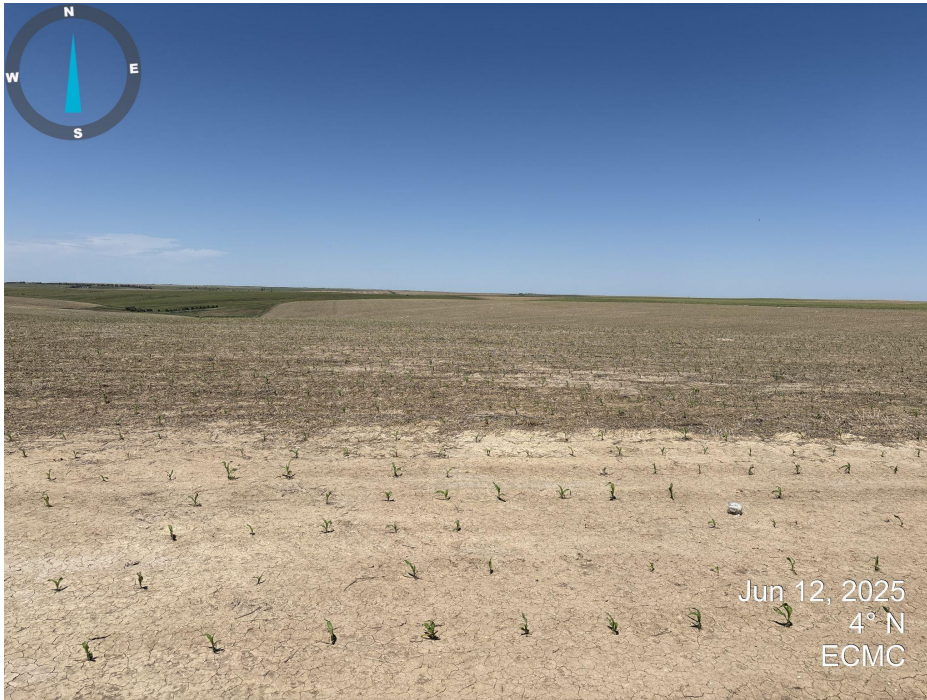
Photo 9. Looking north from the well location. The northern half of the well location is within cropland planted with corn. Germination was observed at time of inspection.

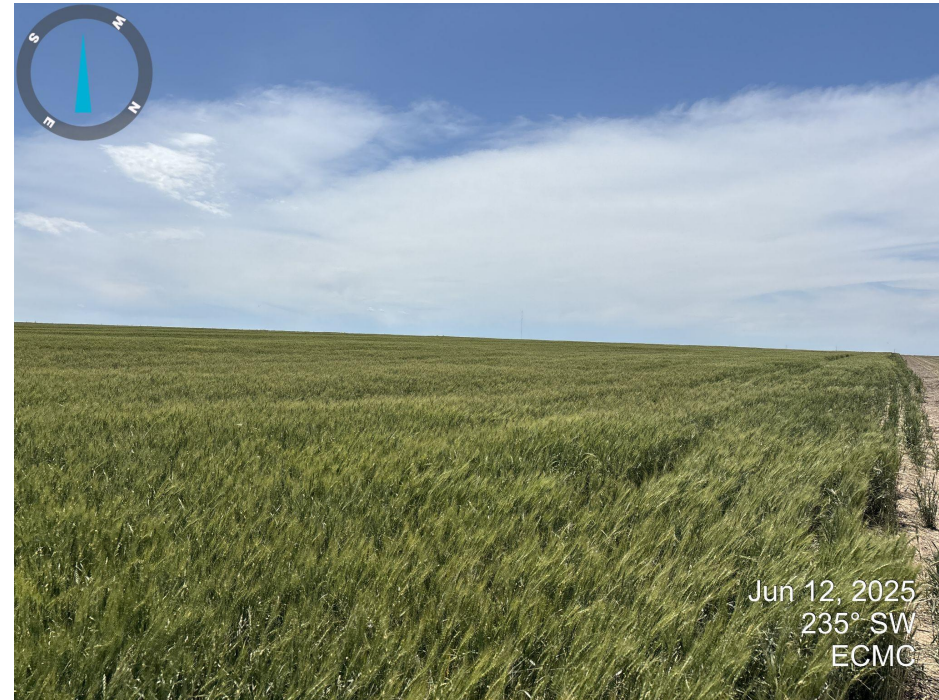
Photo 10. Reference cropland to the west of the well location.
