ECMC
Environmental
Field Inspection

Lowe Tank Battery
© 30-May-25 12:10:33 PM
ECMC Environmental Inspection

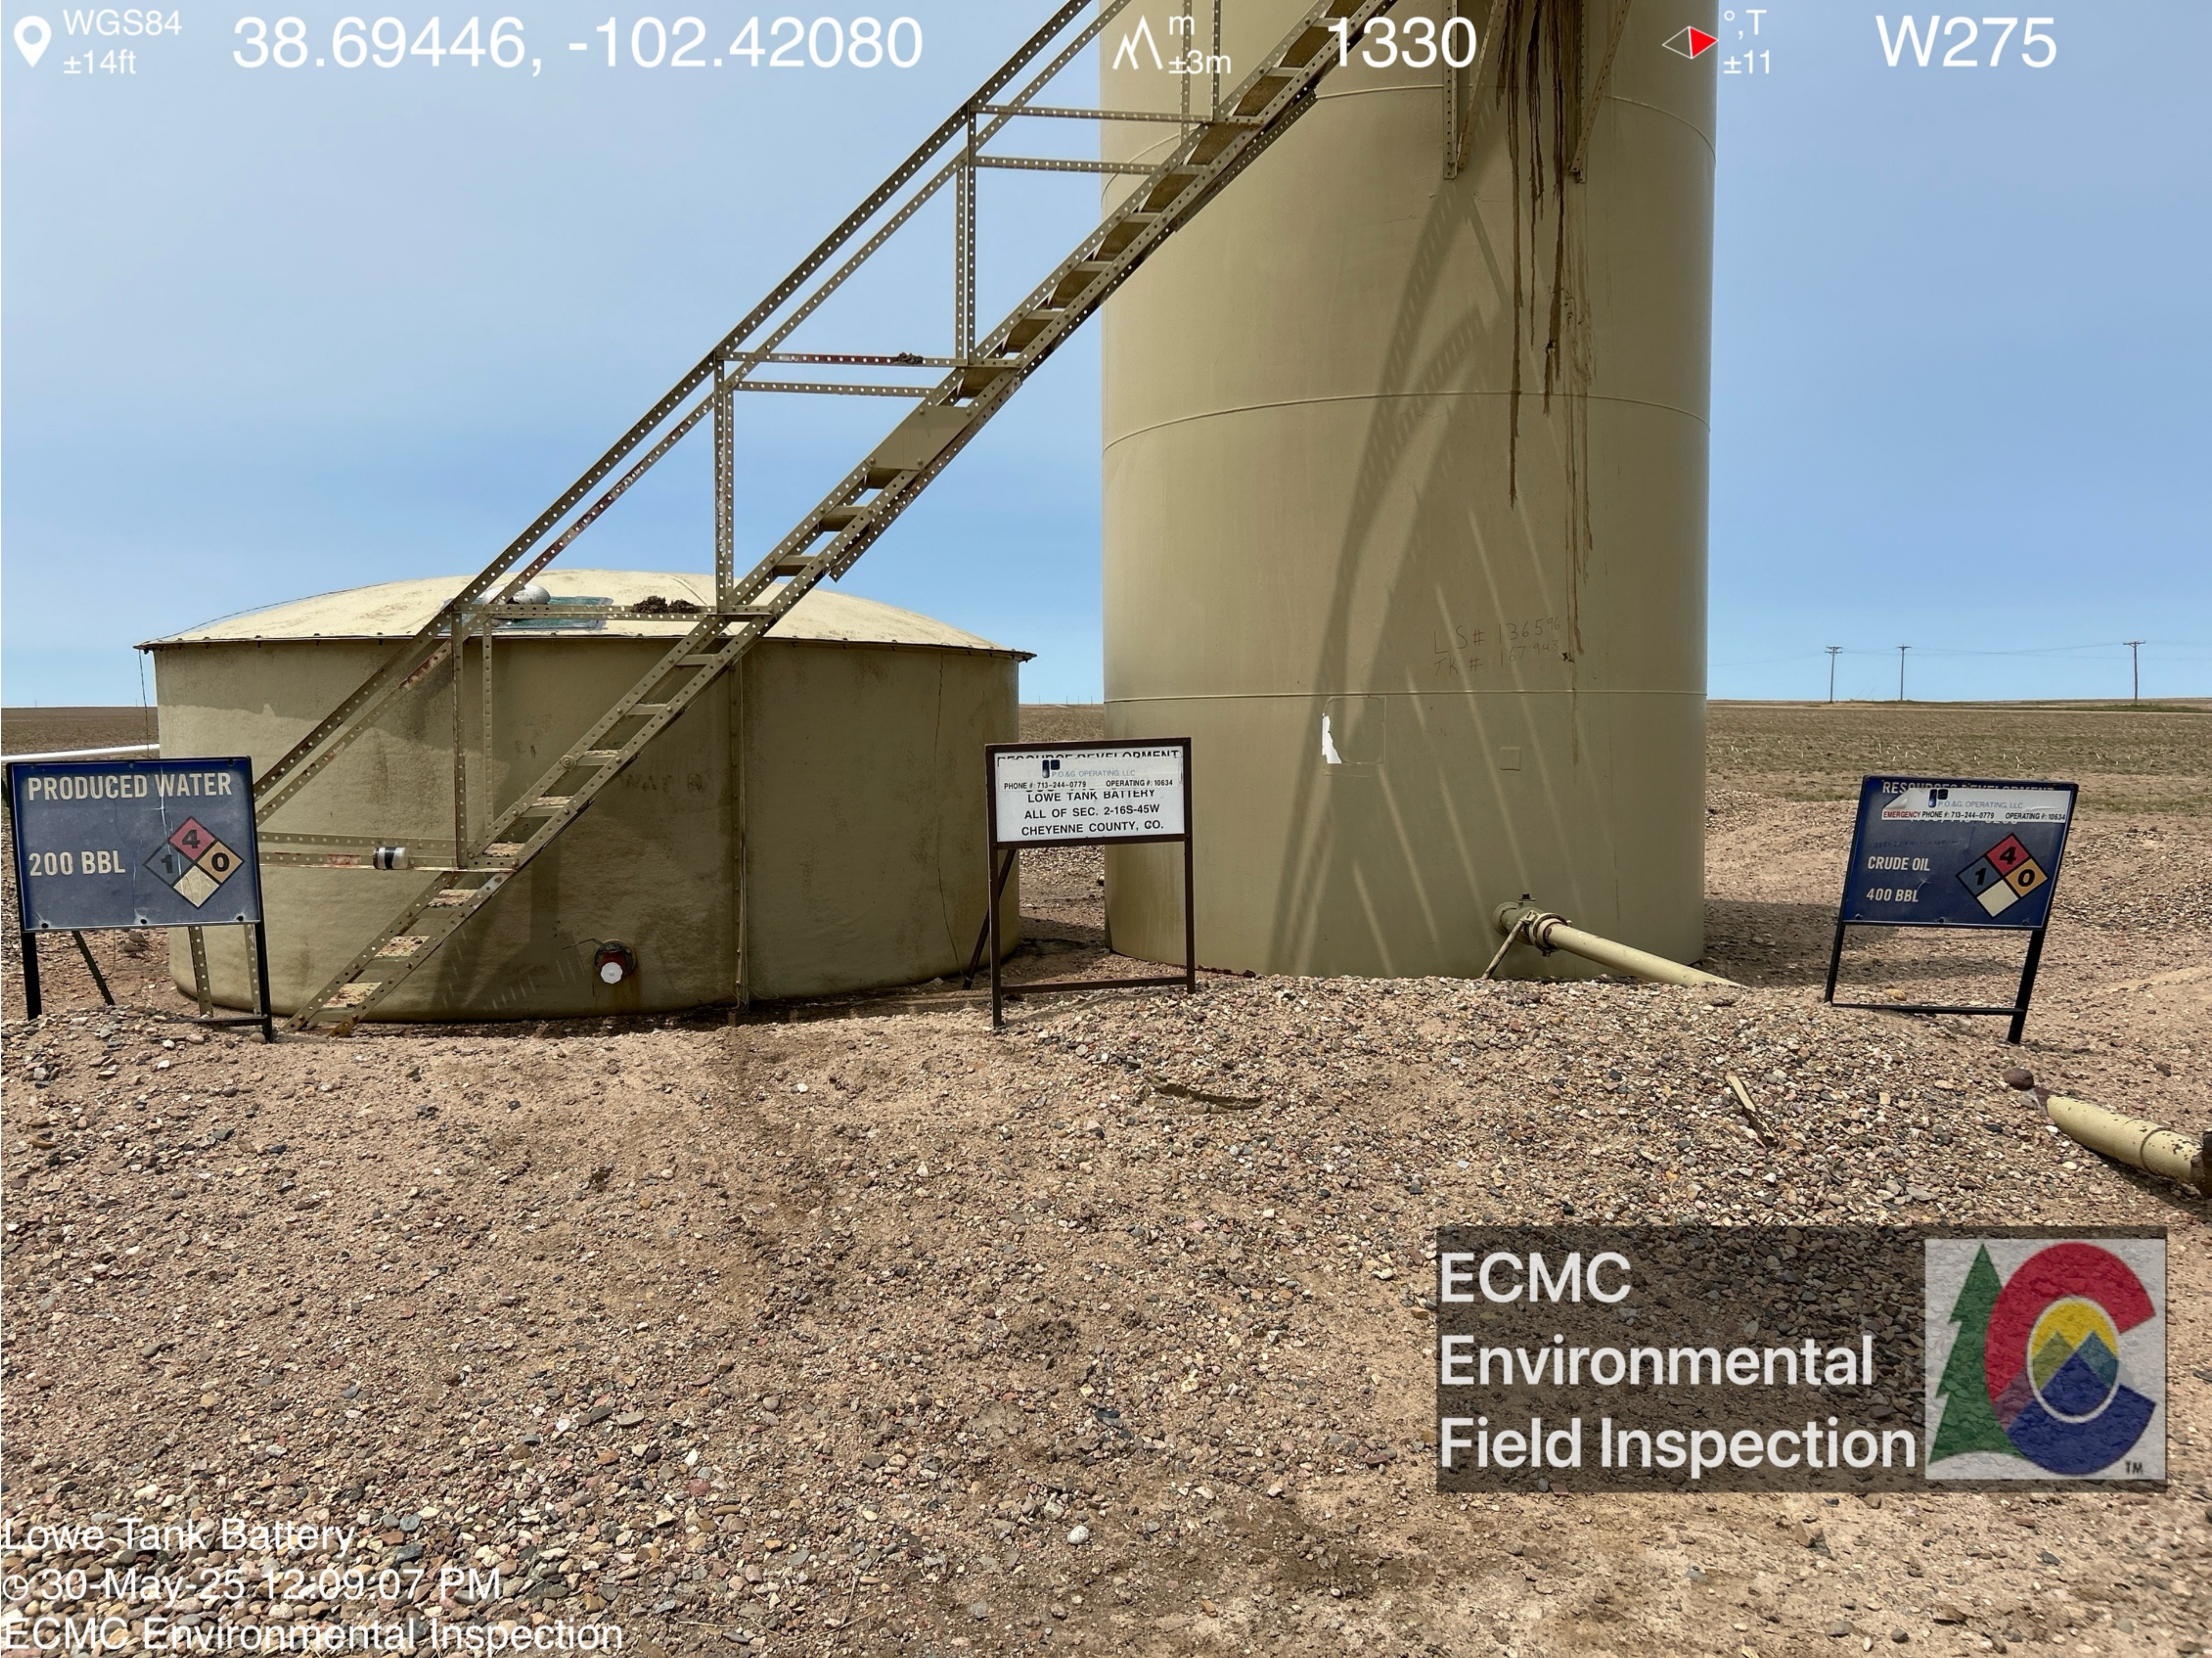
Signage with emergency contact number is visible. Labels/placards are legible.

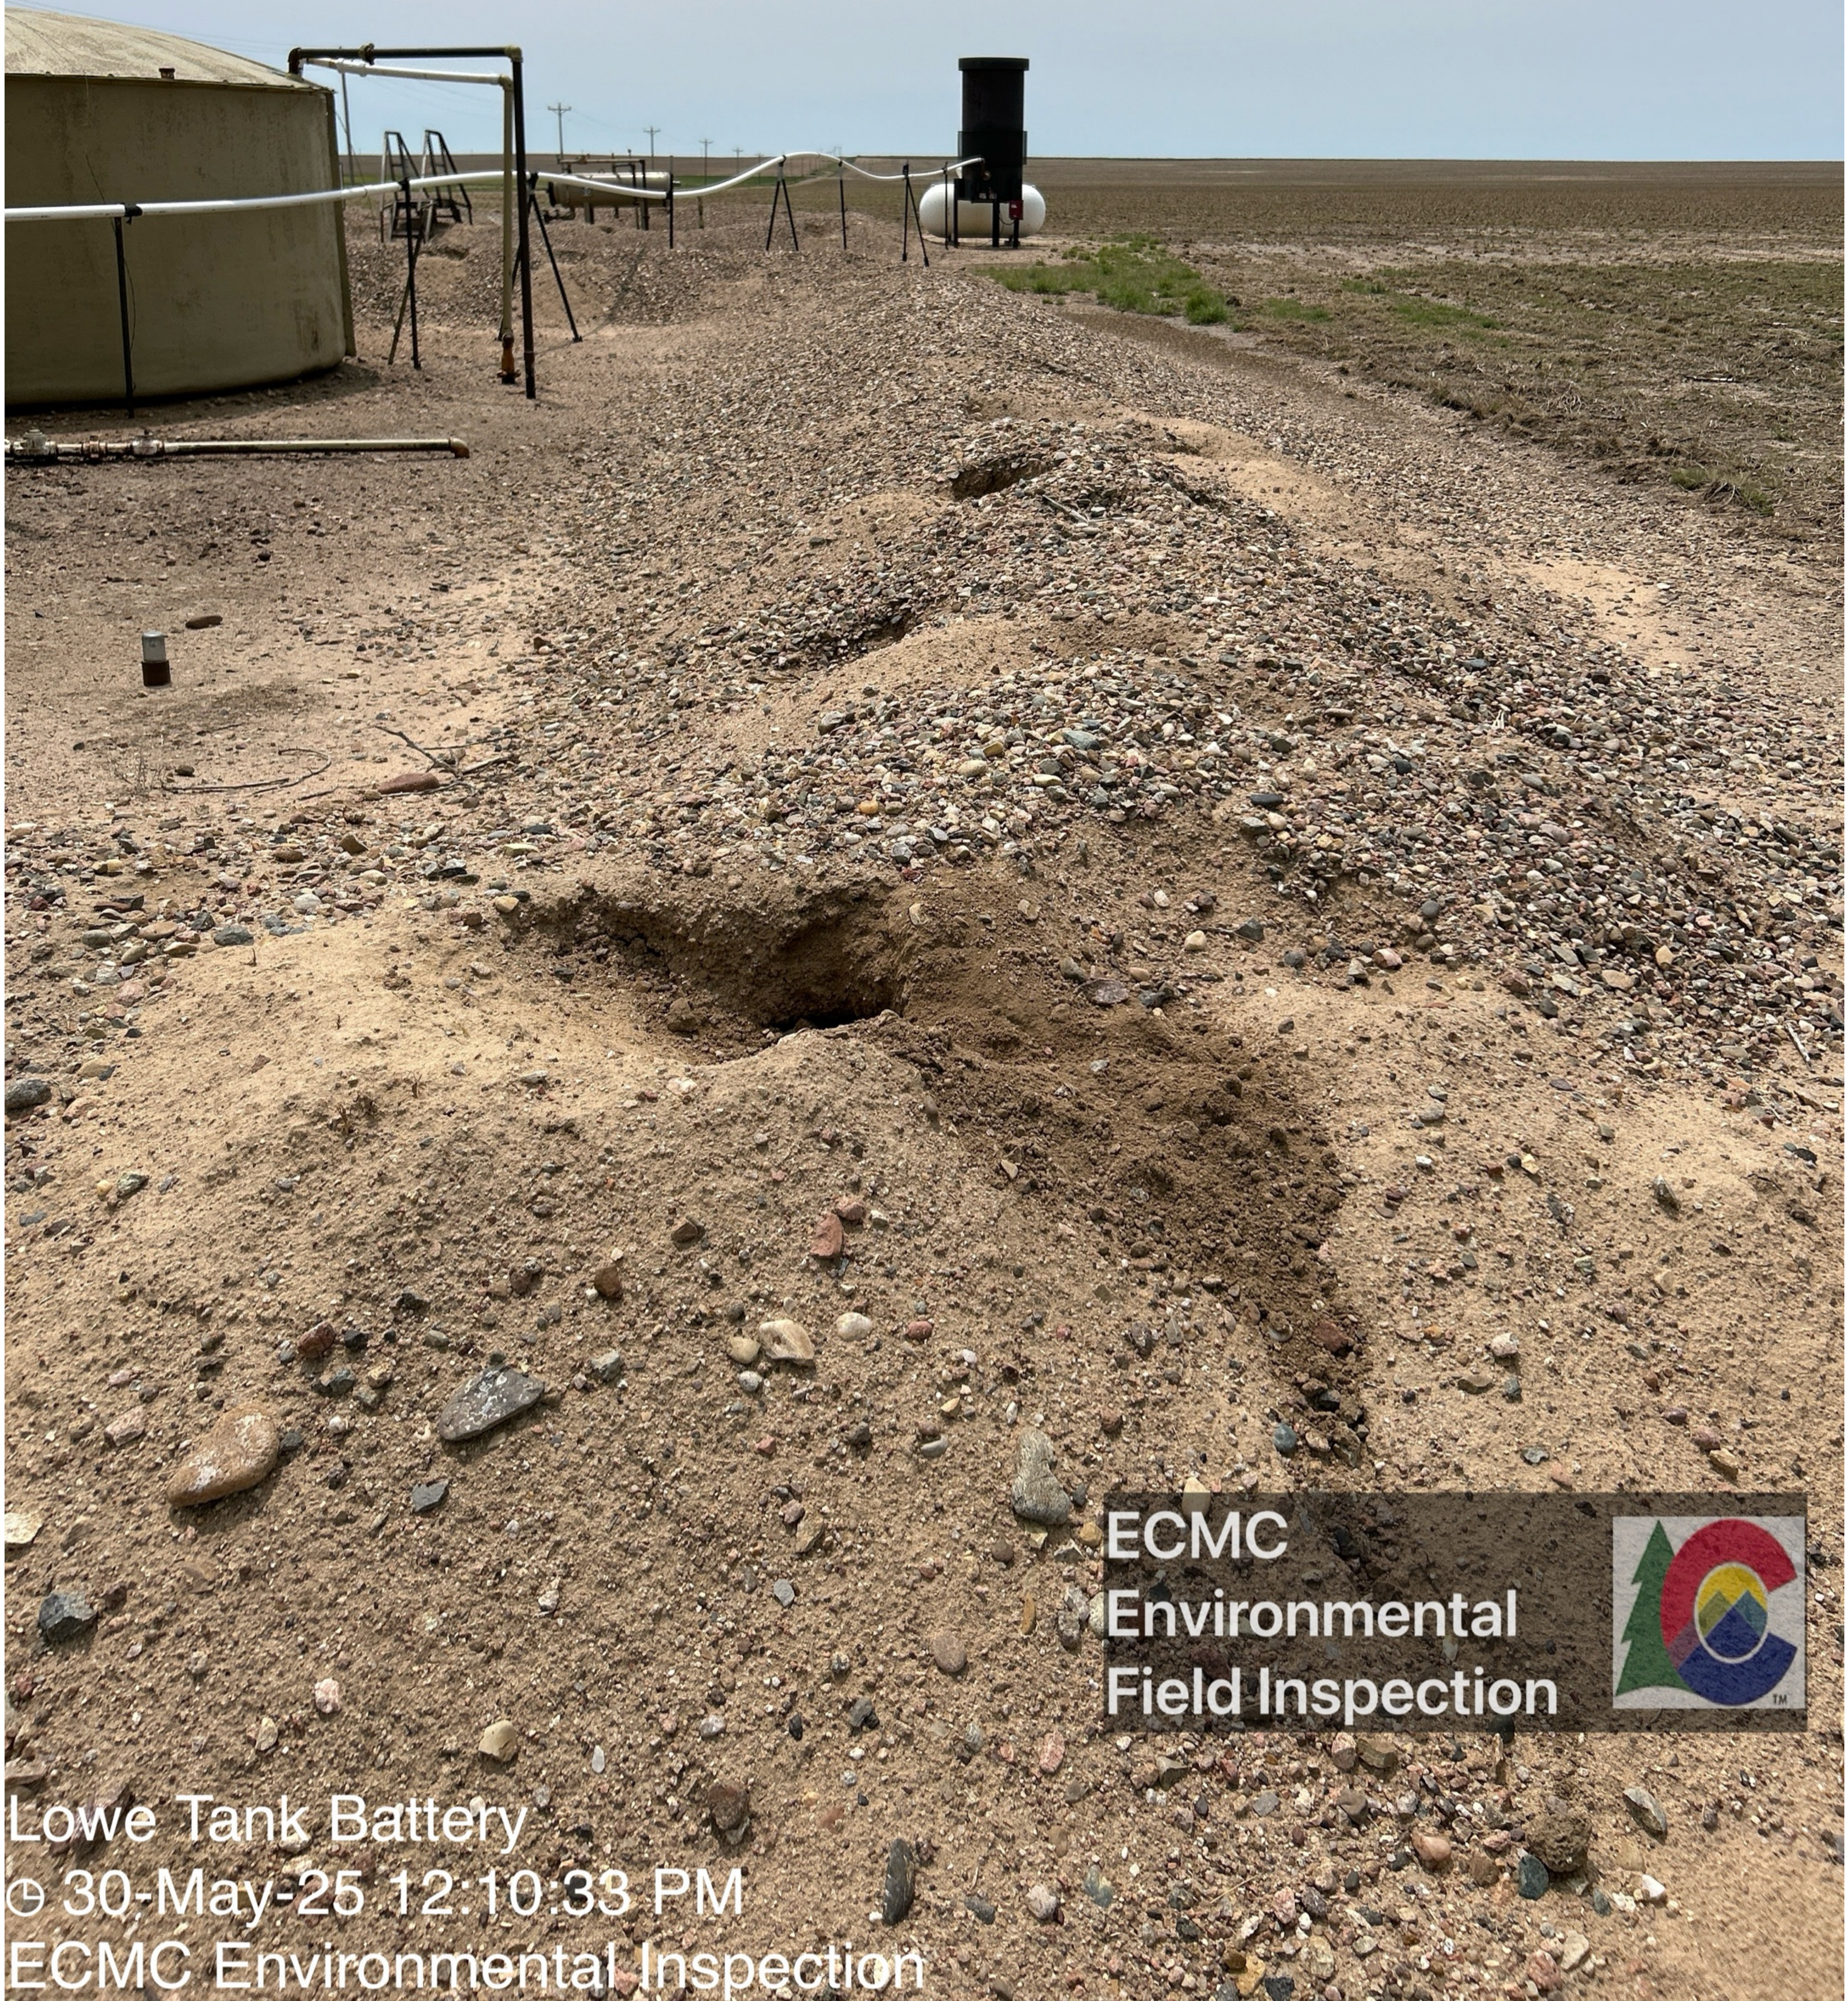
Animal burrows are visible in multiple areas of the shared production tank and produced water vessel containment berm. A plastic pipe connecting the production tank to the emission control device is visible; the pipe is attached to fence posts by tape.

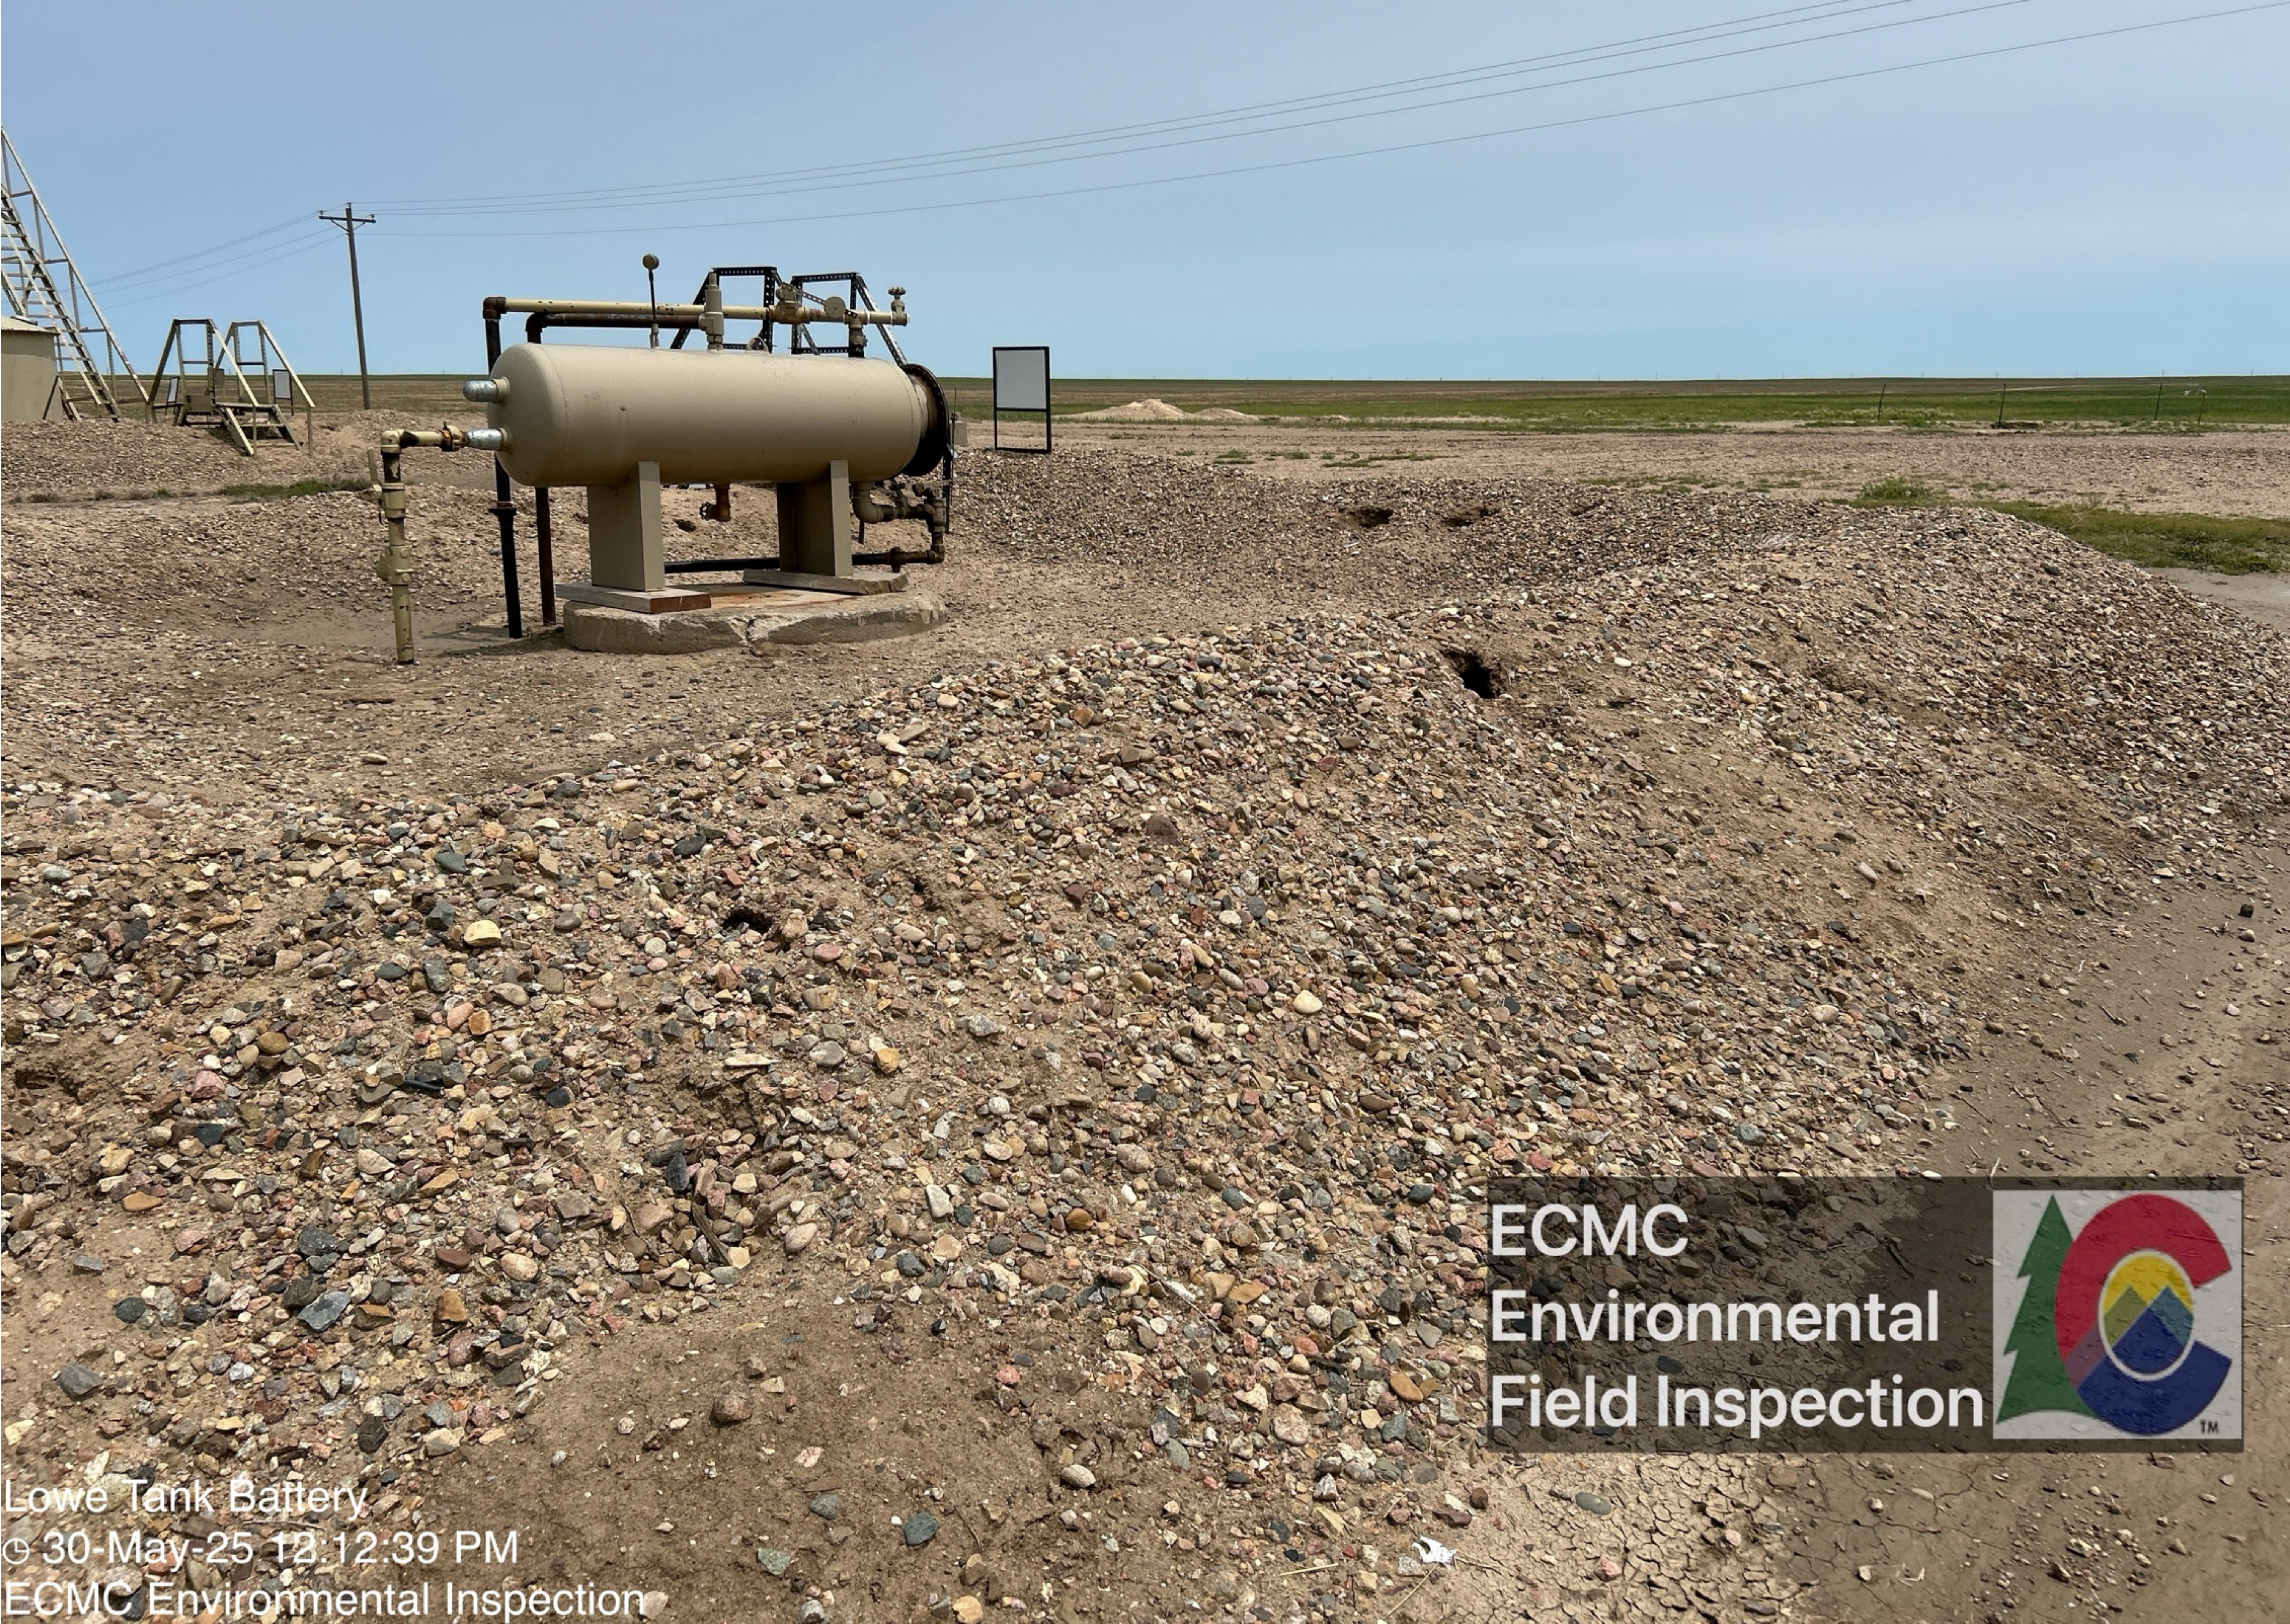
Lowe Tank Battery
© 30-May-25 12:12:39 PM
ECMC Environmental Inspection

Animal burrows are visible in multiple areas of the separator containment berm.

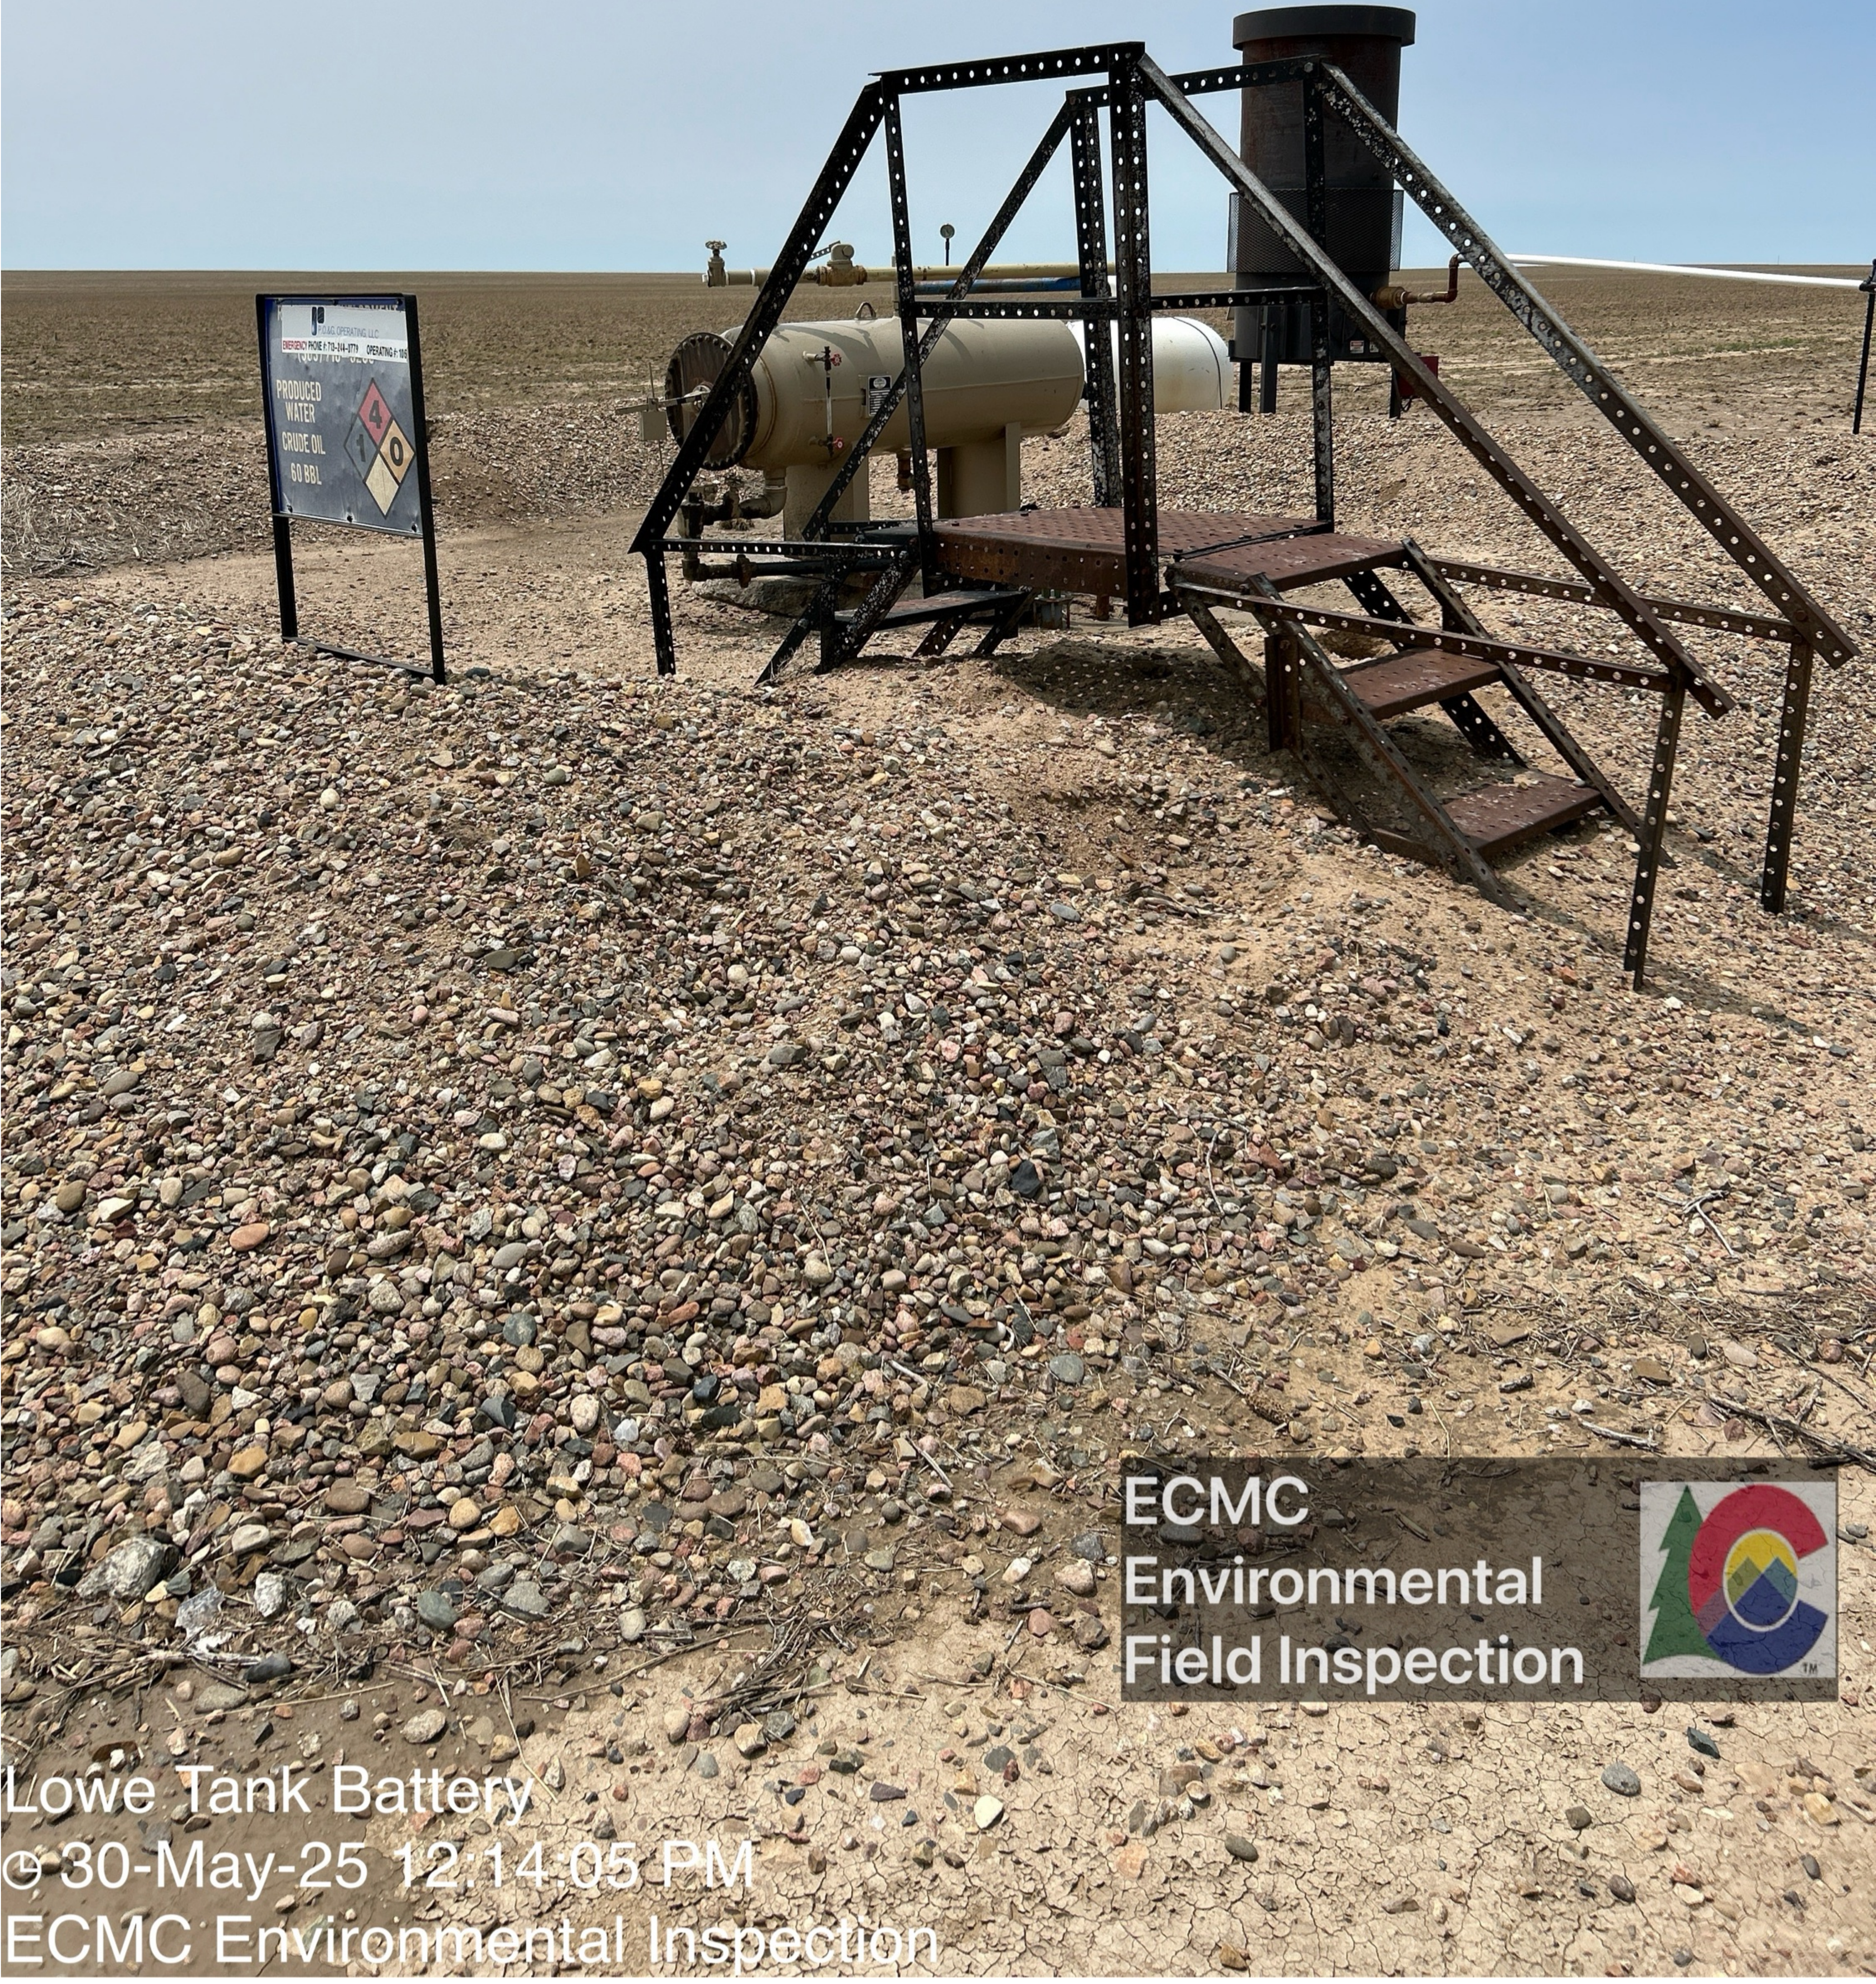
Lowe Tank Battery
© 30-May-25 12:14:05 PM
ECMC Environmental Inspection

Labels/placards are legible.
