# Inspection Photos

**Operator:** QB ENERGY OPERATING LLC

**Location ID:** 334786

**Inspection Doc:** 719200005

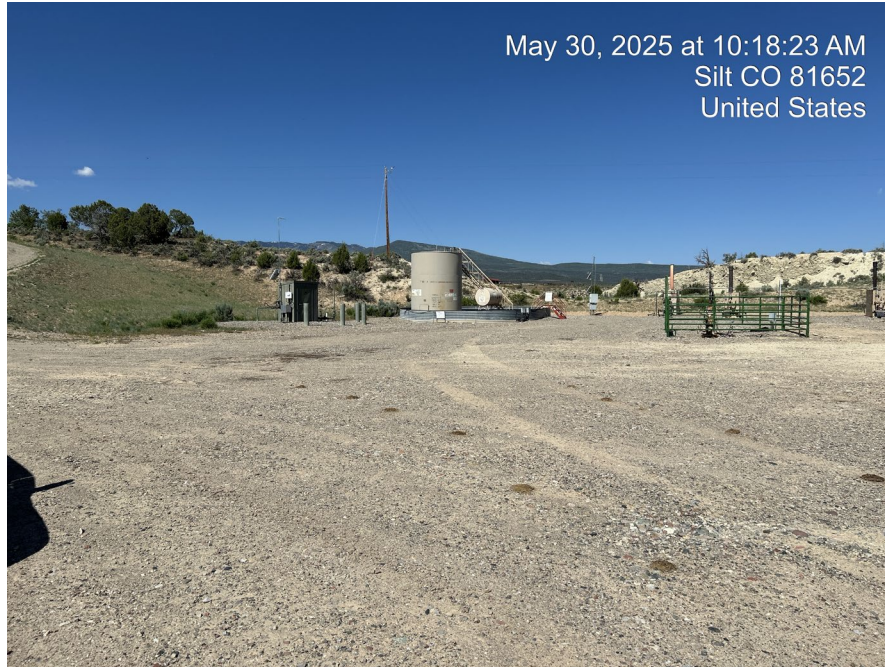
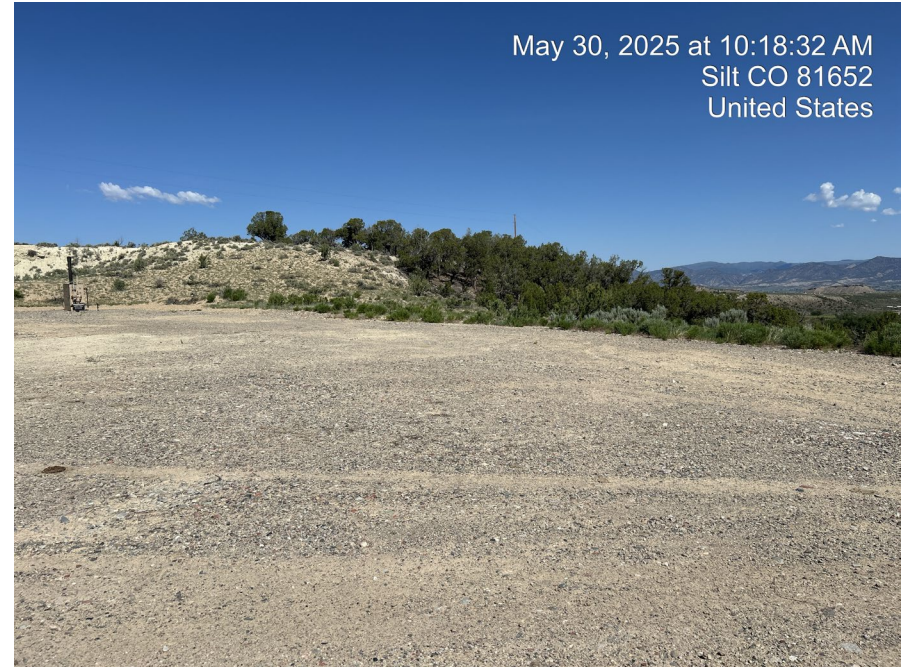
**Photo 1:** Photos are taken from the central portion of the Location looking at the western pad. Photos provide an overview of the Location looking southwest and northwest, respectively. Location has been reduced to areas reasonably needed for production; vegetation appears to be progressing towards 1003 Standards.

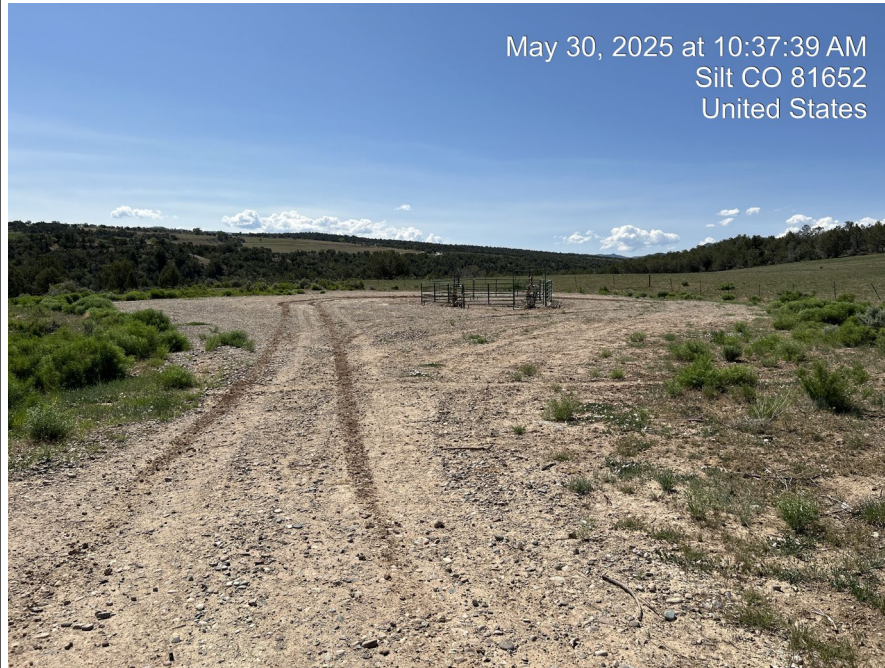
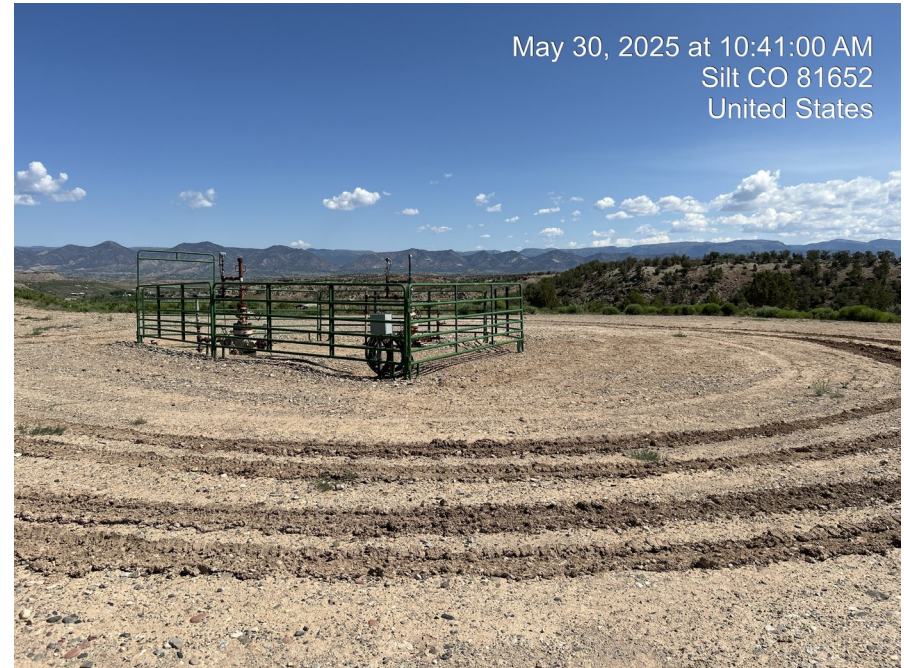
**Photo 2:** Photos are taken from the eastern pad of the Location looking east and southwest, respectively. The eastern pad is showing signs of light sediment tracking. BMP's show signs of disrepair; maintenance advised.

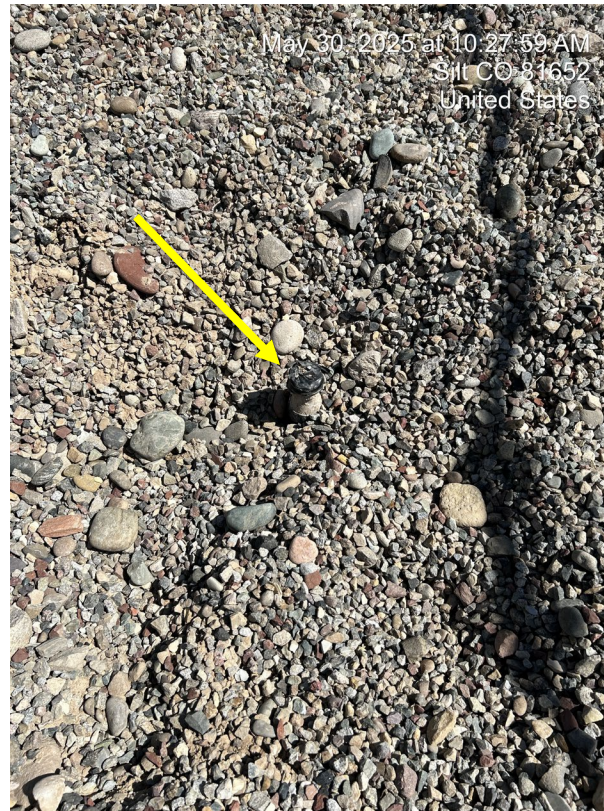
**Photo 3:** Photo taken from between the separator equipment on the west end of the Location. Photos shows riser associated with abandoned wells/equipment remaining on the Location. The riser requires cutting, capping and removal.

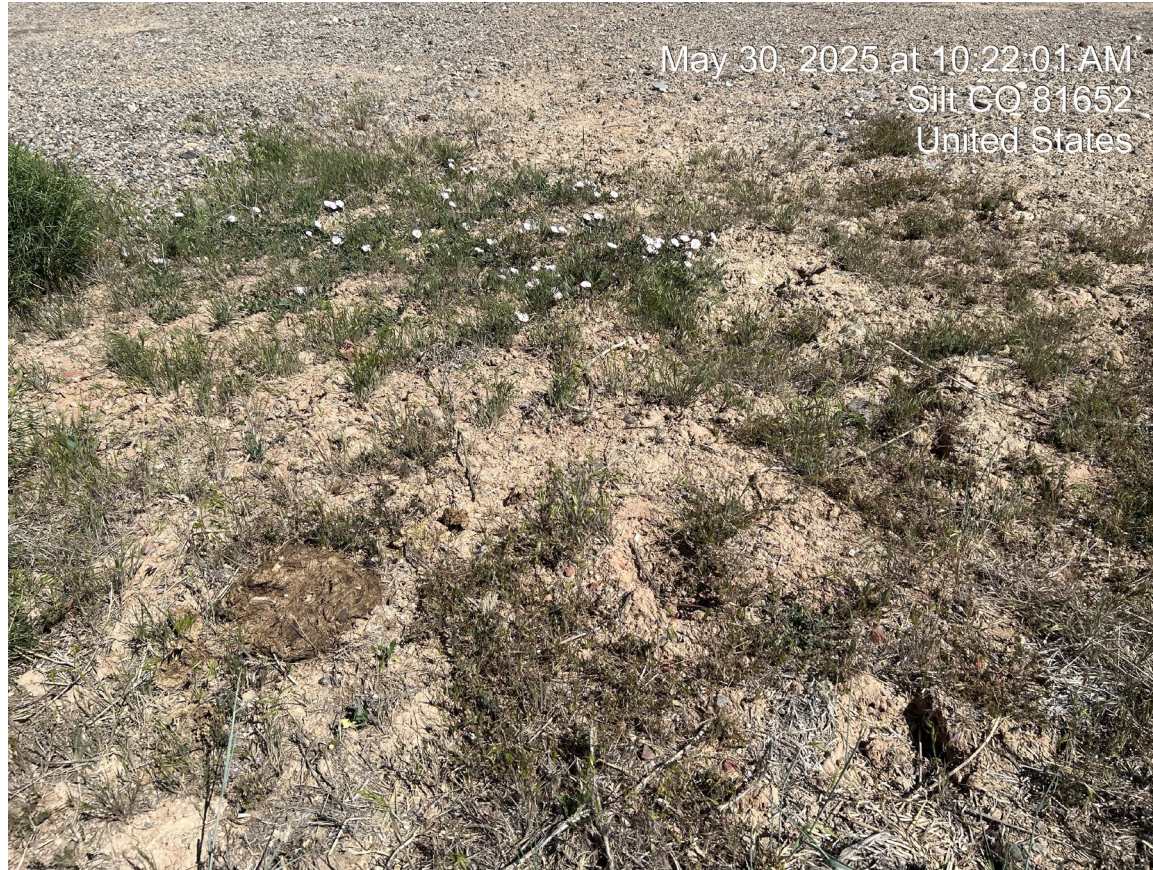
**Photo 4:** Photo taken from the edge of the working pad surface and interim areas of the Location. Photo example showing bindweed, cheatgrass and redstem fillaree have established on the Location.

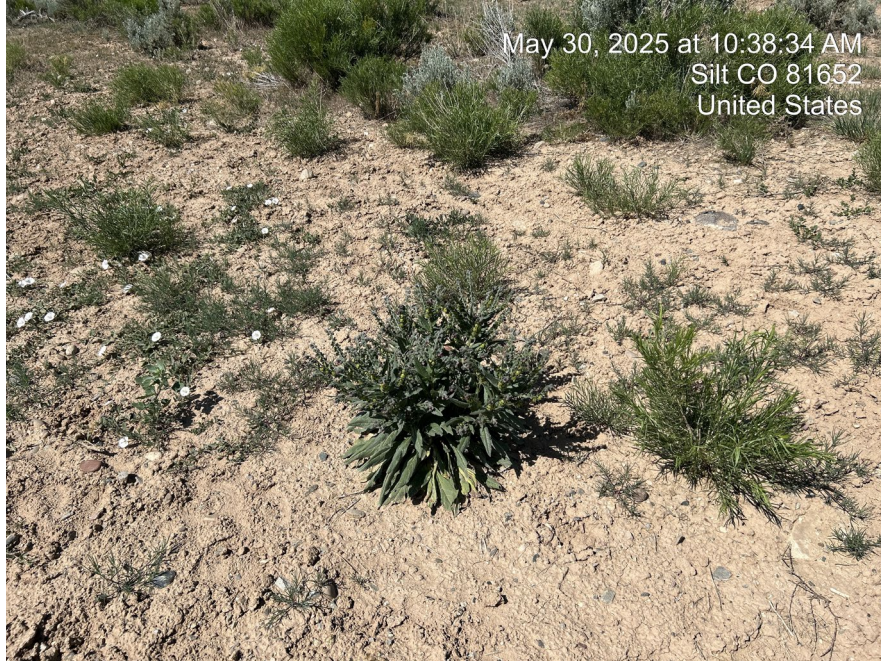
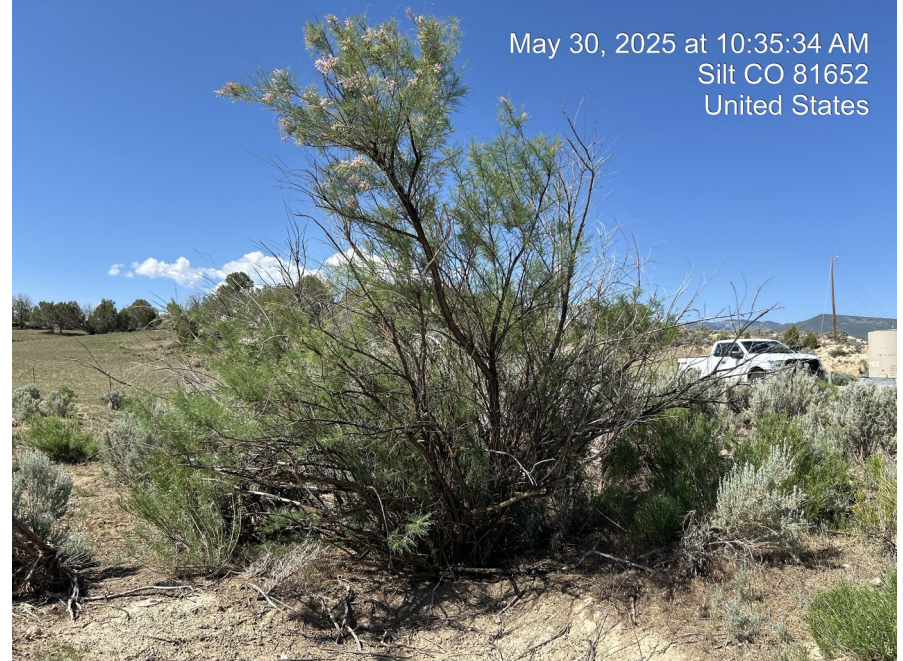
**Photo 4:** Photo taken from the edge of the working pad surface and interim areas of the Location. Photo example showing houndstongue and tamarisk have established at the Location.

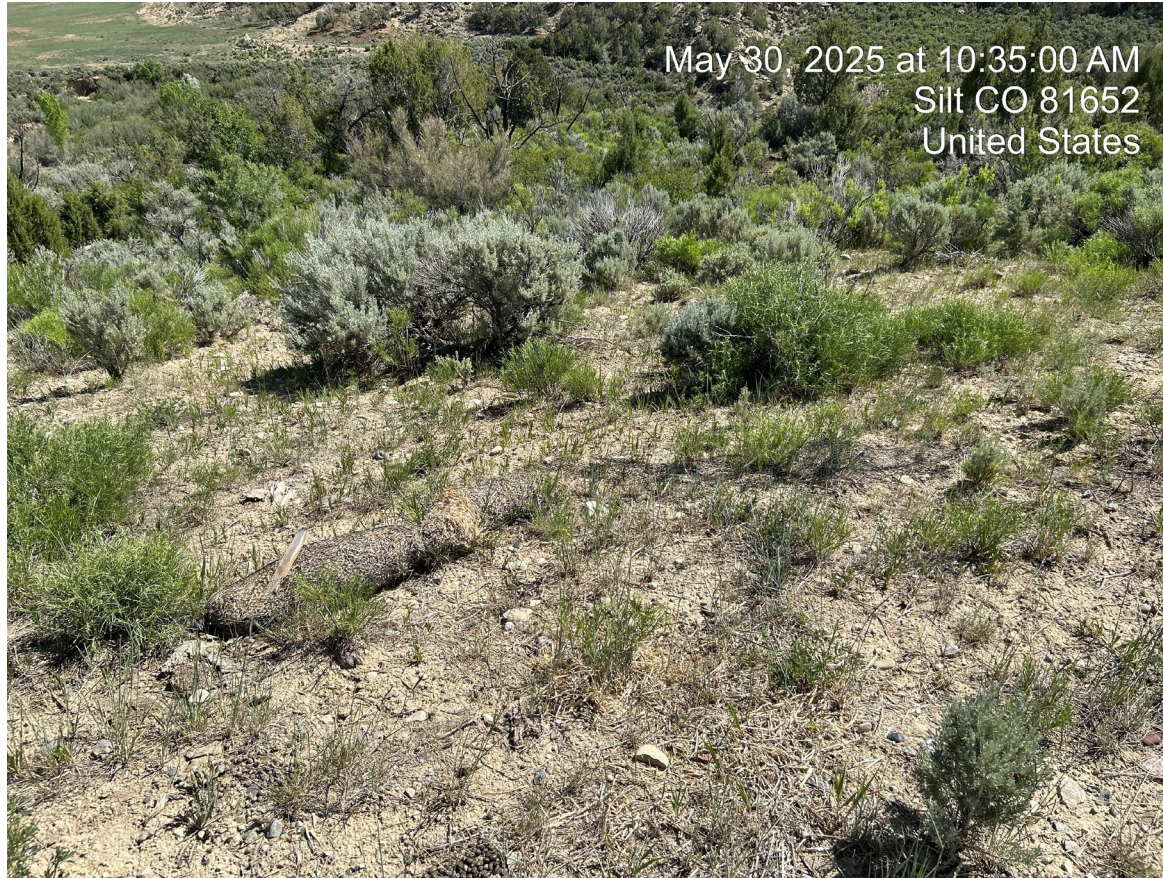
**Photo 5:** Photo taken from the interim area on the northern end of the Location. Photo shows a non-functional wattle; removal is advised.

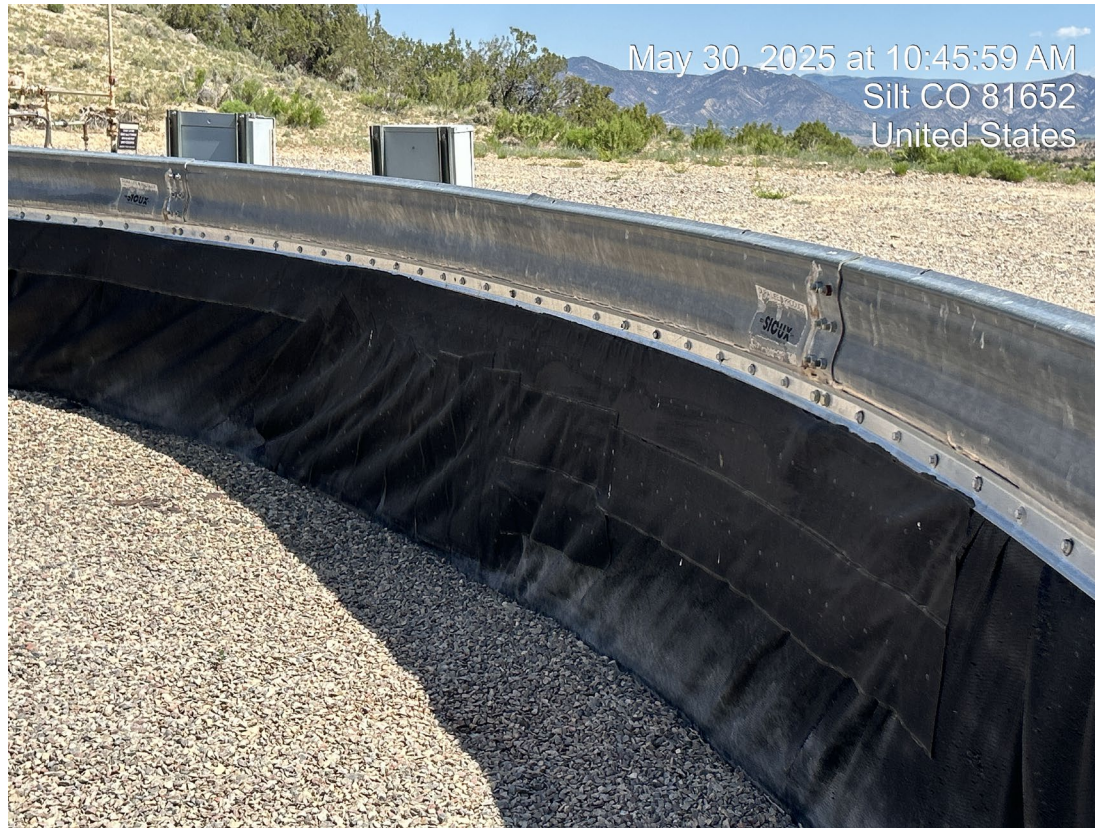
**Photo 6:** The tank battery liner appears to be aging and may need replaced soon.
