Final Reclamation Inspection

Operator: PDC ENERGY INC - 69175

Location ID: 310123

Inspection Photos
Location Name: BUTTERBALL #13-19
Location ID: 310123

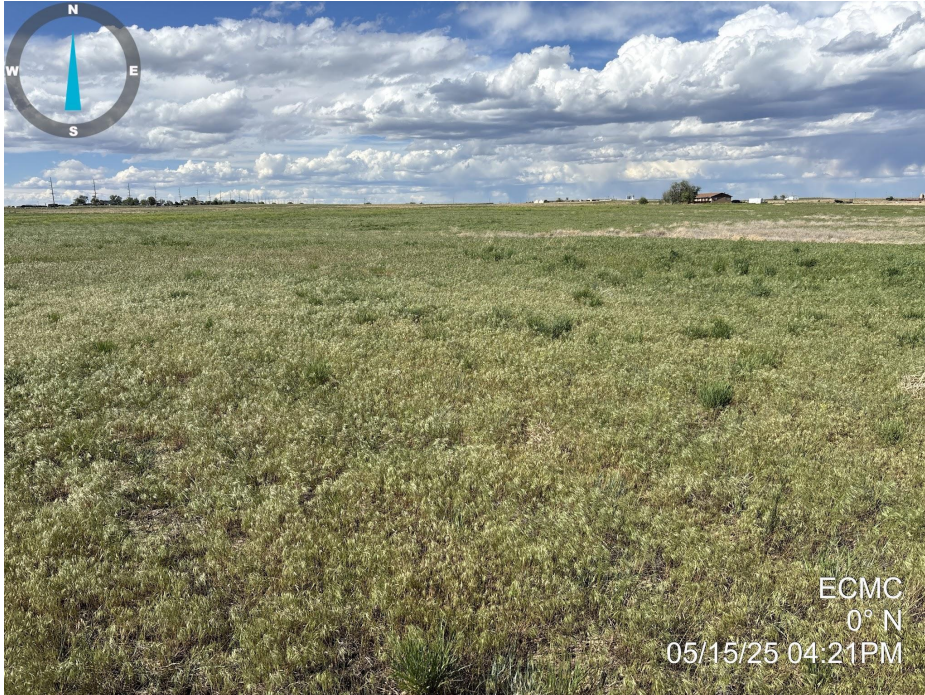
Photo 1. Photo taken from the well location, facing North. Photo illustrates that vegetation at the location is dominated by cheatgrass (*Bromus tectorum*), a List C noxious weed, and therefore does not meet Rule 1004 standards.

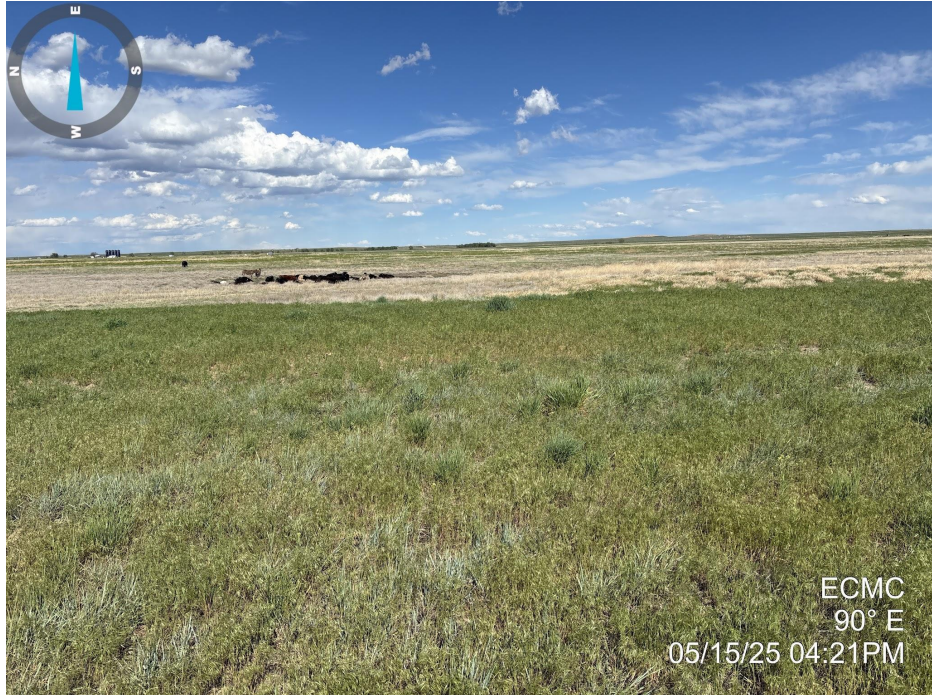
Photo 2. Photo taken from the well location, facing East. See comments under Photo 1.

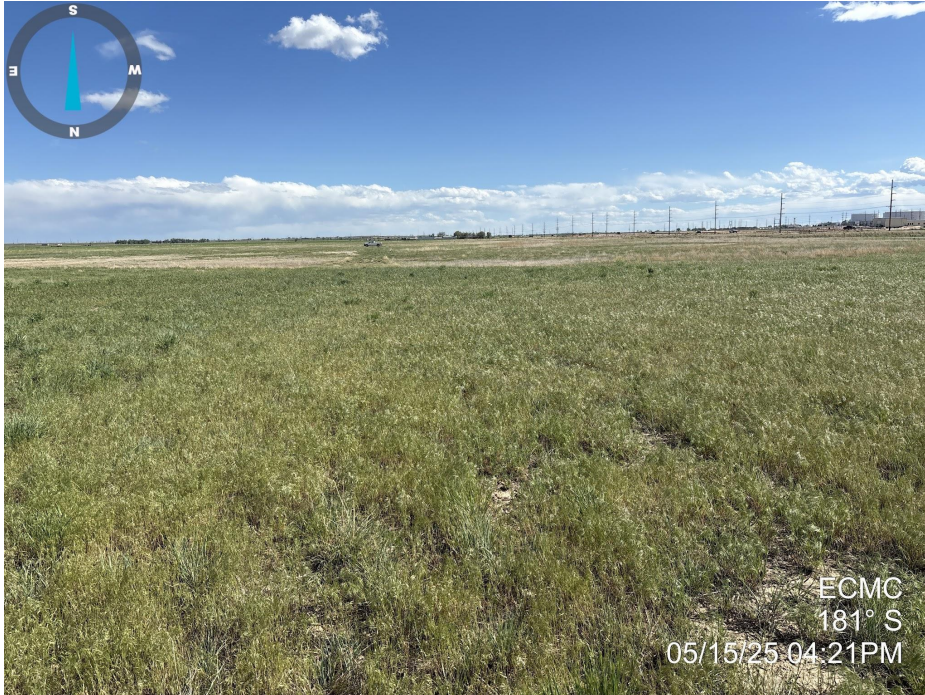
Photo 3. Photo taken from the well location, facing South. See comments under Photo 1.

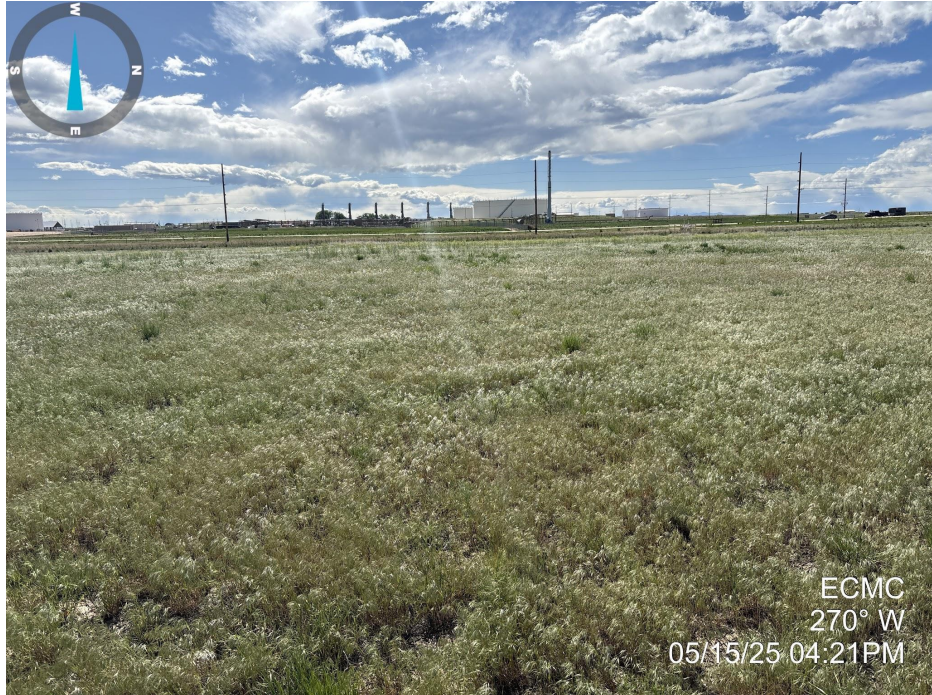
Photo 4. Photo taken from the well location, facing West. See comments under Photo 1.

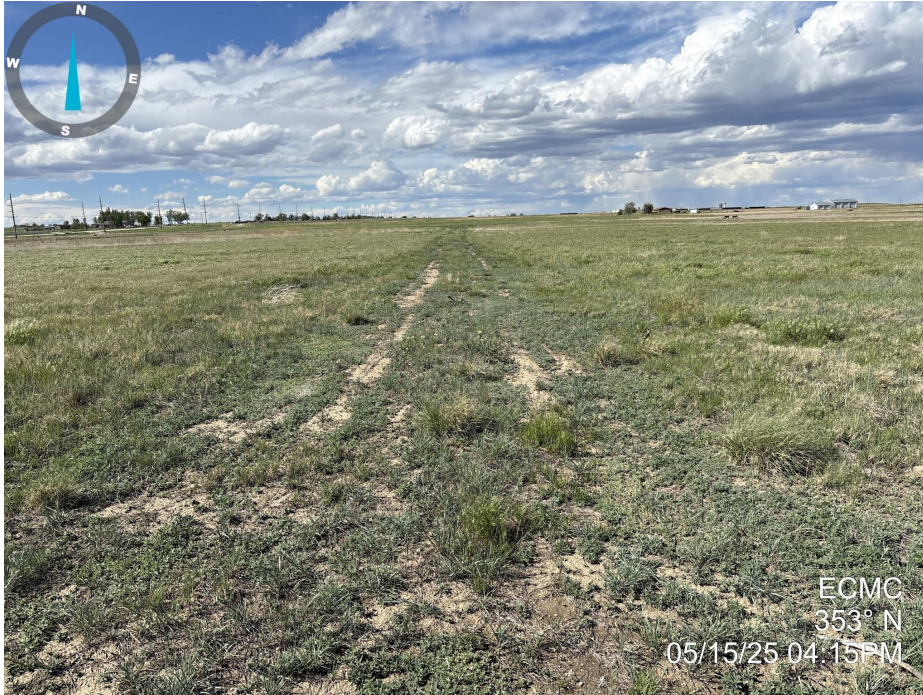
Photo 5. Photo taken from the access road, facing North towards the well location. Photo illustrates that vegetation has not established to Rule 1004 standards along the access road and weedy annual vegetation, including cheatgrass (*Bromus tectorum*) is present.

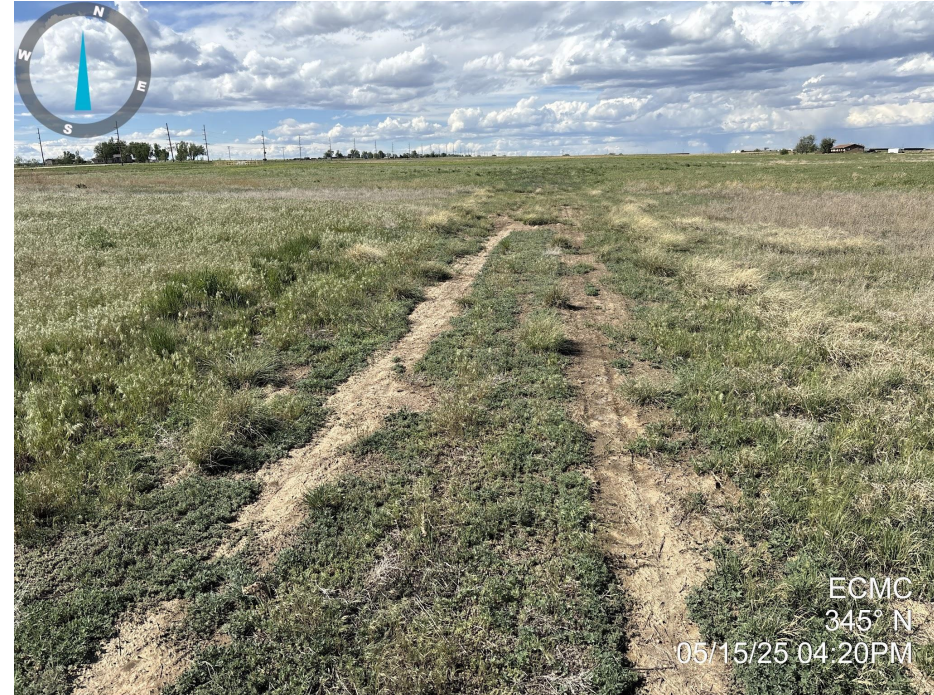
Photo 6. Photo taken of the access road, facing North. See comments under Photo 5.

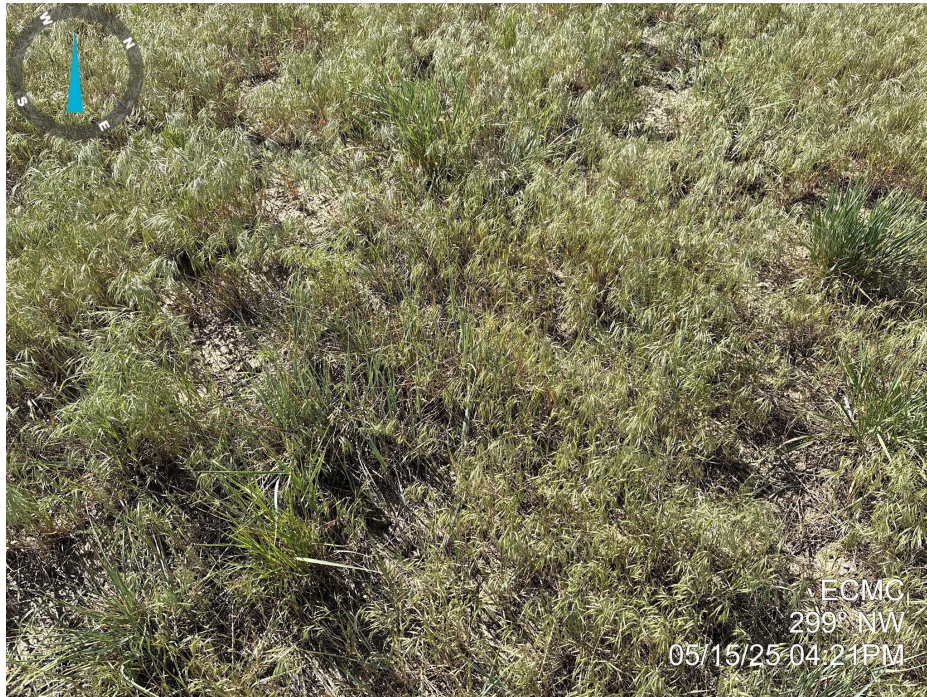
Photo 7. Photo taken of vegetation at the well location. Photo illustrates cheatgrass (*Bromus tectorum*) has established across the well site and access road.

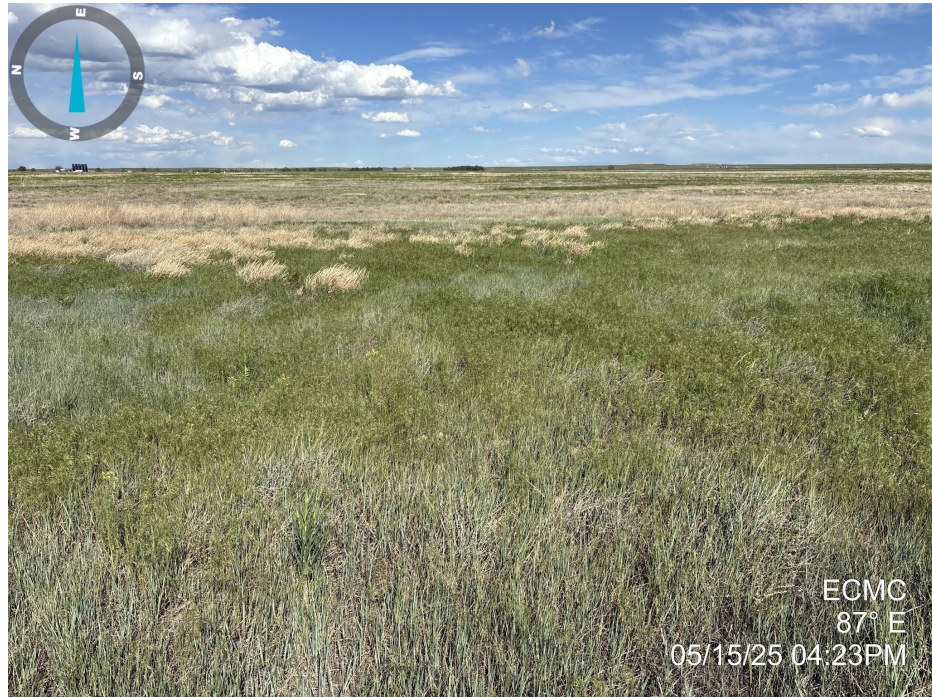
Photo 8. Photo taken of the reference area, southeast of the location, facing East. Photo illustrates perennial grass vegetation.
