Final Reclamation Inspection

Operator: PDC ENERGY INC - 69175

Location ID: 310125

Inspection Photos
Location Name: BUTTERBALL #23-19
Location ID: 310125

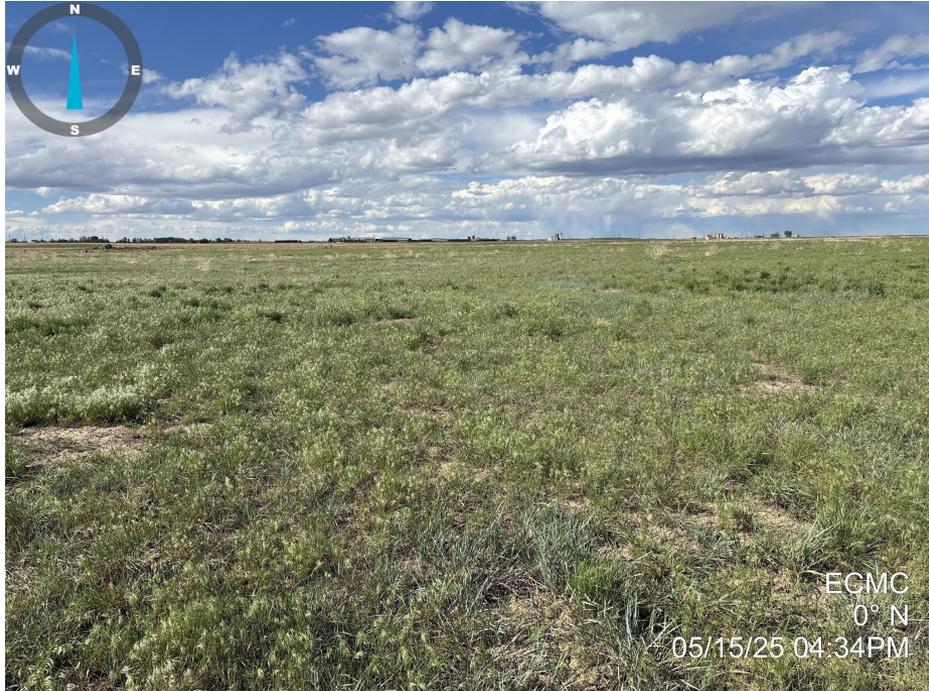
Photo 1. Photo taken from the well location, facing North. Photo illustrates that vegetation at the location is dominated by cheatgrass (*Bromus tectorum*), a List C noxious weed, and therefore does not meet Rule 1004 standards.

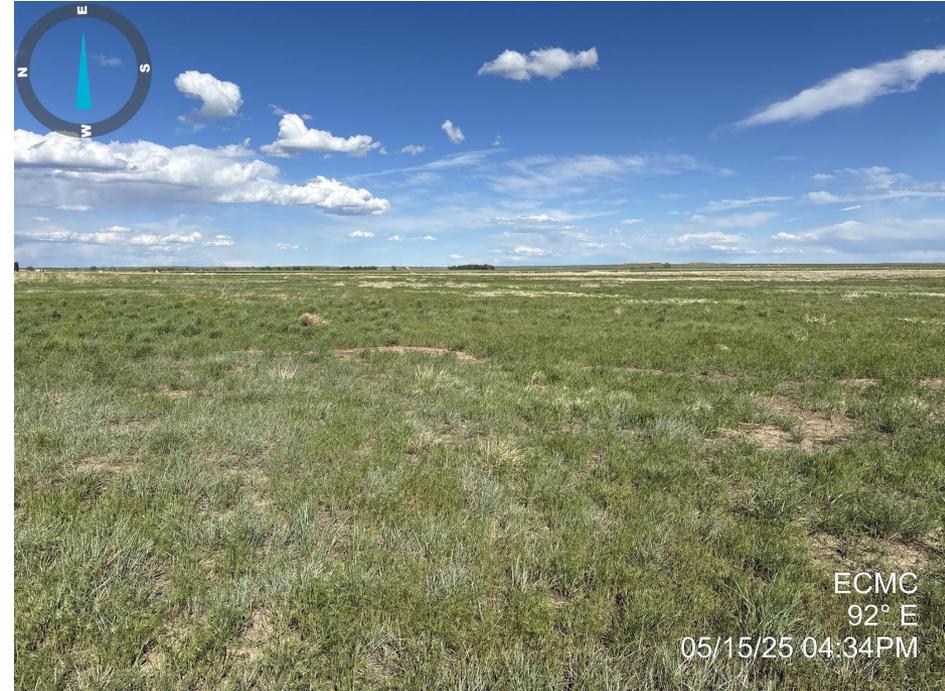
Photo 2. Photo taken from the well location, facing East. See comments under Photo 1.

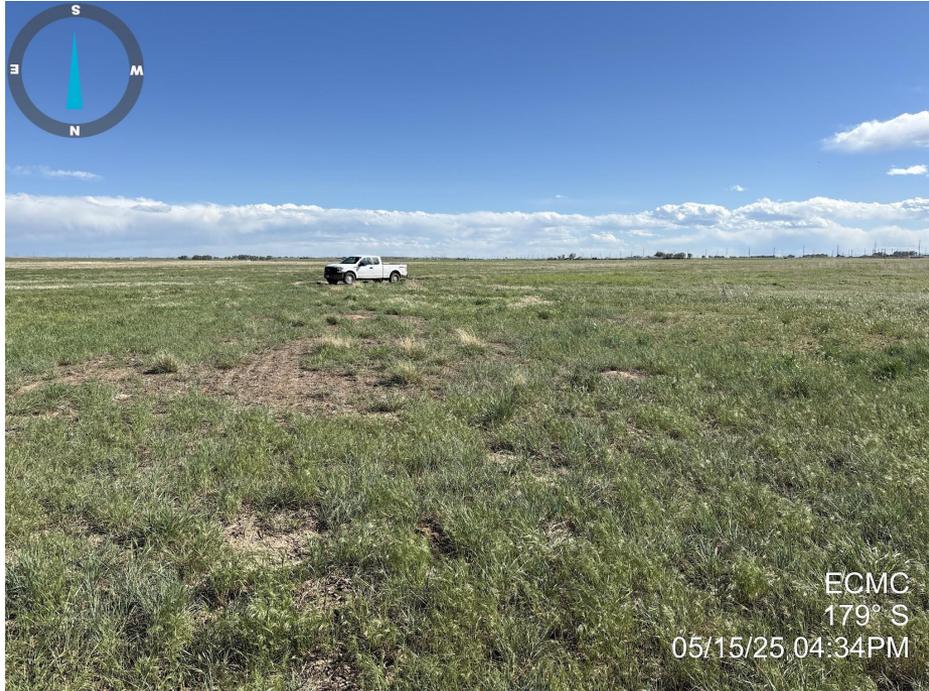
Photo 3. Photo taken from the well location, facing South. See comments under Photo 1.

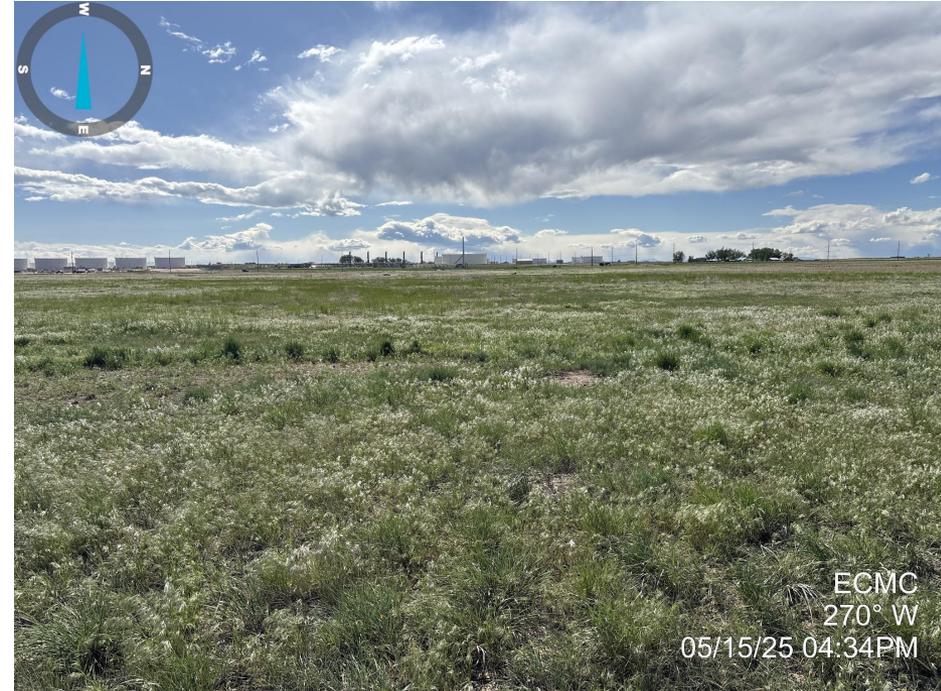
Photo 4. Photo taken from the well location, facing West. See comments under Photo 1.

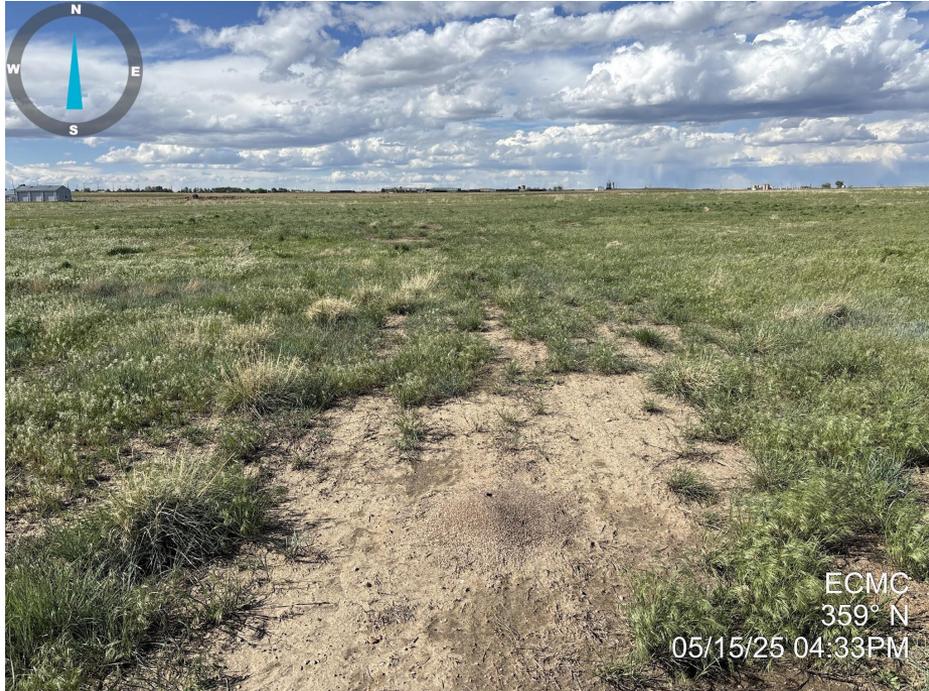
Photo 5. Photo taken from the access road, facing North towards the well location. Photo illustrates that vegetation has not established to Rule 1004 standards along the access road and weedy annual vegetation, including cheatgrass (*Bromus tectorum*) is present.

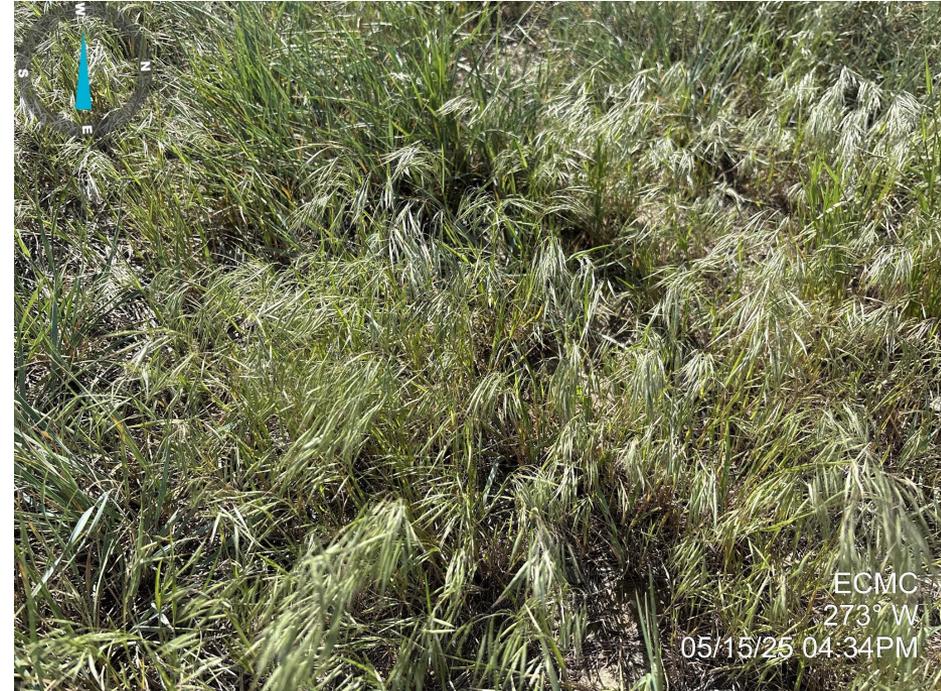
Photo 6. Photo taken of vegetation at the location. Photo illustrates cheatgrass (*Bromus tectorum*), has established at the well location and along the access road.

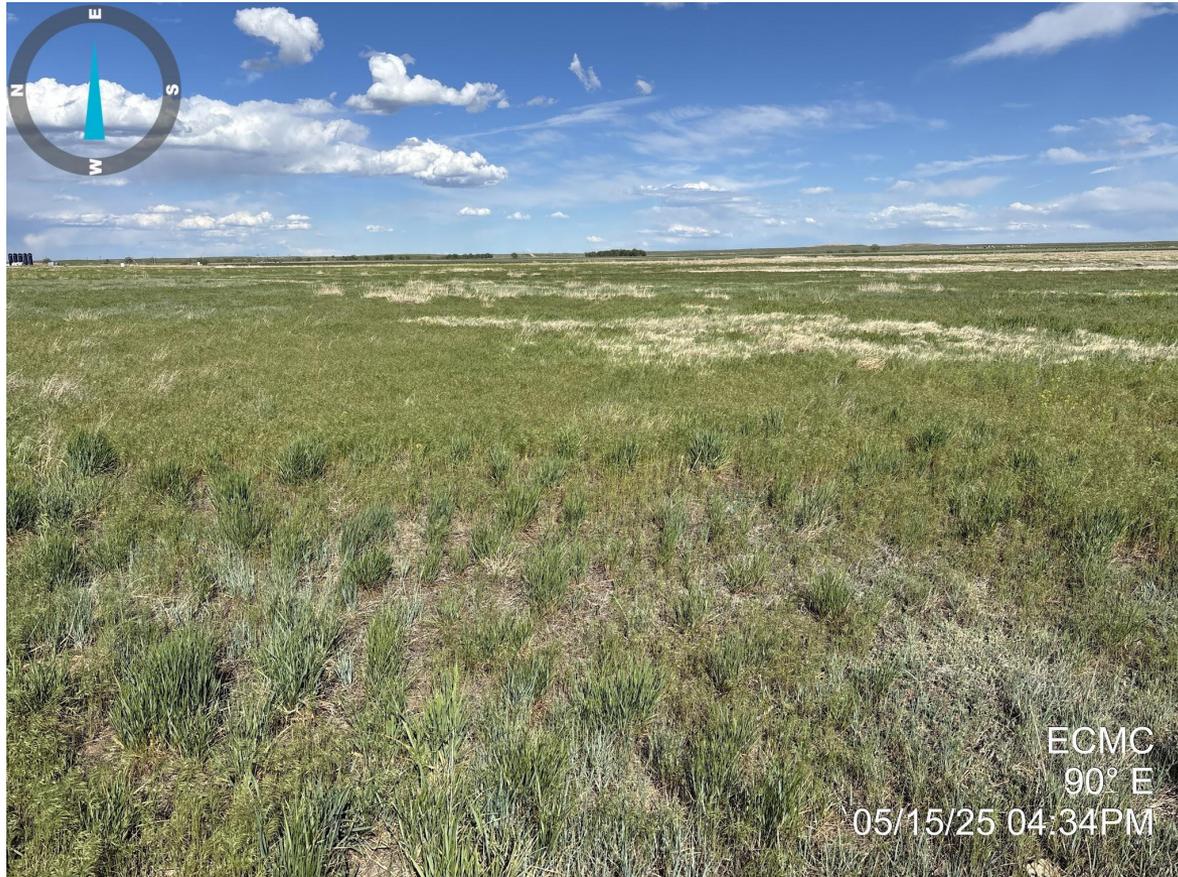
Photo 7. Photo taken of the reference area, southeast of the location, facing East. Photo illustrates perennial grass vegetation with some cheatgrass encroachment.
