Final Reclamation Inspection

Operator: PDC ENERGY INC - 69175

Location ID: 447140

Inspection Photos
Location Name: Butterball B4
Location ID: 447140

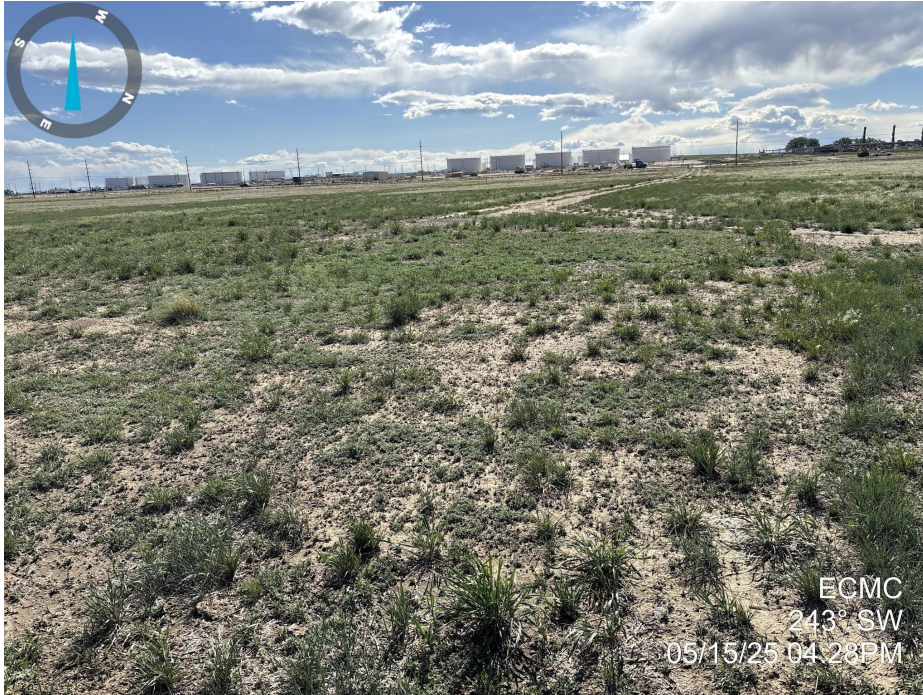
Photo 1. Photo taken from tank battery location, facing Southwest. Photo illustrates that final reclamation activities have taken place, with evidence of drill row seeding, but vegetation has not established to Rule 1004 standards.

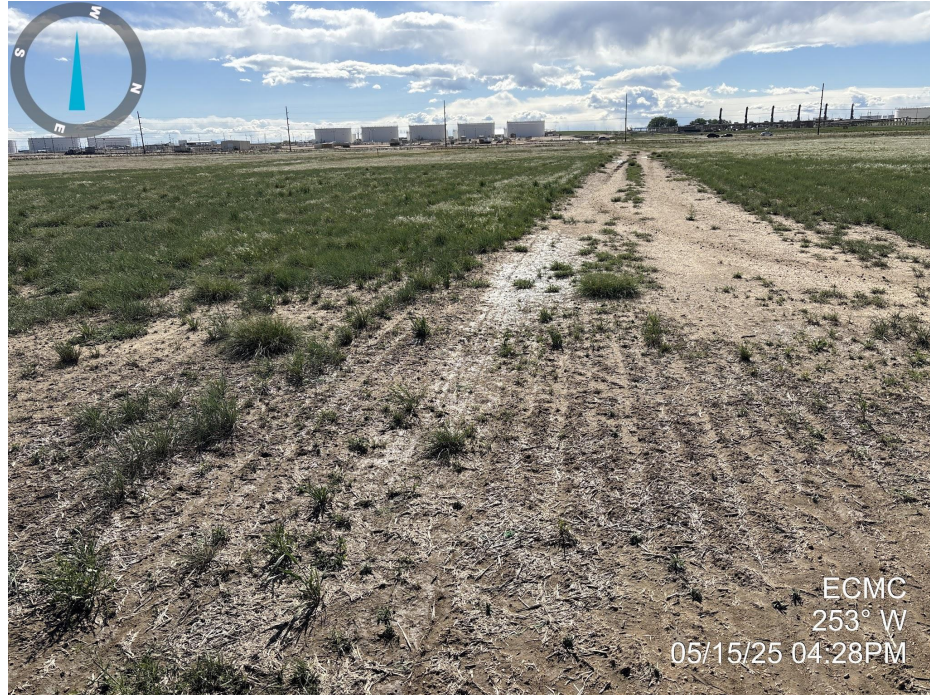
Photo 2. Photo taken from the tank battery location, facing West. See comments under Photo 1.

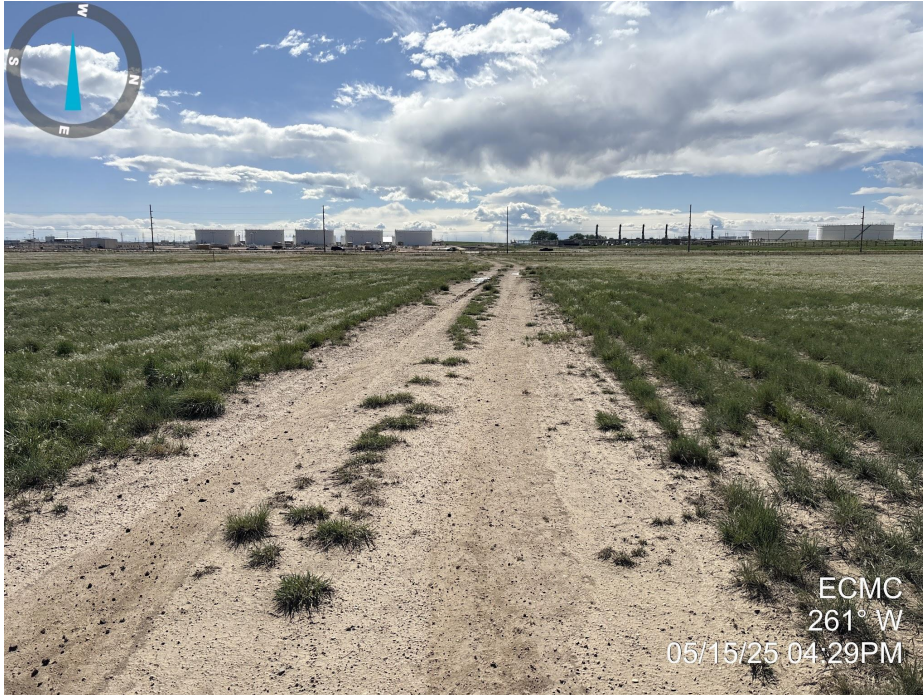
Photo 3. Photo taken from the tank battery location, facing West, towards the access road. Photo illustrates that vegetation has not established to Rule 1004 standards at the location or along the access road.

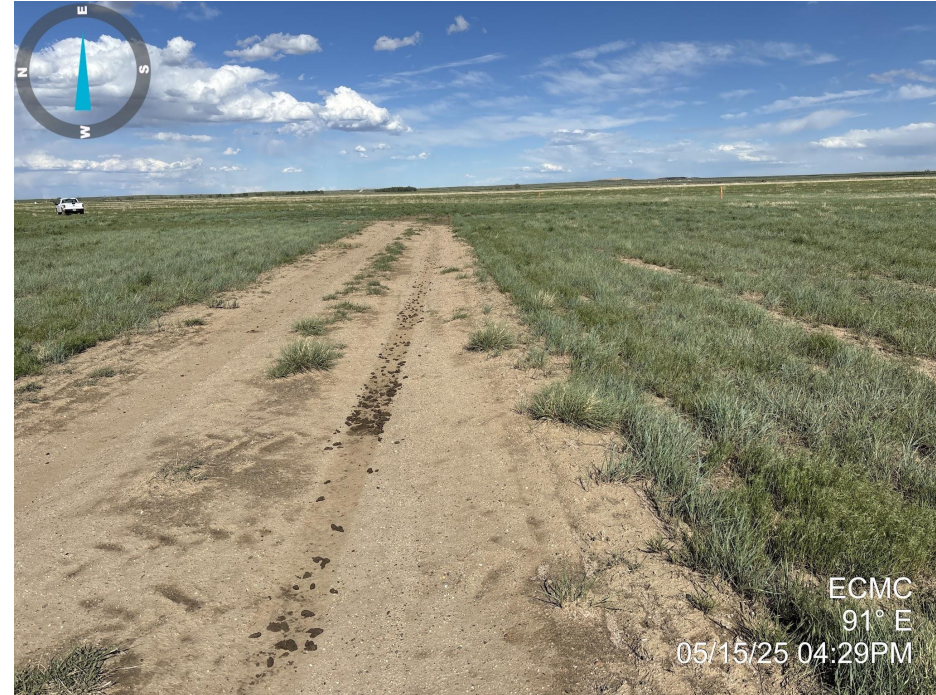
Photo 4. Photo taken from the tank battery location and access road, facing East. See comments under Photo 3.

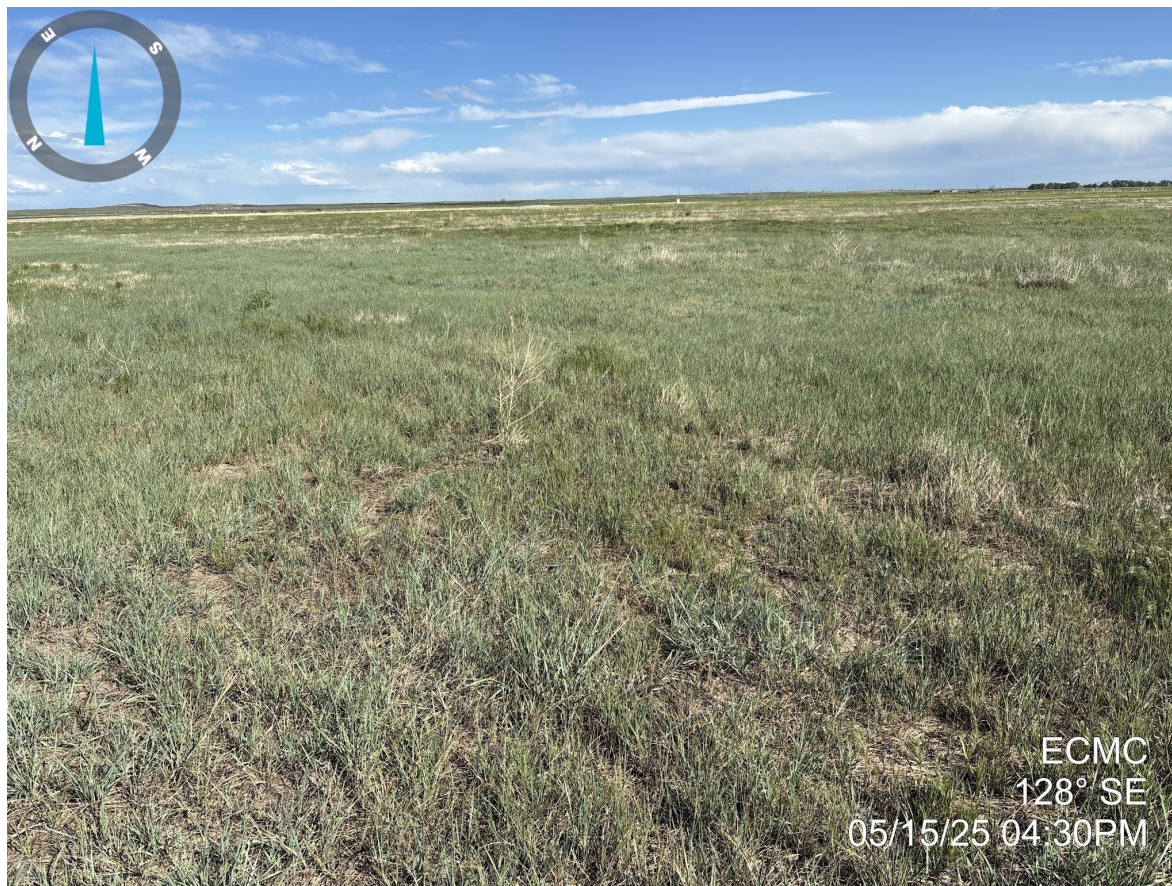
Photo 5. Photo taken of the reference area, south of the location, facing Southeast. Photo illustrates perennial grass vegetation.
