# Final Reclamation Inspection

Operator: KERR MCGEE OIL & GAS ONSHORE LP - 47120

Location ID: 327359

Inspection Photos  
Location Name: BALLANTYNE USX WW #1-1  
Location ID: 327359

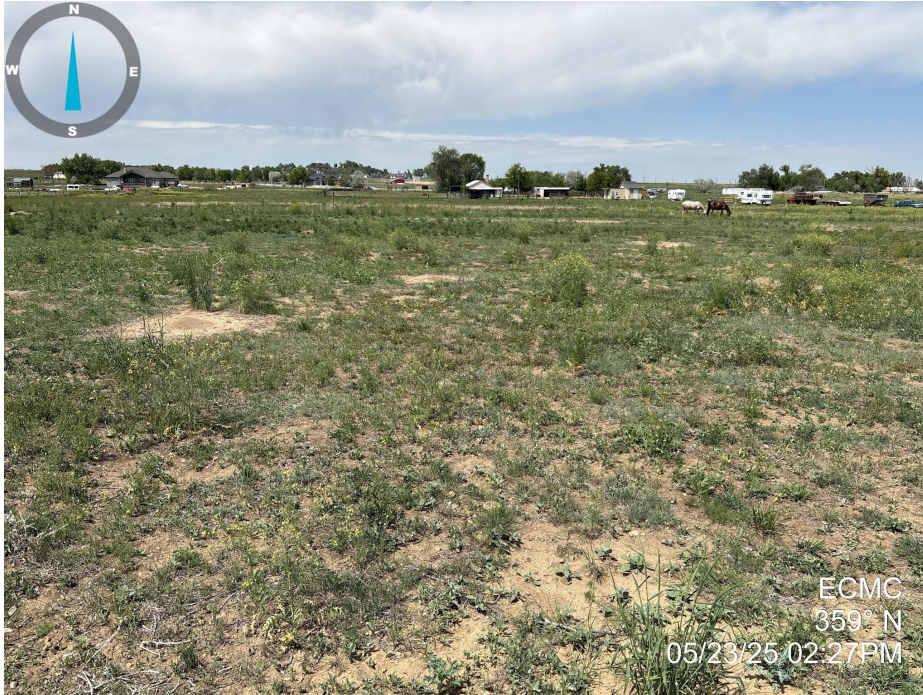
**Photo 1.** Photo taken from the well location, facing North. Photo illustrates that the final reclamation activities appear to have taken place, but vegetation establishment does not meet Rule 1004 standards.

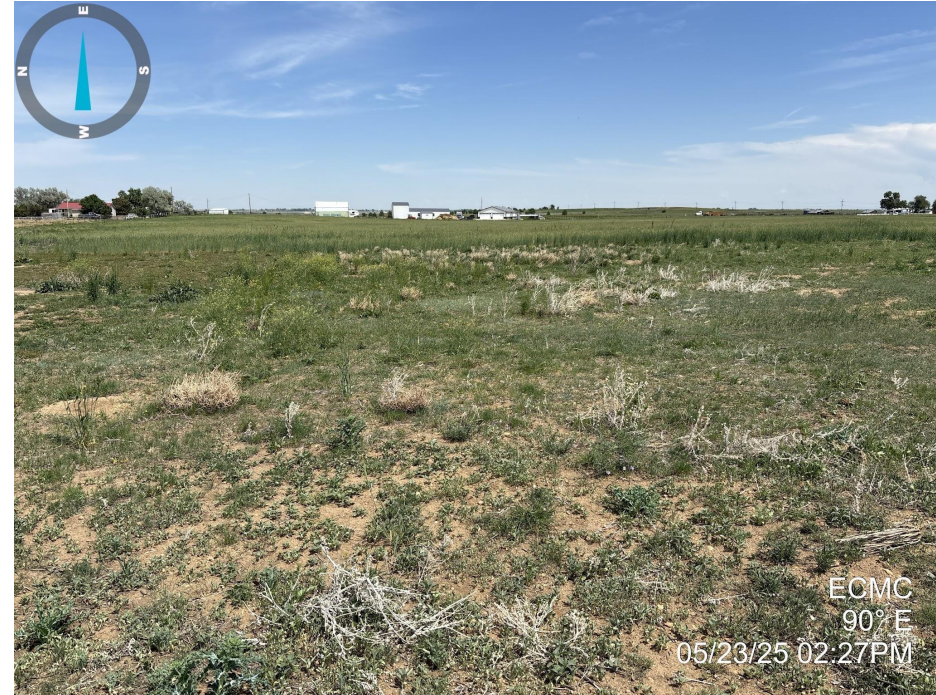
**Photo 2.** Photo taken from the well location, facing East. See comments under Photo 1.

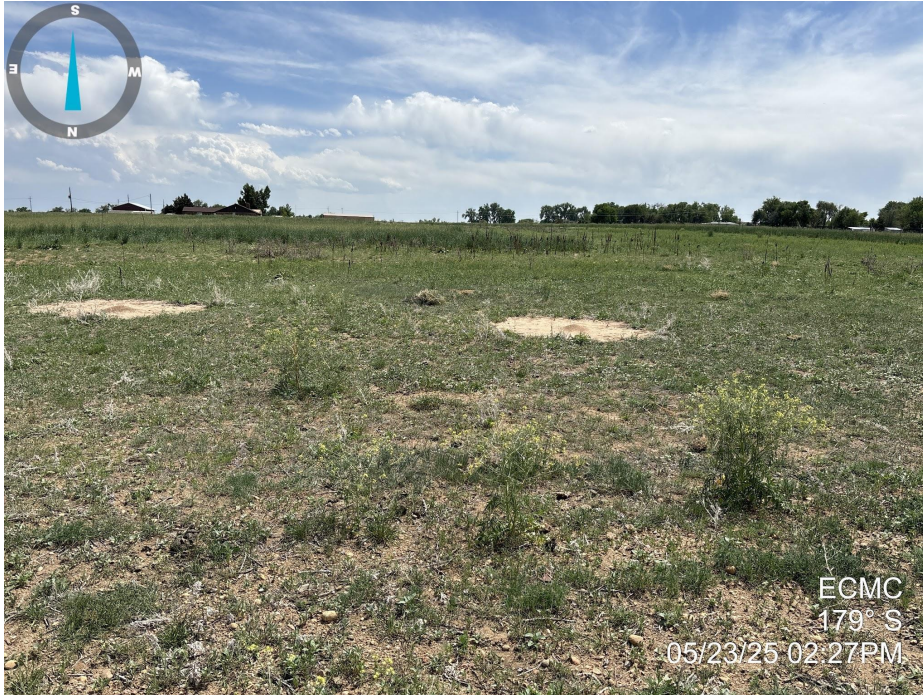
**Photo 3.** Photo taken from the well location, facing South. See comments under Photo 1.

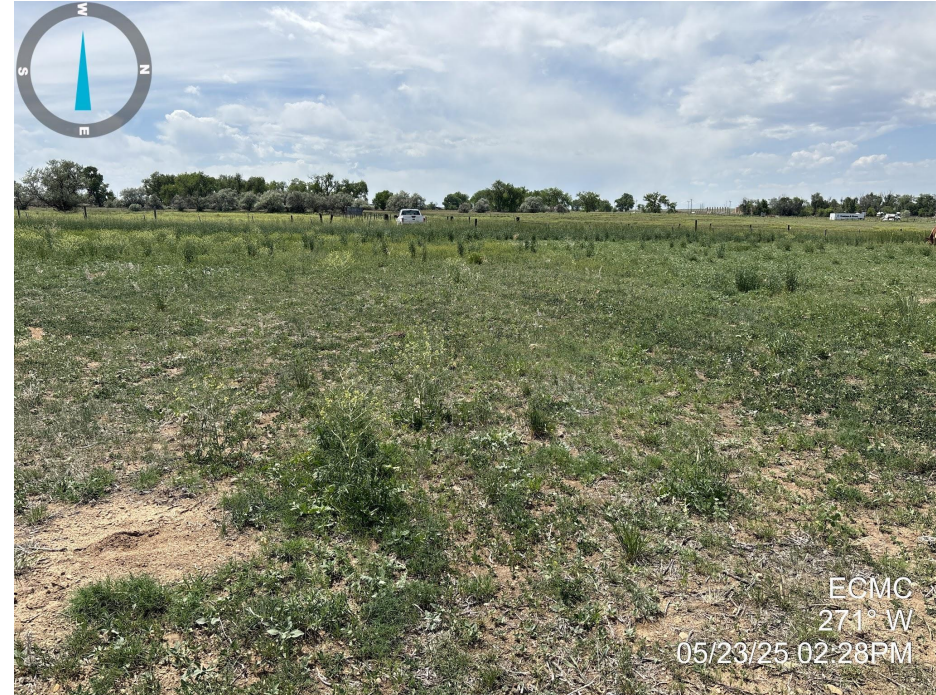
**Photo 4.** Photo taken from the well location, facing West. See comments under Photo 1.

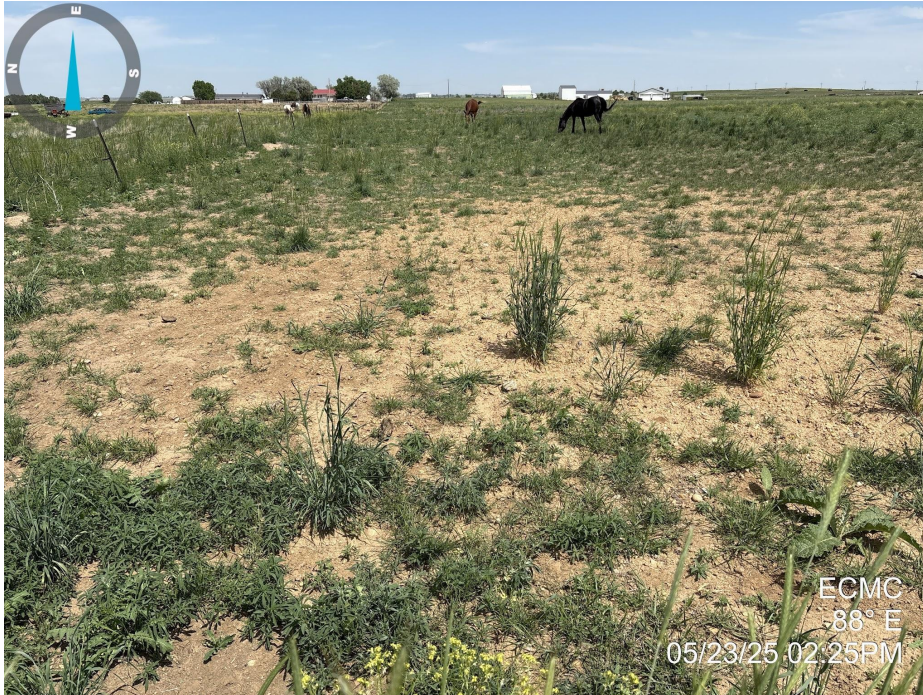
**Photo 5.** Photo taken from the tank battery location, facing East. Photo illustrates that bare ground remains at the tank battery location, and vegetation has not established to Rule 1004 standards.

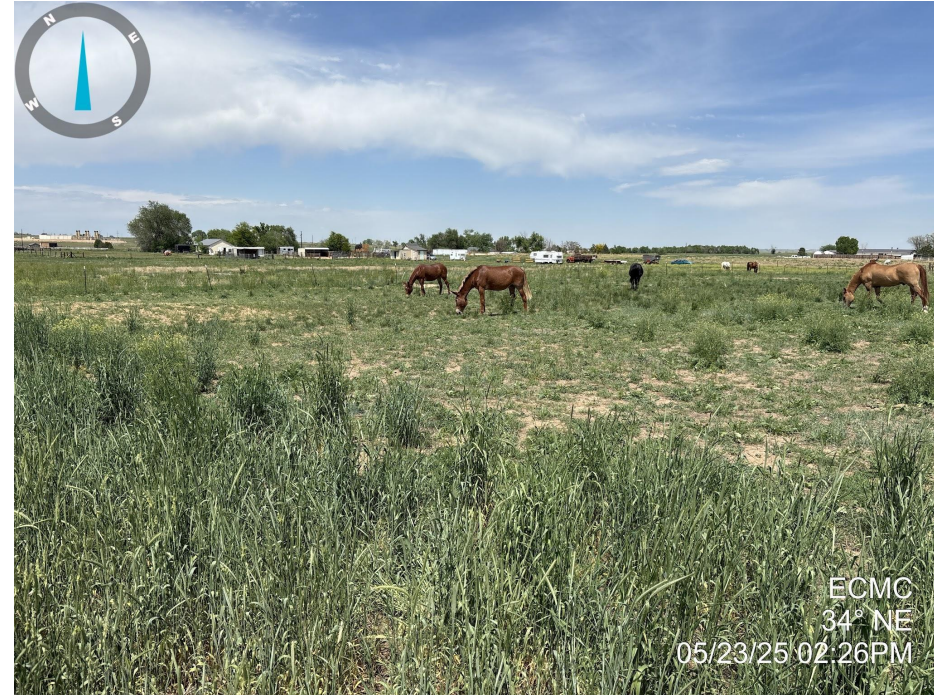
**Photo 6.** Photo taken from the tank battery location, facing Northeast. See comments under Photo 5.

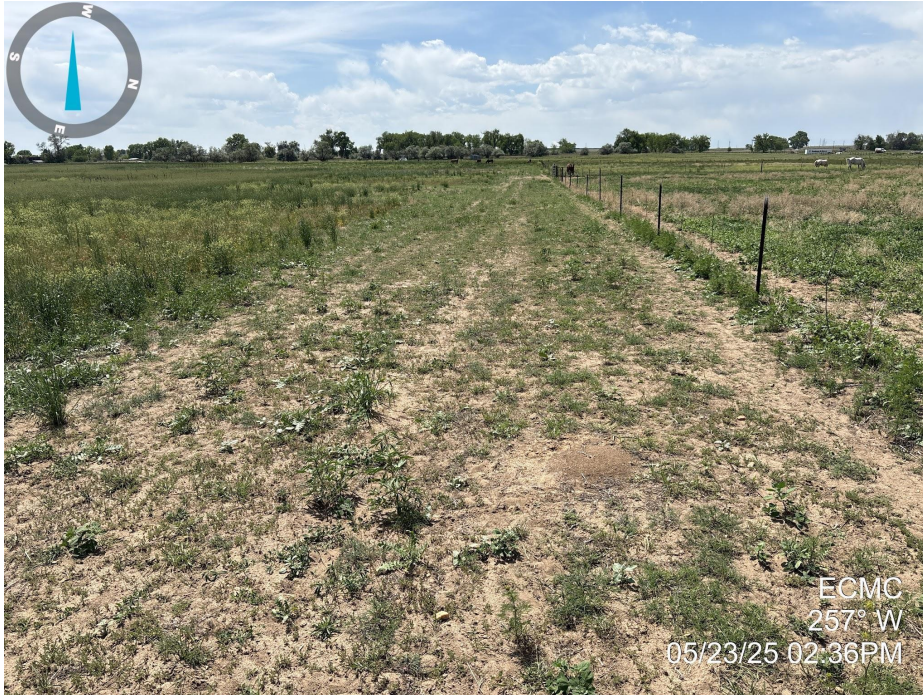
**Photo 7.** Photo taken from the access road to the tank battery location, facing West towards the location. Photo illustrates that vegetation establishment does not meet Rule 1004 standards.

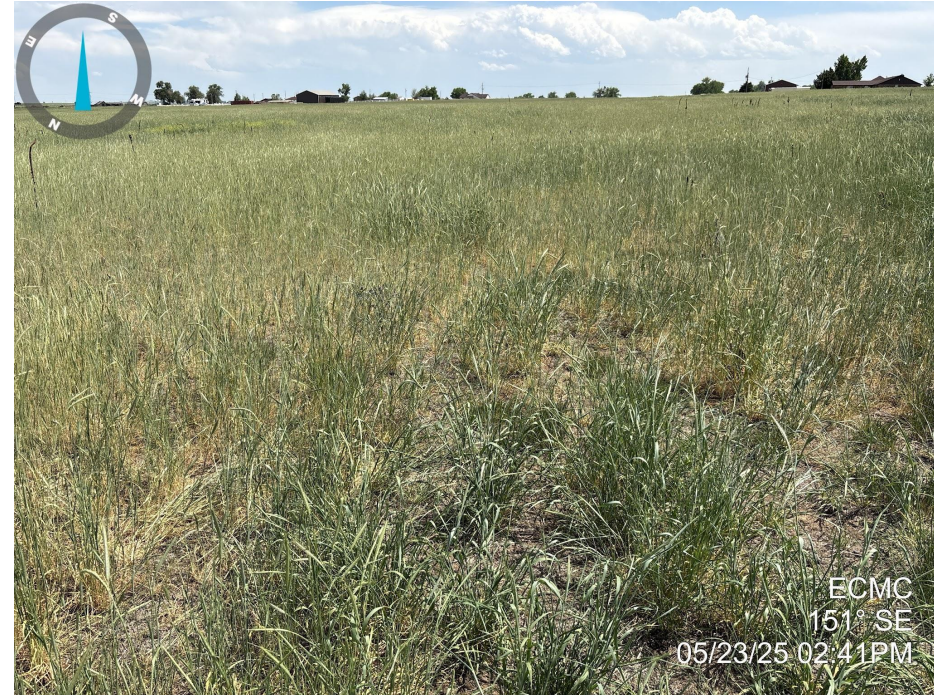
**Photo 8.** Photo taken from the reference area, east of the location, facing Southeast. Photo illustrates Rye (*Secale cereale*).
