Final Reclamation Inspection

Operator: KERR MCGEE OIL & GAS ONSHORE LP - 47120

Location ID: 302883

Inspection Photos
Location Name: WAKEFIELD #41-1
Location ID: 302883

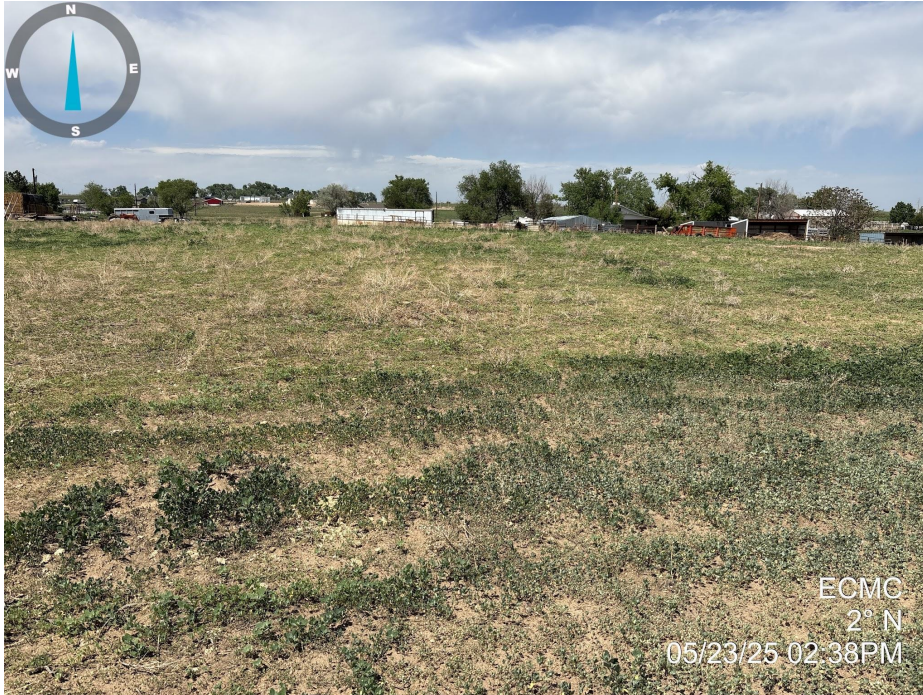
Photo 1. Photo taken from the well location, facing North. Photo illustrates that final reclamation activities have taken place, but vegetation has not established to Rule 1004 standards.

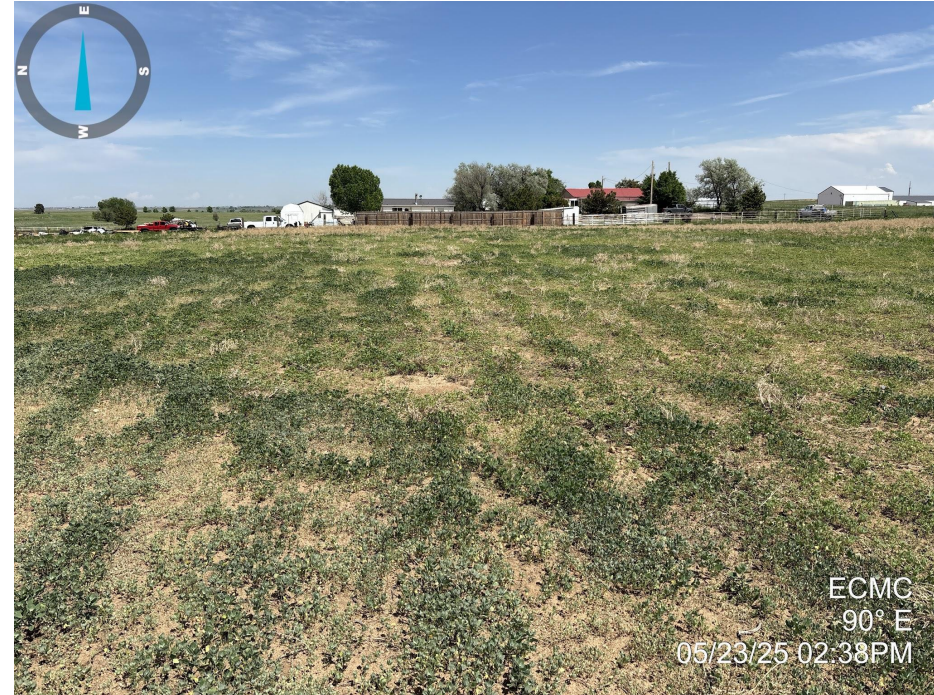
Photo 2. Photo taken from the well location, facing East. See comments under Photo 1.

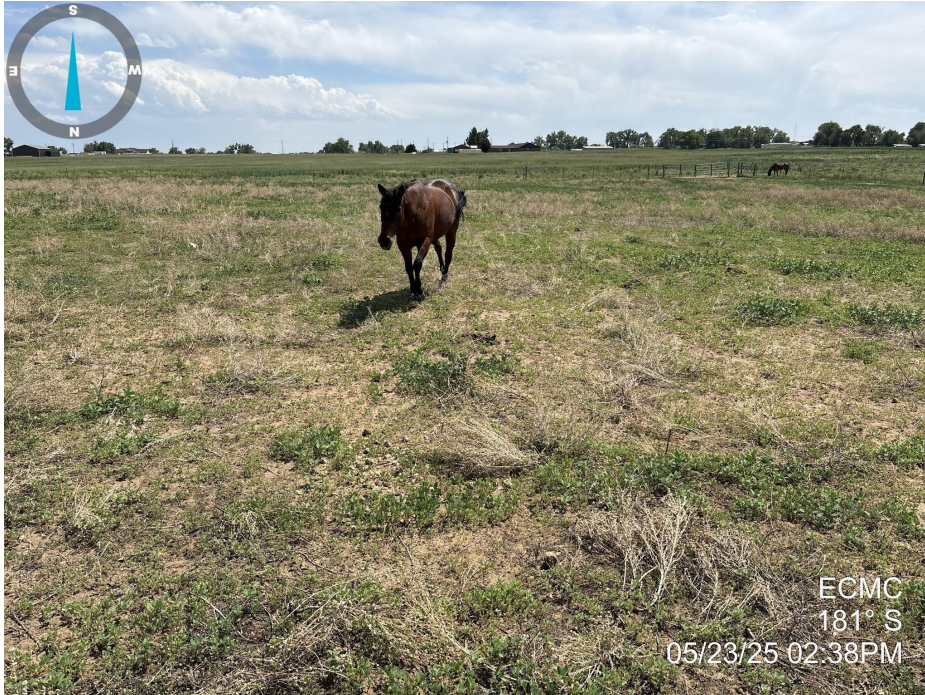
Photo 3. Photo taken from the well location, facing South. See comments under Photo 1.

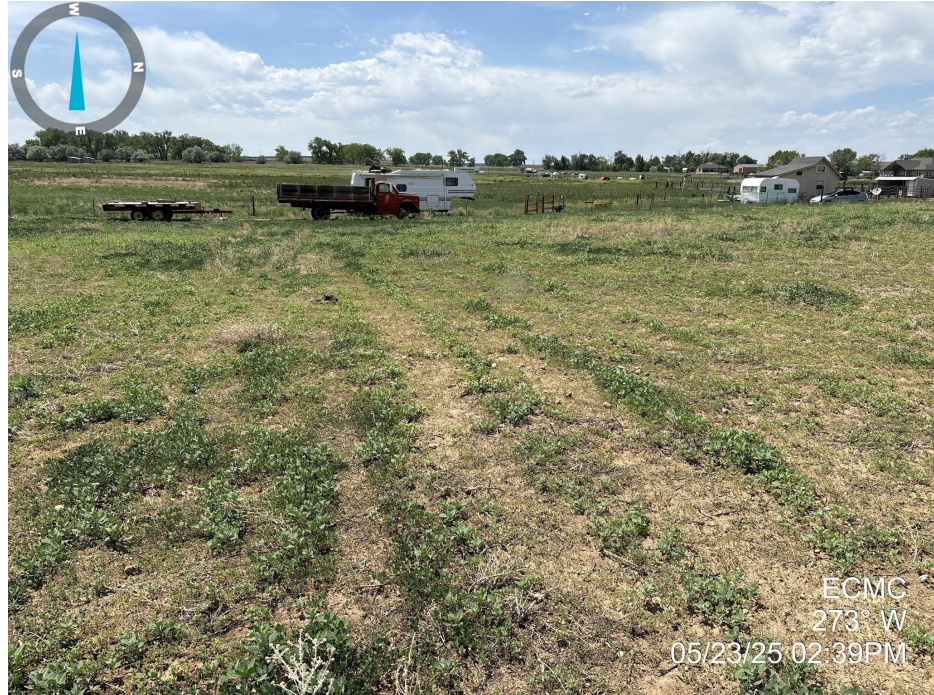
Photo 4. Photo taken from the well location, facing West. See comments under Photo 1.

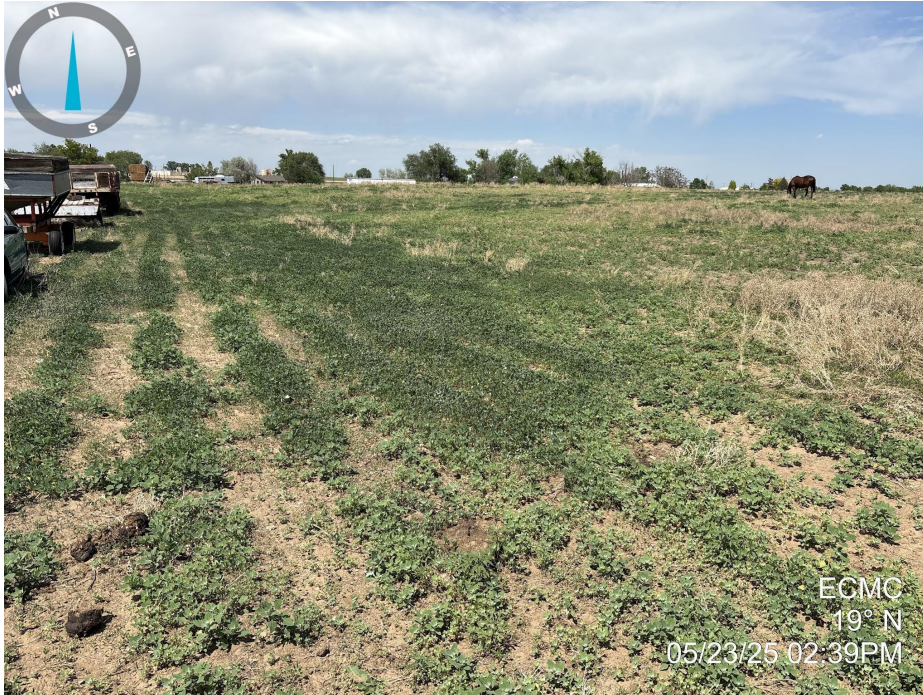
Photo 5. Photo taken from the access road, facing North towards the well location. Photo illustrates that gravel remains along the access road (see Photo 7) and vegetation establishment does not meet Rule 1004 standards.

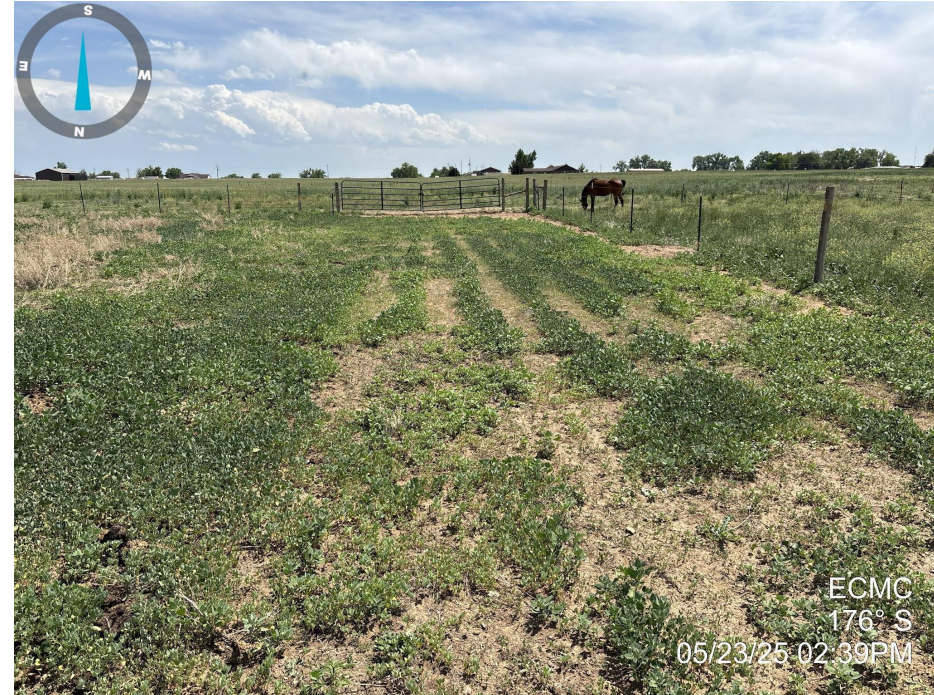
Photo 6. Photo taken from the access road, facing South away from the well location. See comments under Photo 5.

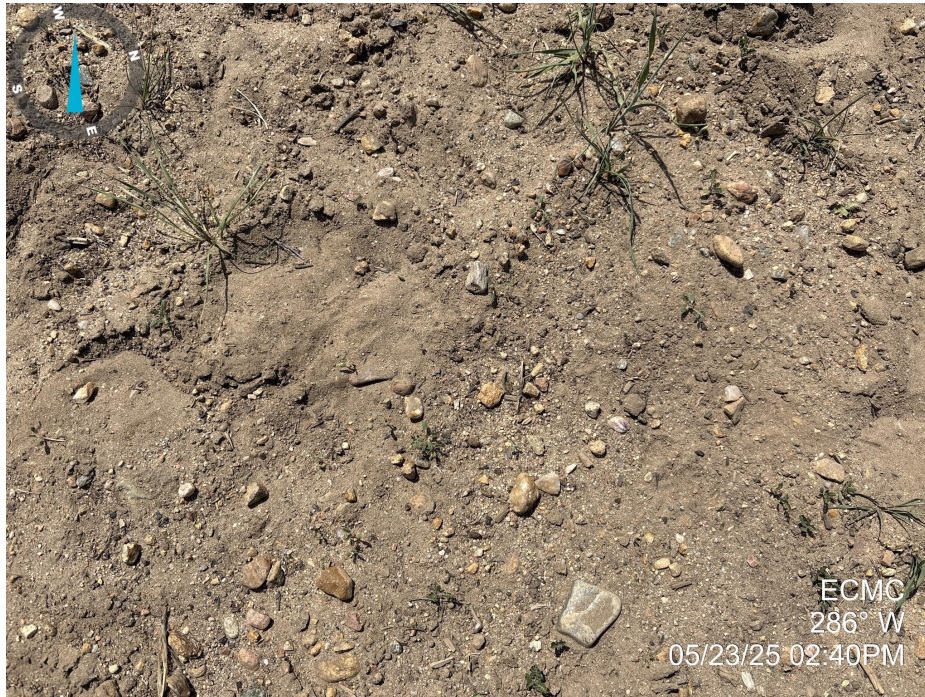
Photo 7. Photo taken of ground cover along the access road. Photo illustrates that bare ground and gravel remains at the access road.

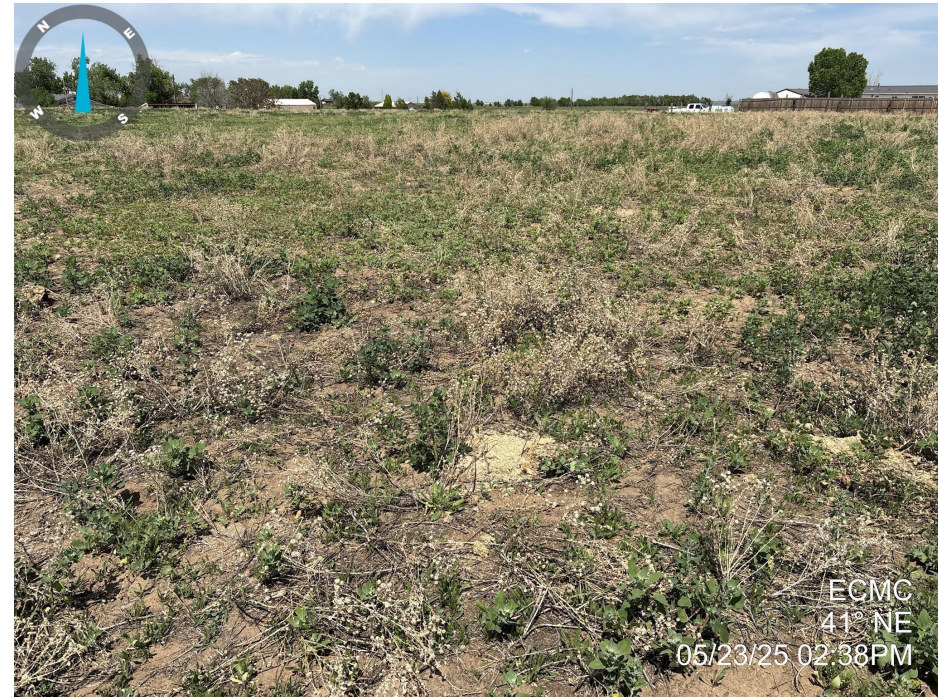
Photo 8. Photo taken of the reference area, south of the well location, facing Northeast. Photo illustrates weedy annual vegetation dominates the site.
