# Final Reclamation Inspection

Operator: NOBLE ENERGY INC - 100322

Location ID: 332835

Inspection Photos  
Location Name: CAMENISCH-SUPREME  
CAMP-64N66W/3SWNW  
Location ID: 332835

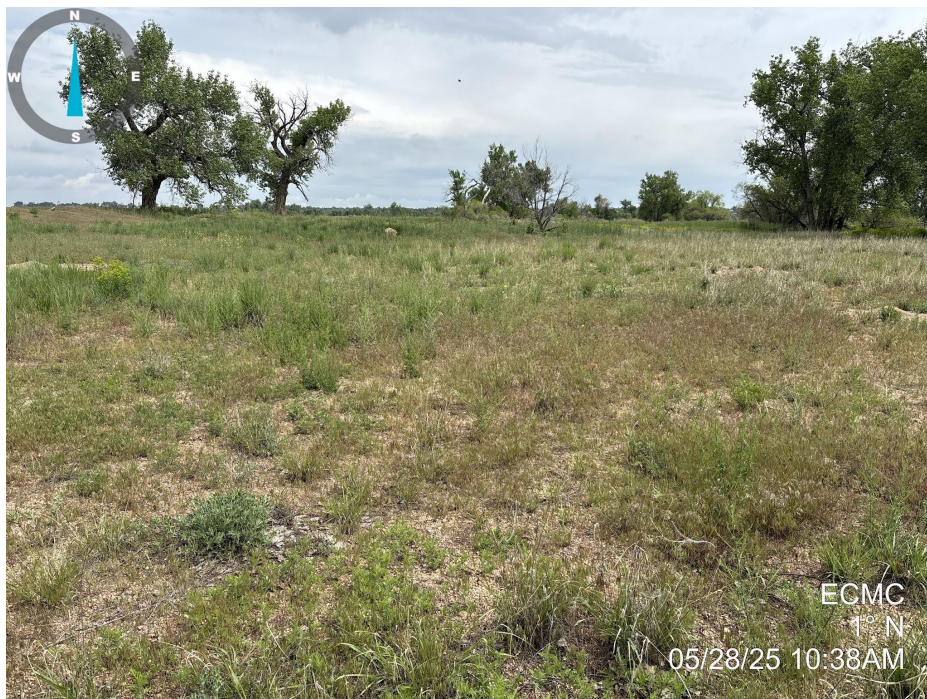
**Photo 1.** Photo taken from the multi-well location, from well API# 123-26201 (CAMENISCH-UPPR #6-3BX), facing North. Photo illustrates that final reclamation activities have taken place, but vegetation has not established to Rule 1004 standards and the site is dominated by weedy annual vegetation, including cheatgrass (*Bromus tectorum*), a List C Noxious Weed species.

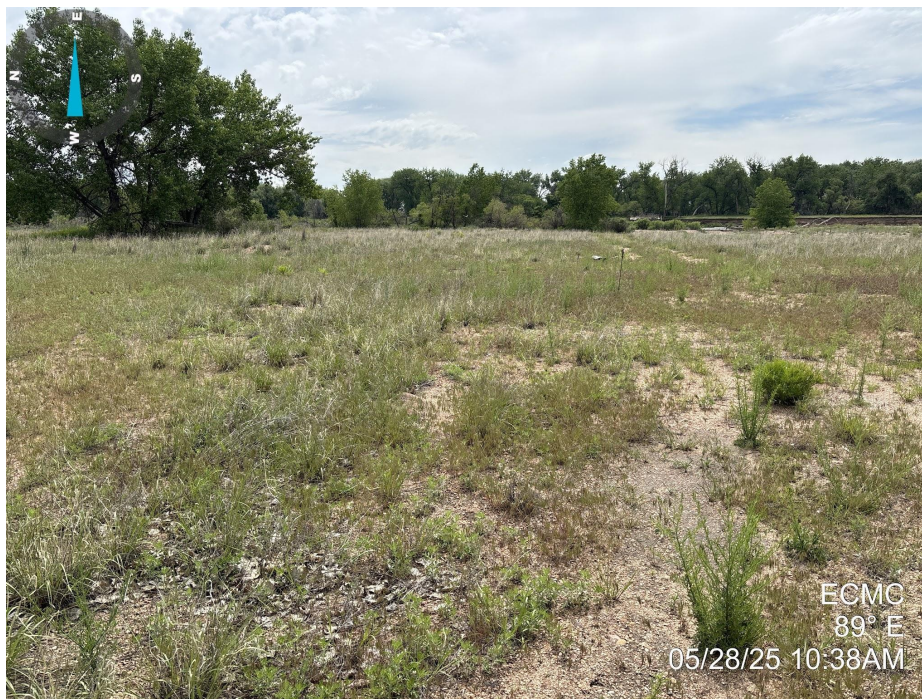
**Photo 2.** Photo taken from the multi-well location, from well API# 123-26201 (CAMENISCH-UPPR #6-3BX), facing East. See comments under Photo 1.

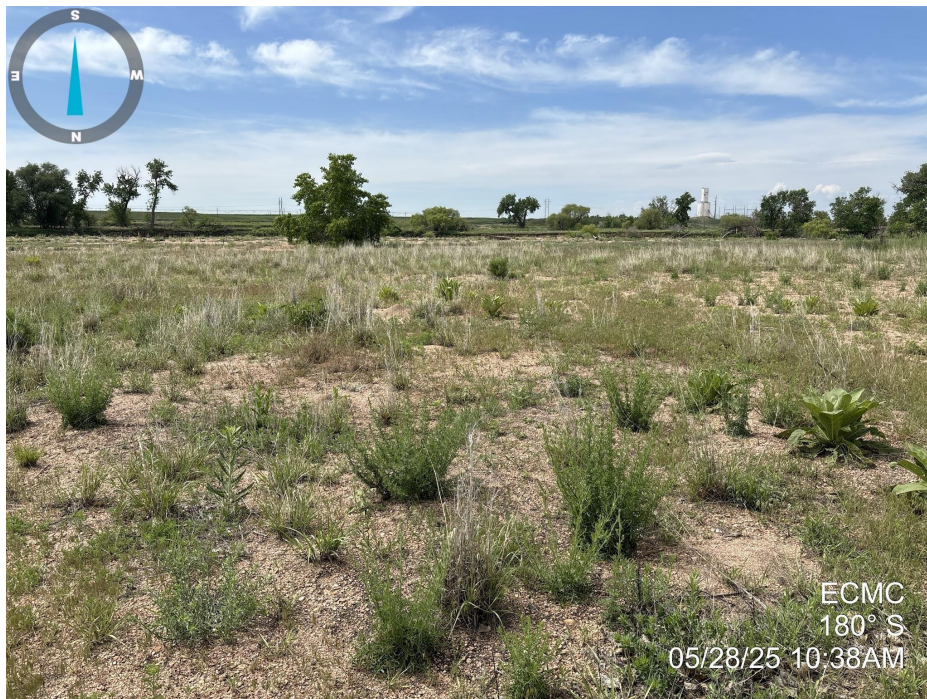
**Photo 3.** Photo taken from the multi-well location, from well API# 123-26201 (CAMENISCH-UPPR #6-3BX), facing South. See comments under Photo 1.

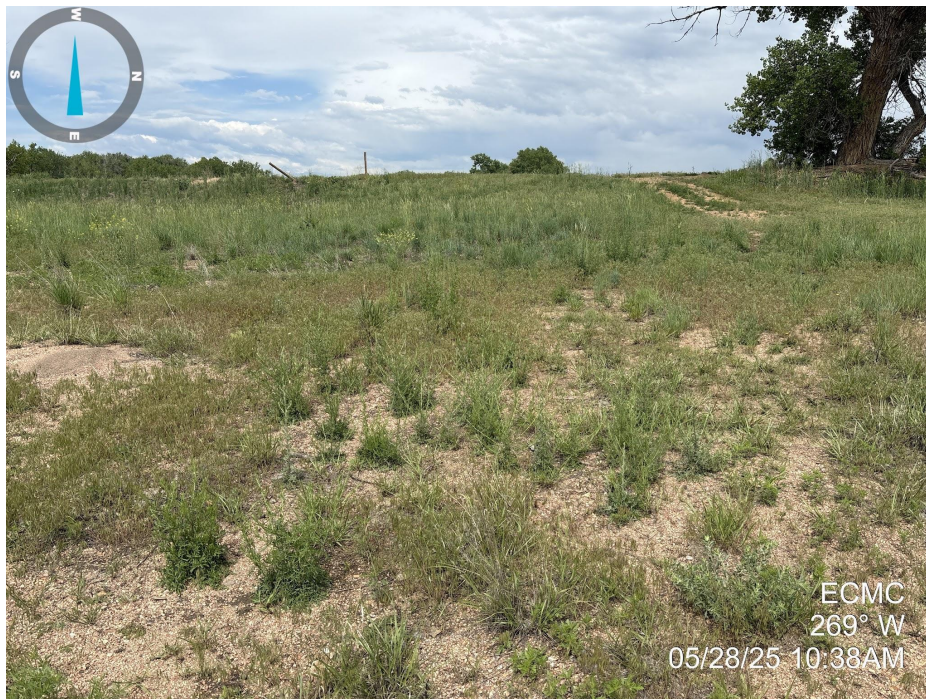
**Photo 4.** Photo taken from the multi-well location, from well API# 123-26201 (CAMENISCH-UPPR #6-3BX), facing West. See comments under Photo 1.

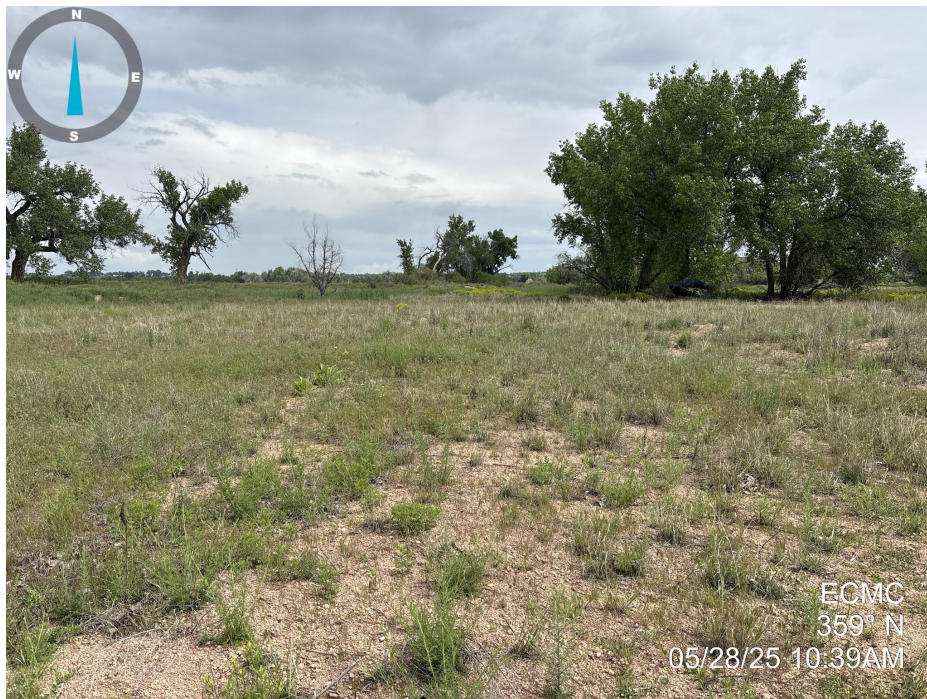
**Photo 5.** Photo taken from the multi-well location, from well API# 123-20231 (CAMENISCH-UPRR #6-3), facing North. See comments under Photo 1.

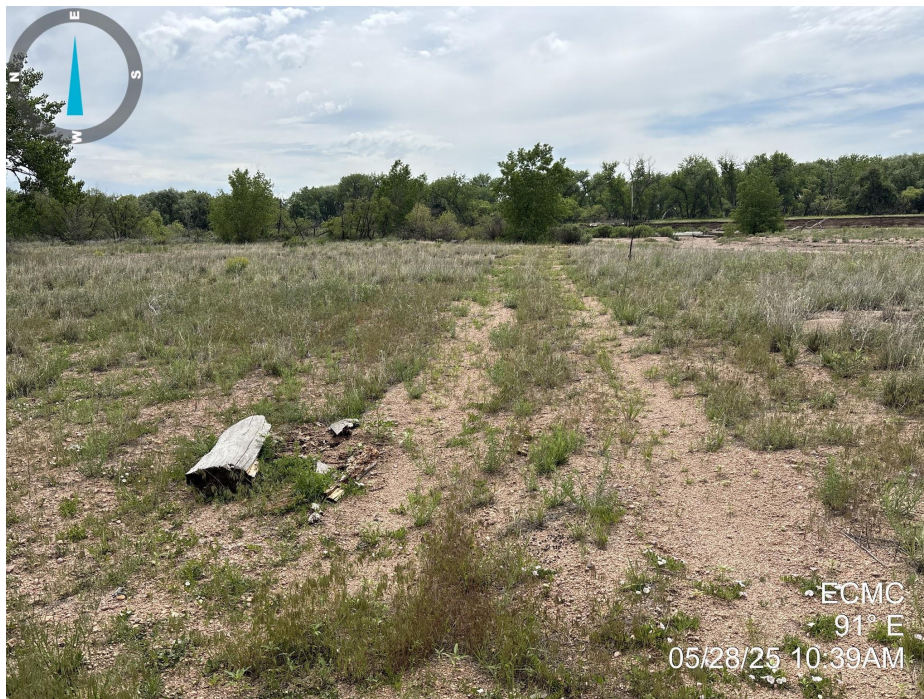
**Photo 6.** Photo taken from the multi-well location, from well API# 123-20231 (CAMENISCH-UPRR #6-3), facing East. See comments under Photo 1.

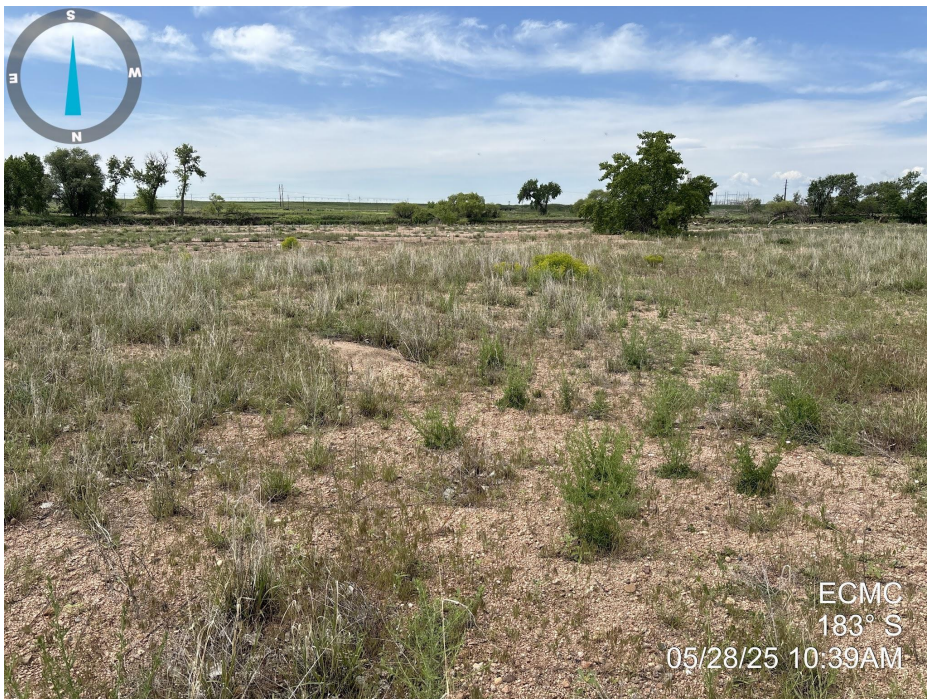
**Photo 7.** Photo taken from the multi-well location, from well API# 123-20231 (CAMENISCH-UPRR #6-3), facing South. See comments under Photo 1.

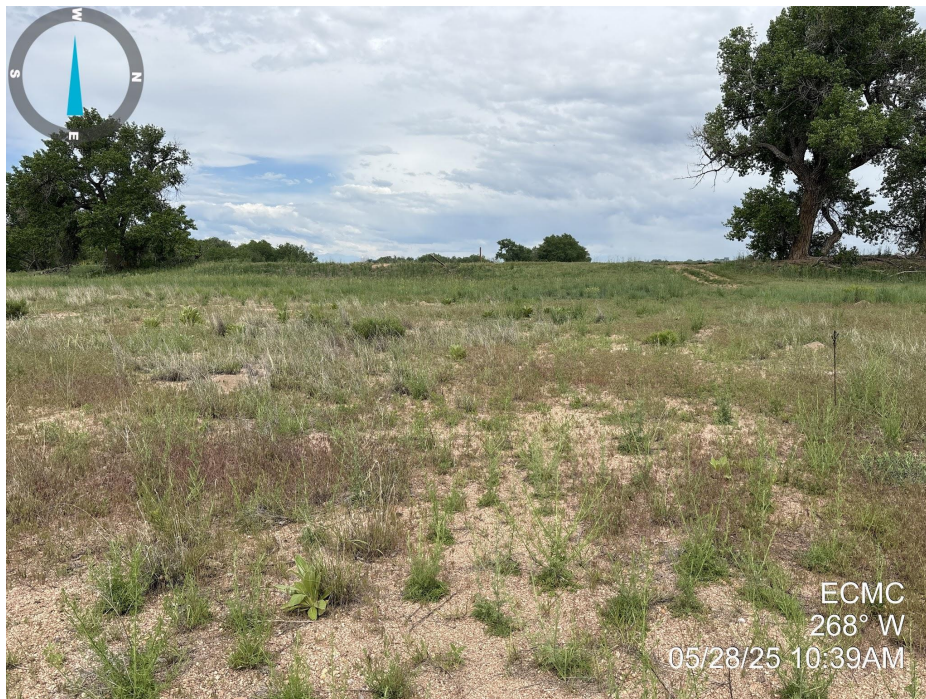
**Photo 8.** Photo taken from the multi-well location, from well API# 123-20231 (CAMENISCH-UPRR #6-3), facing West. See comments under Photo 1.

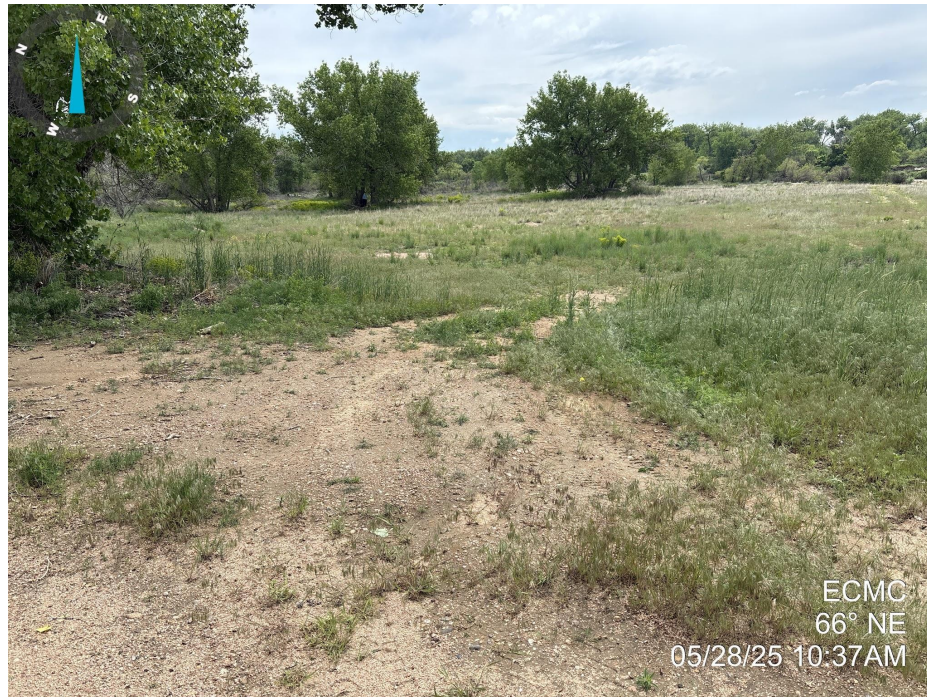
**Photo 9.** Photo taken of the access road to the multi-well location. Photo illustrates that vegetation establishment does not meet Rule 1004 standards.

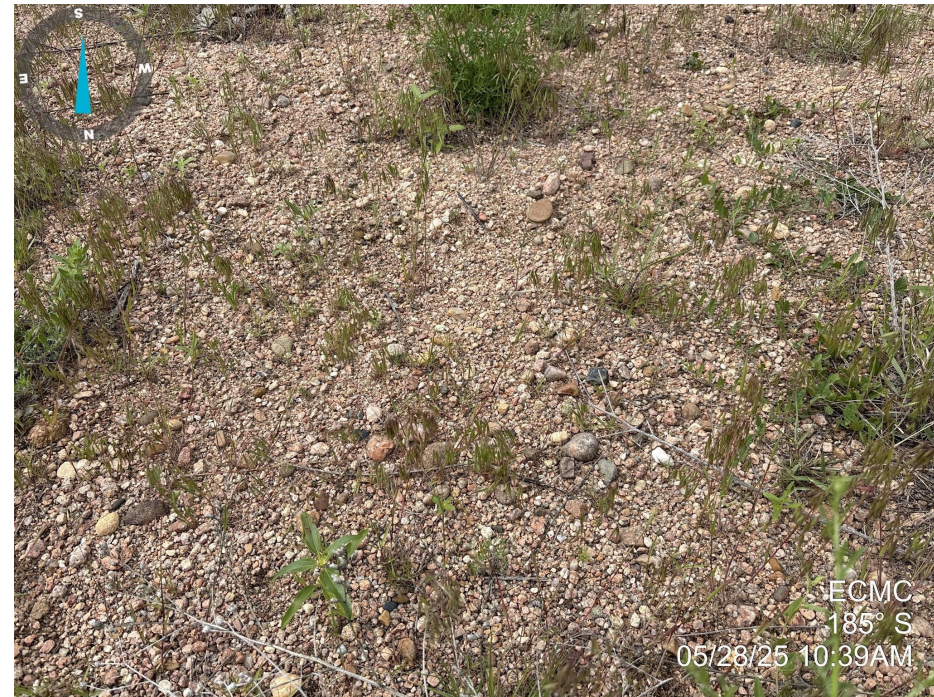
**Photo 10.** Photo taken of ground cover at the multi-well location. Photo illustrates that gravel and weedy annual vegetation was found at the location. However, gravel is found across the floodplain surrounding the location, see the reference photo, Photo #11.

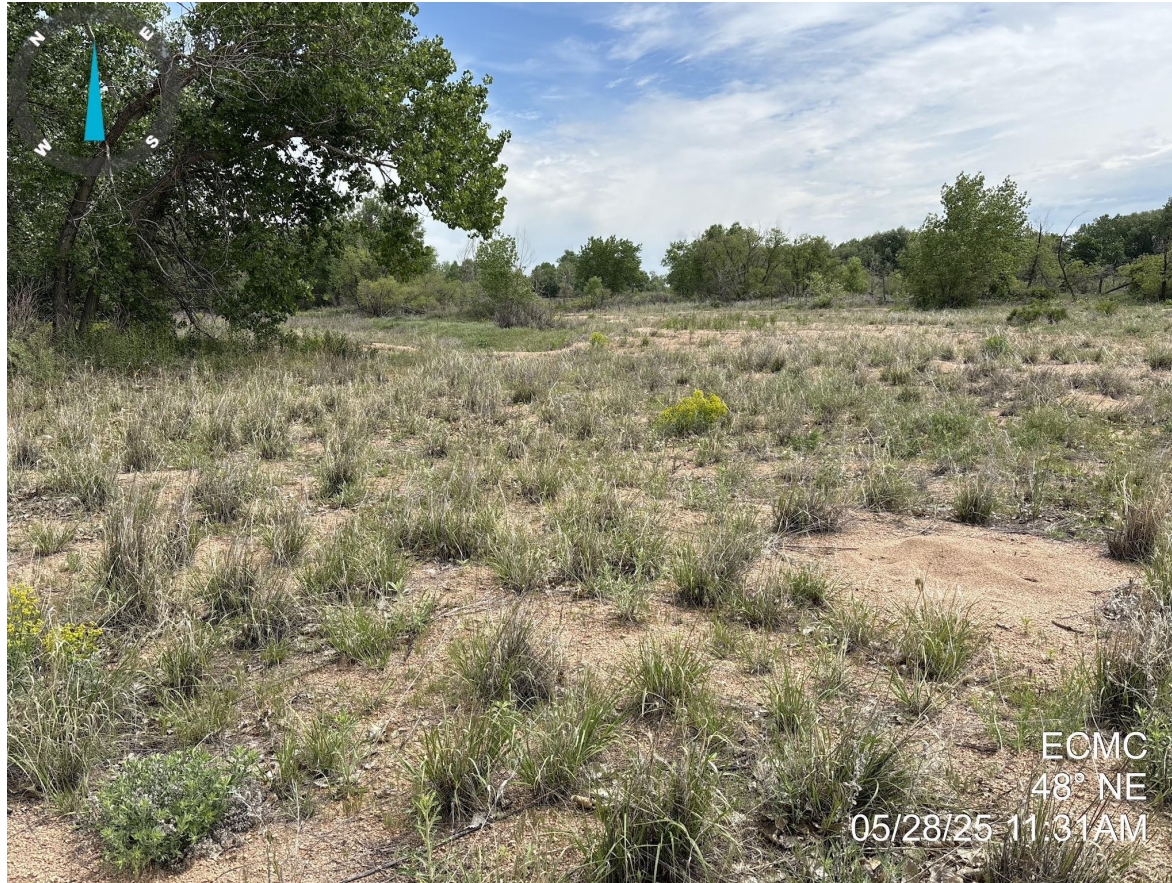
**Photo 11.** Photo taken of reference area, east of the location, facing Northeast.  
Photo illustrates grass vegetation and gravel across the location.
