Final Reclamation Inspection

Operator: NOBLE ENERGY INC - 100322

Location ID: 447436

Location Name: CAMENISCH CAMP 05-03B,
CAMENISCH UP RR
Location ID: 447436

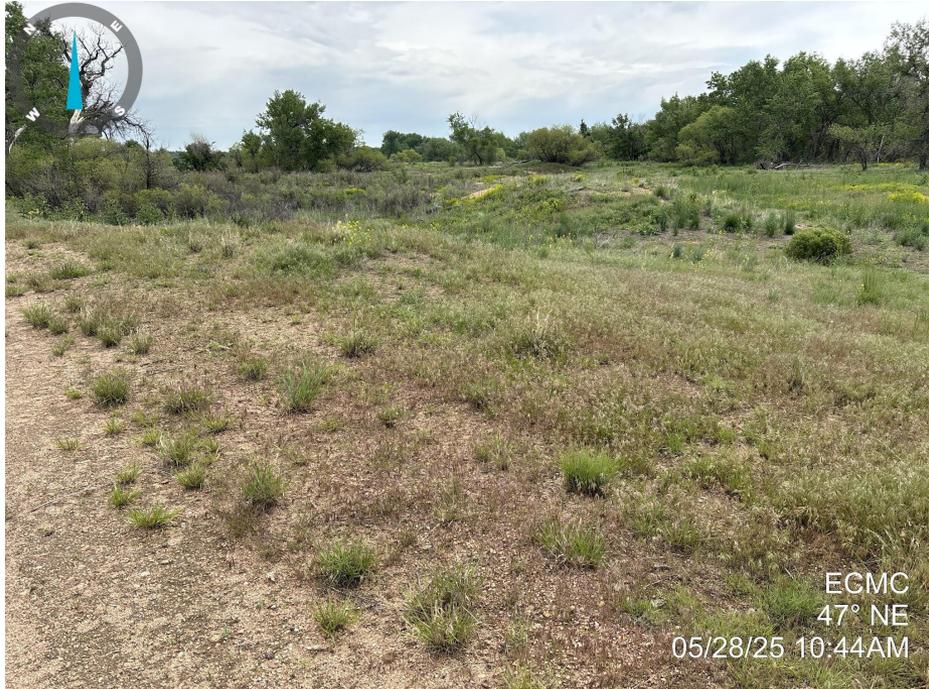
Photo 1. Photo taken of the northern portion of the tank battery location, facing Northeast. Photo illustrates that final reclamation activities appear to have taken place, but gravel remains and vegetation has not established to Rule 1004 standards. Weedy annual vegetation including cheatgrass (*Bromus tectorum*) was observed across the location.

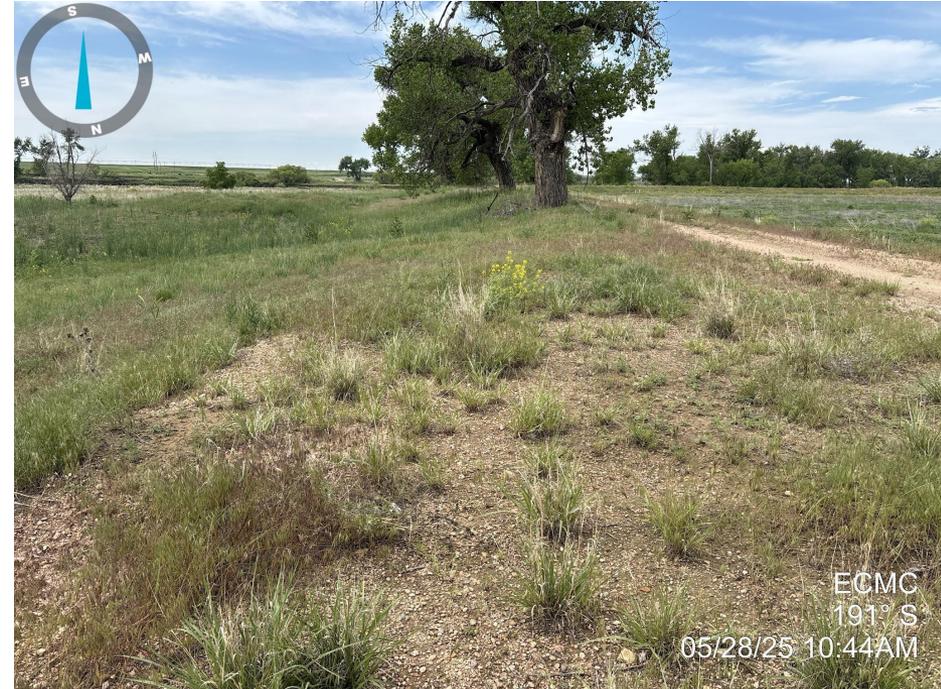
Photo 2. Photo taken from the northern portion of the tank battery location, facing South. See comments under Photo 1.

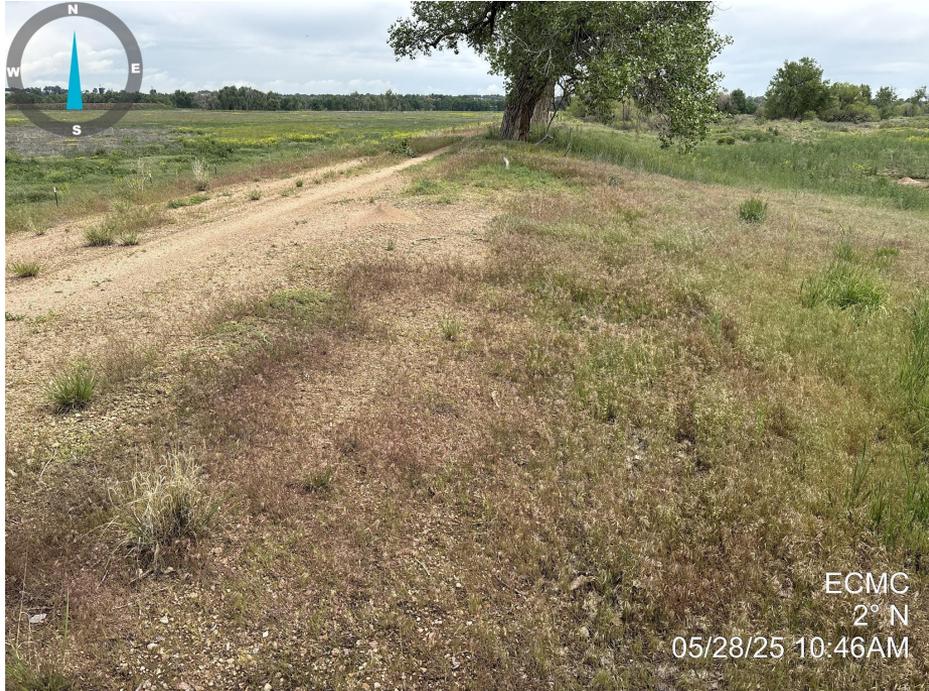
Photo 3. Photo taken from the southern portion of the tank battery location, facing North. See comments under Photo 1.

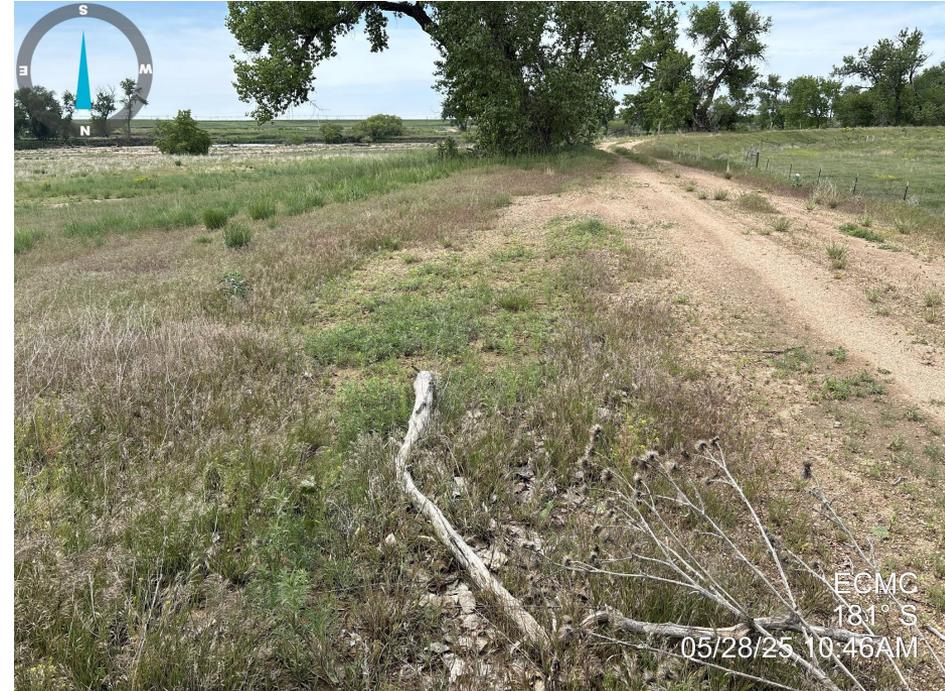
Photo 4. Photo taken from the southern portion of the tank battery location, facing South. See comments under Photo 1.

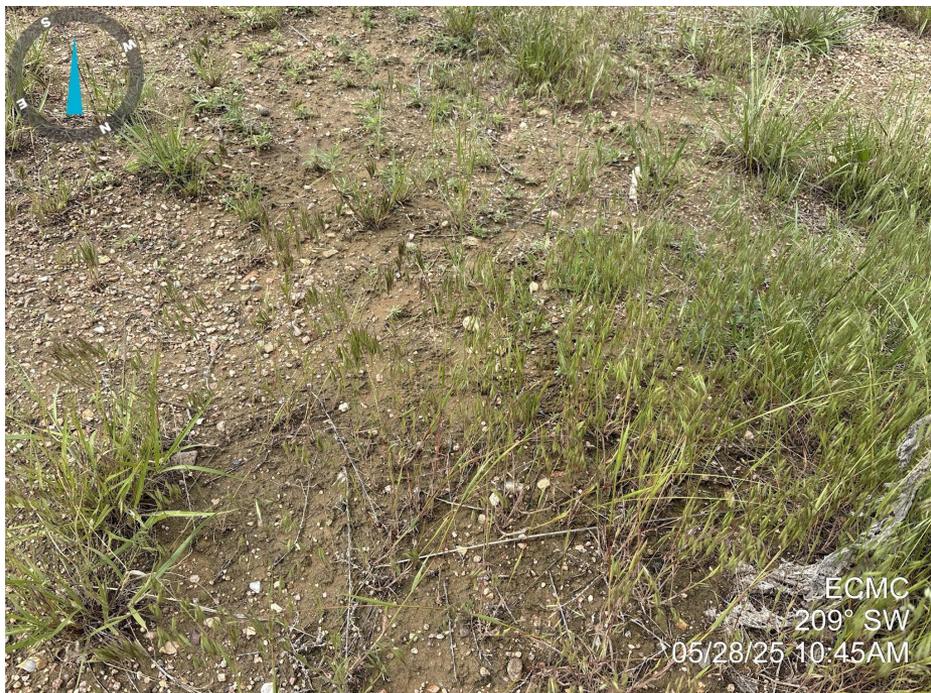
Photo 5. Photo taken of ground cover at the tank battery location. Photo illustrates that gravel remains and cheatgrass (*Bromus tectorum*), a List C Noxious Weed, was observed across the location.

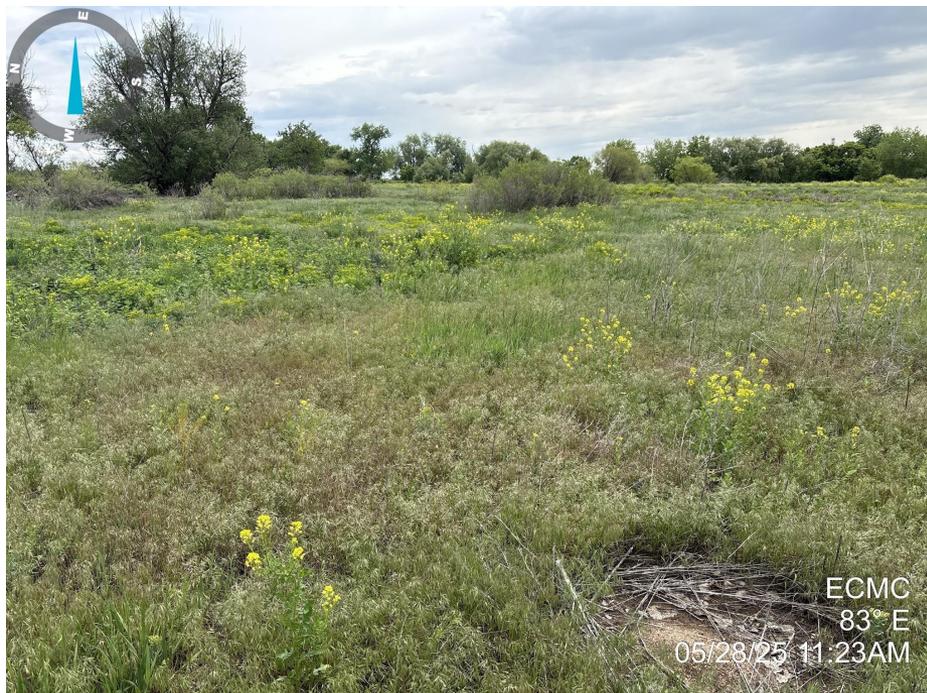
Photo 6. Photo taken of the reference area, north of the tank battery location, facing East. Photo illustrates that weedy annual vegetation is present at the reference location.
