Final Reclamation Inspection

Operator: NOBLE ENERGY INC - 100322

Location ID: 332848

Inspection Document #: 718800404

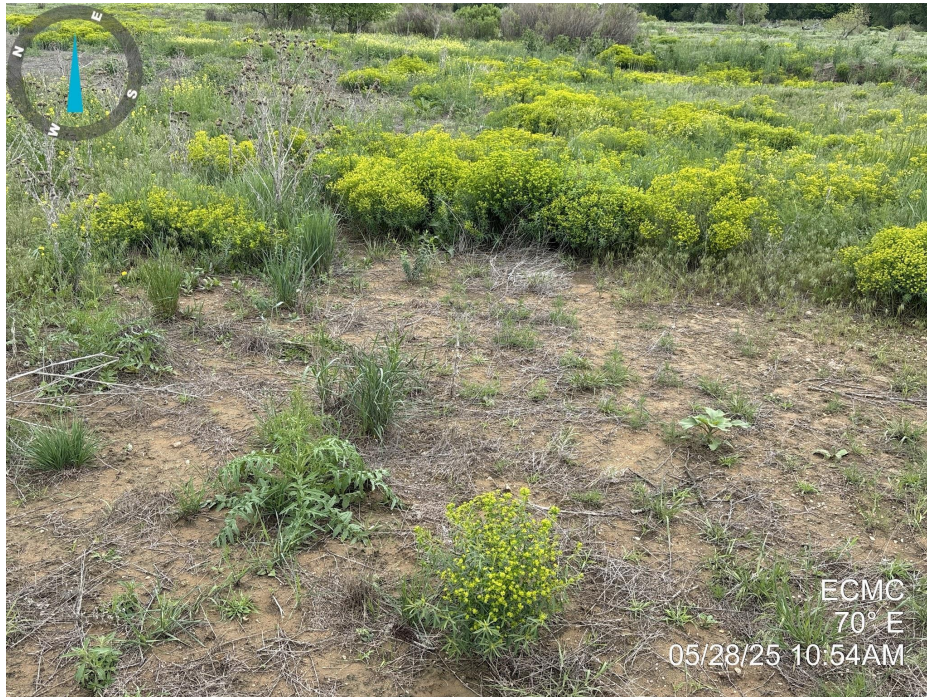
Photo 1. Photo taken from the multi-well location, from well API# 123-10950 (CAMENISCH-UPRR #1-3), facing North. Photo illustrates that final reclamation activities have taken place, but gravel remains, vegetation has not established to Rule 1004 standards and the site is dominated by weedy annual vegetation. List B and C Noxious Weed Species were observed across the location, including leafy spurge (*Euphorbia esula*) and cheatgrass (*Bromus tectorum*).

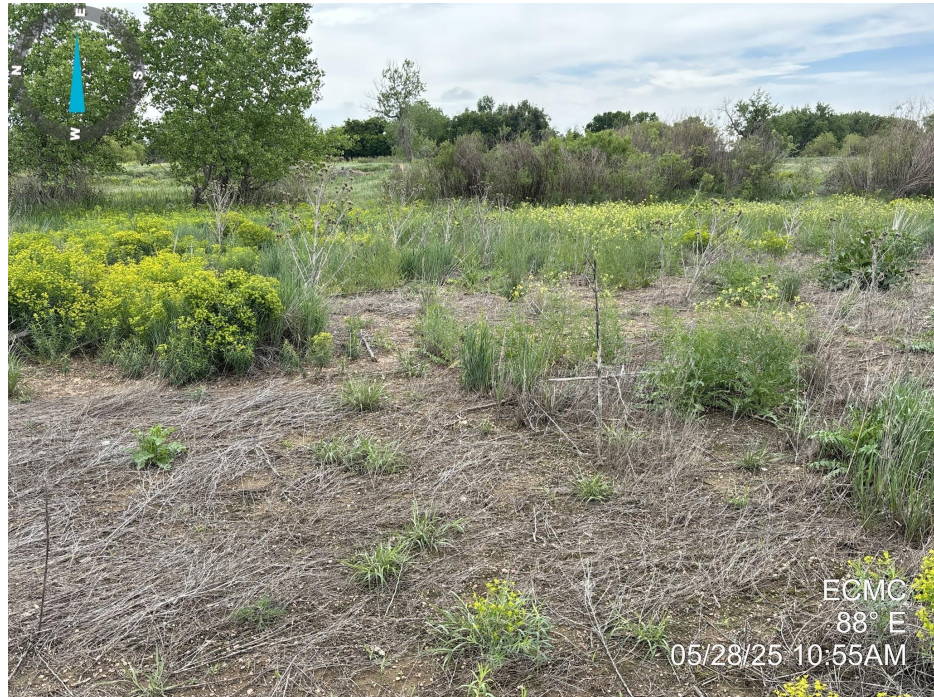
Photo 2. Photo taken from the multi-well location, from well API# 123-10950 (CAMENISCH-UPRR #1-3), facing East. See comments under Photo 1.

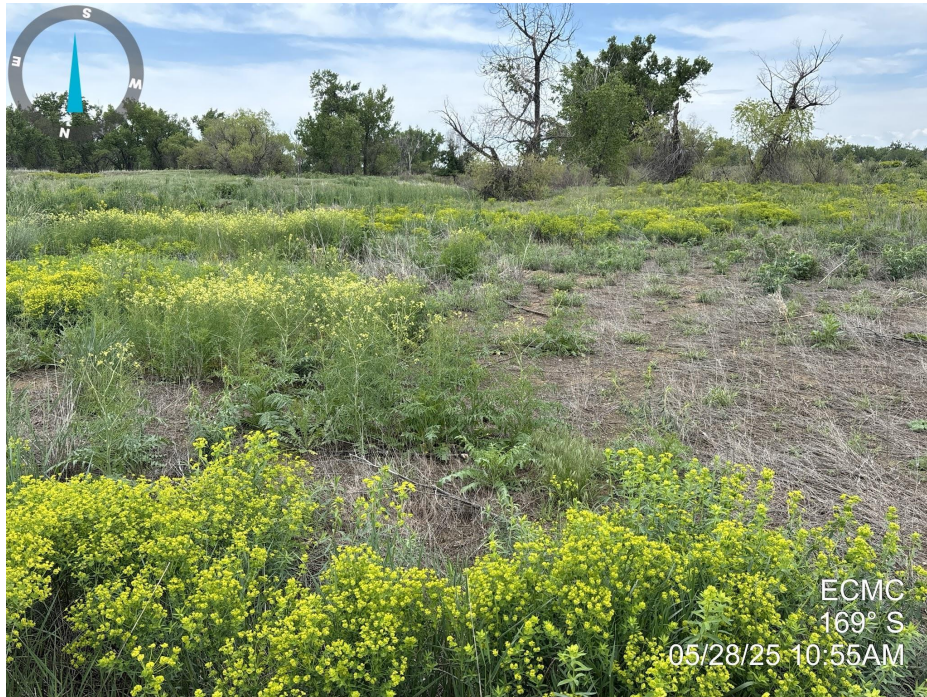
Photo 3. Photo taken from the multi-well location, from well API# 123-10950 (CAMENISCH-UPRR #1-3), facing South. See comments under Photo 1.

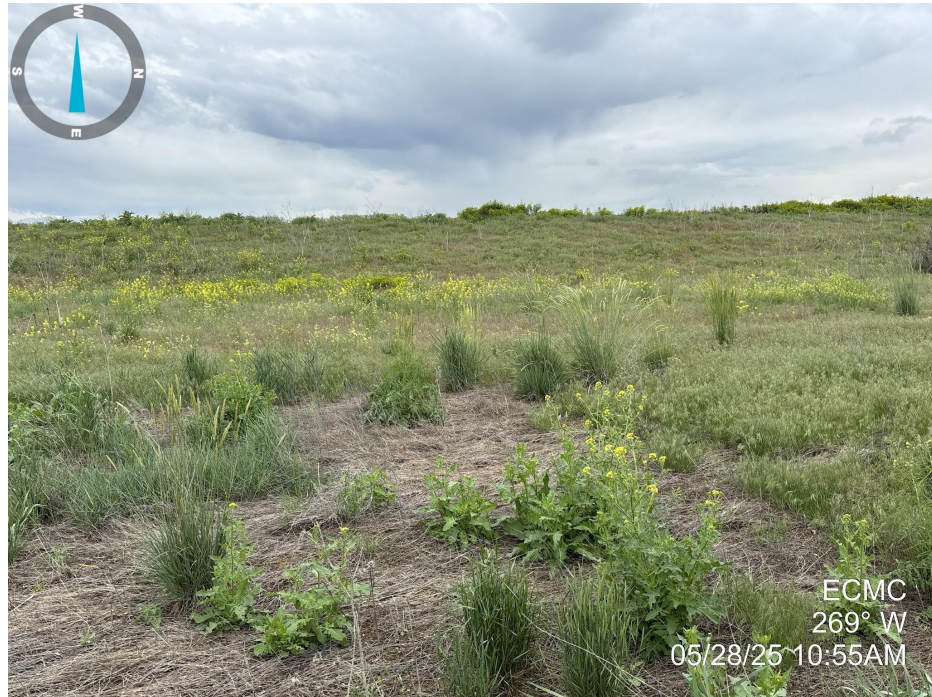
Photo 4. Photo taken from the multi-well location, from well API# 123-10950 (CAMENISCH-UPRR #1-3), facing West. See comments under Photo 1.

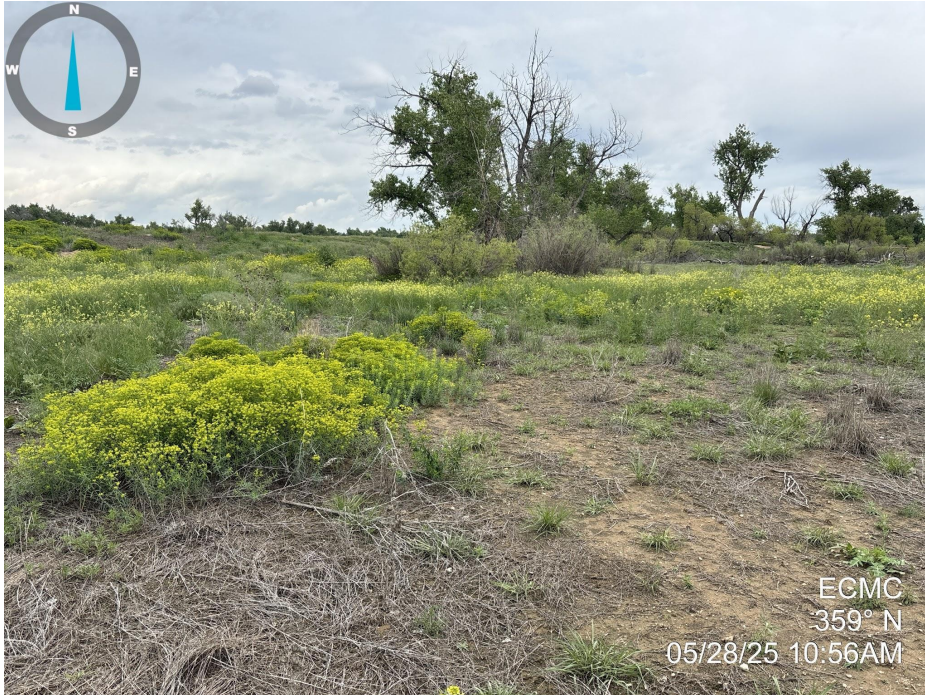
Photo 5. Photo taken from the multi-well location, from well API# 123-26460 (CAMENISCH-UPRR #1-3B), facing North. See comments under Photo 1.

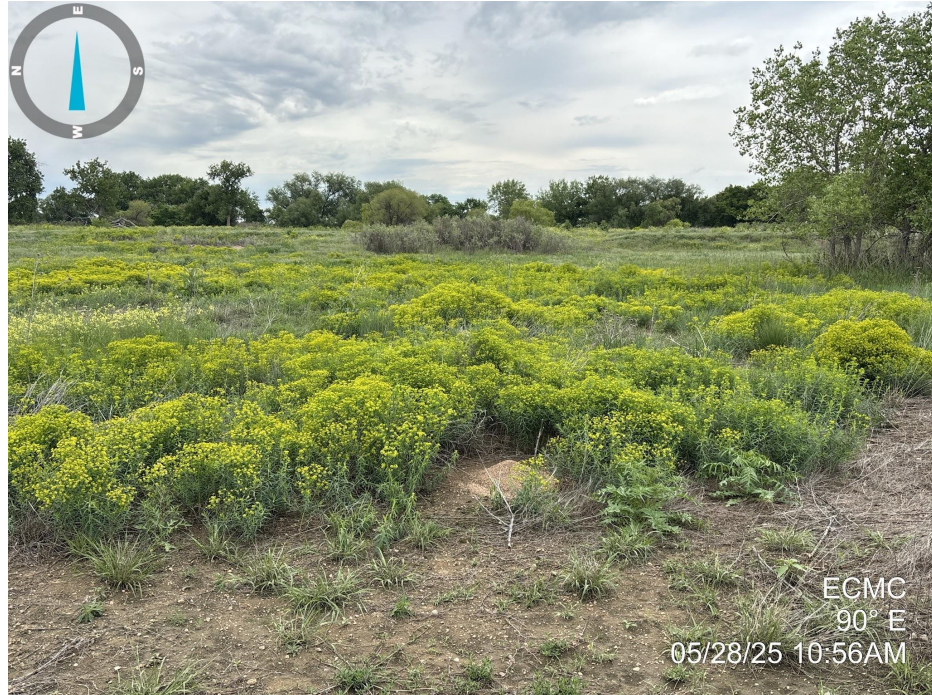
Photo 6. Photo taken from the multi-well location, from well API# 123-26460 (CAMENISCH-UPRR #1-3B), facing East. See comments under Photo 1.

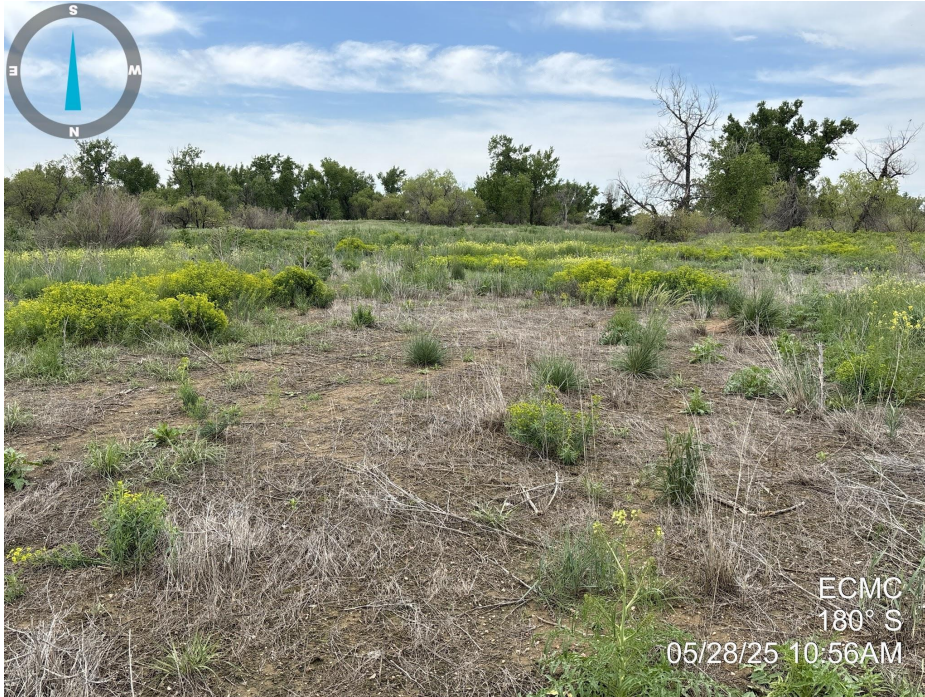
Photo 7. Photo taken from the multi-well location, from well API# 123-26460 (CAMENISCH-UPRR #1-3B), facing South. See comments under Photo 1.

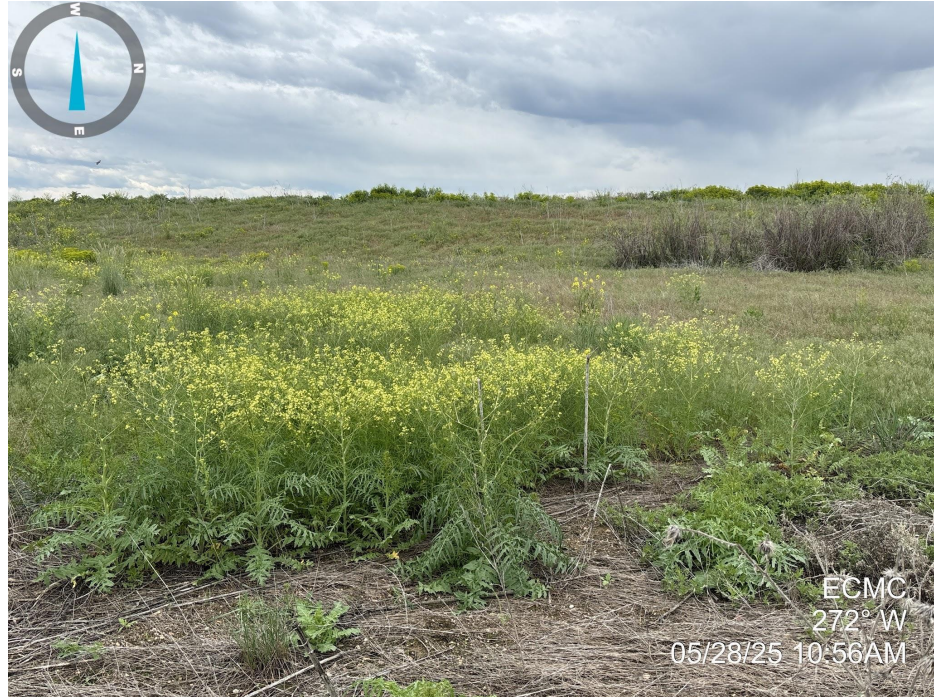
Photo 8. Photo taken from the multi-well location, from well API# 123-26460 (CAMENISCH-UPRR #1-3B), facing West. See comments under Photo 1.

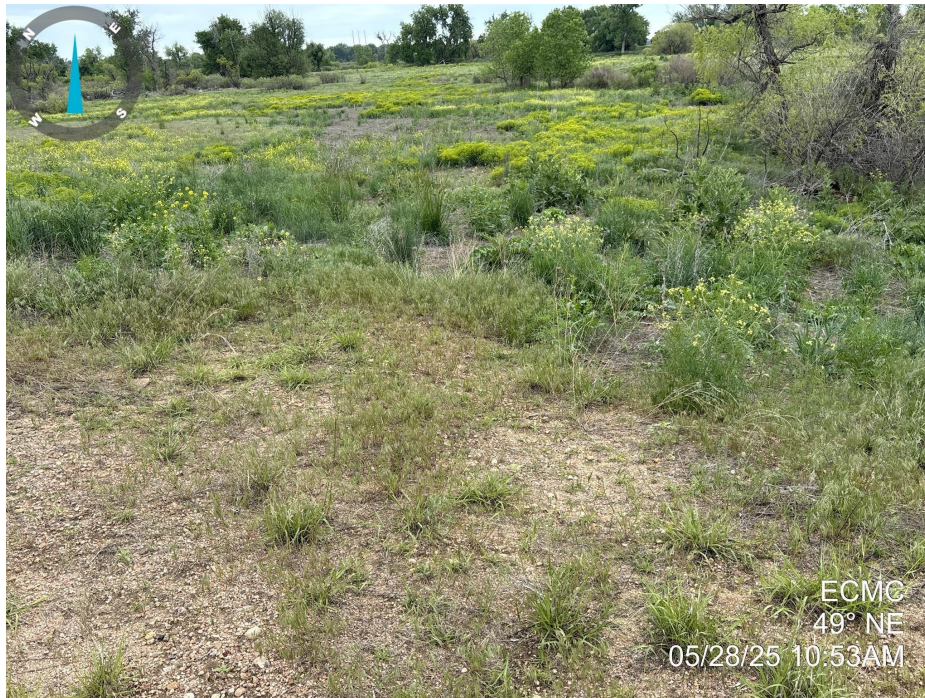
Photo 9. Photo taken of the access road to the multi-well location. Photo illustrates that vegetation establishment does not meet Rule 1004 standards and gravel remains across the access road.

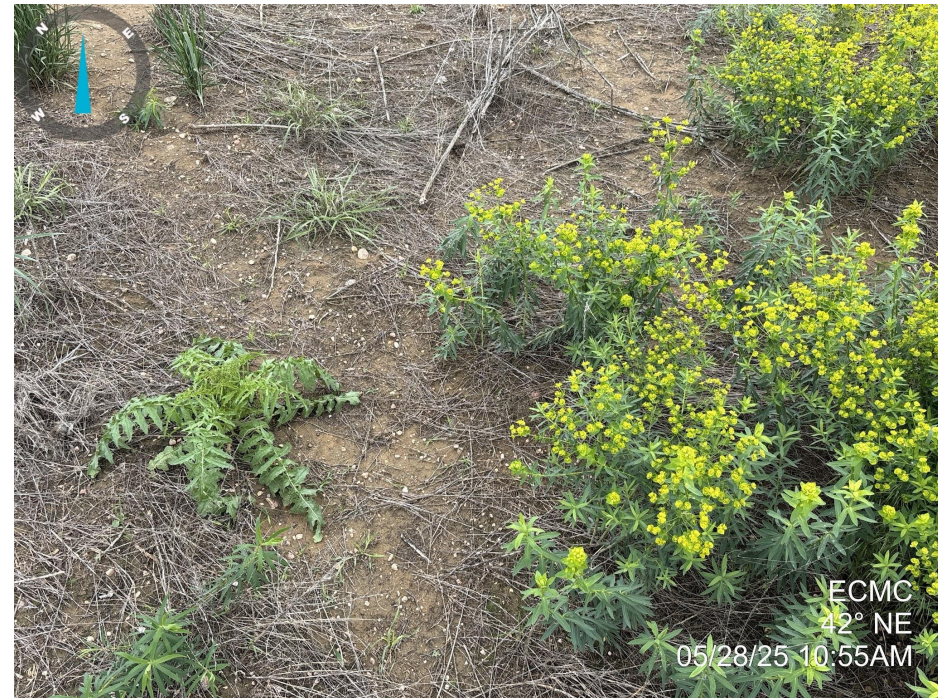
Photo 10. Photo taken of ground cover at the multi-well location. Photo illustrates that gravel and weedy annual vegetation was found at the location, including List B & C Noxious Weeds species leafy spurge (*Euphorbia esula*) and cheatgrass (*Bromus tectorum*).

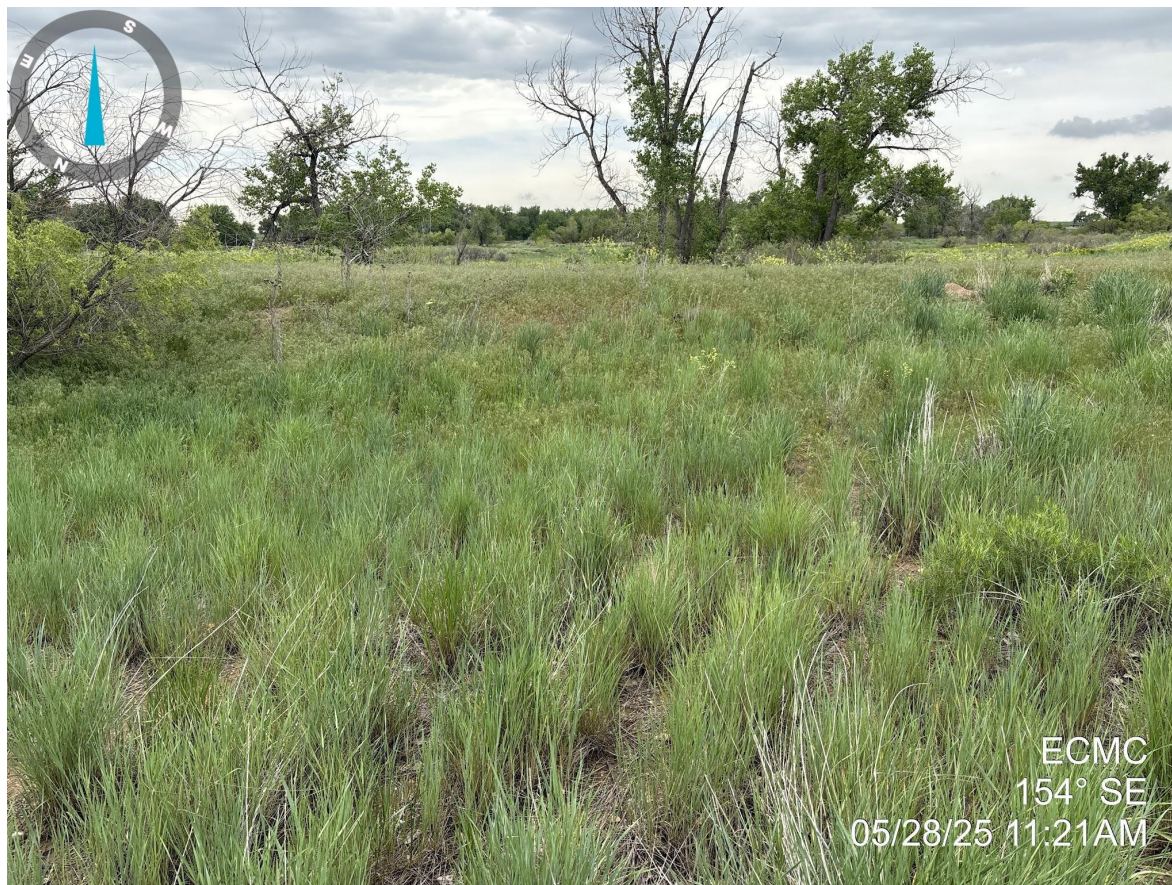
Photo 11. Photo taken of reference area, north of the location, facing Southeast.
Photo illustrates perennial grass vegetation.
