Final Reclamation Inspection

Operator: NOBLE ENERGY INC - 100322

Location ID: 447324

Location Name: CAMENISCH UPRR 01-03, 01-03B

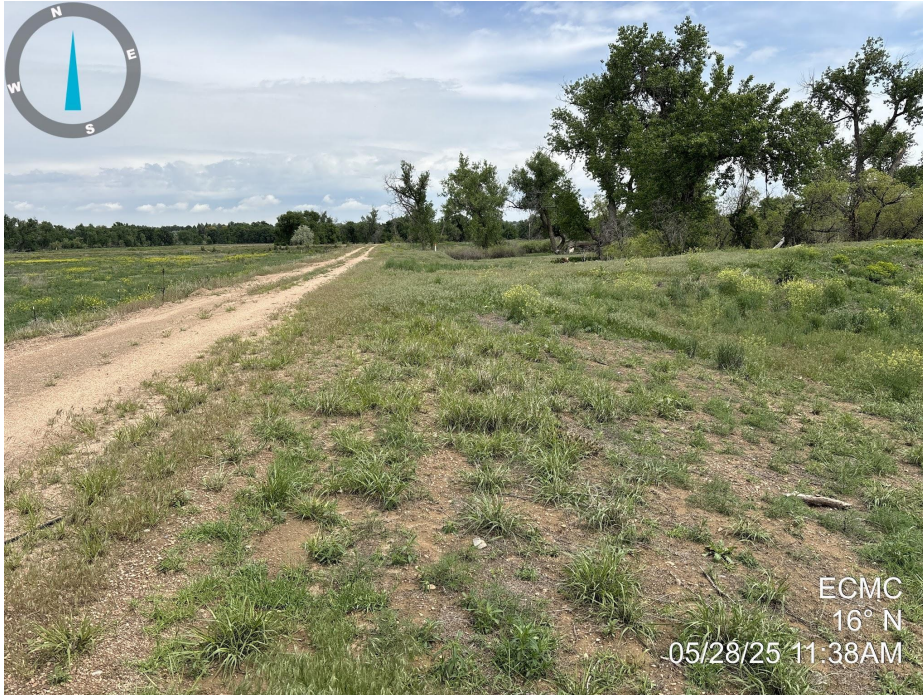
Photo 1. Photo taken of the southern portion of the tank battery location, facing North. Photo illustrates that final reclamation activities appear to have taken place, but gravel remains and vegetation has not established to Rule 1004 standards. Weedy annual vegetation including cheatgrass (*Bromus tectorum*) was observed across the location.

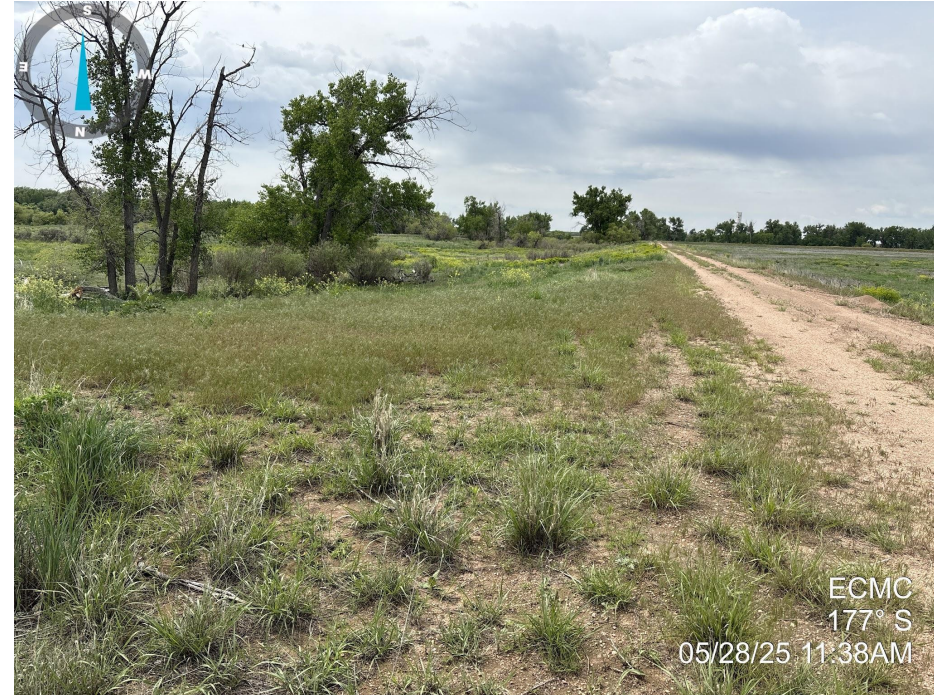
Photo 2. Photo taken from the southern portion of the tank battery location, facing South. See comments under Photo 1.

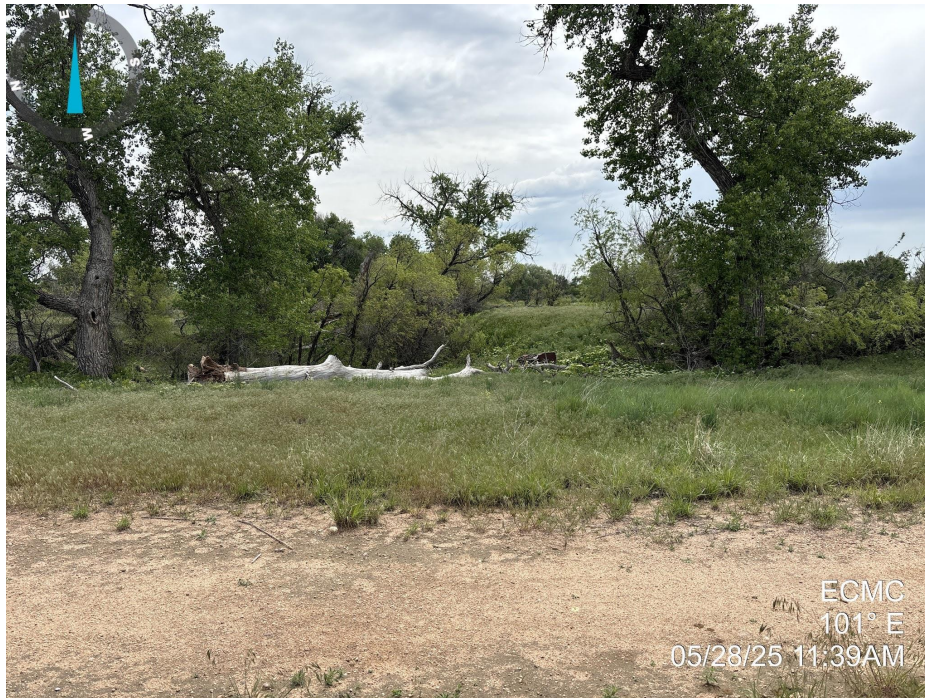
Photo 3. Photo taken of the northern portion of the tank battery location, from the access road, facing East. See comments under Photo 1.

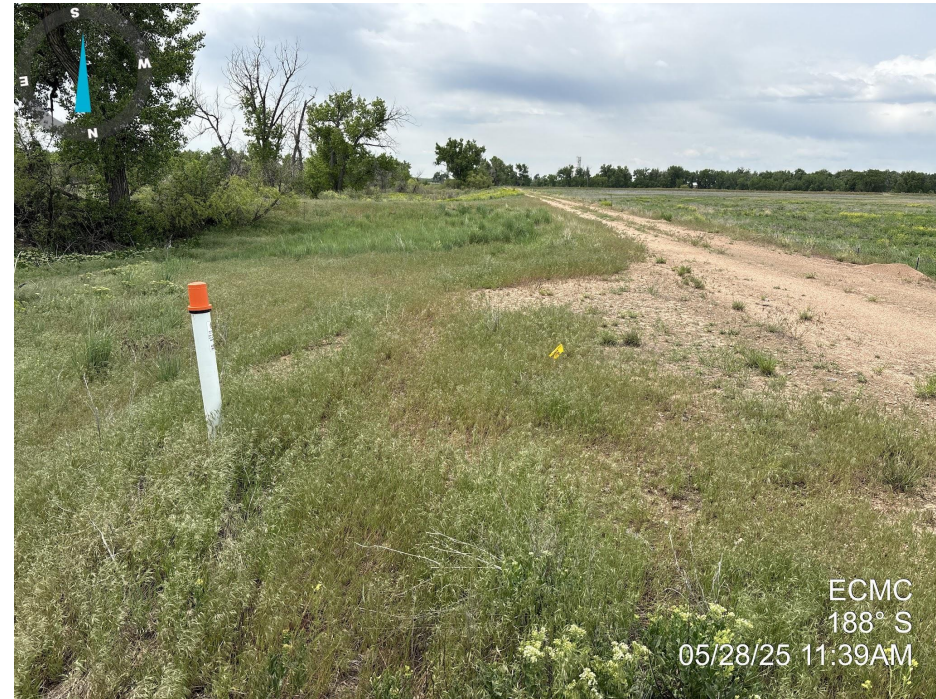
Photo 4. Photo taken from the northern portion of the tank battery location, facing South. Photo illustrates that midstream equipment remains on the location.

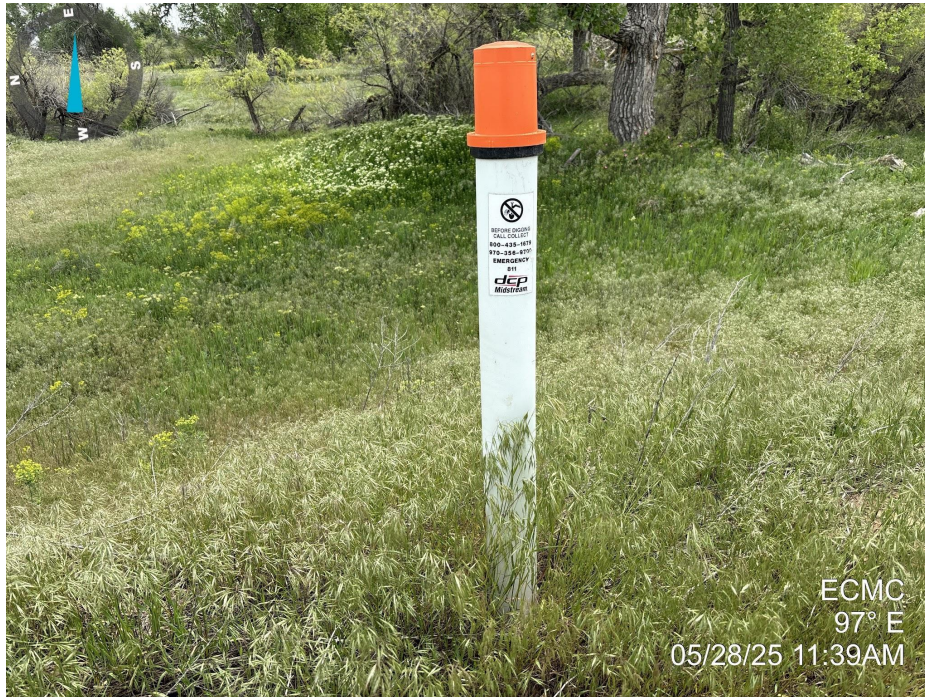
Photo 5. Photo taken of midstream equipment at the tank battery location.

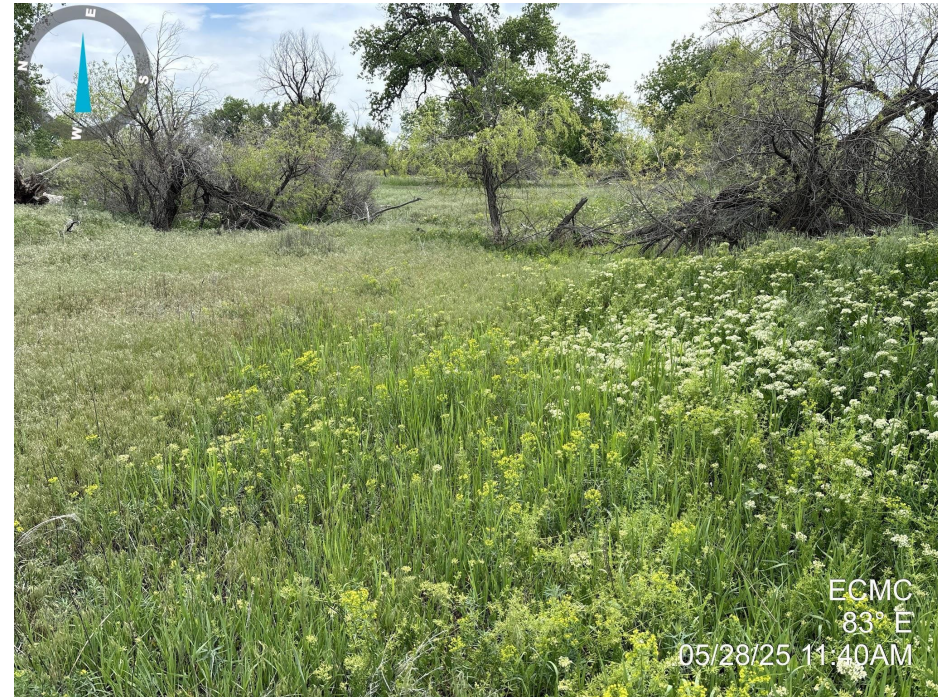
Photo 6. Photo taken of the reference area, east of the tank battery location, facing East. Photo illustrates that weedy annual vegetation is present at the reference location.
