Final Reclamation Inspection

Operator: NOBLE ENERGY INC - 100322

Location ID: 329883

Inspection Photos
Location Name: RUMSEY #3-1216
Location ID: 329883

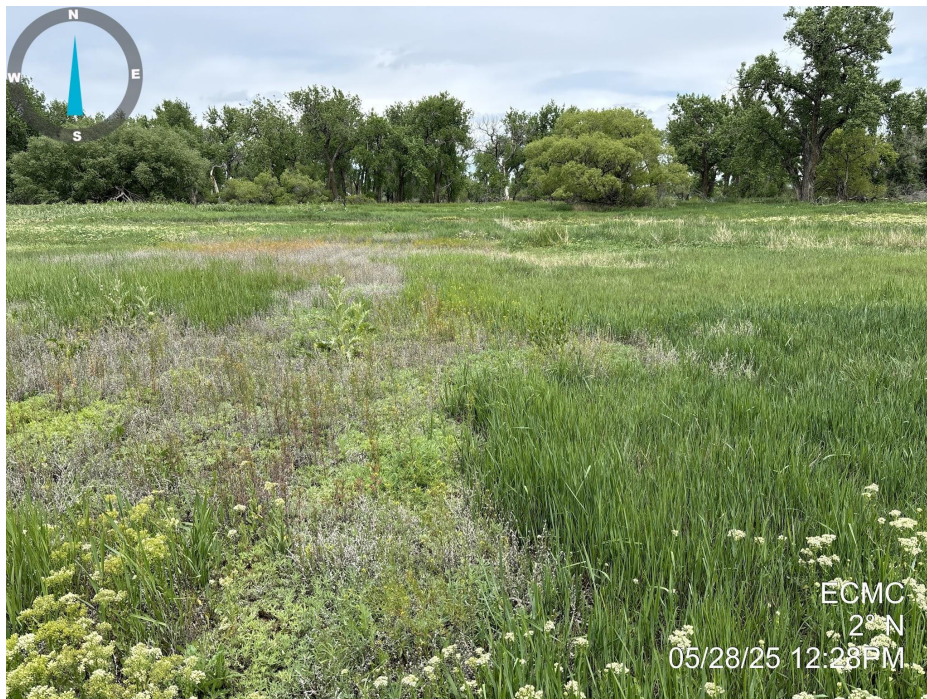
Photo 1. Photo taken from the well location, facing North. Photo illustrates that final reclamation activities have taken place, however the location does not meet Rule 1004 standards as the site is dominated by weedy annual vegetation including kochia (*Kochia scoparia*).

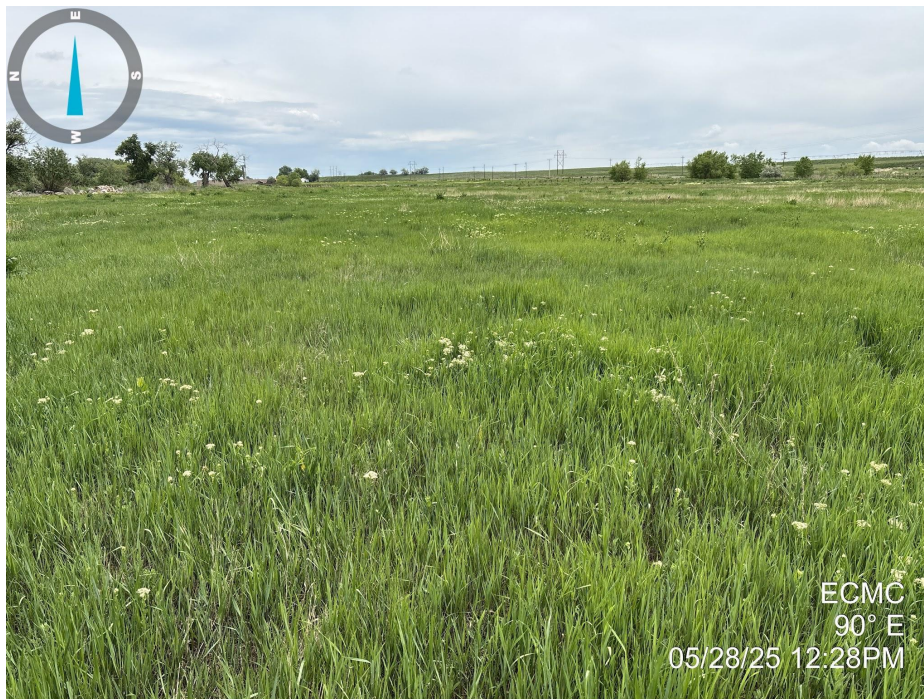
Photo 2. Photo taken from the well location, facing East. See comments under Photo 1.

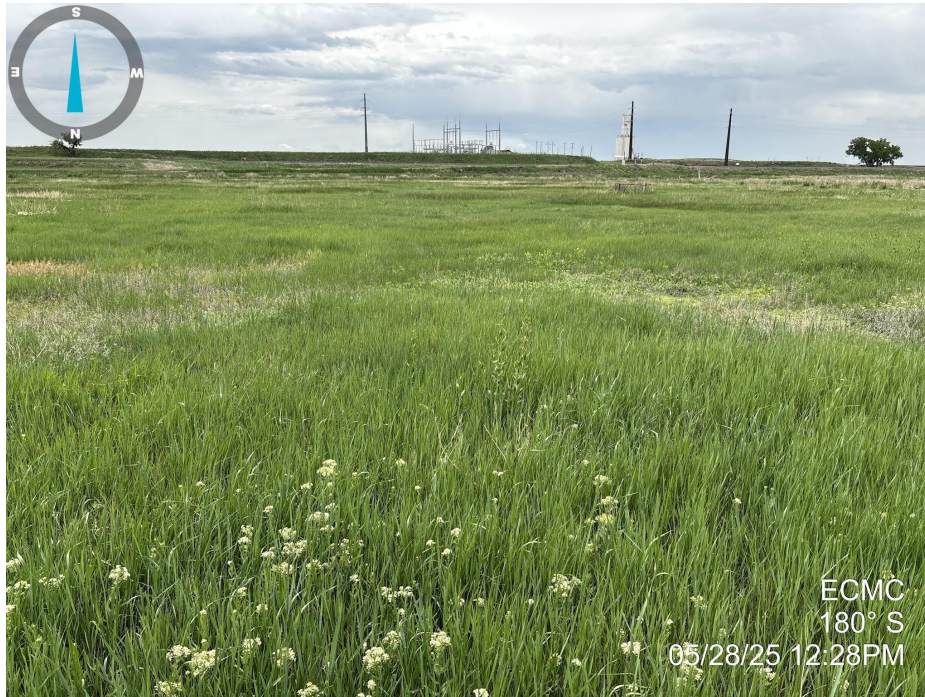
Photo 3. Photo taken from the well location, facing South. See comments under Photo 1.

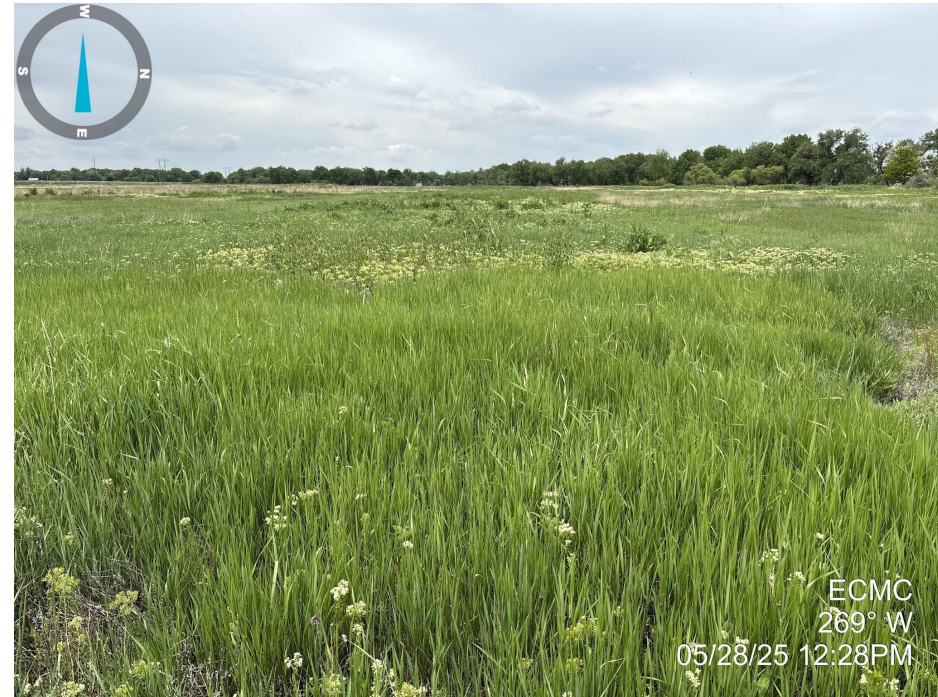
Photo 4. Photo taken from the well location, facing West. See comments under Photo 1.

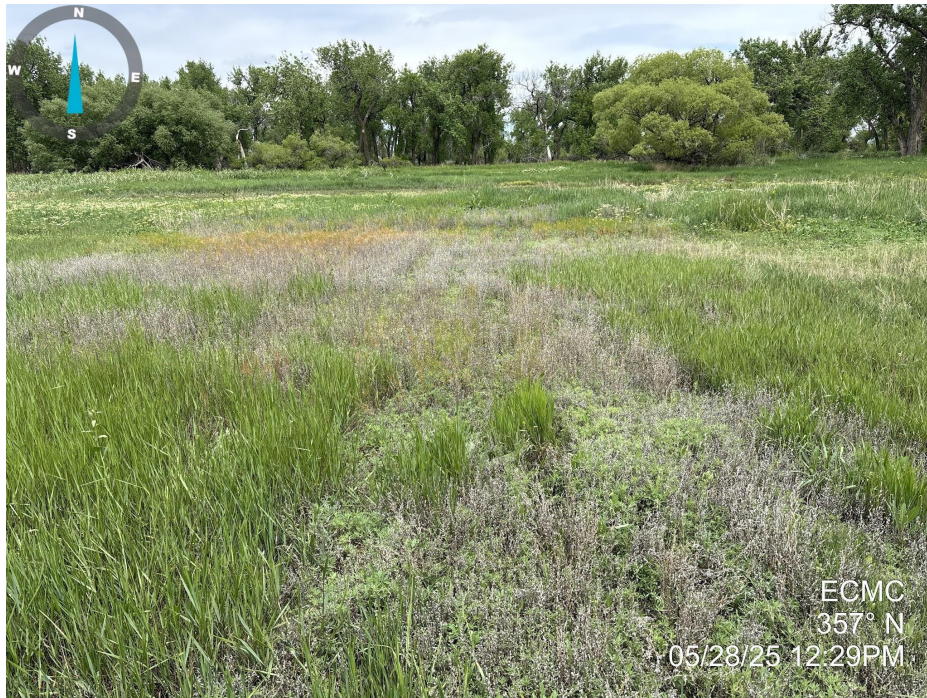
Photo 5. Photo taken of the access road, facing North away from the well location. Photo illustrates that weedy annual vegetation is present throughout the well location and access road.

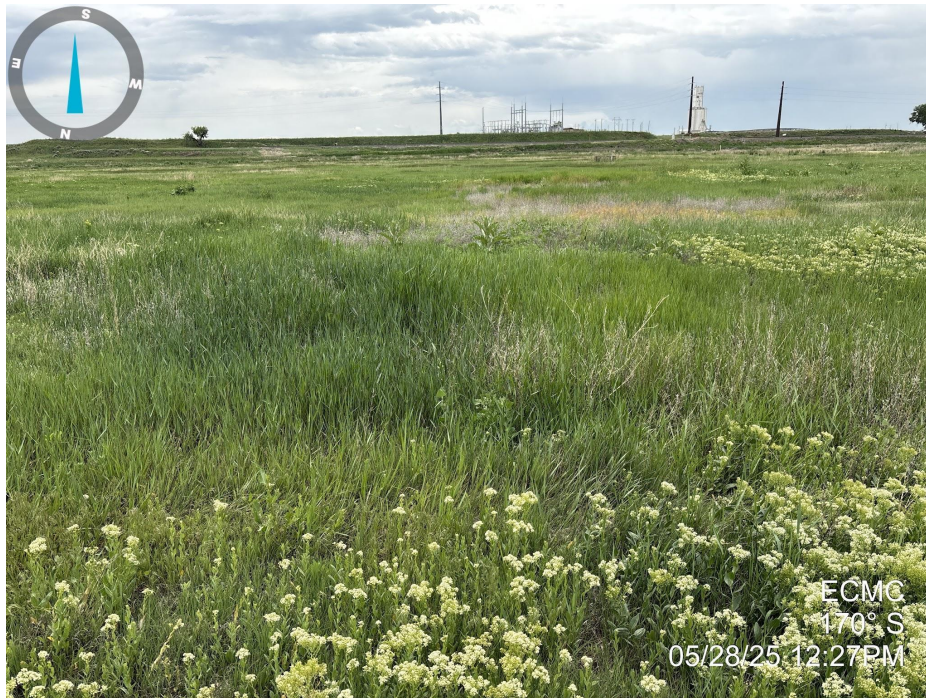
Photo 6. Photo taken of the access road, facing South towards the well location. See comments under Photo 5.

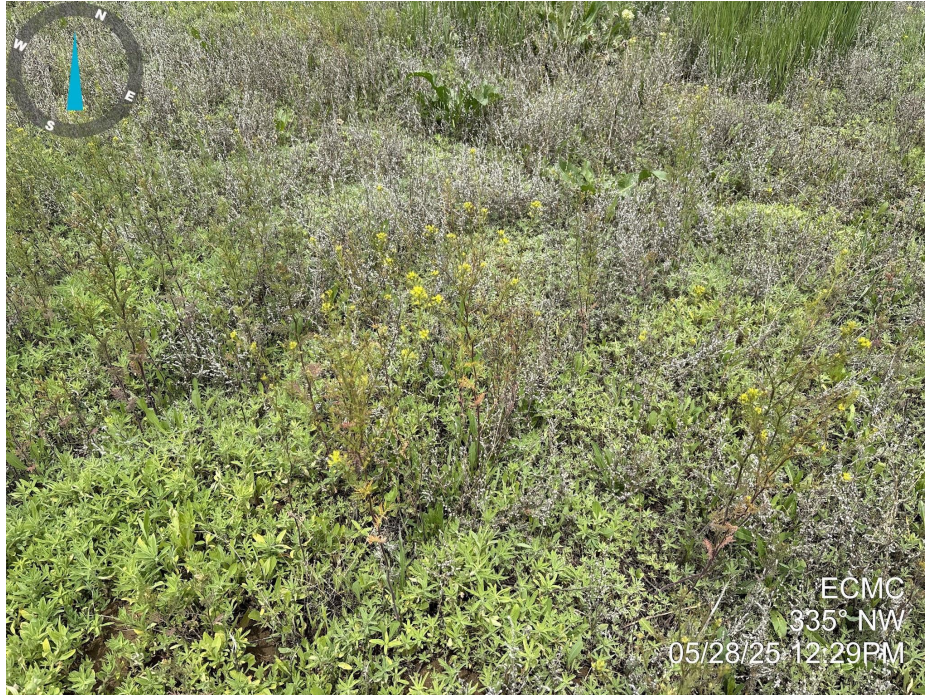
Photo 7. Photo taken of ground cover at the well site. Photo illustrates weedy annual vegetation including kochia (*Kochia scoparia*).

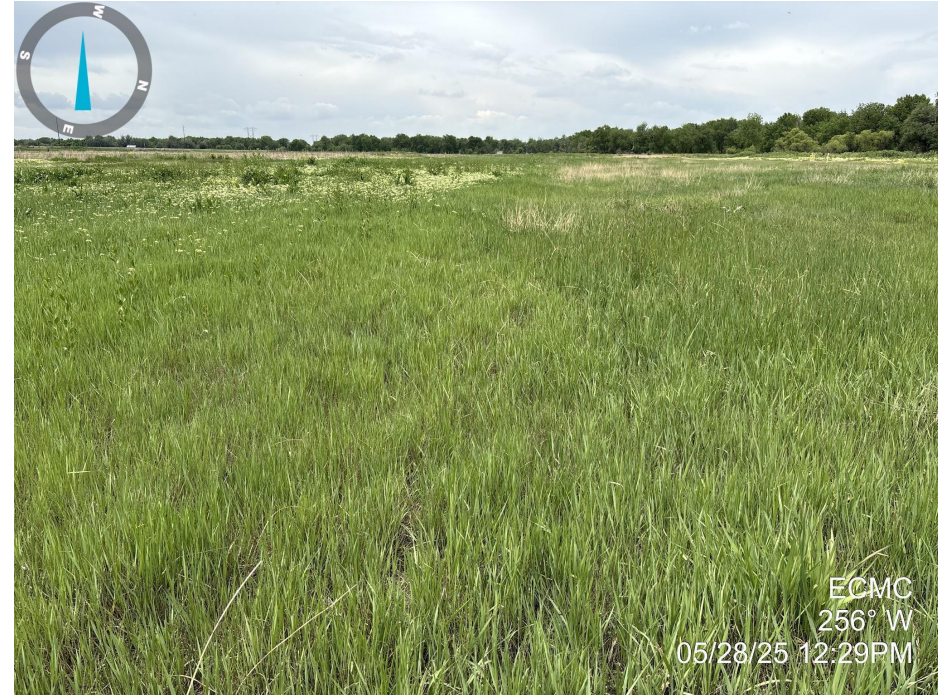
Photo 8. Photo taken of the reference area, northwest of the location, facing West. Photo illustrates perennial grass vegetation.
