Final Reclamation and Stormwater Inspection

June 23, 2025

Operator: VERDAD RESOURCES LLC - 10651

Location Name: Perry/1

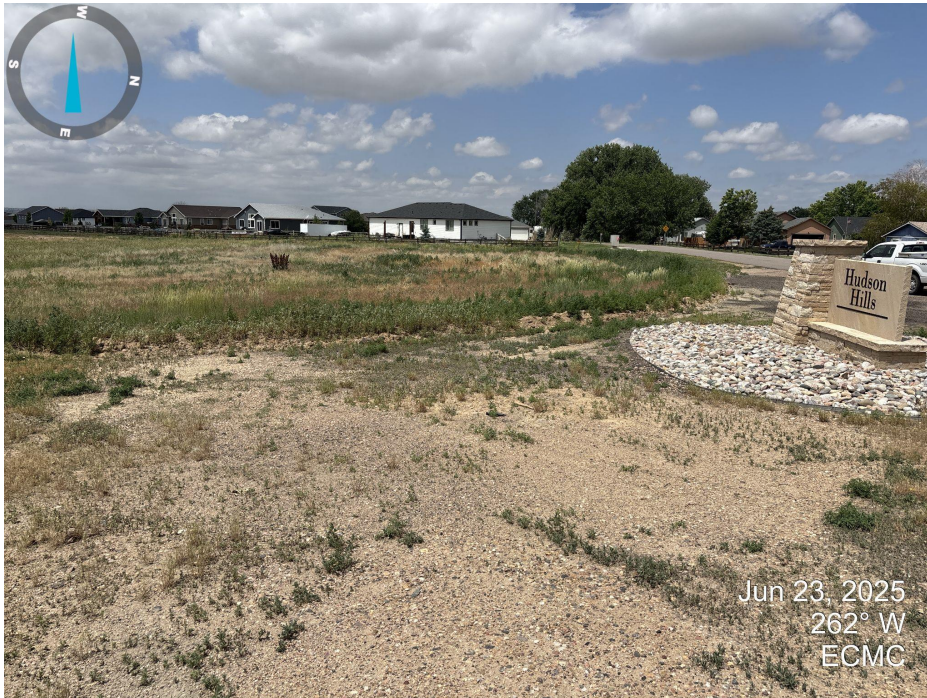
Photo 1. Looking west across the location. Gravel remains on the east side of the location near the former eastern entrance.

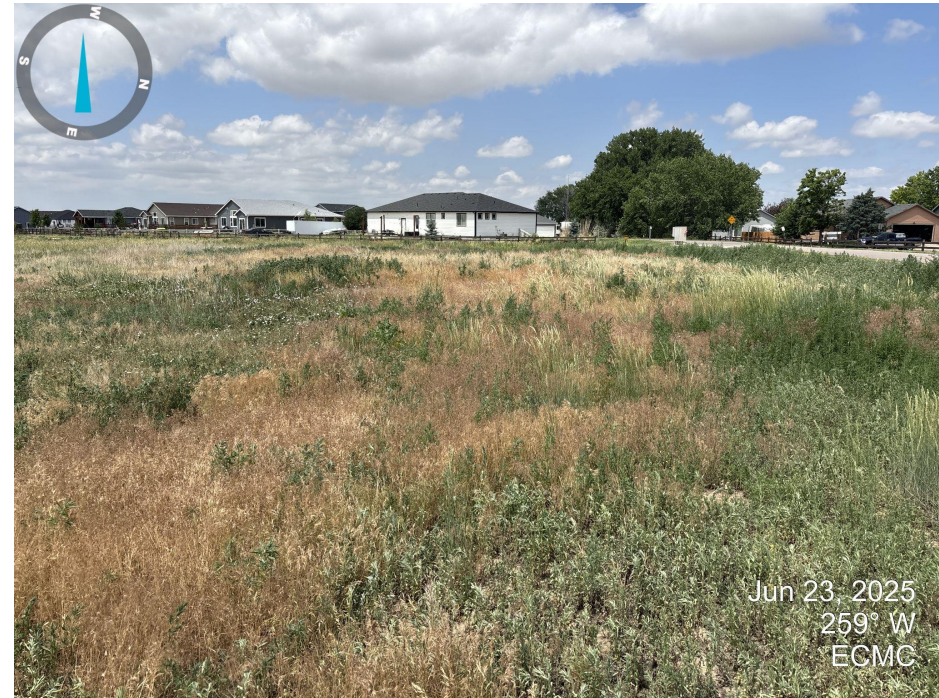
Photo 2. picture taken near the center of the location looking west. Vegetation on location is primarily undesirable weeds such as kochia and list C noxious weed cheatgrass. No oil and gas equipment remains on location.

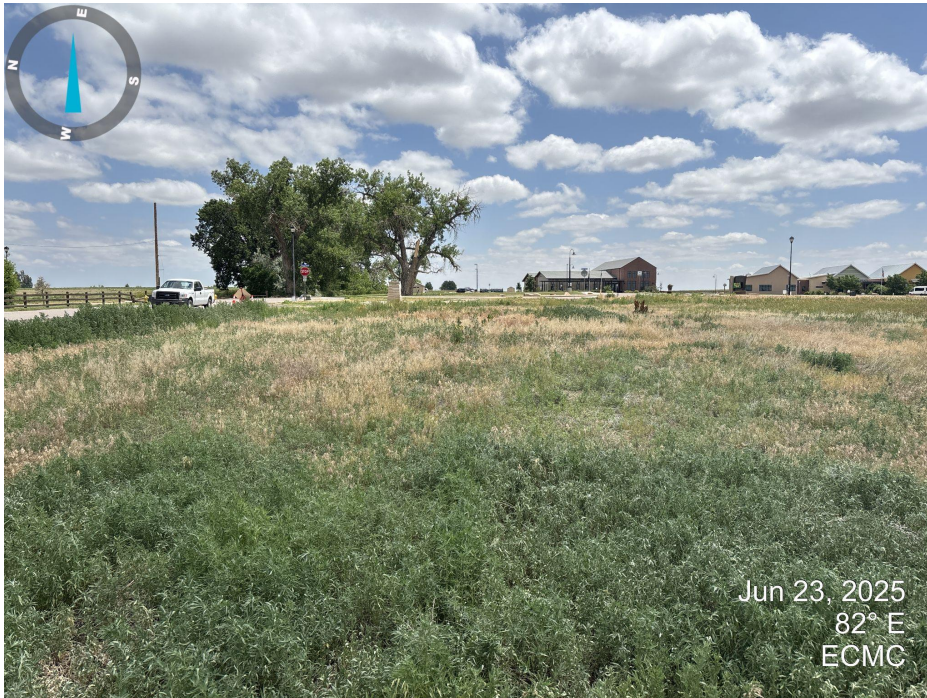
Photo 3. Looking east across the location. See photo 2 comments.

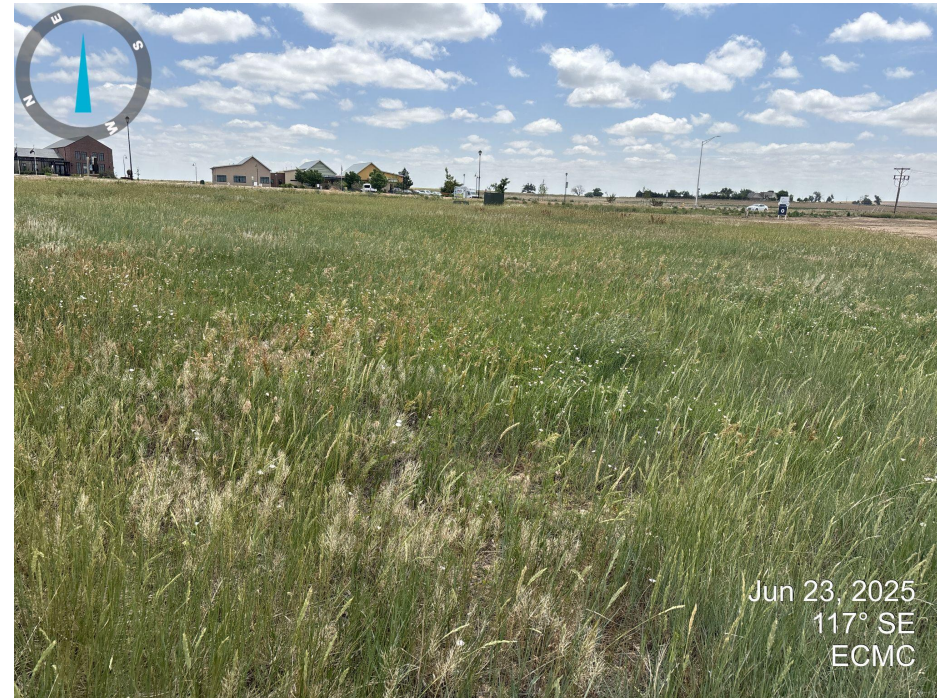
Photo 4. reference vegetation to the south of the location. Primarily smooth brome and western wheatgrass.
