# Final Reclamation Inspection

Operator: NOBLE ENERGY INC - 100322

Location ID: 329613

Inspection Photos  
Location Name: HSR-ARISTOCRAT #12-34A  
Location ID: 329613

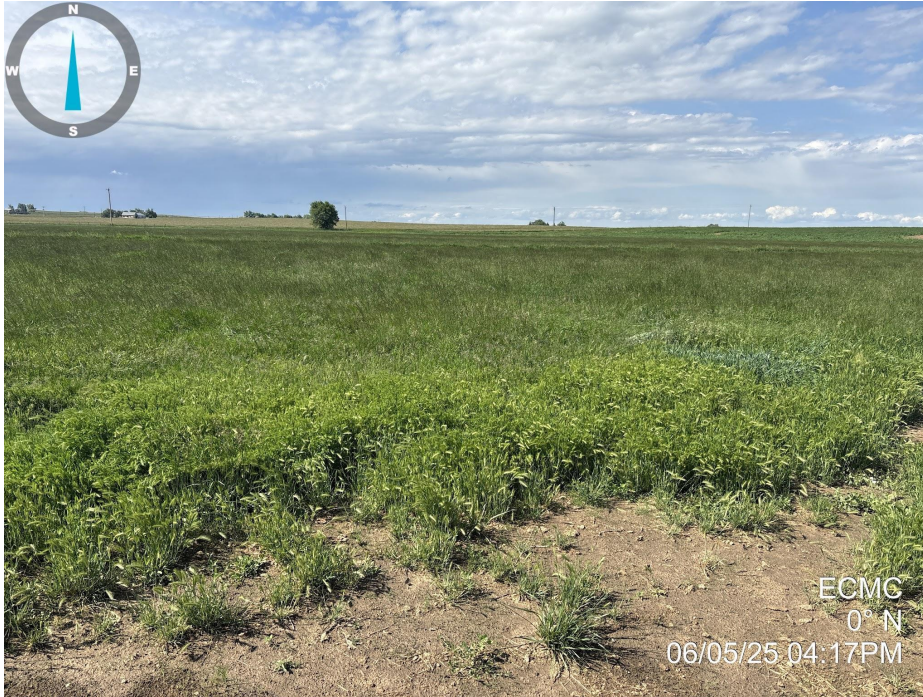
**Photo 1.** Photo taken from the well location, facing North. Photo illustrates that vegetation has not established to Rule 1004 standards on the location as there is bare ground and weedy annual vegetation, including cheatgrass (*Bromus tectorum*).

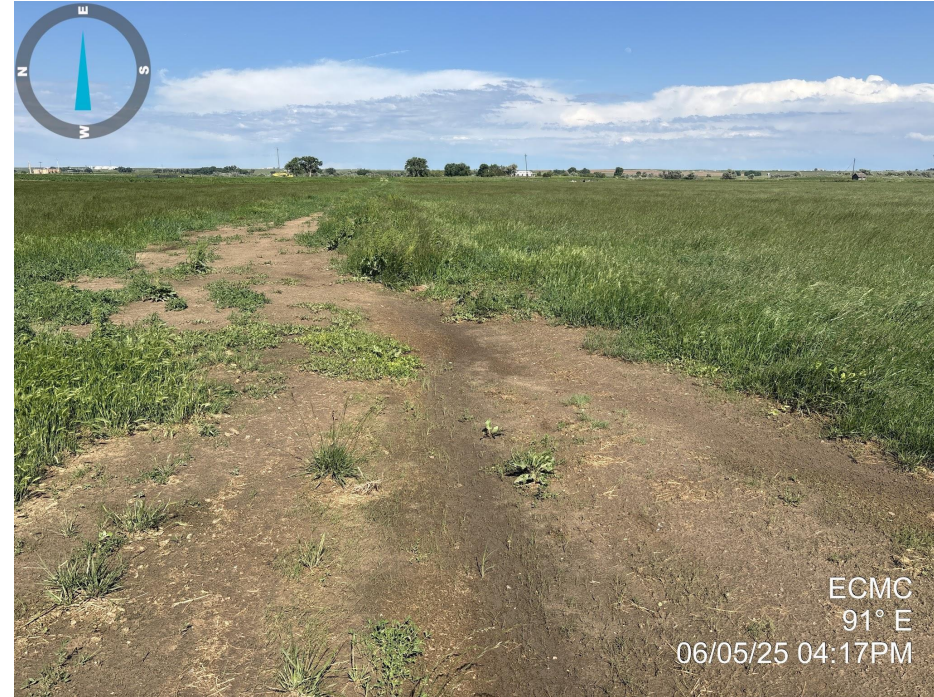
**Photo 2.** Photo taken from the well location, facing East. See comments under Photo 1.

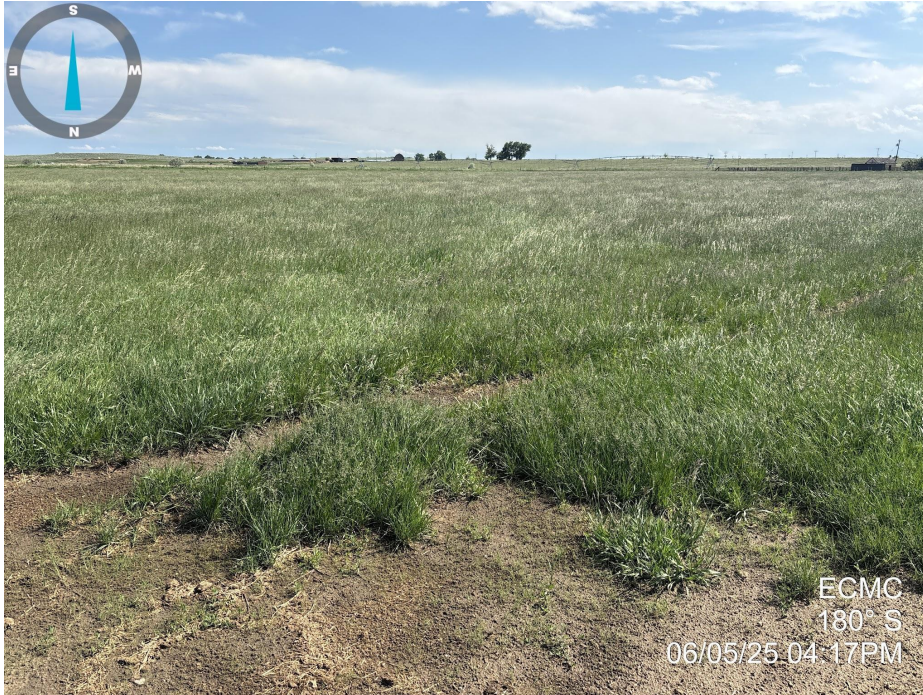
**Photo 3.** Photo taken from the well location, facing South. See comments under Photo 1.

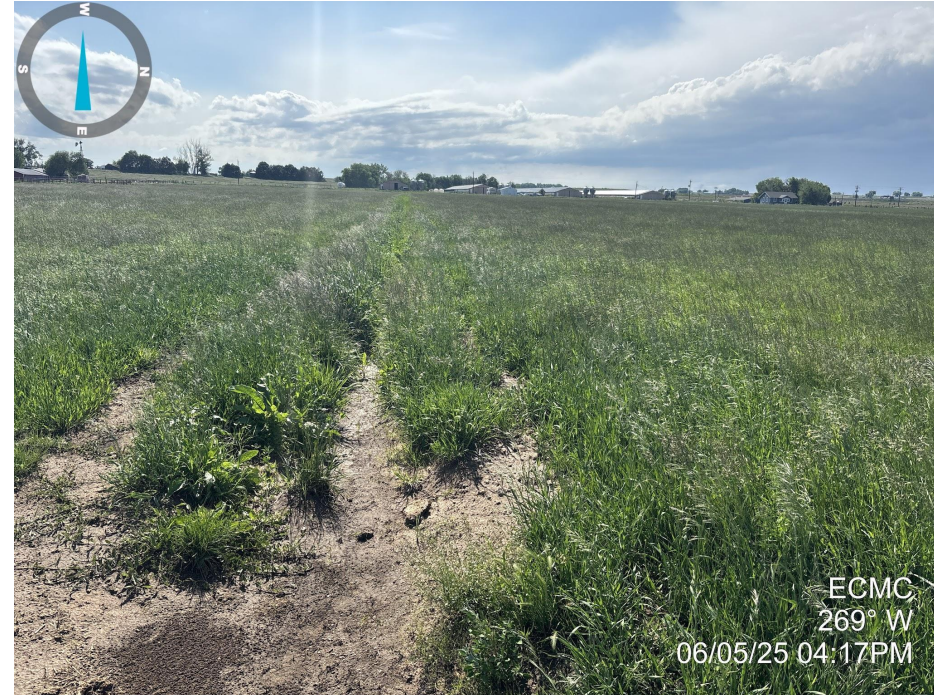
**Photo 4.** Photo taken from the well location, facing West. See comments under Photo 1.

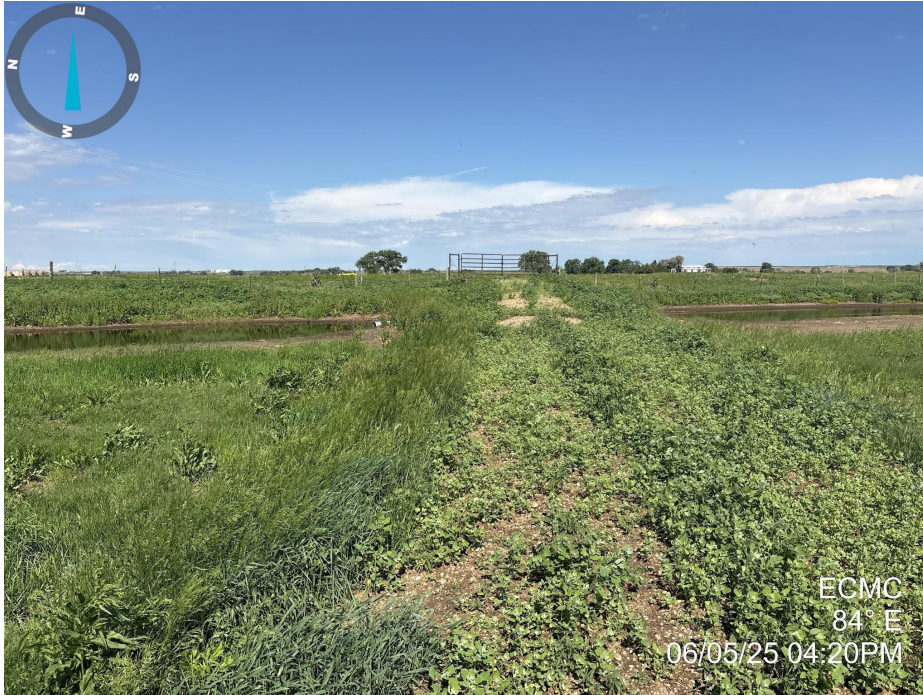
**Photo 5.** Photo taken of the access road to the well location, facing east. Photo illustrates that bare ground, gravel, and weedy annual vegetation remains along the road.

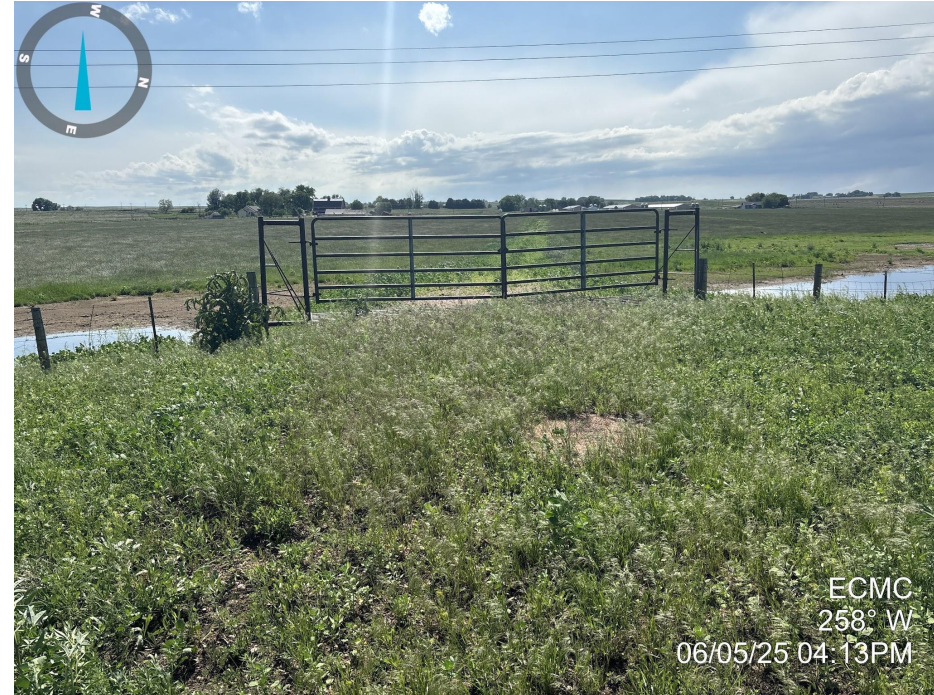
**Photo 6.** Photo taken of the access road to the well location, facing west. Photo illustrates that final reclamation activities have not taken place and the site is dominated by weedy annual vegetation, including cheatgrass (*Bromus tectorum*), a List C Noxious Weed species.

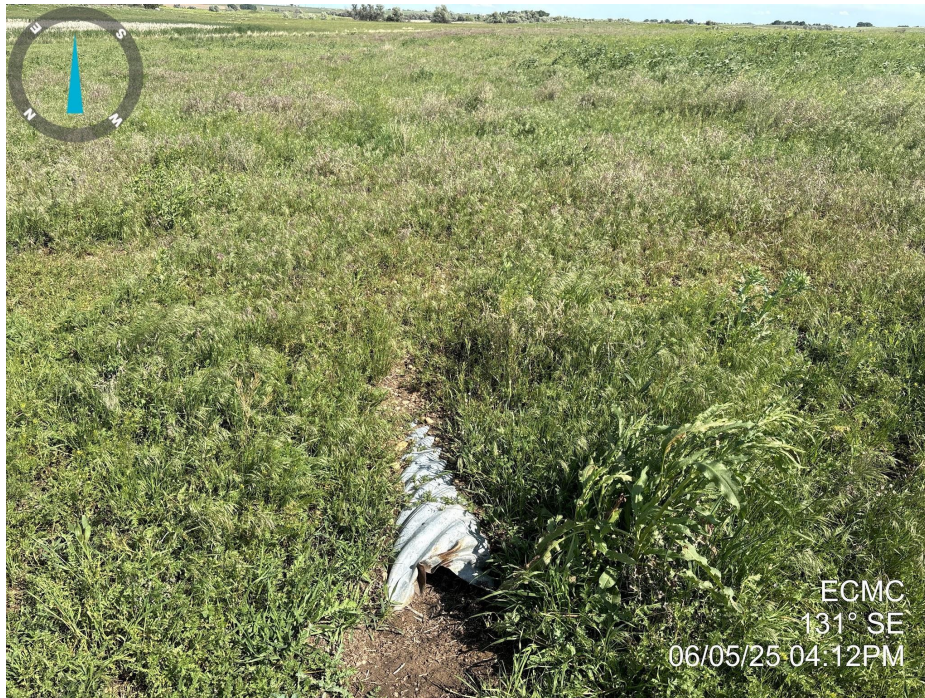
**Photo 7.** Photo taken of the access road to the well location, facing southeast. Photo illustrates that a partially-collapsed culvert remains on the access road.

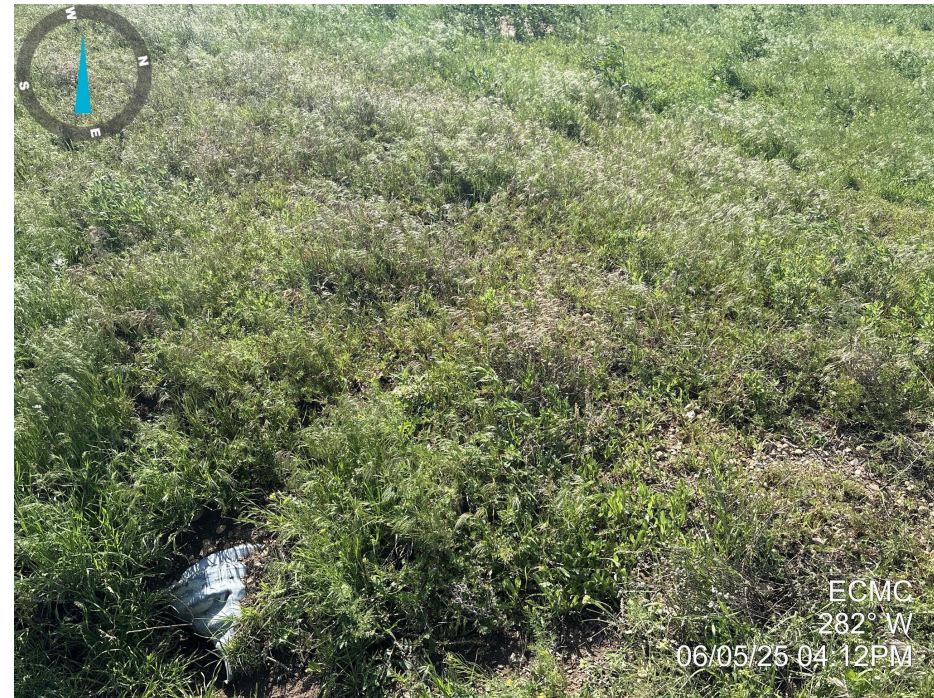
**Photo 8.** Photo taken of the access road. Photo illustrates gravel and a culvert remaining at the location.

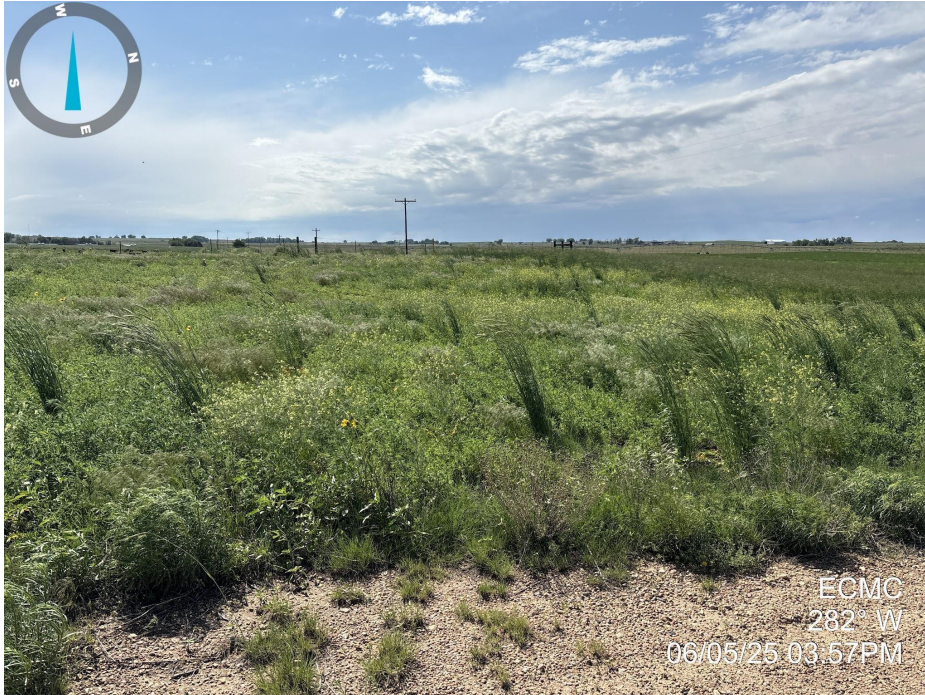
**Photo 9.** Photo taken of the tank battery location, facing West. Photo illustrates the location does not meet Rule 1004 standards as it is dominated by weedy, annual vegetation.

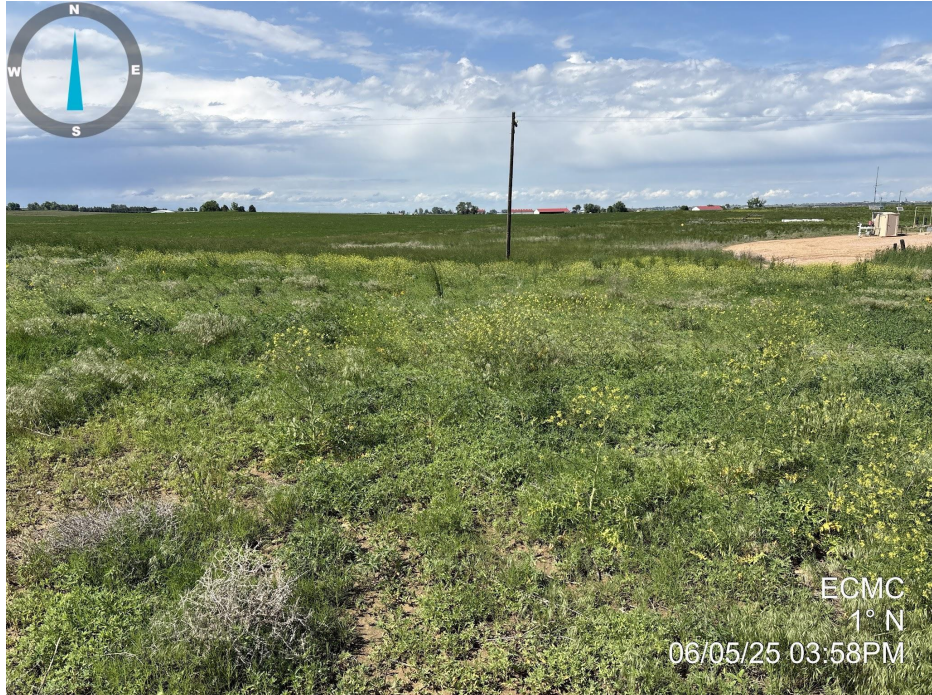
**Photo 10.** Photo taken of the tank battery location, facing North. See comments under Photo 9.

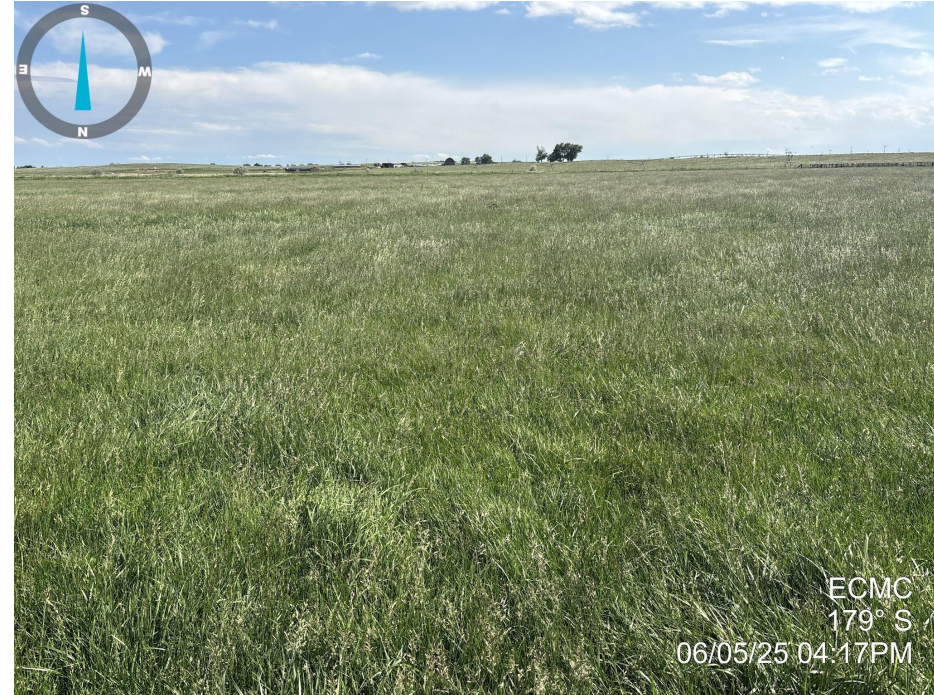
**Photo 14.** Photo taken of the reference area for the well location, south of the location, facing south. Photo illustrates perennial grass vegetation.
