# Final Reclamation Inspection

Operator: NOBLE ENERGY INC - 100322

Location ID: 329614

Inspection Photos  
Location Name: HSR-HOUSTON #13-34A  
Location ID: 329614

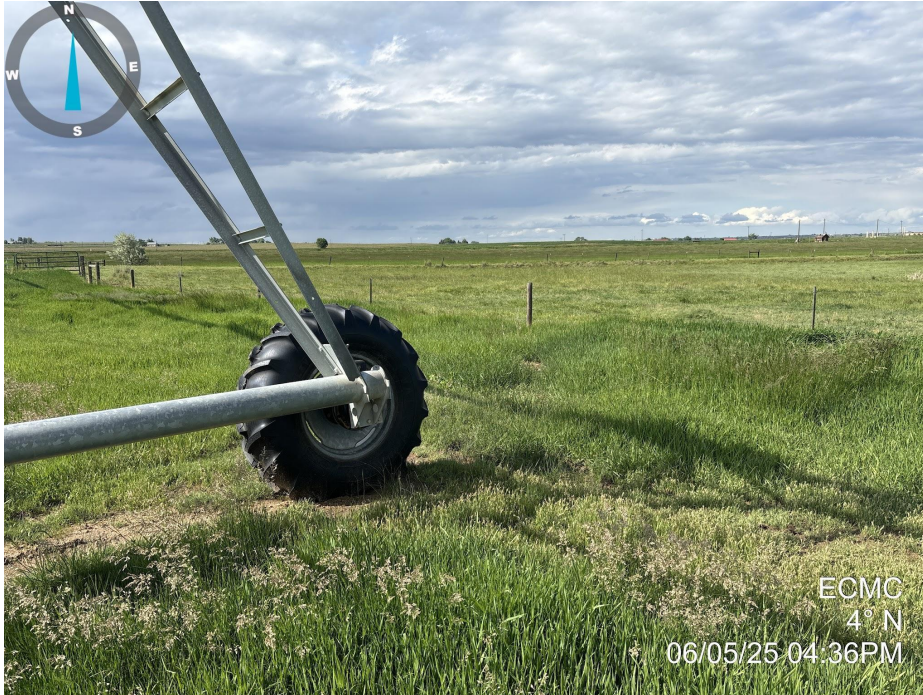
**Photo 1.** Photo taken from the well location, facing North. Photo illustrates that the well site meets Rule 1004 standards.

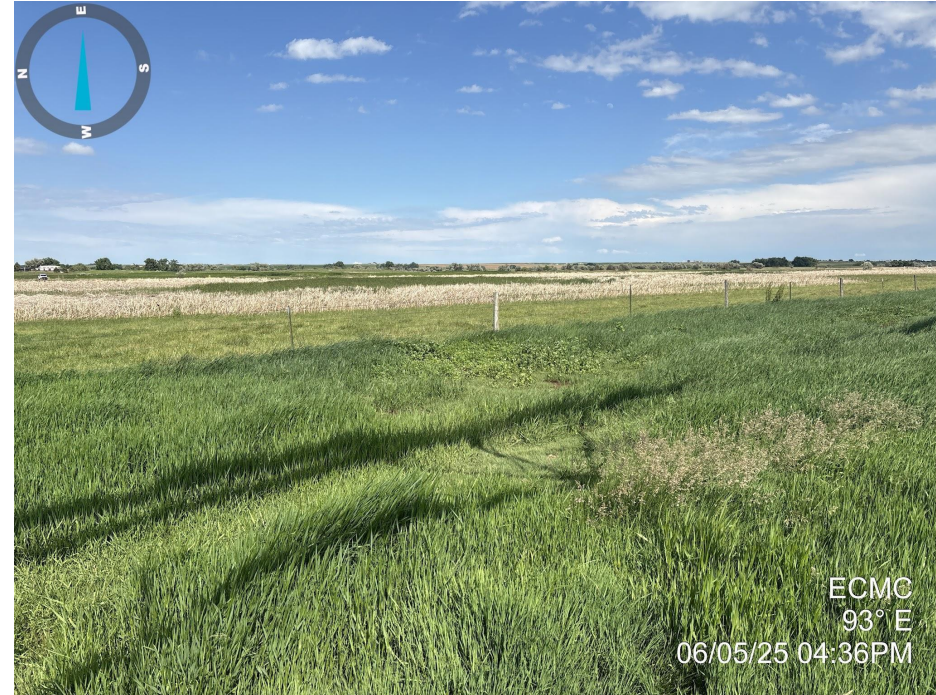
**Photo 2.** Photo taken from the well location, facing East. See comments under Photo 1.

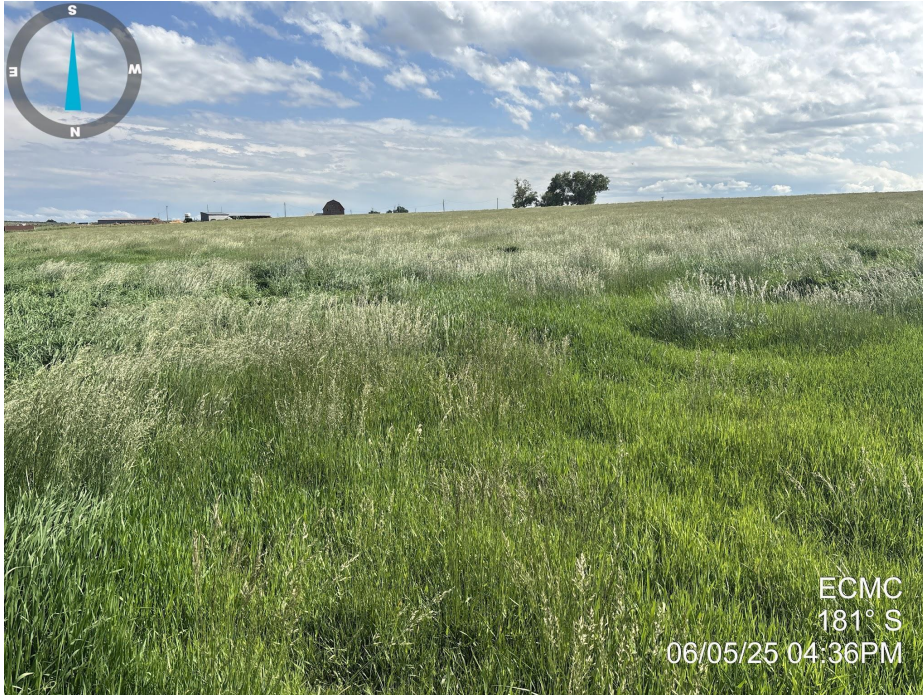
**Photo 3.** Photo taken from the well location, facing South. See comments under Photo 1.

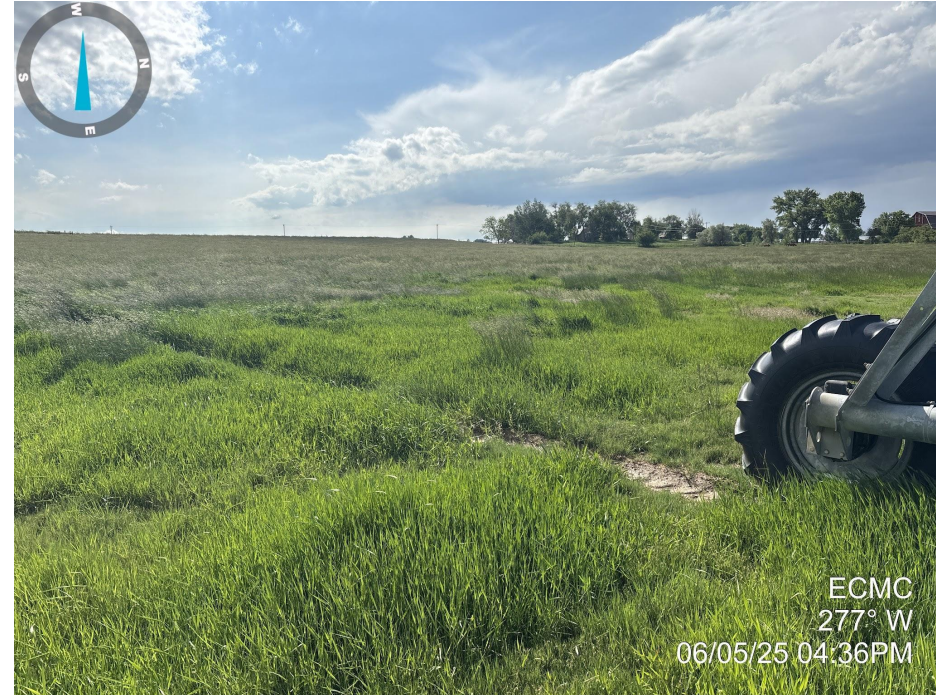
**Photo 4.** Photo taken from the well location, facing West. See comments under Photo 1.

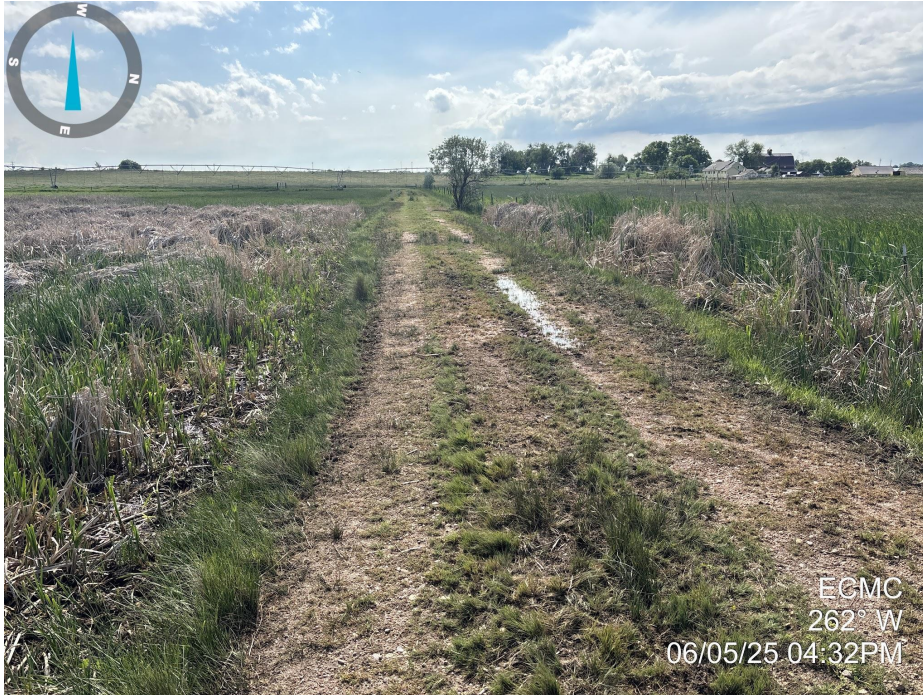
**Photo 5.** Photo taken of the access road to the well location, facing east. Photo illustrates that the access road has not been reclaimed and bare ground and gravel remain.

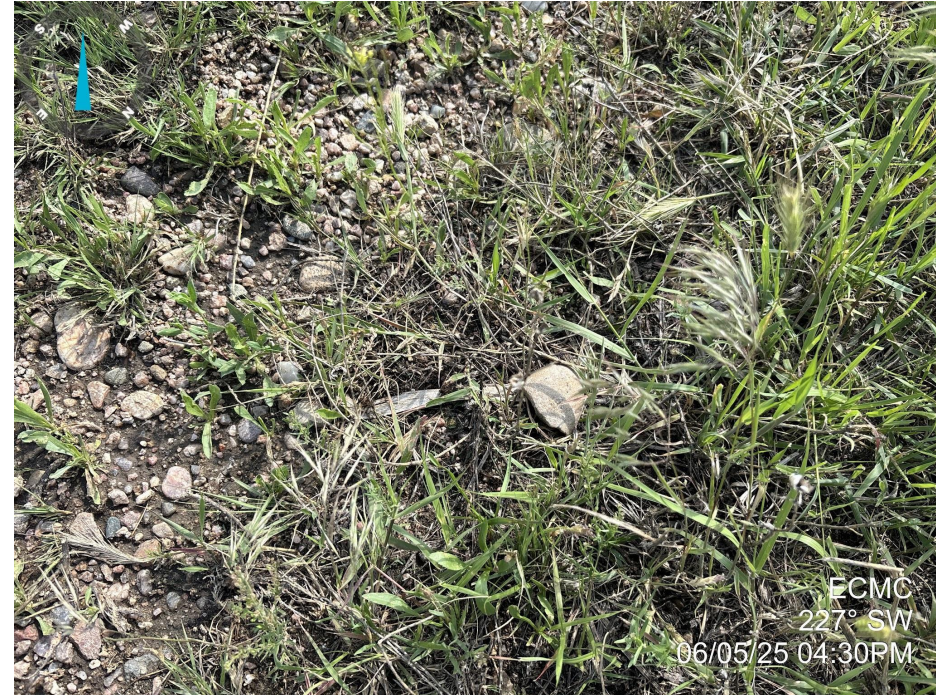
**Photo 6.** Photo taken of ground cover at the access road. Photo illustrates gravel remains across the road.

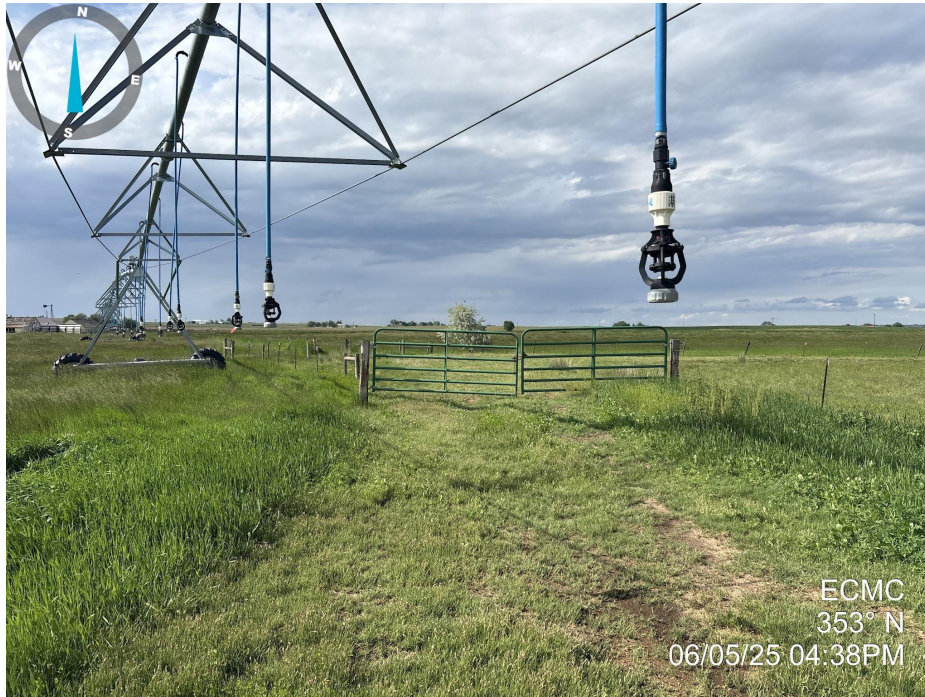
**Photo 7.** Photo taken of the access road to the well location, facing north, away from the location. See comments under Photo 5.

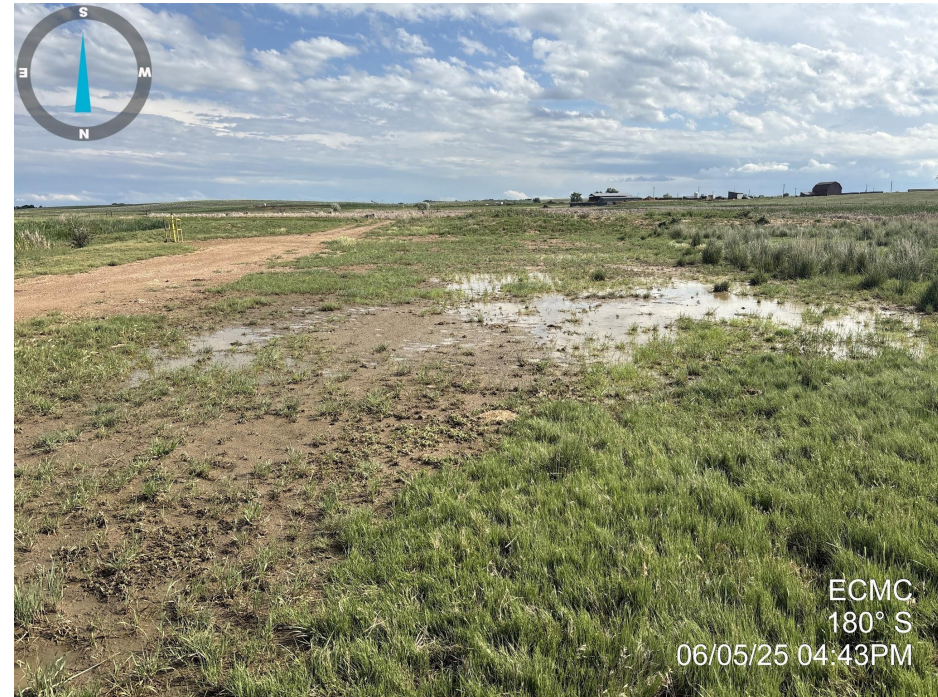
**Photo 8.** Photo taken of the tank battery location, facing South. Photo illustrates that vegetation has not established to Rule 1004 standards at the location.

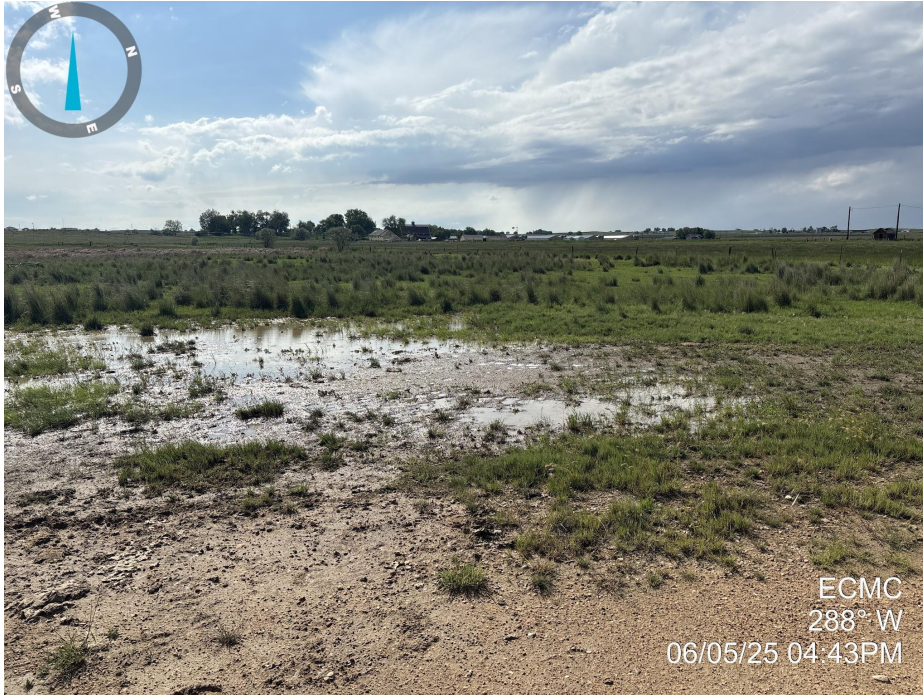
**Photo 9.** Photo taken of the tank battery location, facing West. See comments under Photo 8.

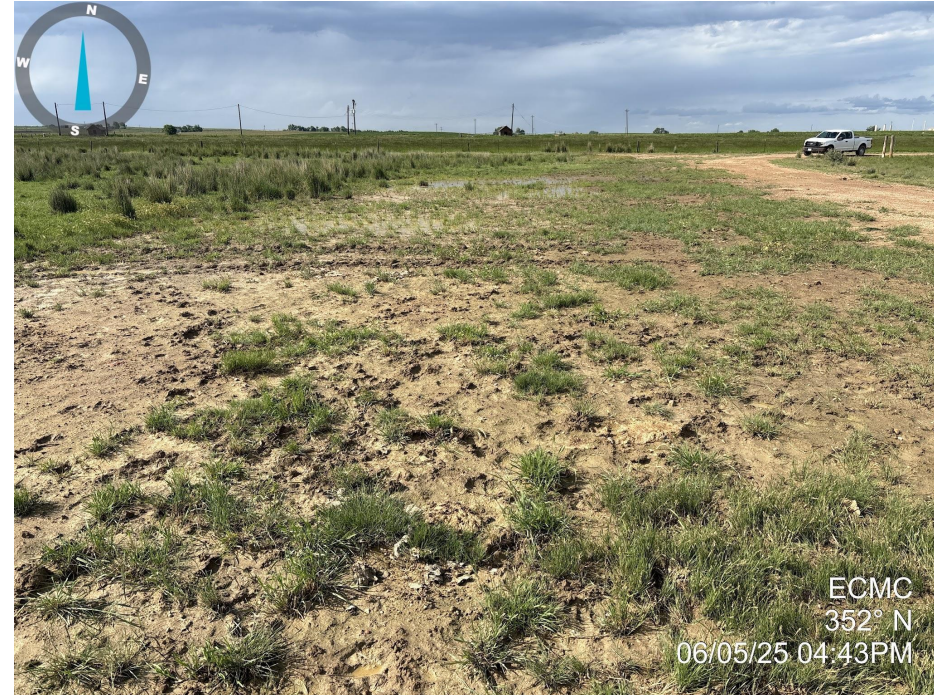
**Photo 10.** Photo taken of the tank battery location, facing North. See comments under Photo 8.

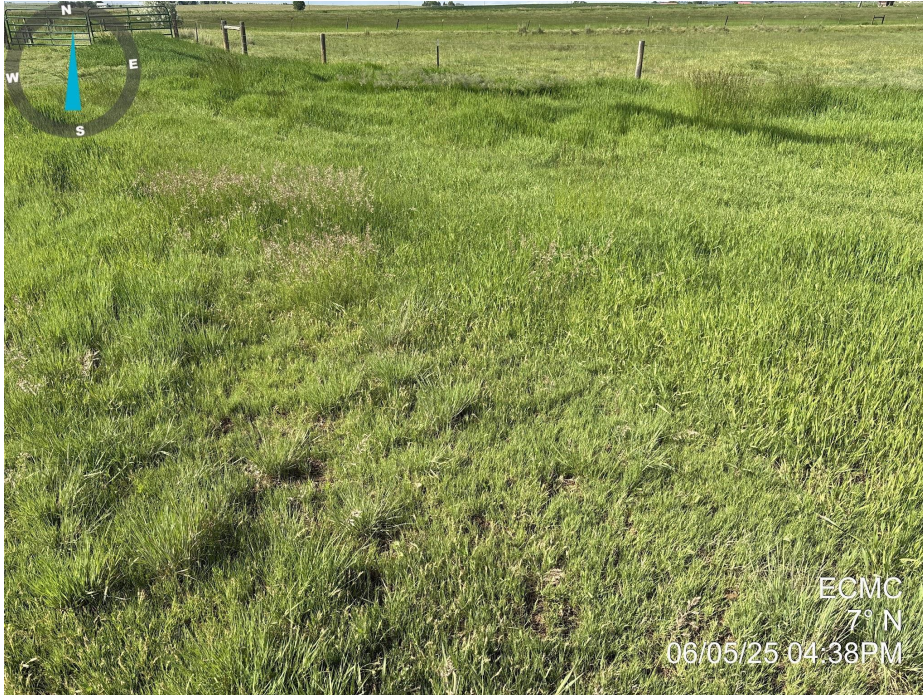
**Photo 11.** Photo taken of the reference area to the well location, located north of the location, facing North. Photo illustrates perennial grass vegetation.

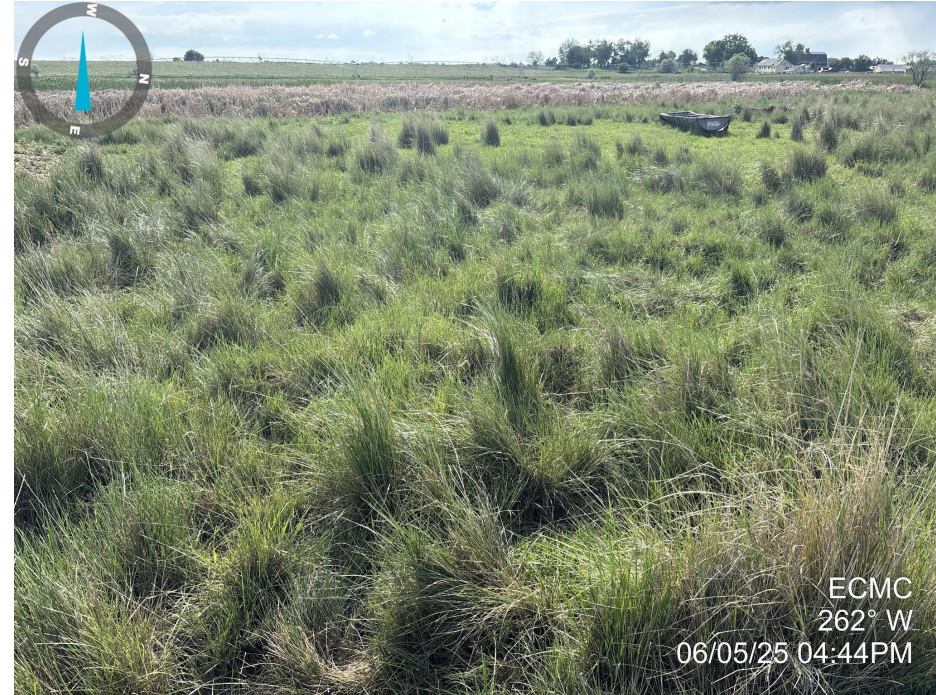
**Photo 12.** Photo taken of the reference area to the tank battery location, located west of the location, facing west. Photo illustrates perennial grass vegetation.
