# Final Reclamation Inspection

Operator: NOBLE ENERGY INC - 100322

Location ID: 330386

Inspection Photos  
Location Name: HSR-FOSTER #4-35  
Location ID: 330386

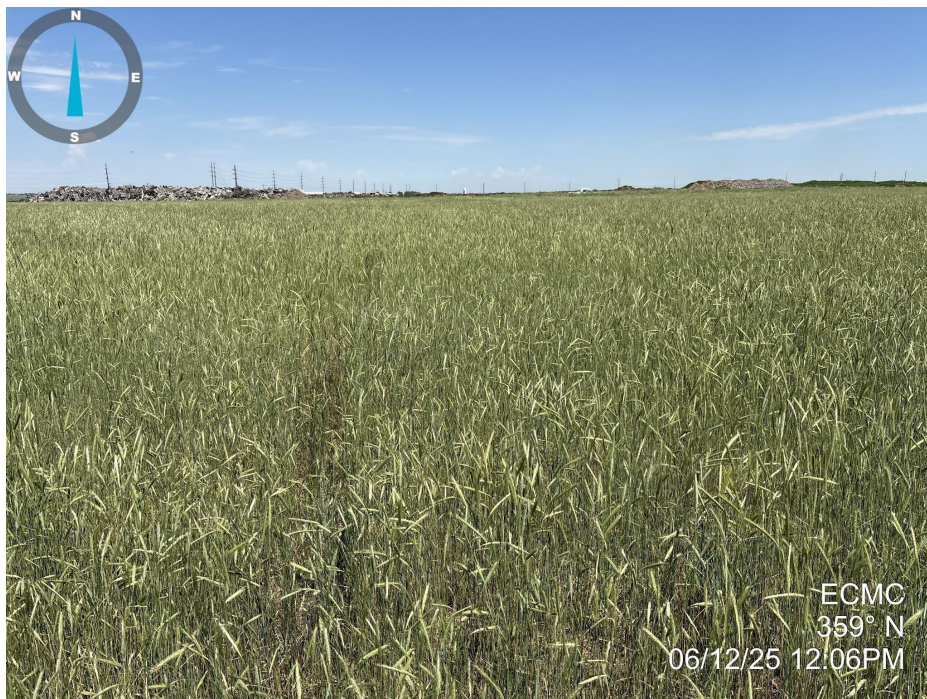
**Photo 1.** Photo taken from the well location, facing North. Photo illustrates that vegetation establishment at the well site meets Rule 1004 standards.

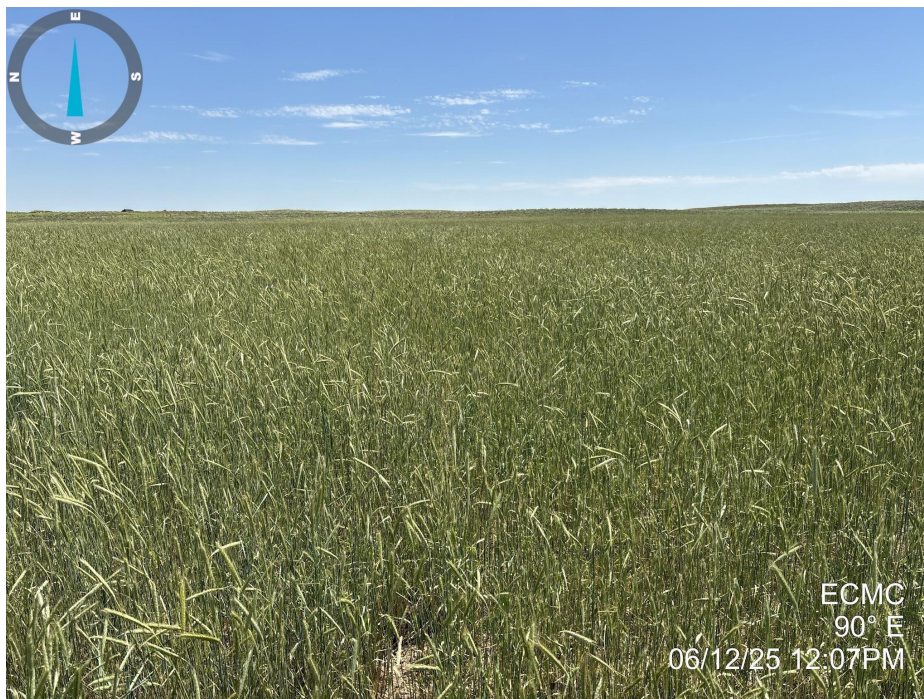
**Photo 2.** Photo taken from the well location, facing East. See comments under Photo 1.

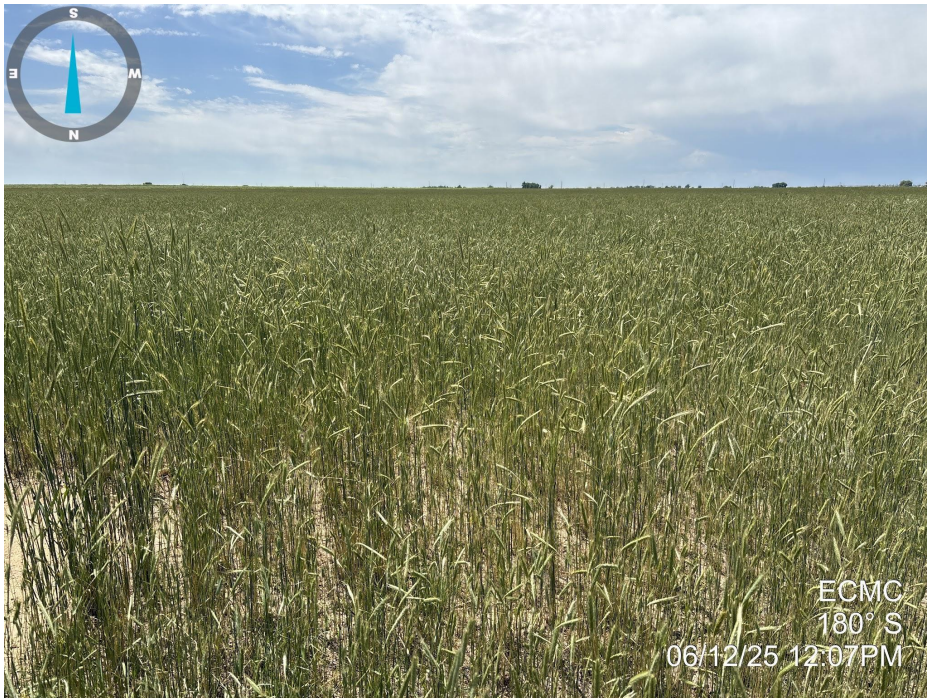
**Photo 3.** Photo taken from the well location, facing South. See comments under Photo 1.

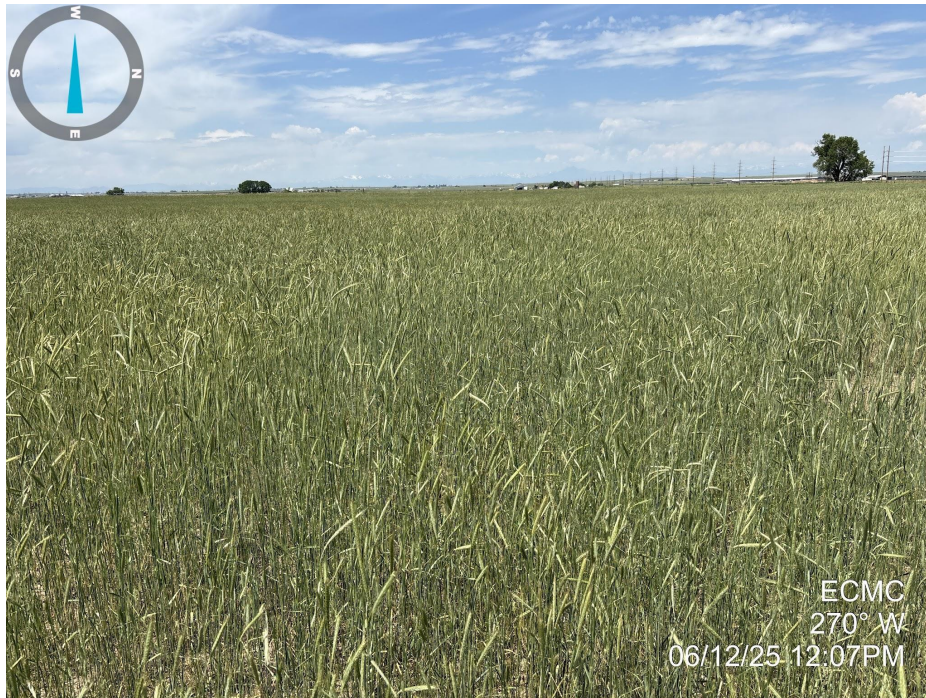
**Photo 4.** Photo taken from the well location, facing West. See comments under Photo 1.

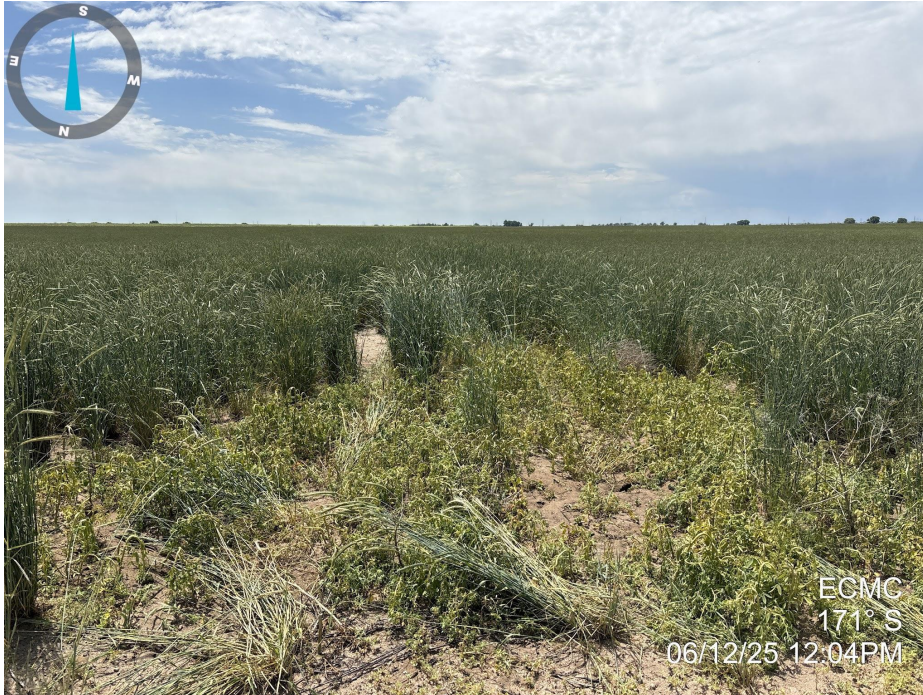
**Photo 5.** Photo taken of the access road to the well location, facing South. Photo illustrates that final reclamation activities have taken place, but weedy annual vegetation is present at the entrance to the access road.

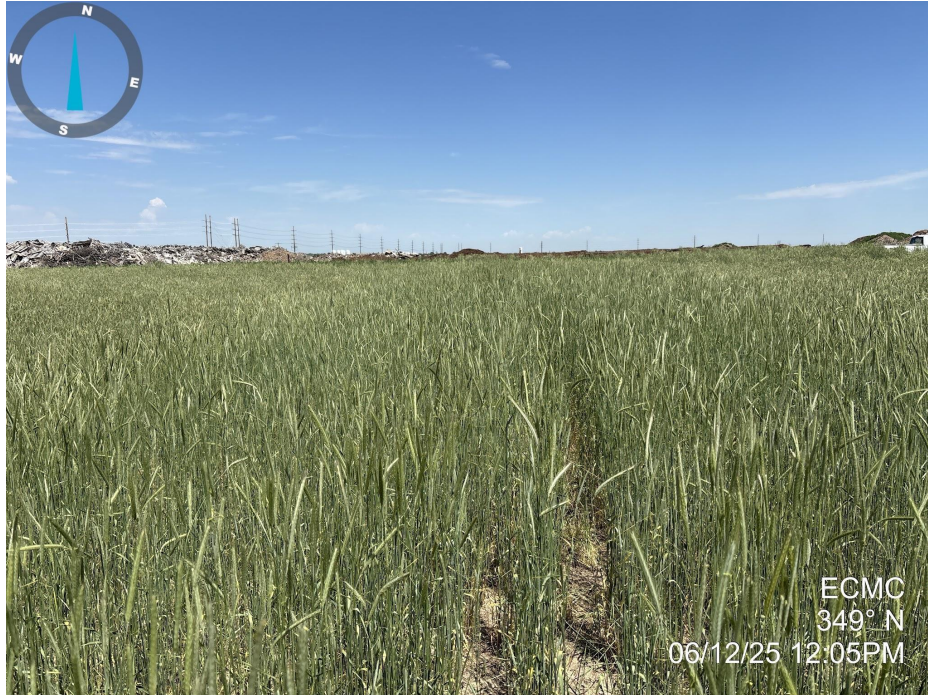
**Photo 6.** Photo taken of the access road, from the well location, facing South away from the location. Photo illustrates that vegetation has established to Rule 1004 standards across this portion of the access road.

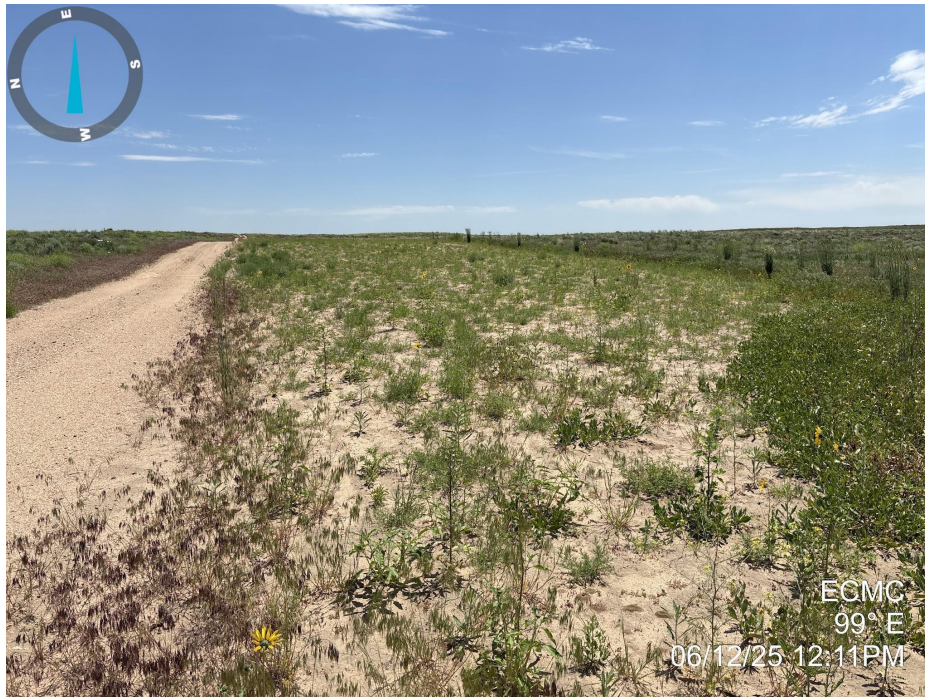
**Photo 7.** Photo taken of the tank battery location, facing East. Photo illustrates that final reclamation activities have taken place, with evidence of drill row seeding, but vegetation has not established to Rule 1004 standards. Weedy annual vegetation, including cheatgrass (*Bromus tectorum*), a List C Noxious Weed species, was observed at the location.

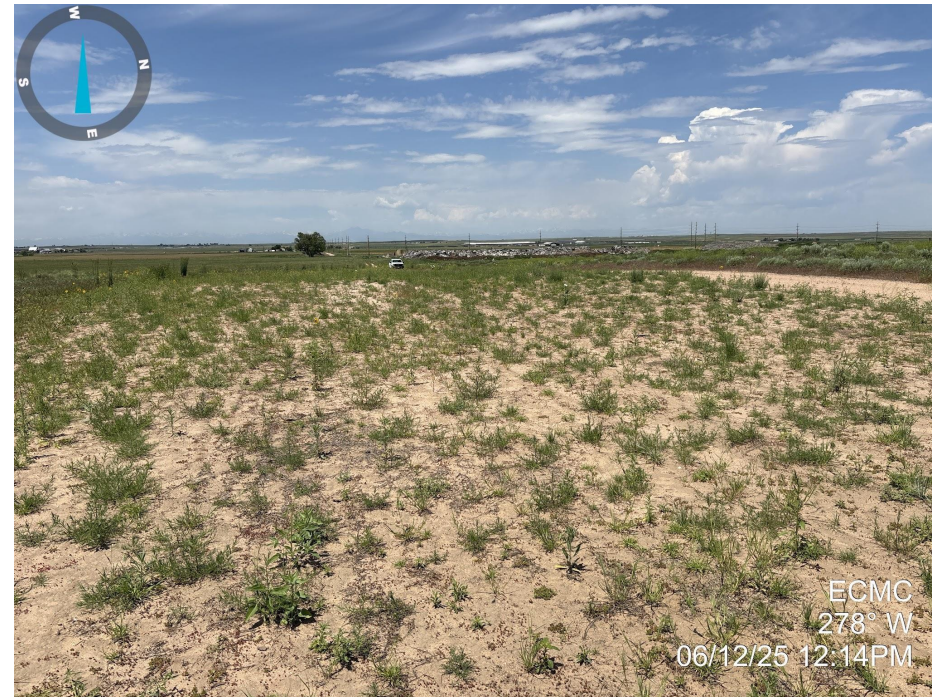
**Photo 8.** Photo taken of the tank battery location, facing West. See comments under Photo 7.

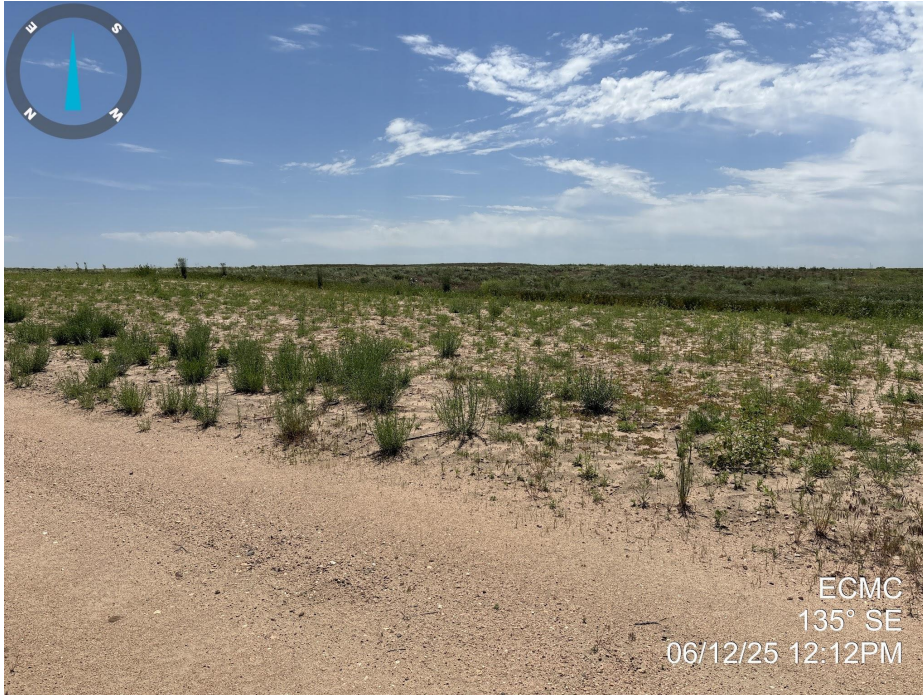
**Photo 9.** Photo taken of the tank battery location from the adjacent road, facing Southeast. See comments under Photo 7.

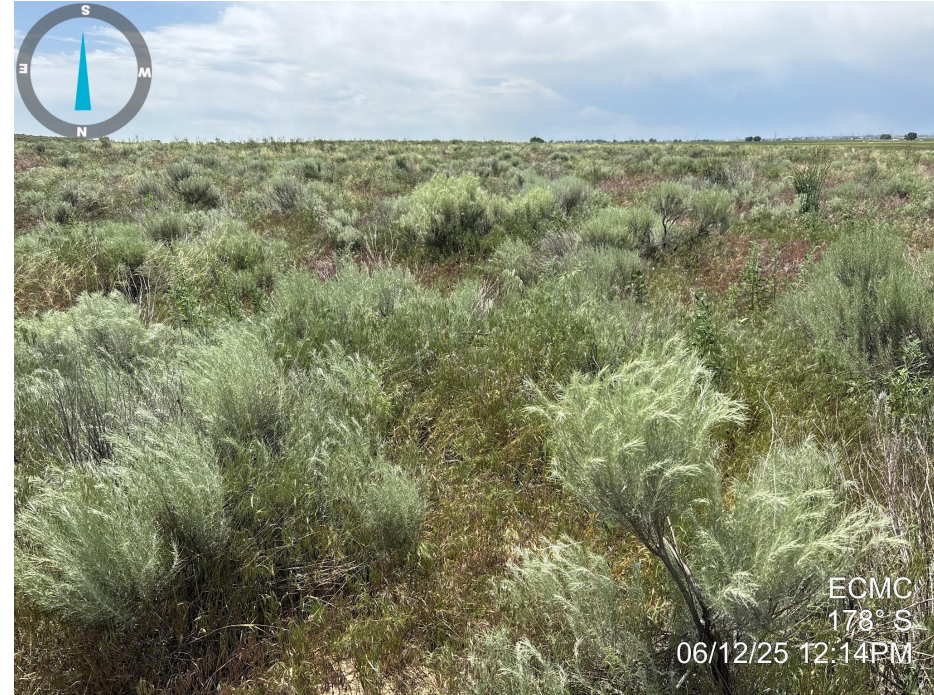
**Photo 10.** Photo taken of the reference area to the tank battery location, southeast of the location, facing South. Photo illustrates shrub and grass vegetation.

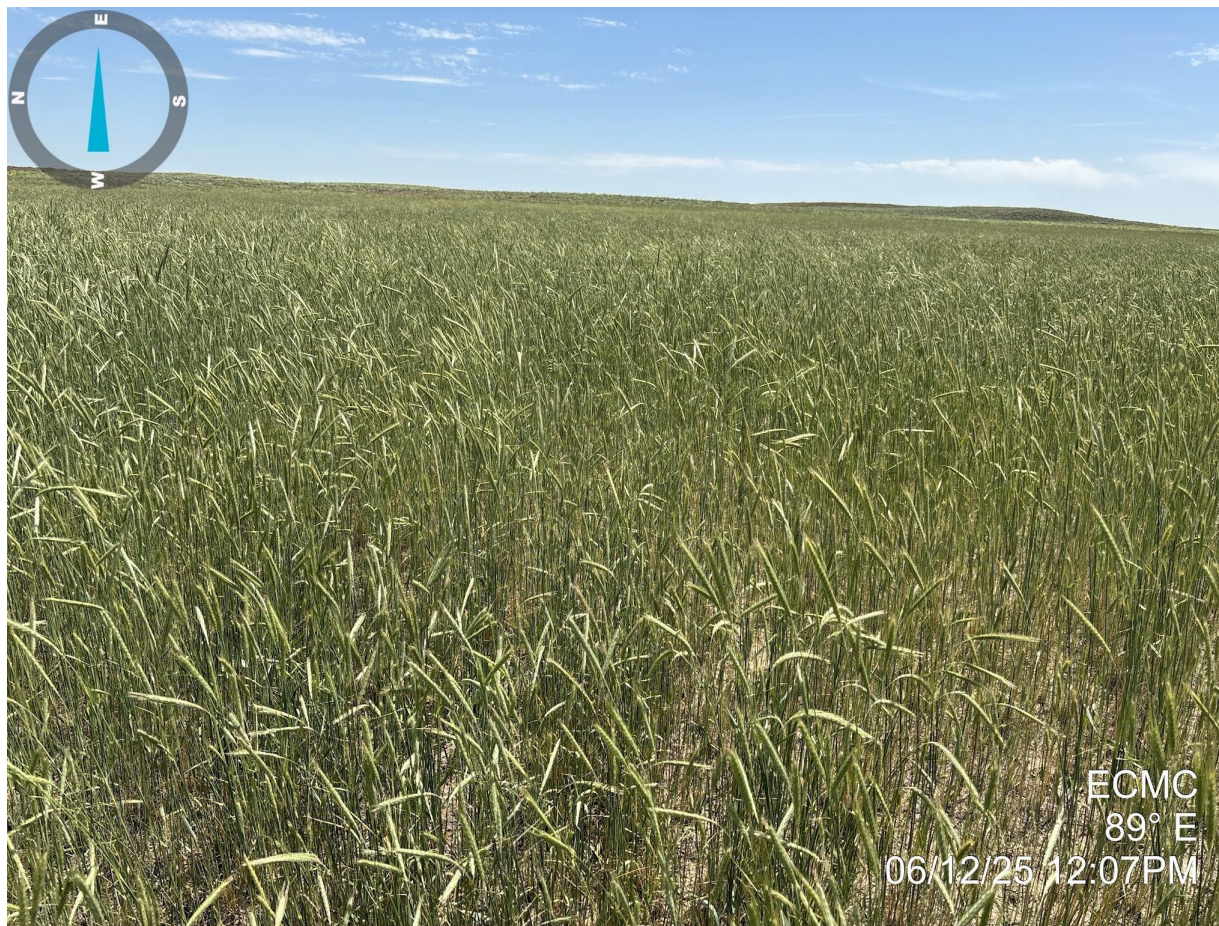
**Photo 11.** Photo taken of reference area to the well location, northeast of the location, facing East. Photo illustrates rye cropland.
