Final Reclamation Inspection

Operator: NOBLE ENERGY INC - 100322

Location ID: 327379

Inspection Photos
Location Name: UPRR 53 PAN AM UT /P/ #2
Location ID: 327379

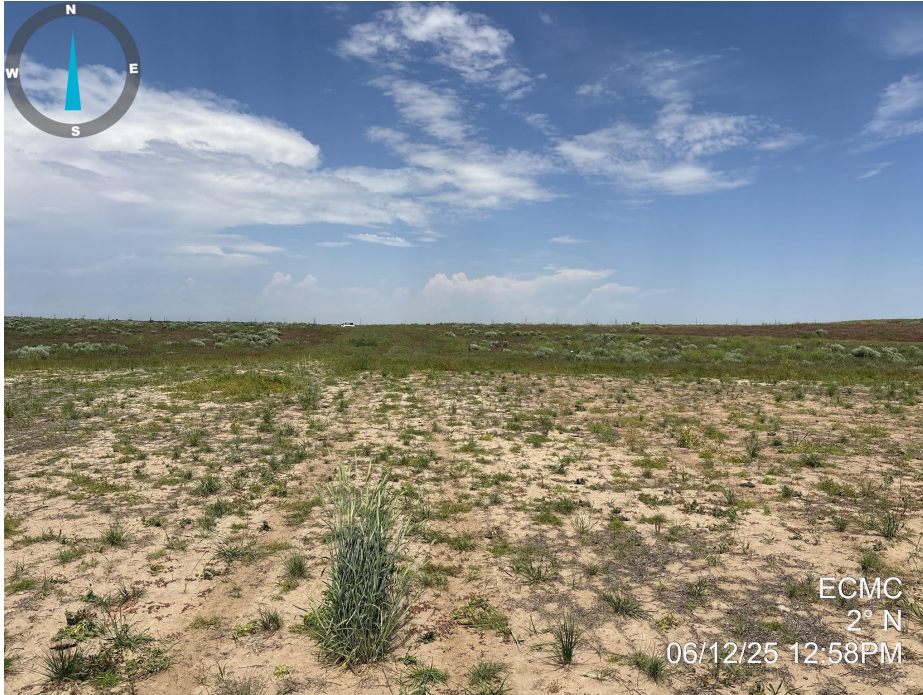
Photo 1. Photo taken from the well location, facing North. Photo illustrates that final reclamation activities have taken place, with evidence of drill rows from seeding, but vegetation establishment does not meet Rule 1004 standards.

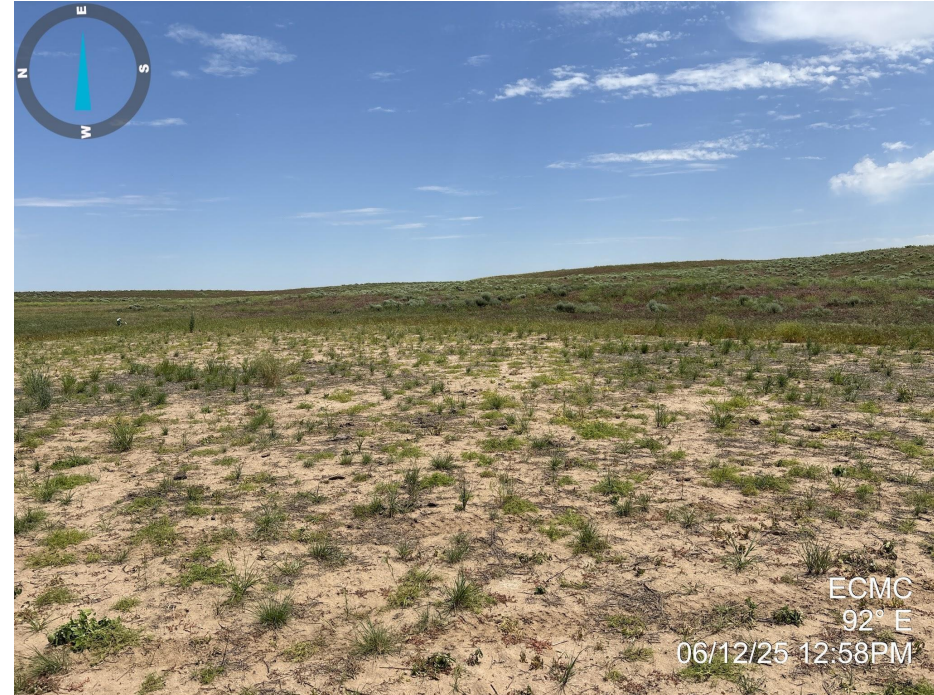
Photo 2. Photo taken from the well location, facing East. See comments under Photo 1.

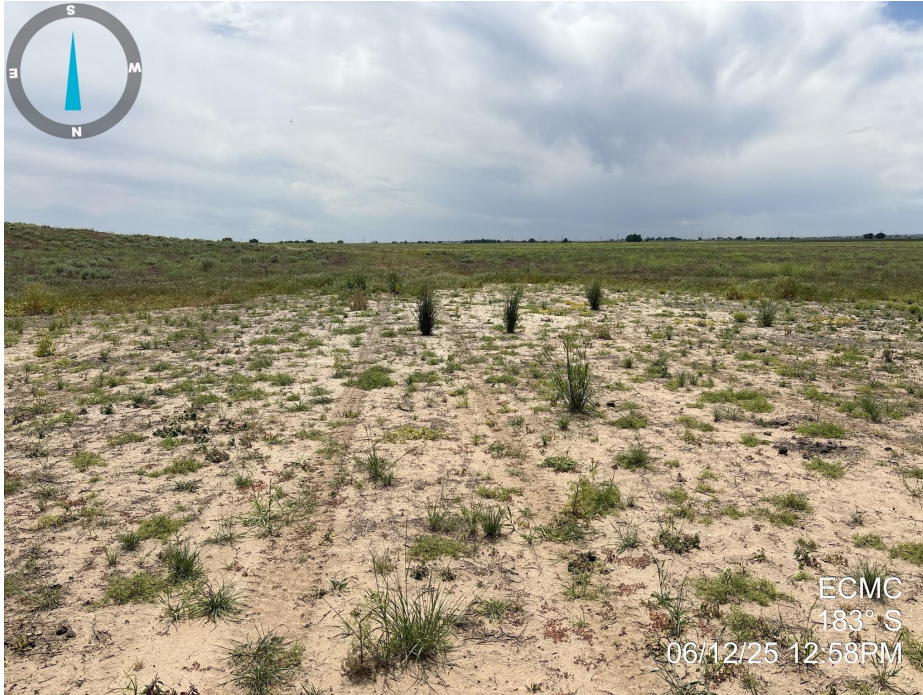
Photo 3. Photo taken from the well location, facing South. See comments under Photo 1.

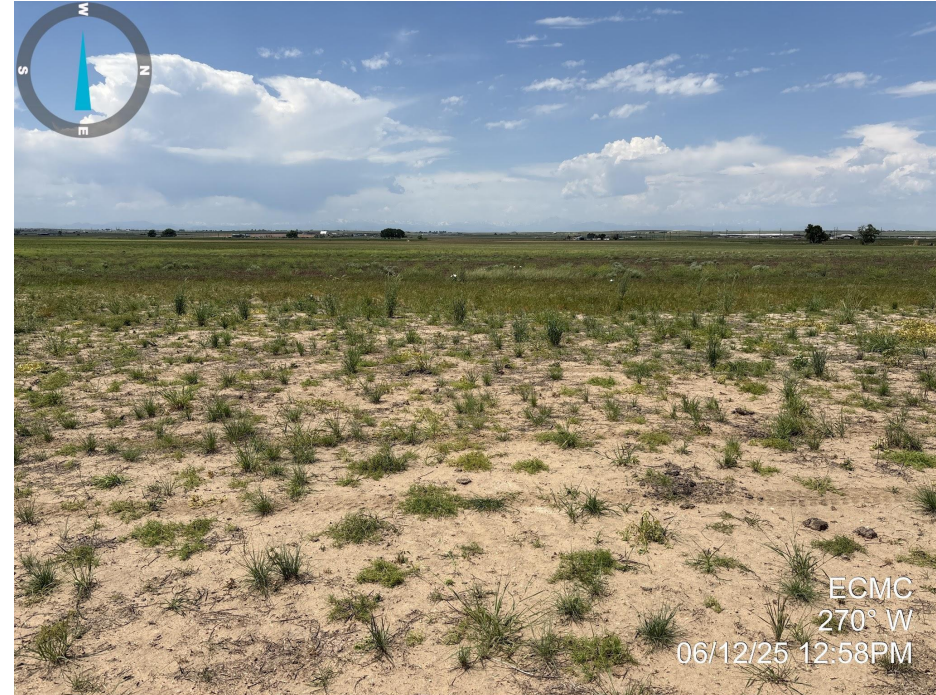
Photo 4. Photo taken from the well location, facing West. See comments under Photo 1.

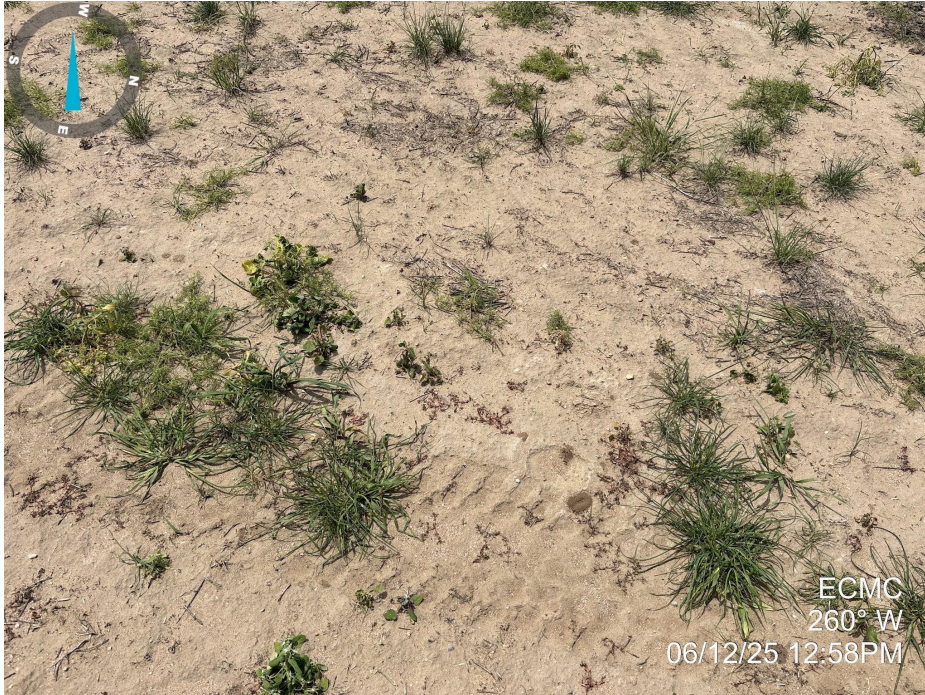
Photo 5. Photo taken of ground cover at the well location. Photo illustrates bare ground and weedy annual vegetation present at the location.

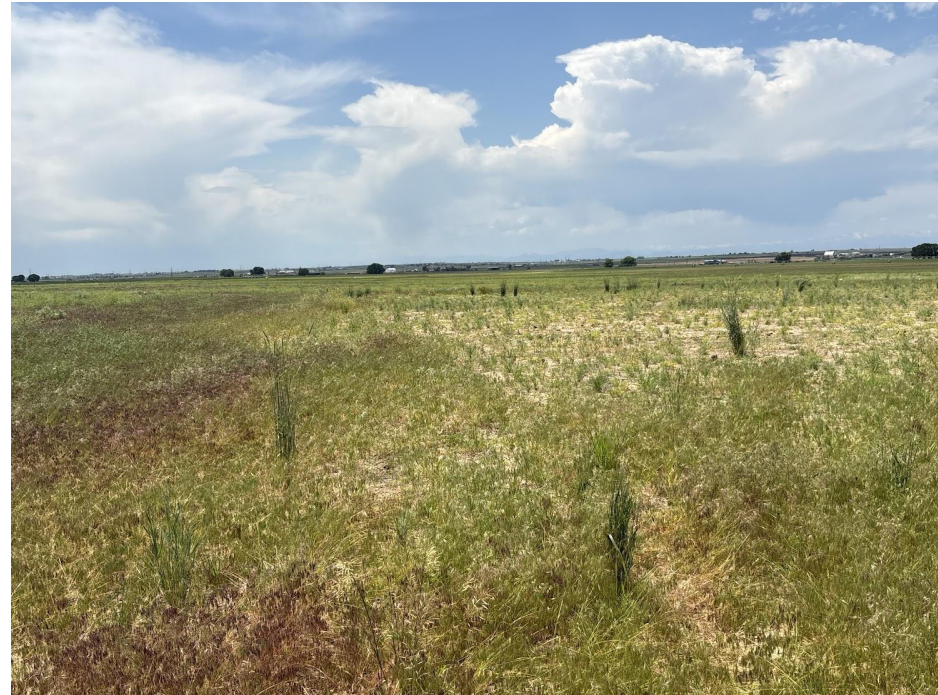
Photo 6. Photo taken of the access road, from the well location, facing Southwest. Photo illustrates that final reclamation has taken place, but the location is dominated by weedy annual vegetation, including cheatgrass (*Bromus tectorum*), a List C Noxious Weed Species.

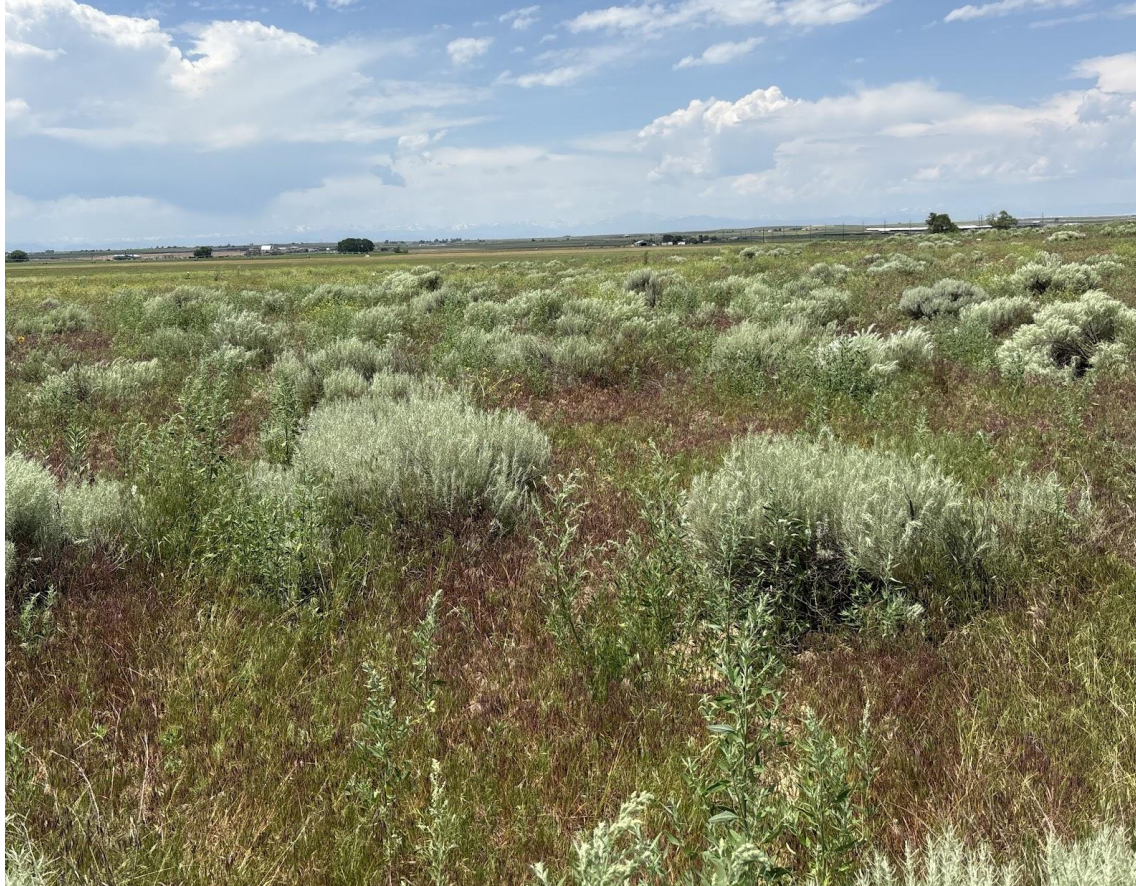
Photo 7. Photo taken of reference area to the well location, north of the location, facing West. Photo illustrates sand sagebrush (*Artemisia filifolia*), with some weedy annual vegetation, including cheatgrass (*Bromus tectorum*).
