Final Reclamation Inspection

Operator: NOBLE ENERGY INC - 100322

Location ID: 332407

Inspection Photos
Location Name: FOSTER #18-35
Location ID: 332407

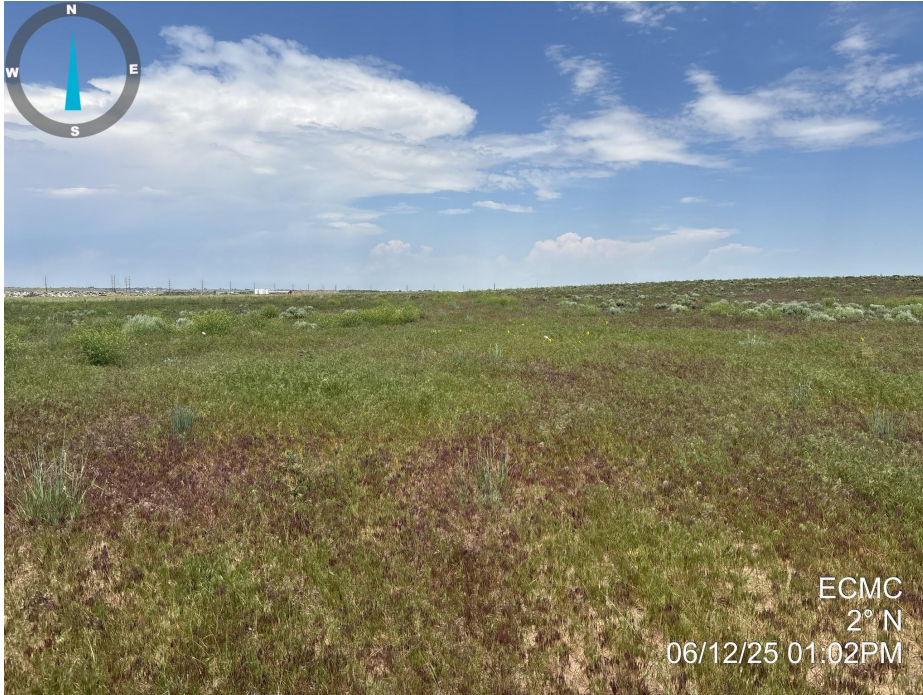
Photo 1. Photo taken from the well location, facing North. Photo illustrates that final reclamation activities have taken place, but vegetation establishment does not meet Rule 1004 standards. The site is dominated by weedy annual vegetation, including cheatgrass (*Bromus tectorum*), a List C Noxious Weed species.

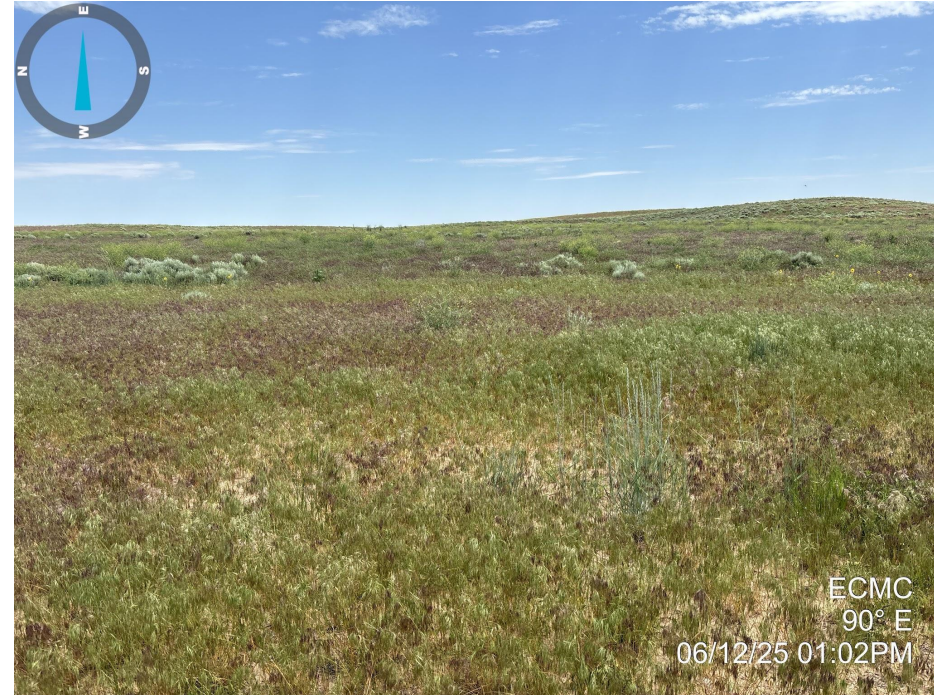
Photo 2. Photo taken from the well location, facing East. See comments under Photo 1.

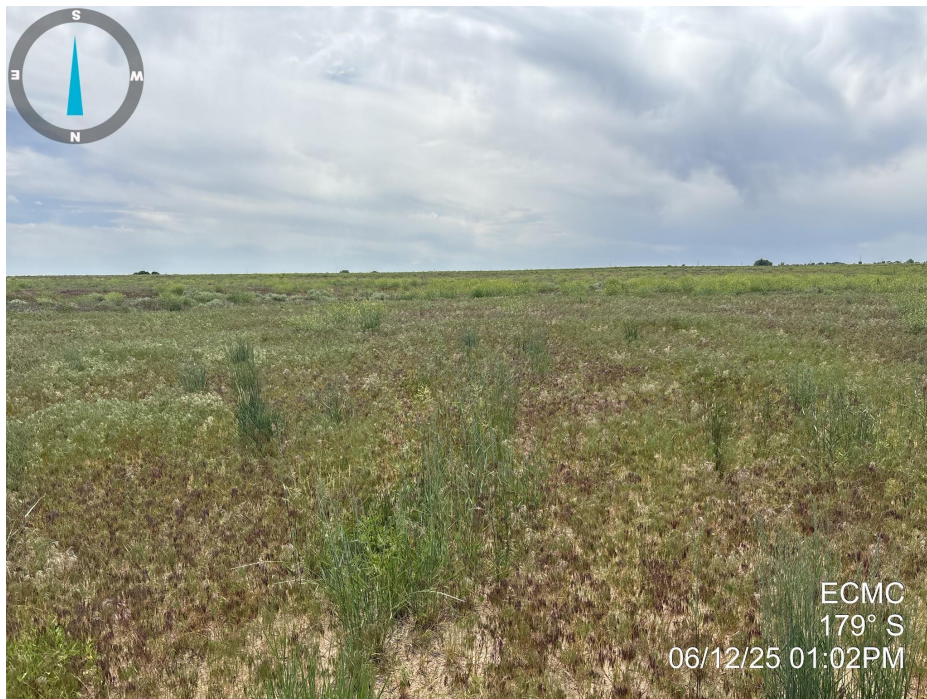
Photo 3. Photo taken from the well location, facing South. See comments under Photo 1.

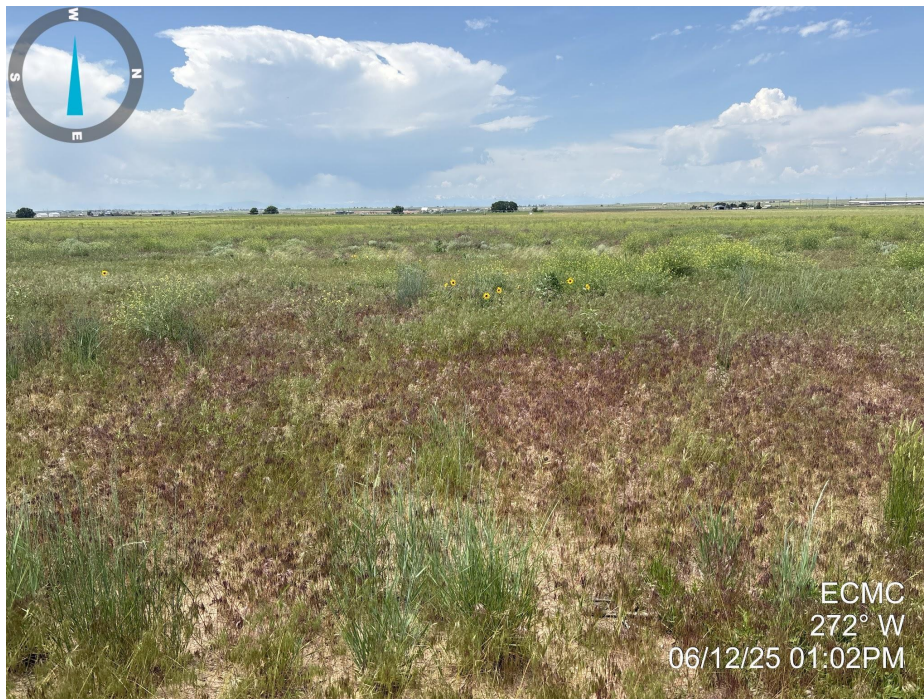
Photo 4. Photo taken from the well location, facing West. See comments under Photo 1.

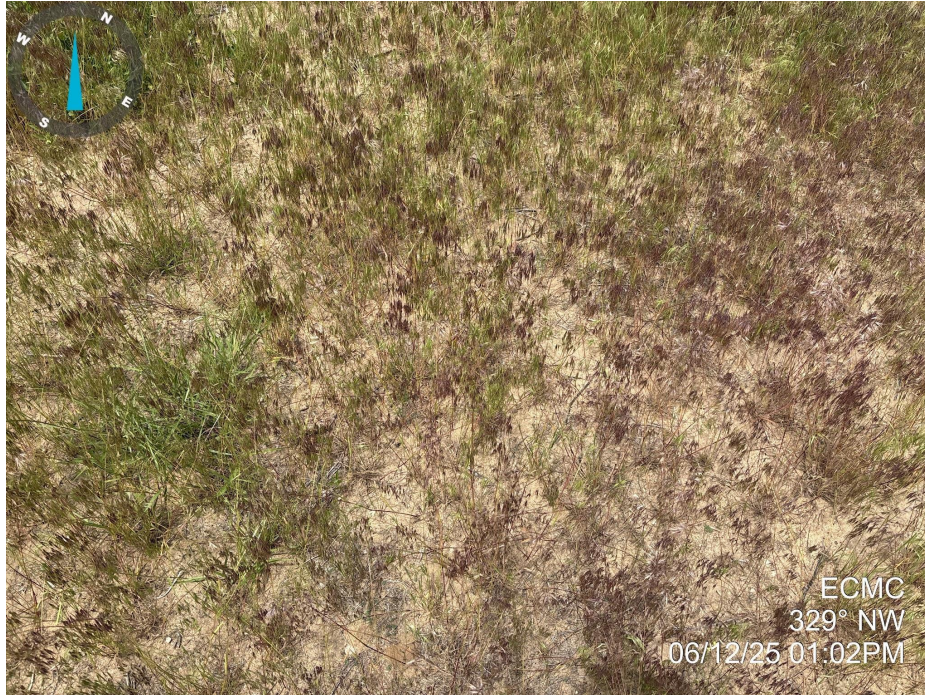
Photo 5. Photo taken of ground cover at the well location. Photo illustrates cheatgrass (*Bromus tectorum*) which was observed across the location.

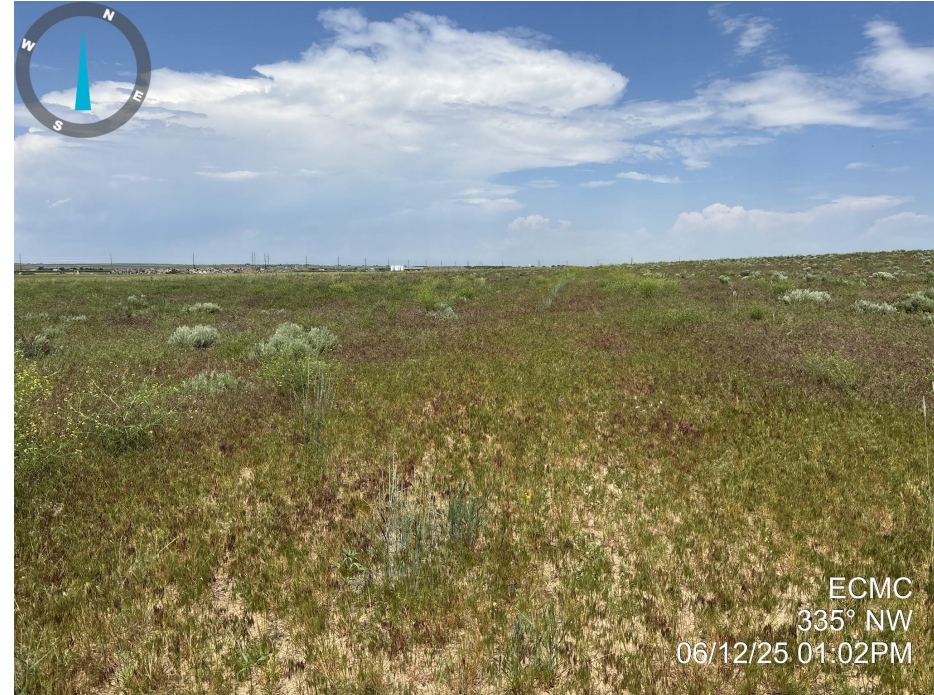
Photo 6. Photo taken of the access road, from the well location, facing Northwest. Photo illustrates that final reclamation has taken place, but the location is dominated by weedy annual vegetation, including cheatgrass (*Bromus tectorum*).

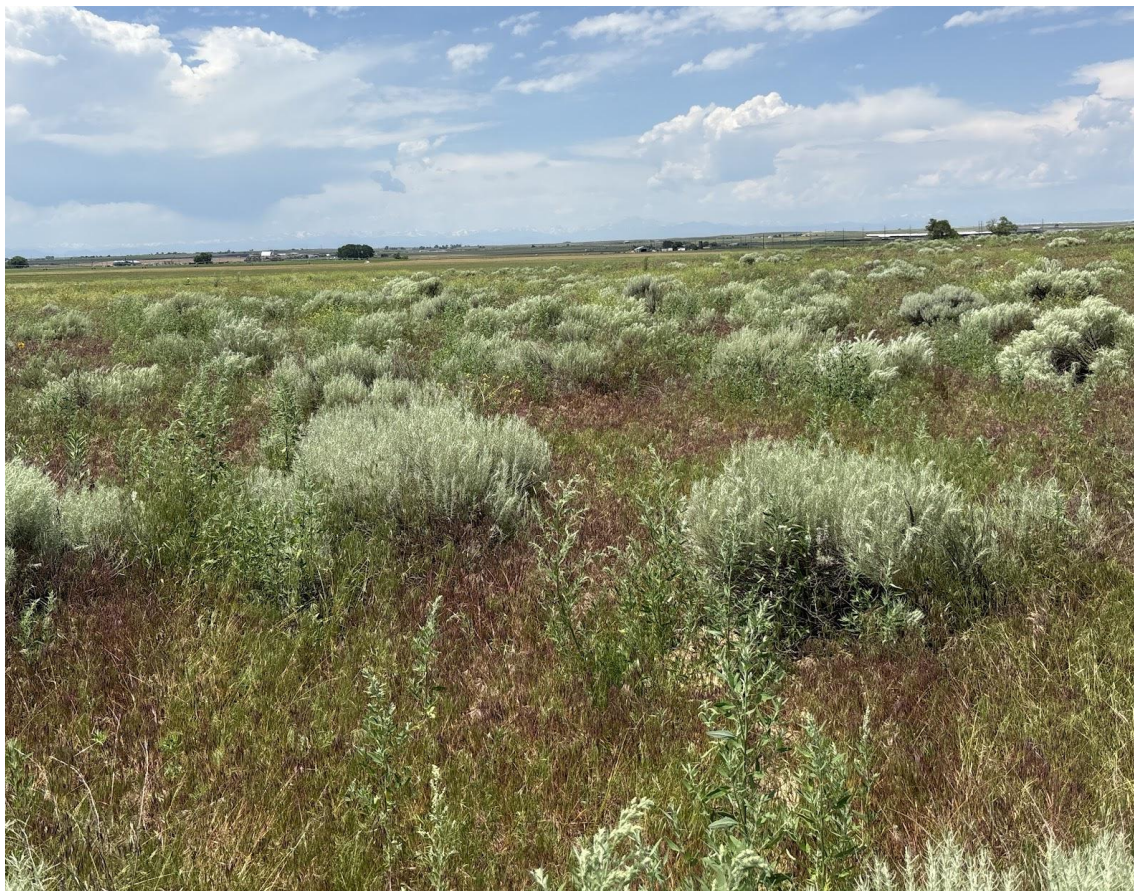
Photo 7. Photo taken of reference area to the well location, north of the location, facing West. Photo illustrates sand sagebrush (*Artemisia filifolia*), with some weedy annual vegetation, including cheatgrass (*Bromus tectorum*).
