# Final Reclamation Inspection

Operator: NOBLE ENERGY INC - 100322

Location ID: 330443

Inspection Photos  
Location Name: HSR-FOSTER #5-35  
Location ID: 330443

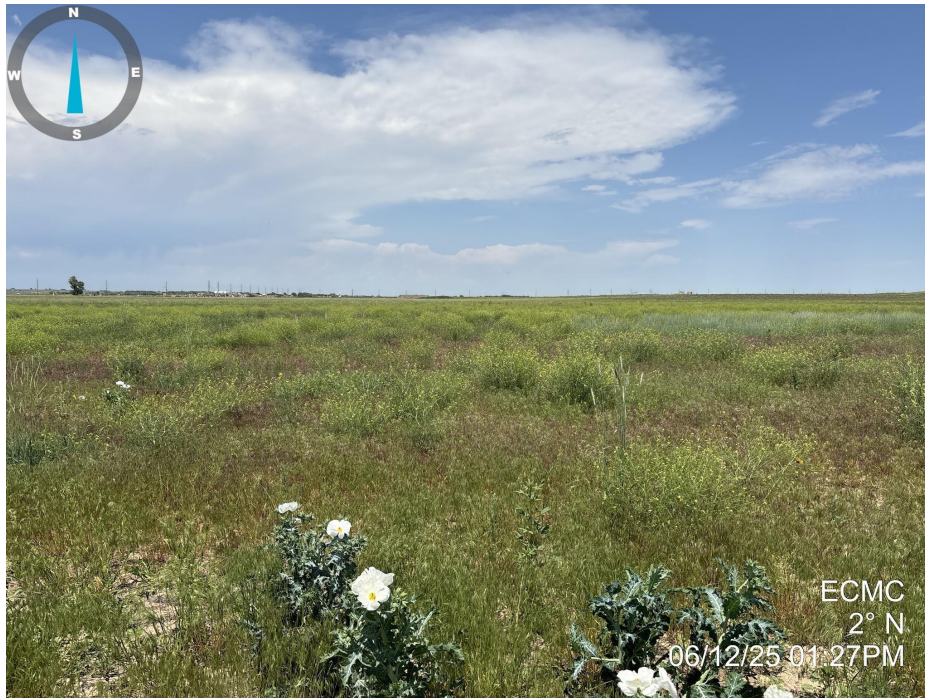
**Photo 1.** Photo taken from the well location, facing North. Photo illustrates that final reclamation activities have taken place, but vegetation establishment does not meet Rule 1004 standards. The site is dominated by weedy annual vegetation, including cheatgrass (*Bromus tectorum*), a List C Noxious Weed species.

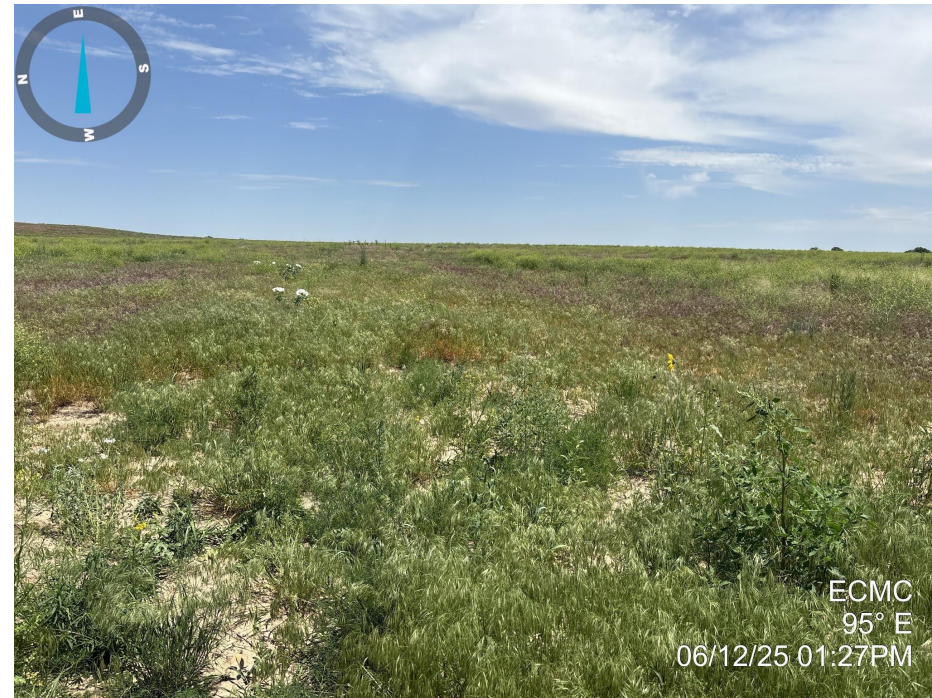
**Photo 2.** Photo taken from the well location, facing East. See comments under Photo 1.

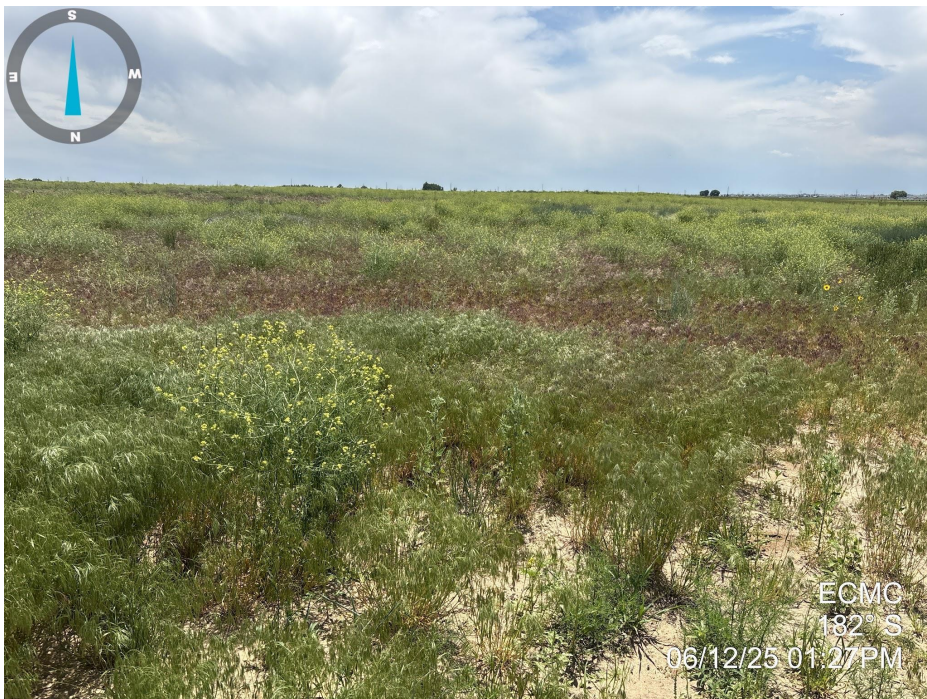
**Photo 3.** Photo taken from the well location, facing South. See comments under Photo 1.

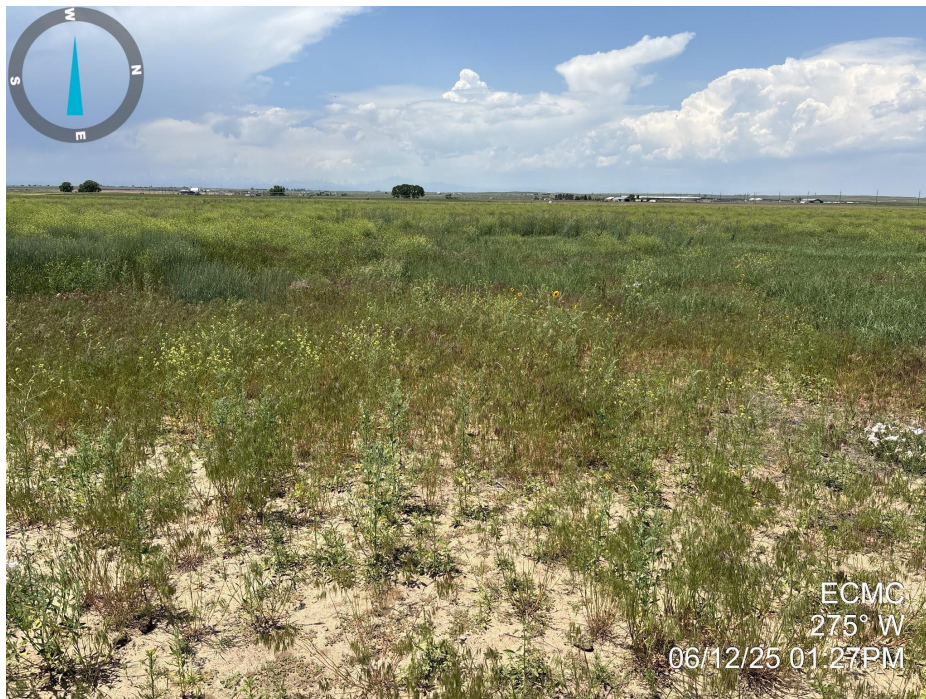
**Photo 4.** Photo taken from the well location, facing West. See comments under Photo 1.

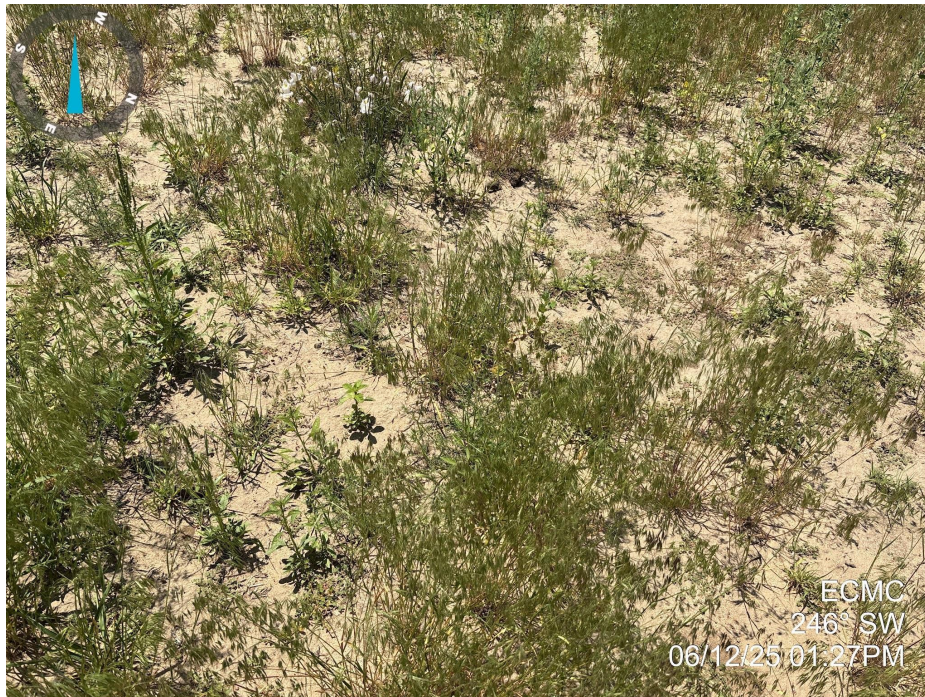
**Photo 5.** Photo taken of ground cover at the location. Photo illustrates bare ground and weedy annual vegetation, including cheatgrass (*Bromus tectorum*), a List C Noxious Weed species.

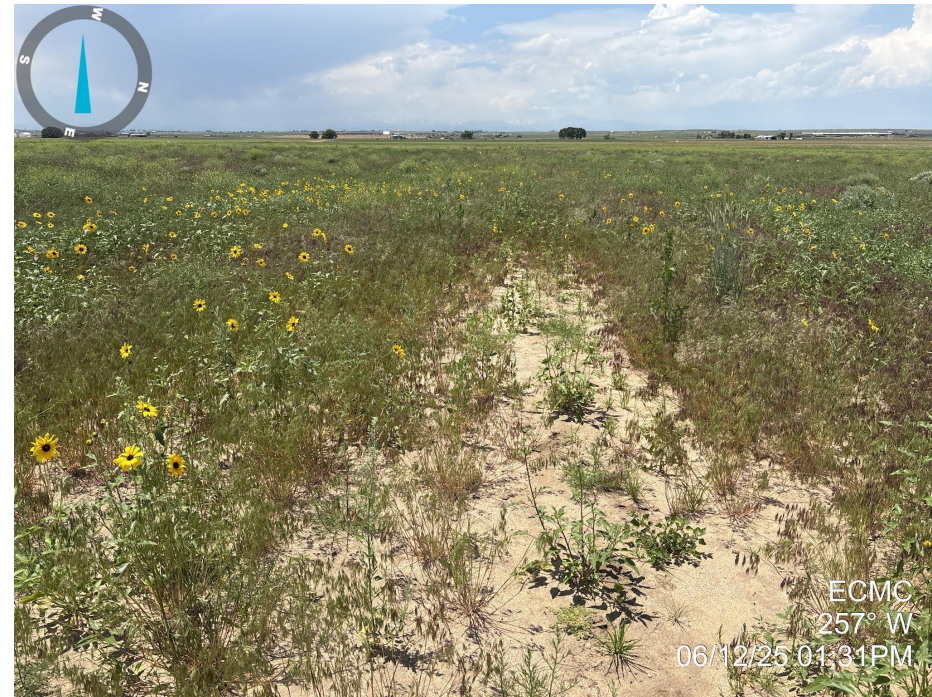
**Photo 6.** Photo taken of the access road, from the well location, facing west. Photo illustrates that final reclamation has taken place, but bare ground remains and the the location is dominated by weedy annual vegetation.

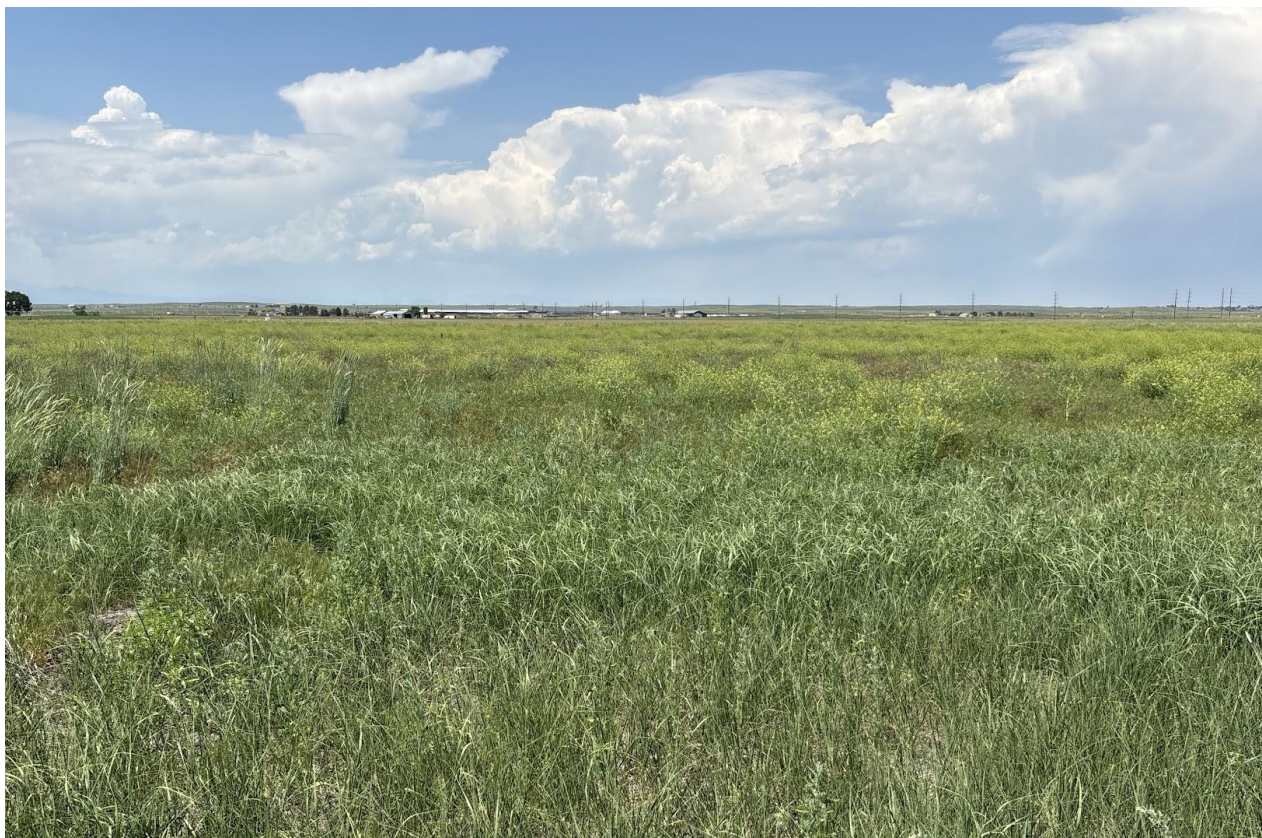
**Photo 7.** Photo taken of reference area to the well location, west of the location, facing west. Photo illustrates perennial grass with some weedy annual vegetation.
