Inspection Photos

Loc: 483009

Operator: BNL (ENTERPRISE) INC

Inspection Date: 7/2/2025

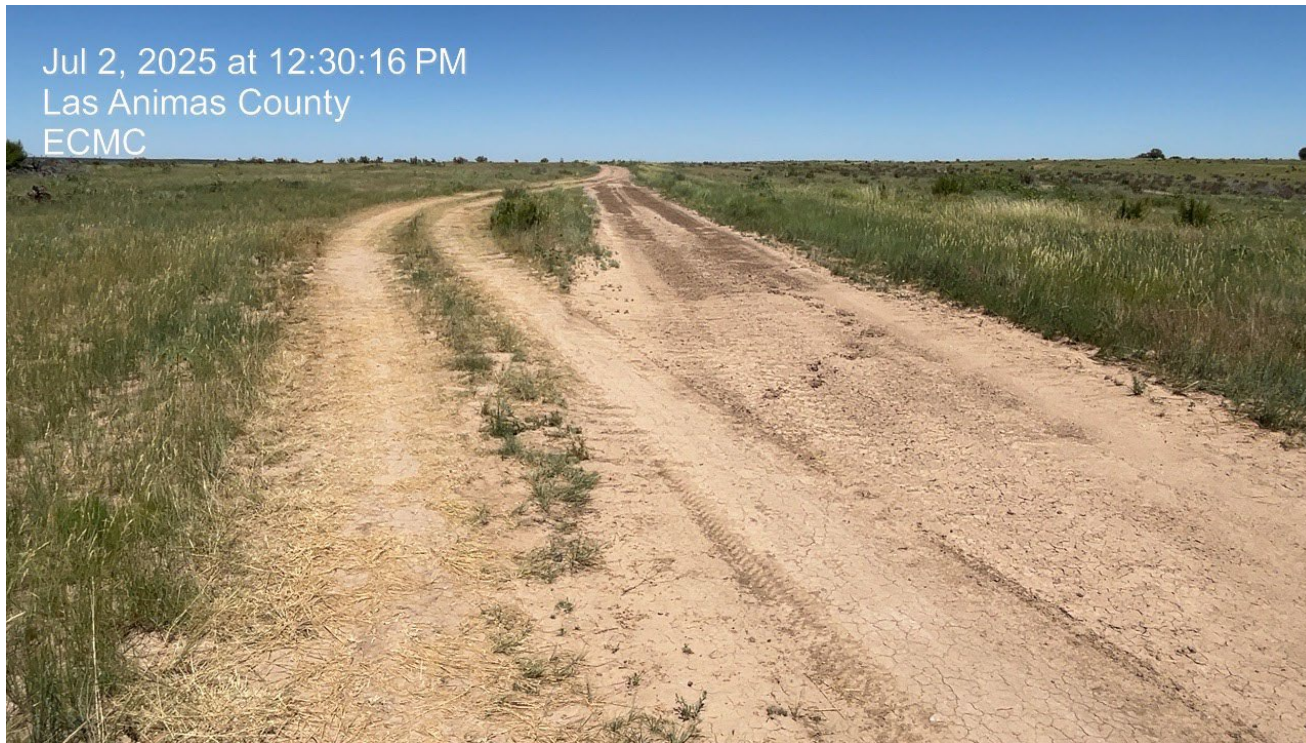
Photo 1. Facing northeast along the access road. Vehicles are driving outside of the road causing unnecessary disturbance. The road needs to be repaired and maintained.

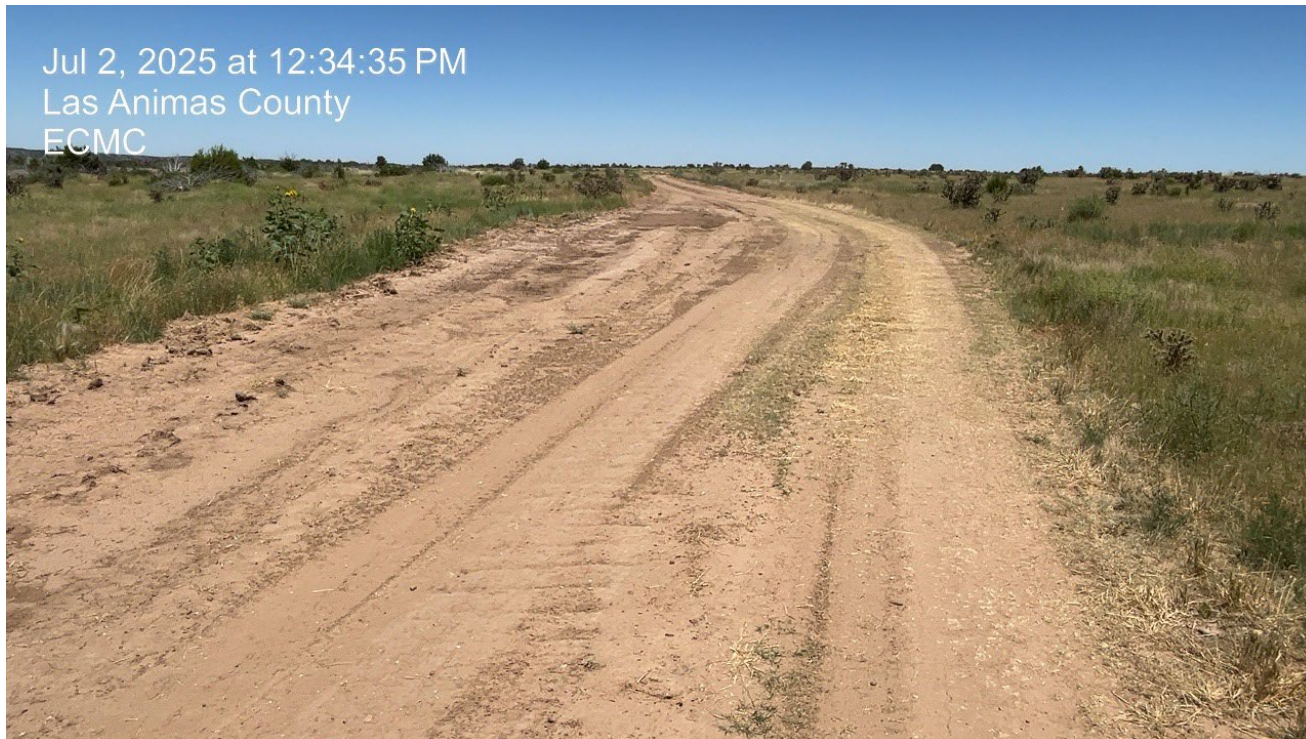
Photo 2. Facing northeast along the access road. Vehicles are driving outside of the road causing unnecessary disturbance. The road needs to be repaired and maintained.

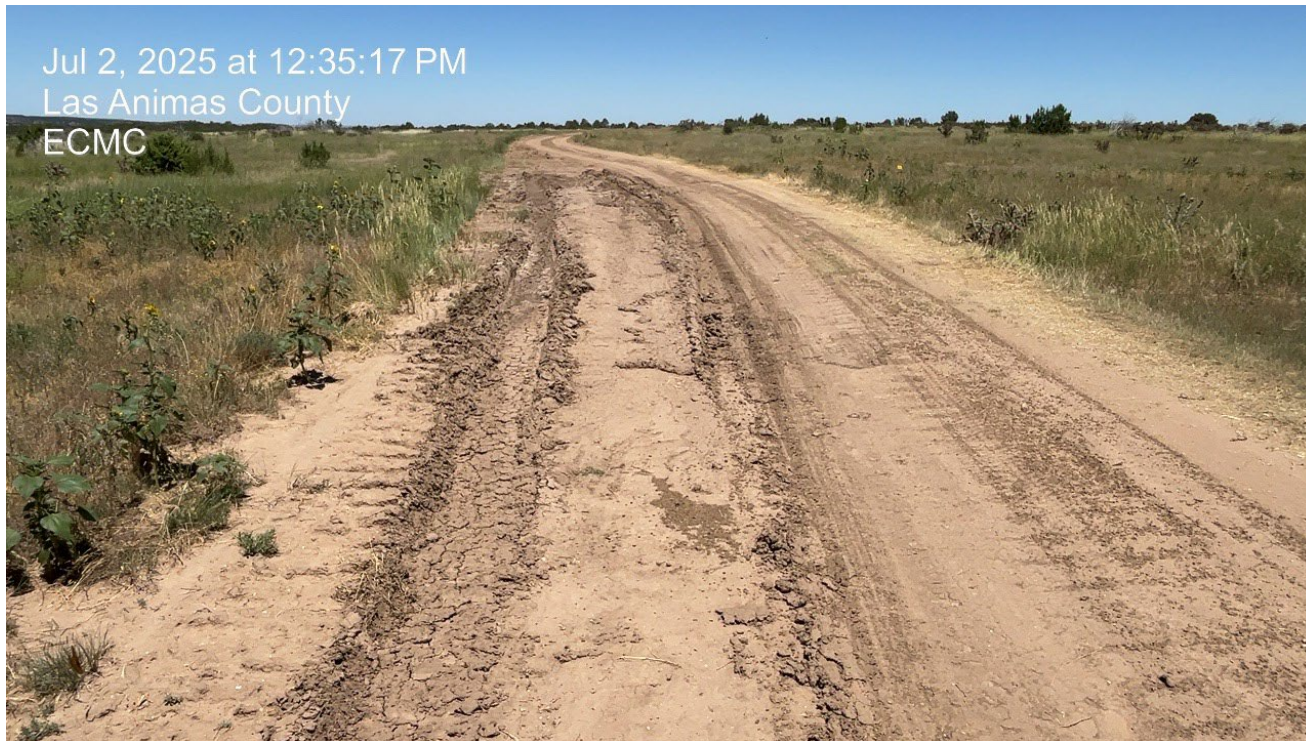
Photo 3. Facing north along the access road. Vehicles are driving outside of the road causing unnecessary disturbance. Vehicle tracking is occurring along the road.

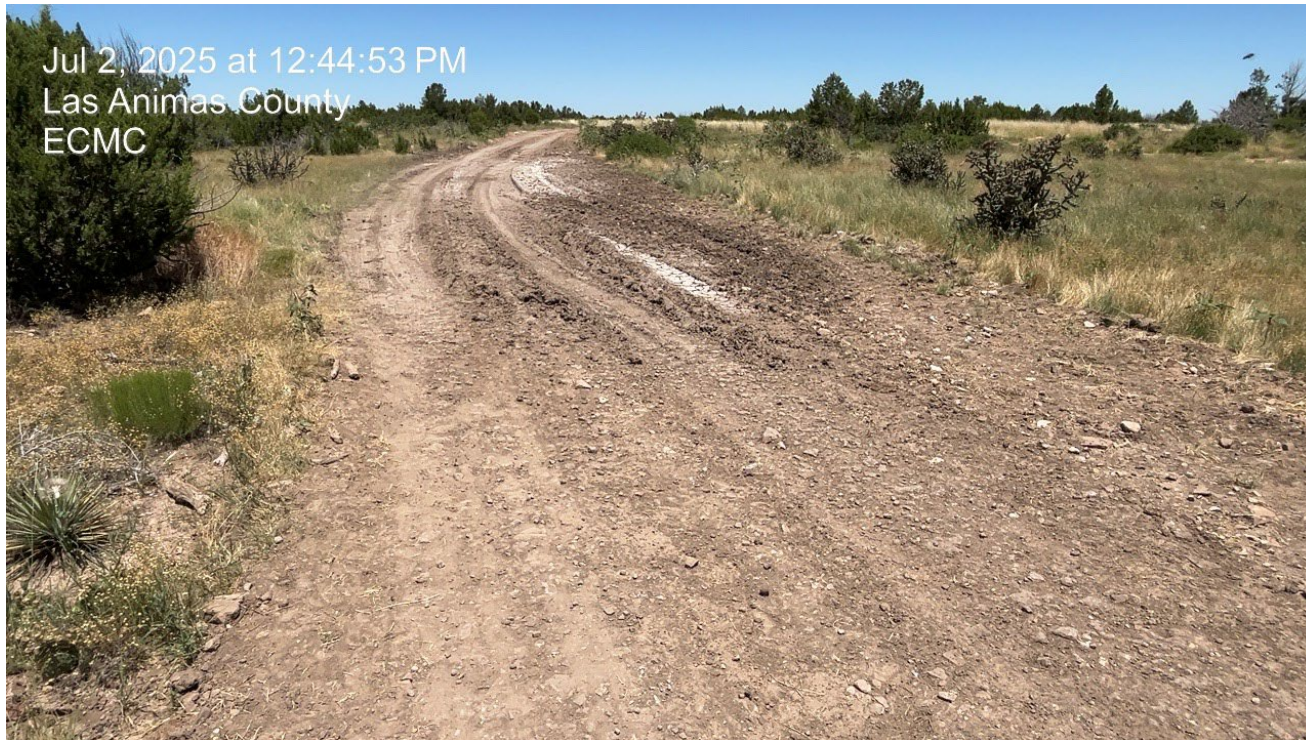
Photo 4. Facing north along the access road. Vehicles are driving outside of the road causing unnecessary disturbance. Vehicle tracking is occurring along the road.

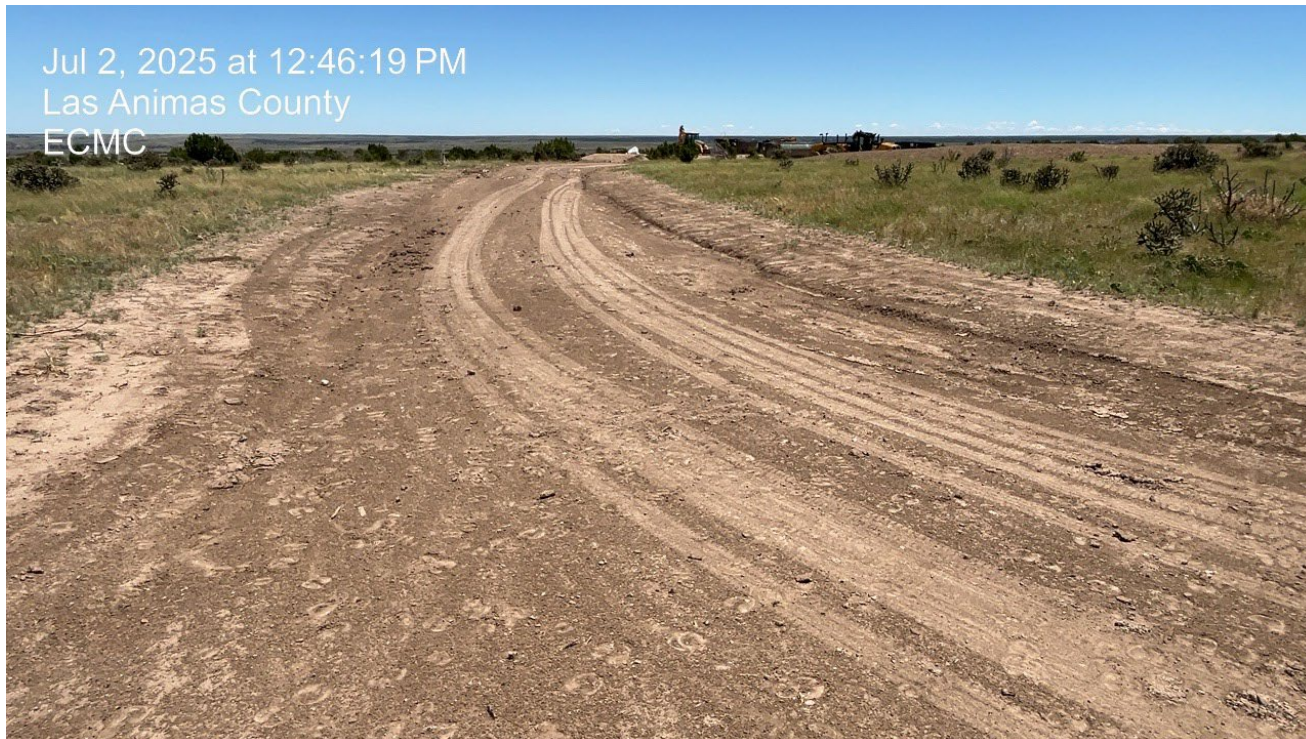
Photo 5. Facing east toward the access road. It appears topsoil was salvaged along this portion of the road.

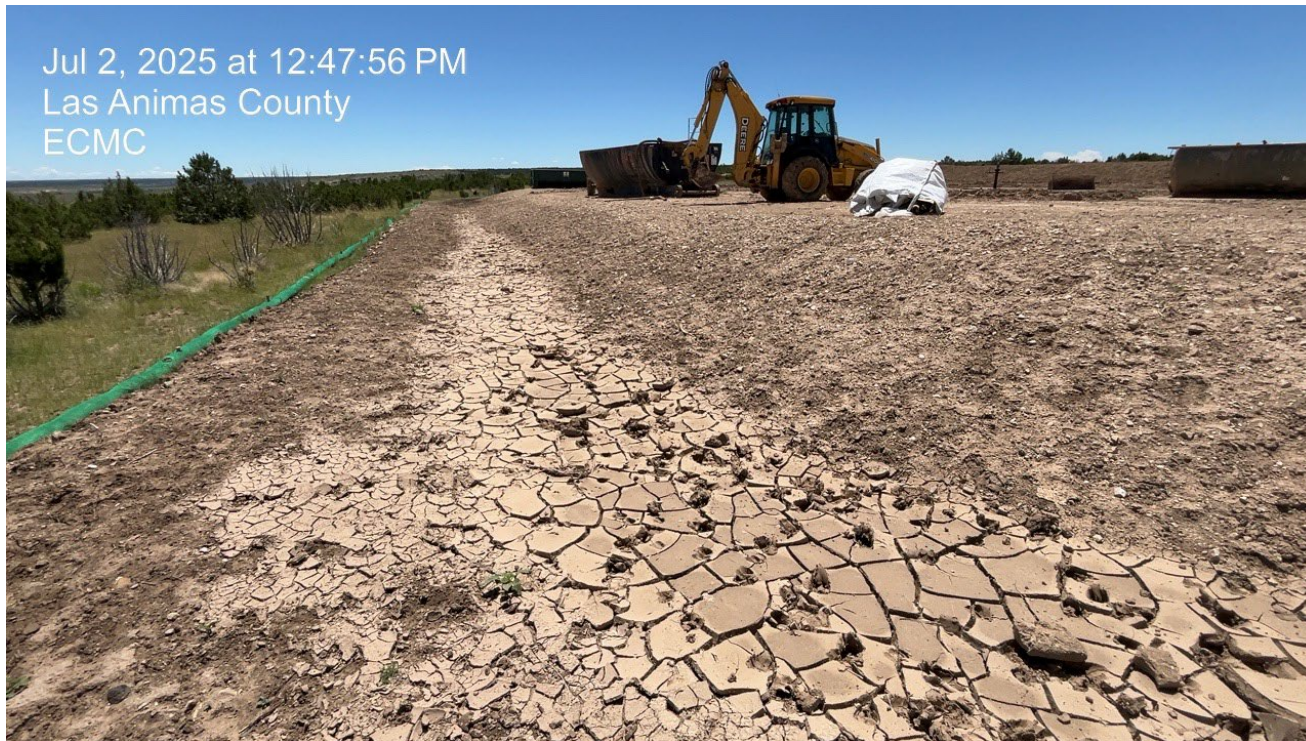
Photo 7. Facing south toward the east downhill perimeter. This ditch has filled in with sediment and needs to be cleaned out.

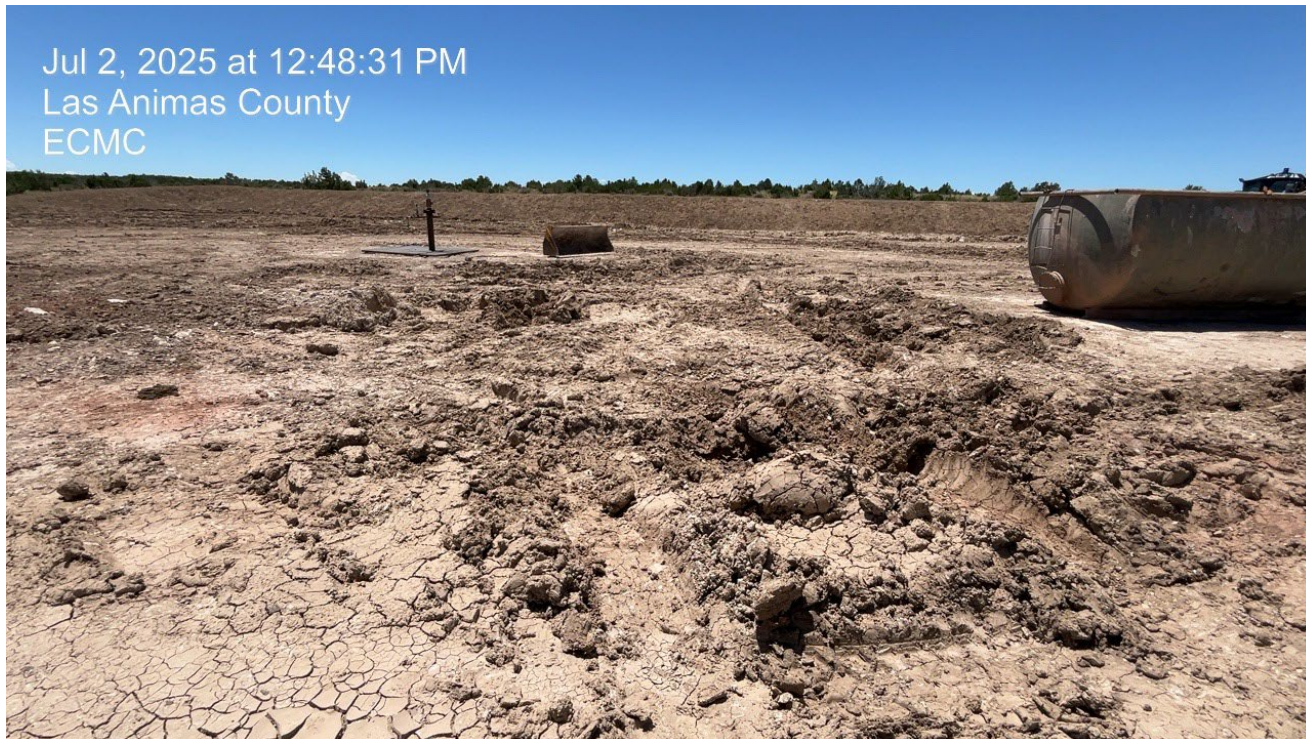
Photo 8. Facing west at the wellsite. The production area is not stabilized and there is vehicle tracking occurring.

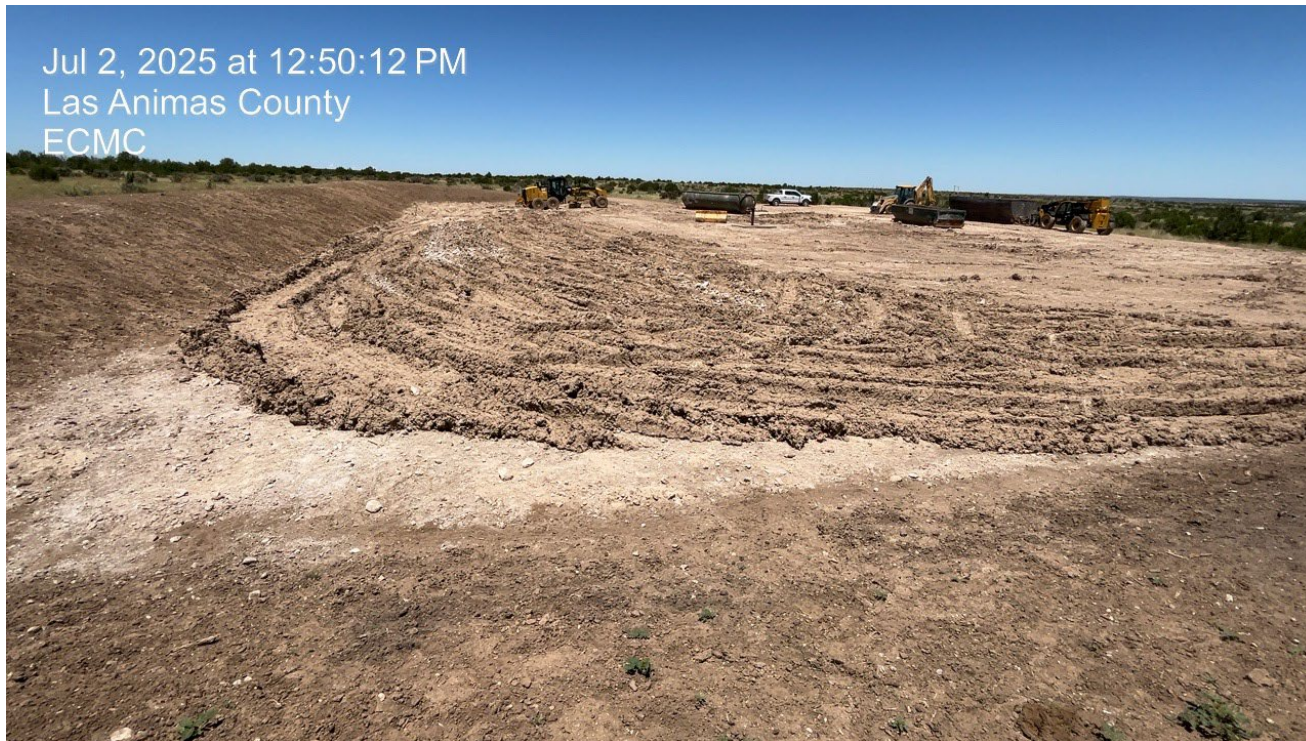
Photo 9. Facing northeast at the location. The production area is not stabilized and there is vehicle tracking occurring.

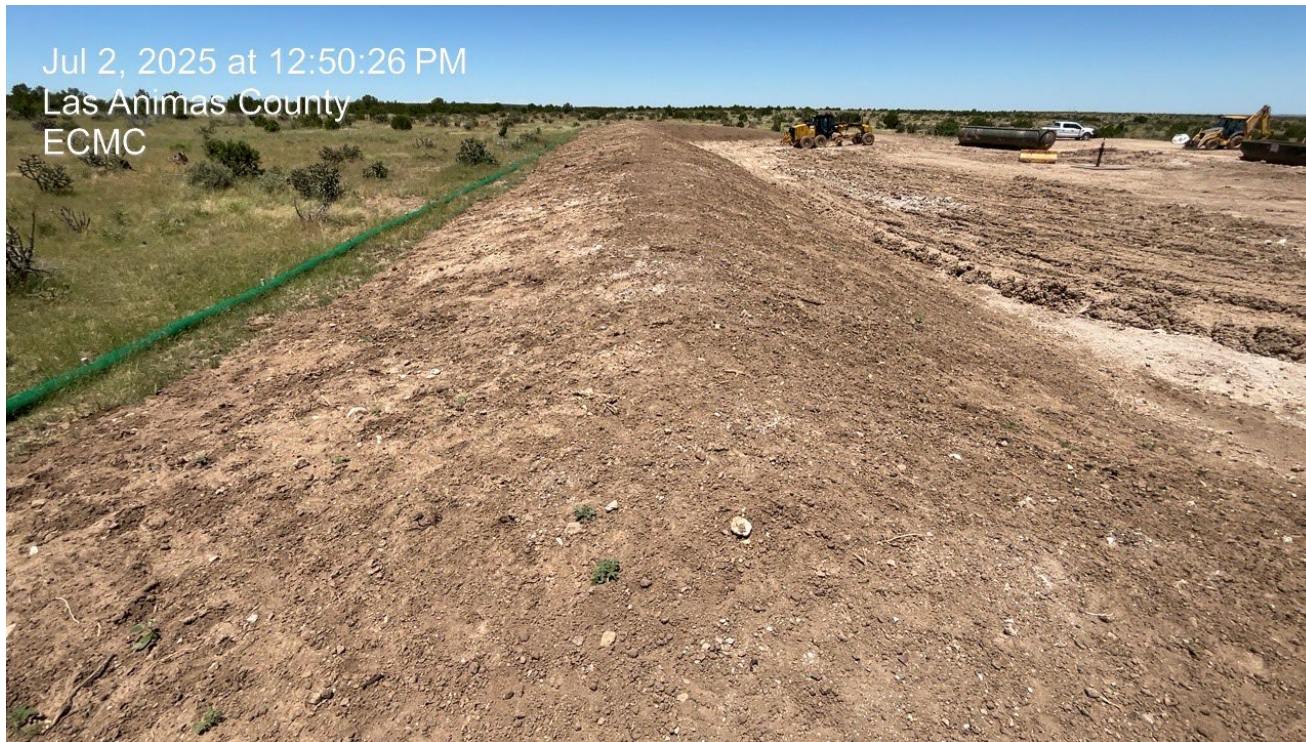
Photo 10. Facing north along the topsoil pile which needs to be seeded and stabilized.
