Inspection Photos

Loc: 307595

Operator: EVERGREEN NATURAL
RESOURCES LLC

Inspection Date: 7/7/2025

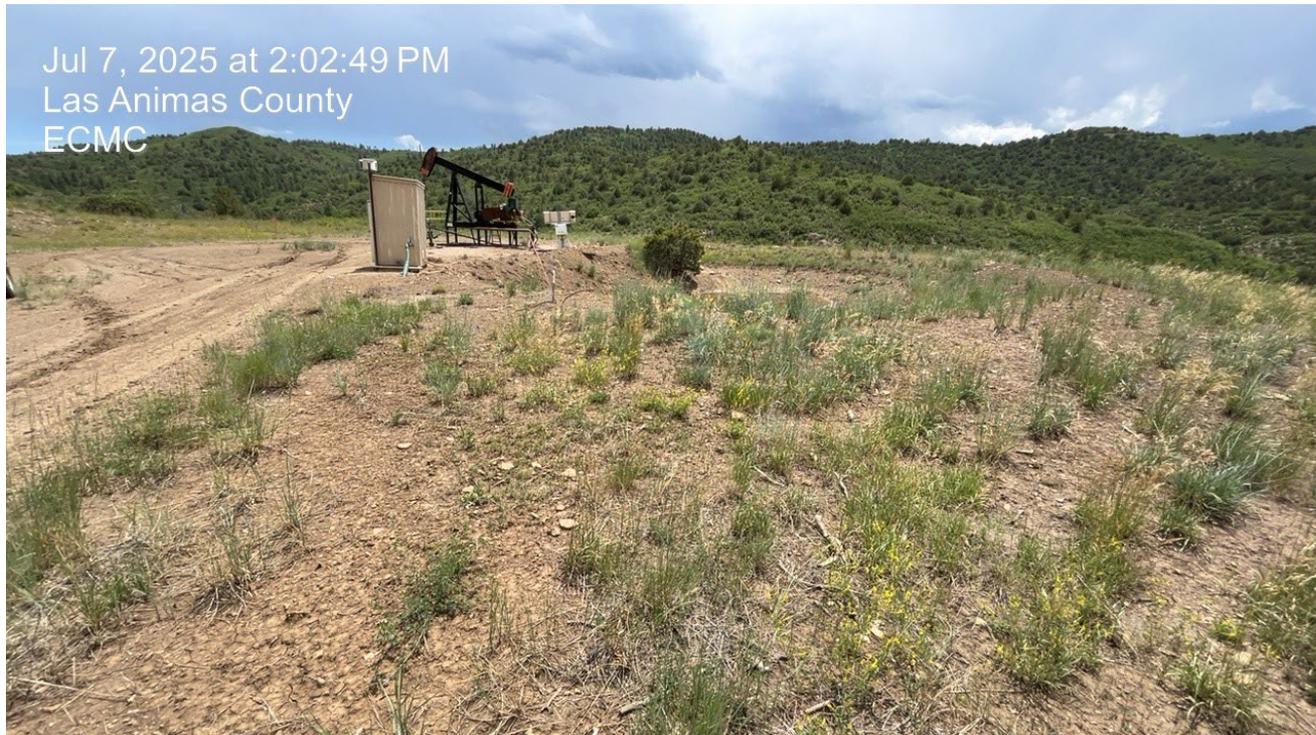
Photo 1. Facing southeast along the access road toward the wellsite.

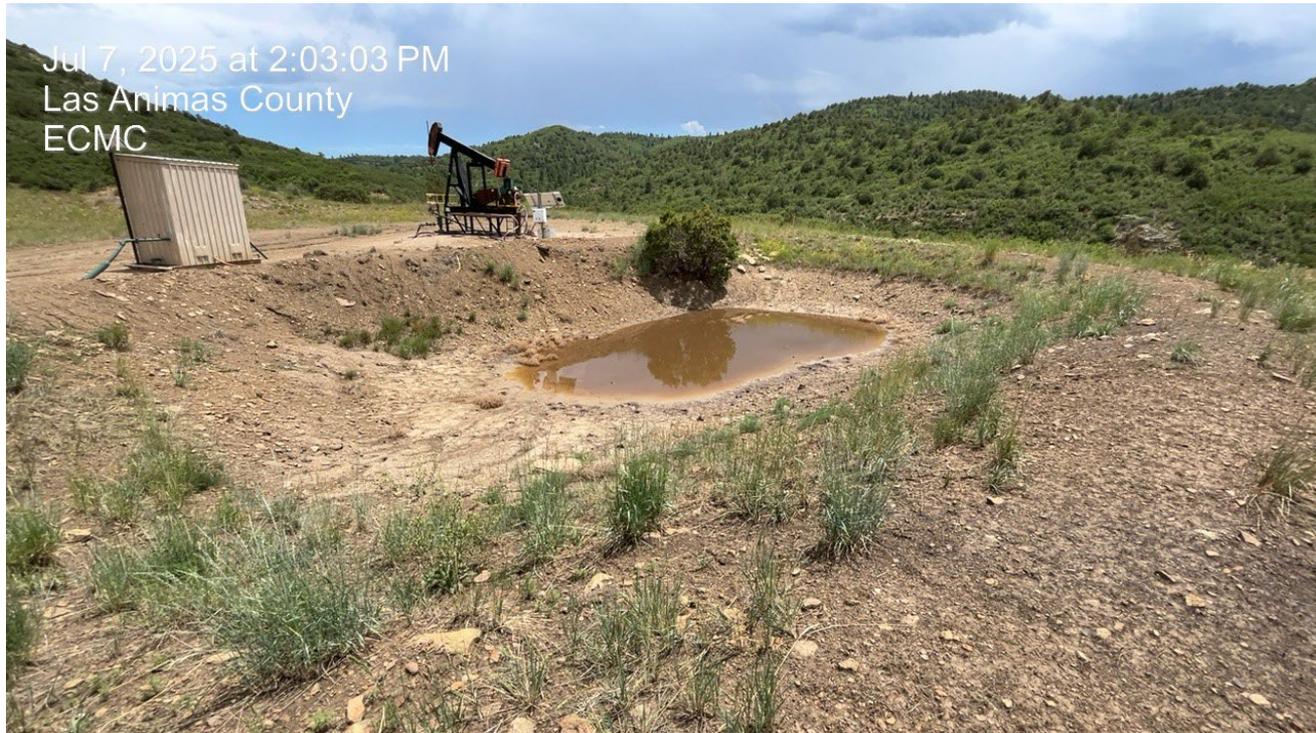
Photo 2. Facing southwest toward the produced water pit.

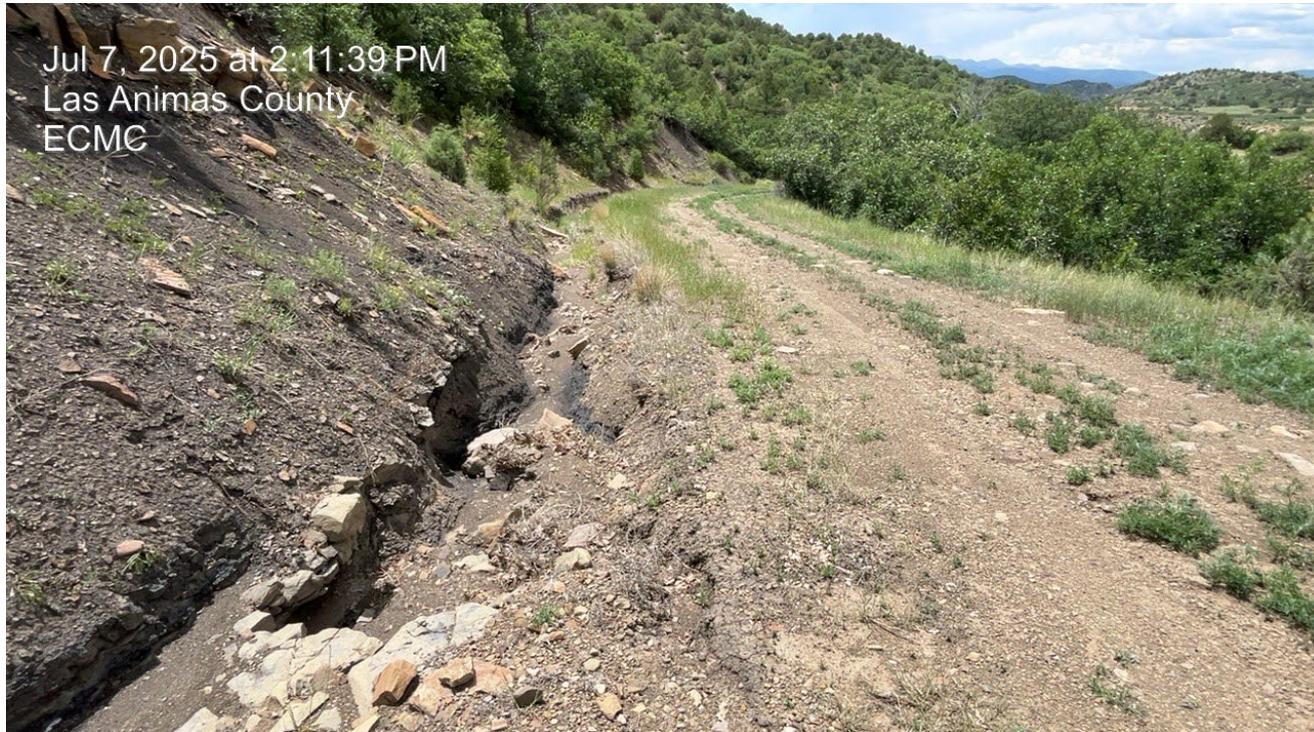
Photo 3. Facing west along the access road traveling east from the wellsite. This area along the road side has eroded and will need BMP's such as check dams, culverts, ect. to further prevent erosion.

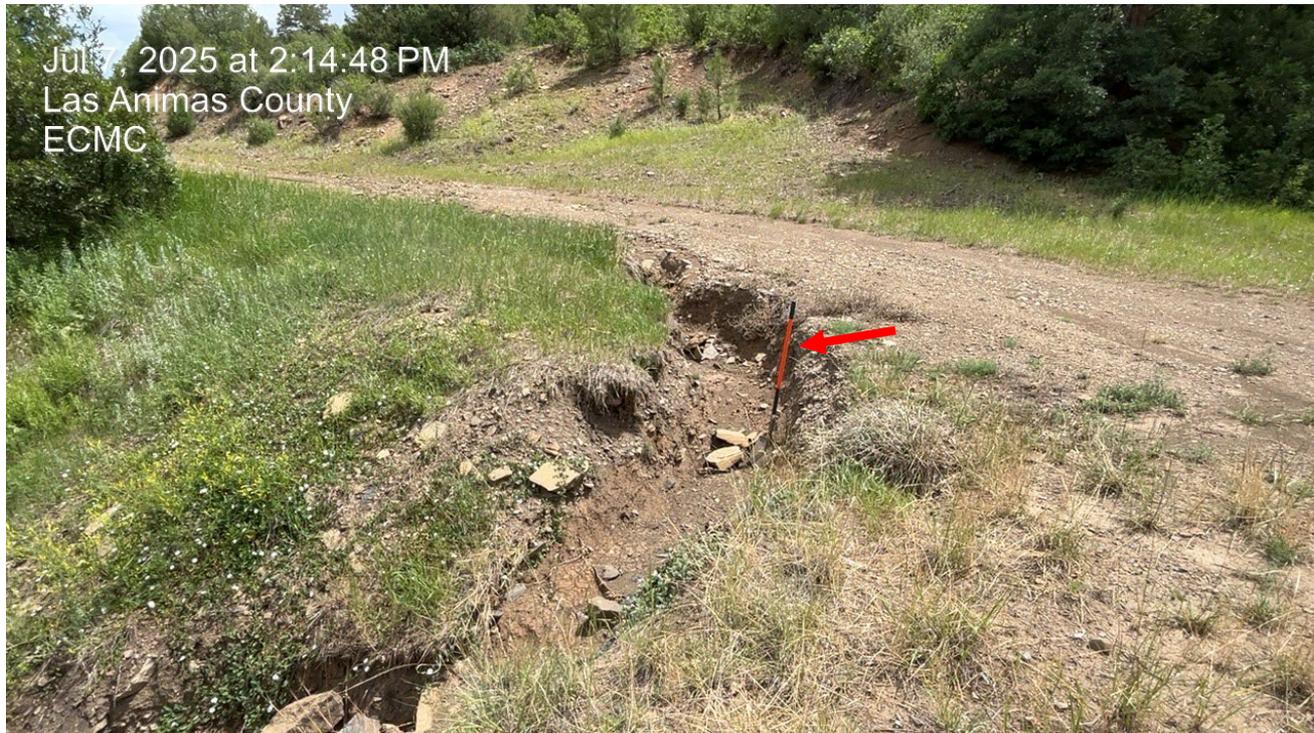
Photo 4. Facing east further along the road. This area has eroded and will need to be repaired and stabilized. Red arrow points to 4.5 ft shovel in the erosion gully.

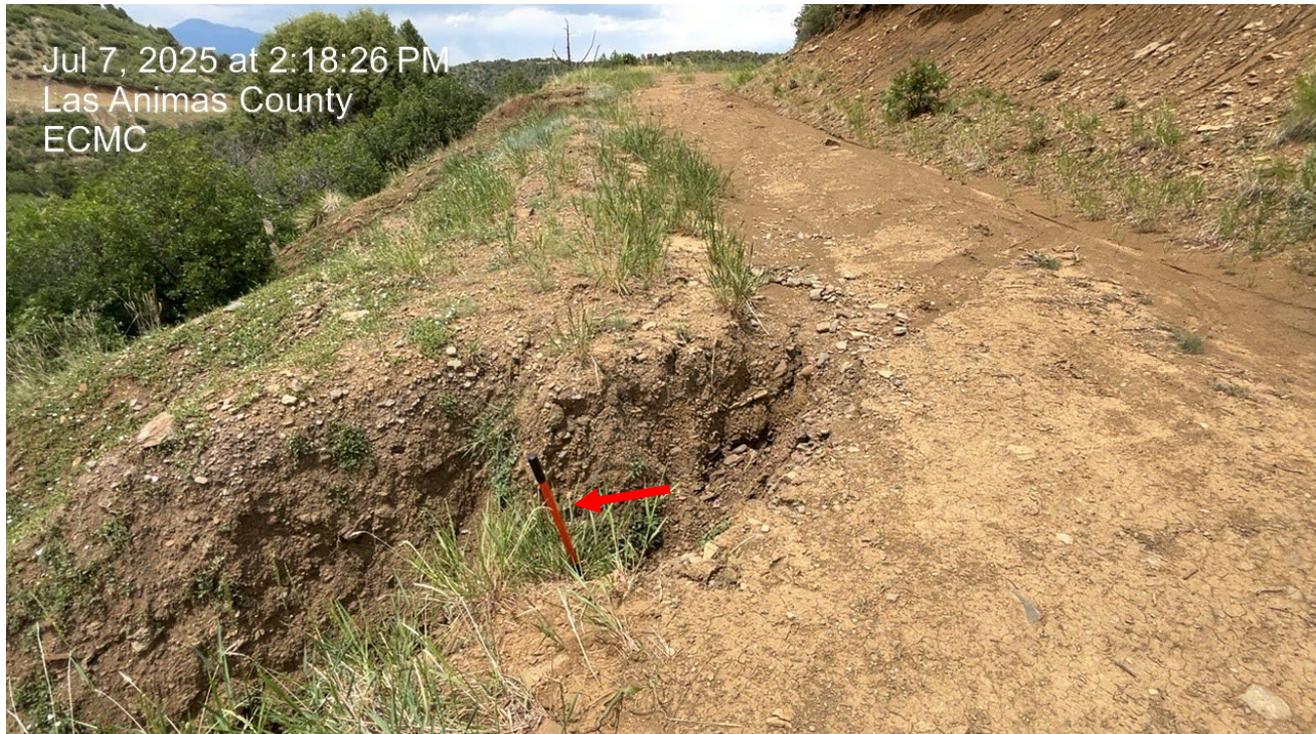
Photo 5. Facing north toward the fill slope of the road. This area has eroded and will need to be repaired and stabilized. Red arrow points to 4.5 ft shovel in the erosion gully.

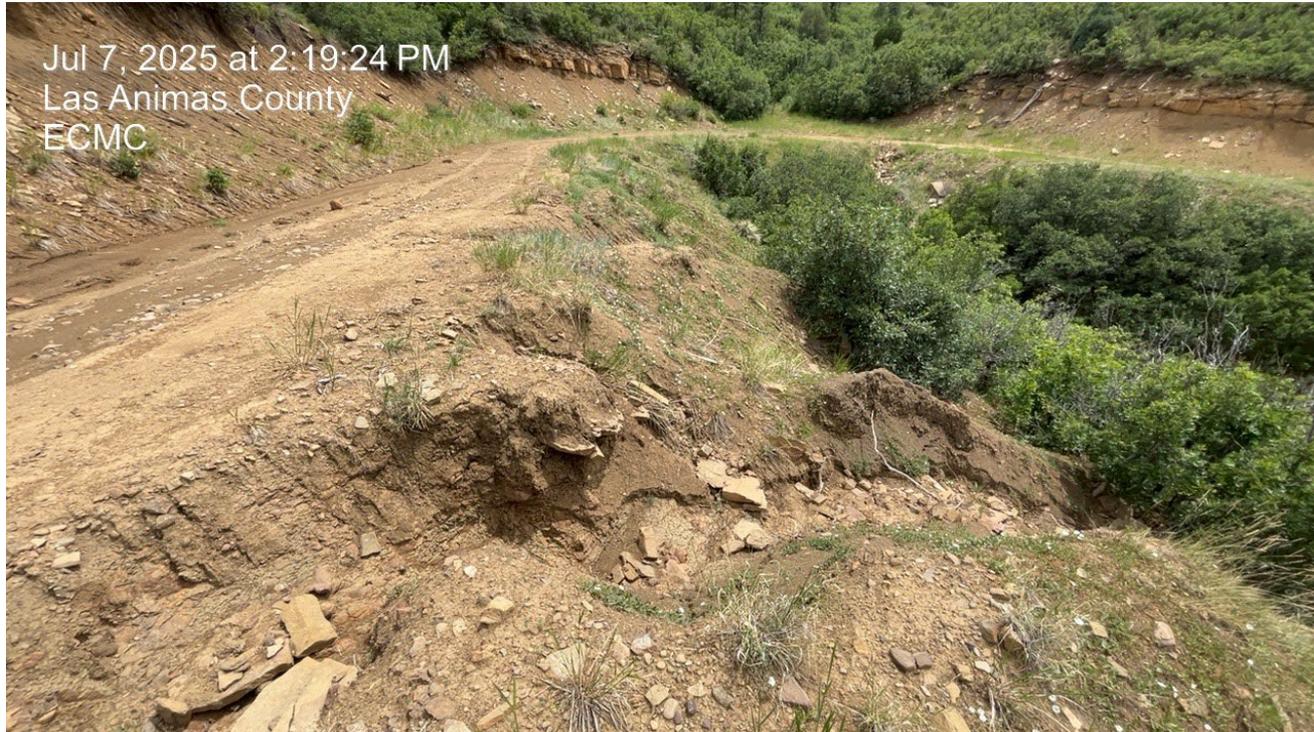
Photo 6. Facing back south at the same area as the previous photo. This area has eroded and will need to be repaired and stabilized.
