Final Reclamation Inspection

Operator: NOBLE ENERGY INC - 100322

Location ID: 327786

Inspection Photos
Location Name: CANNON H #35-13
Location ID: 327786

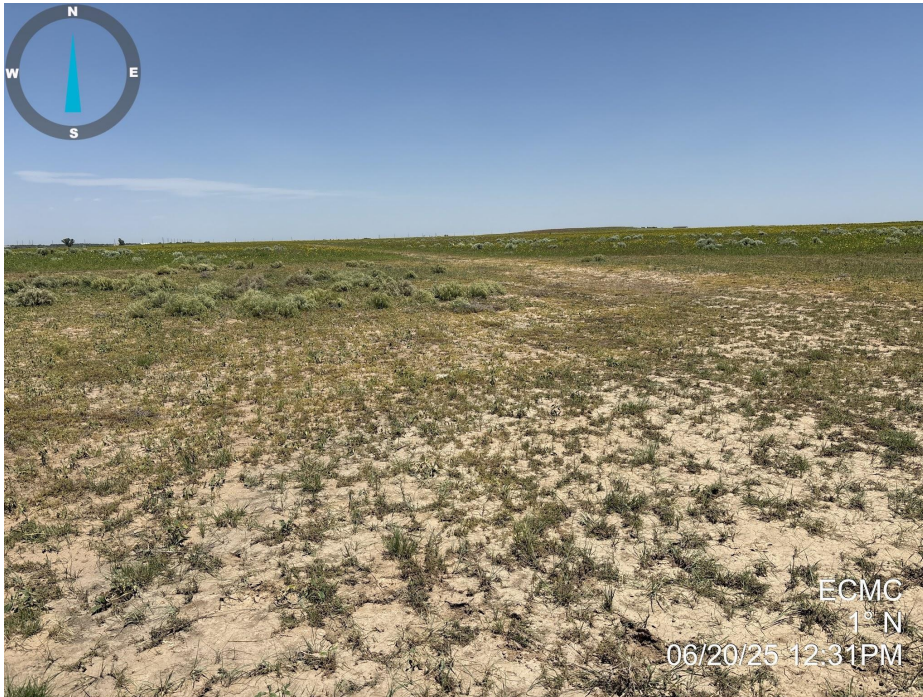
Photo 1. Photo taken from the well location, facing North. Photo illustrates that final reclamation activities have taken place, with evidence of drill row seeding. However, vegetation has not established to Rule 1004 standards.

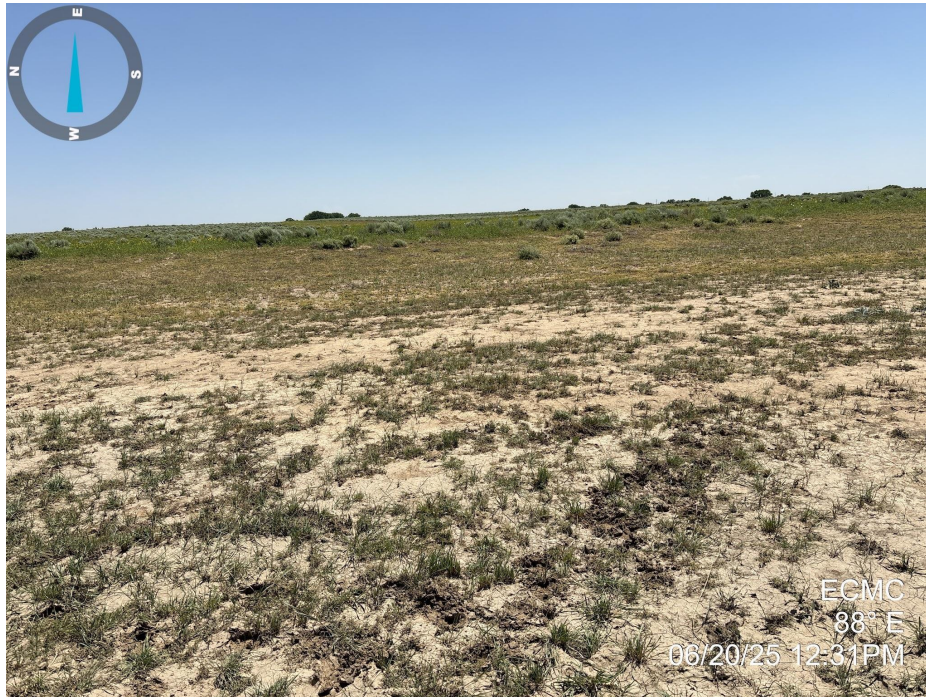
Photo 2. Photo taken from the well location, facing East. See comments under Photo 1.

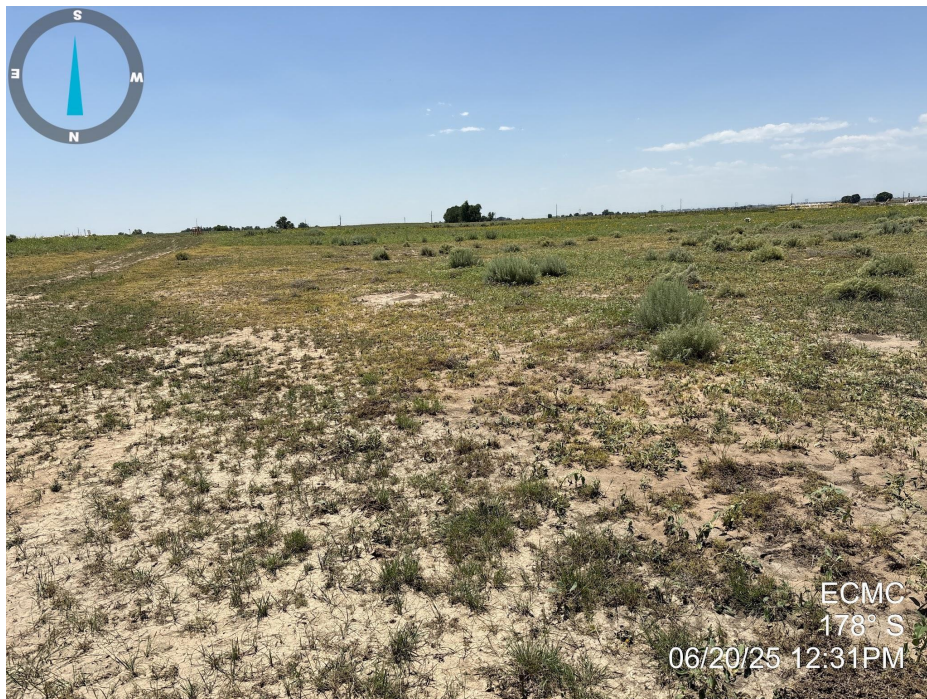
Photo 3. Photo taken from the well location, facing South. See comments under Photo 1.

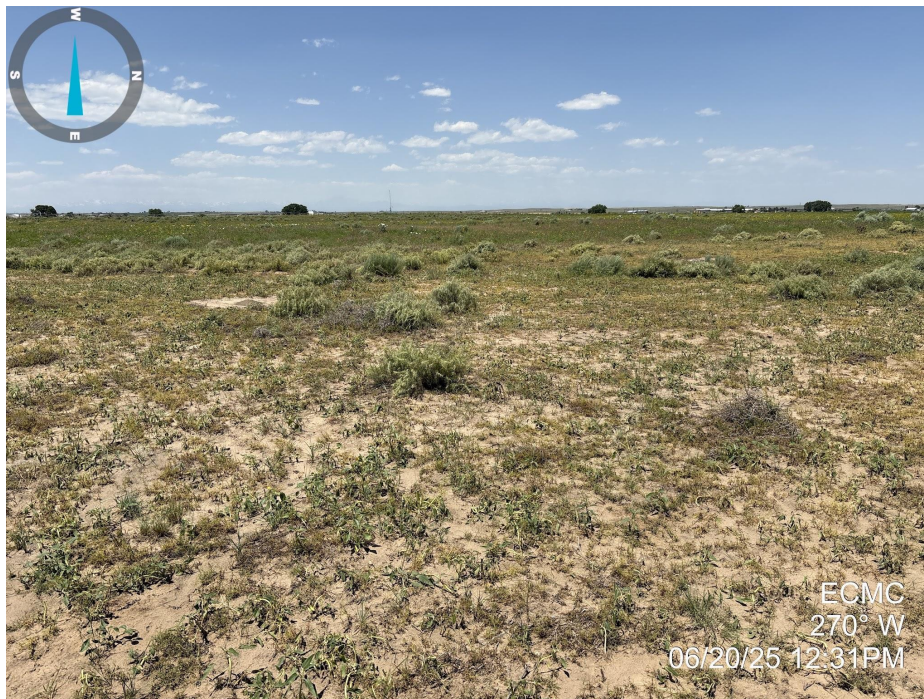
Photo 4. Photo taken from the well location, facing West. See comments under Photo 1.

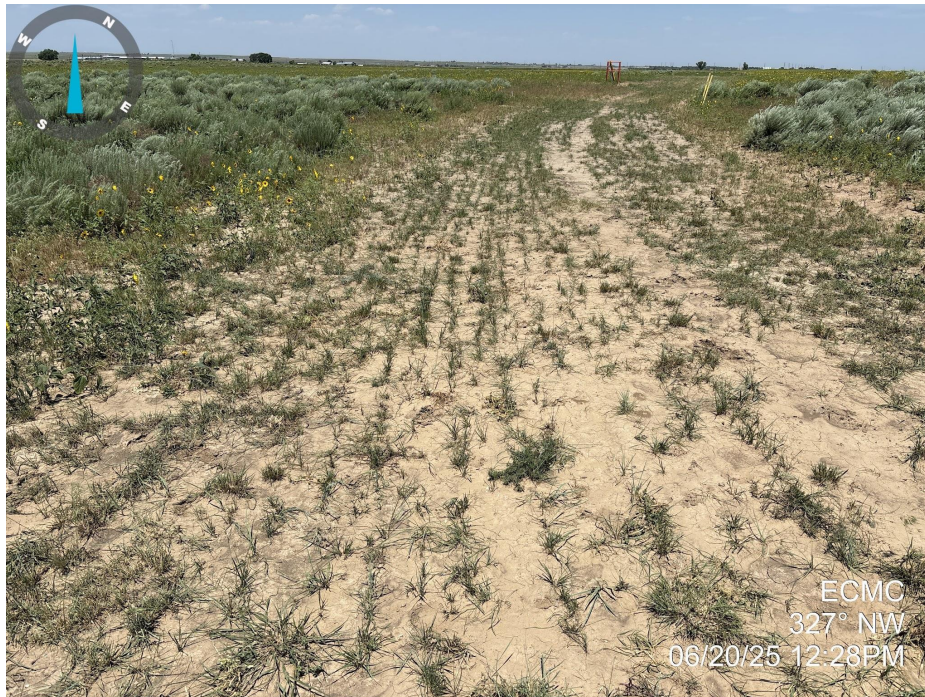
Photo 5. Photo taken of the access road to the well location, facing Northwest towards the location. Photo illustrates that final reclamation activities have taken place, with evidence of drill row seeding, but vegetation has not established to Rule 1004 standards.

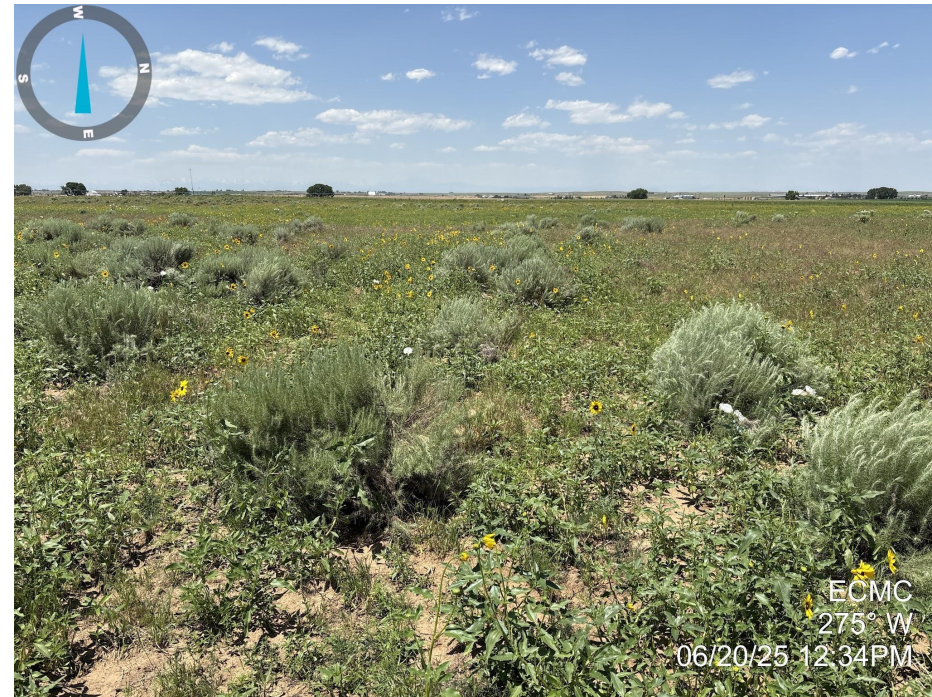
Photo 6. Photo taken of the reference area, located west of the well location, facing West. Photo illustrates sand sagebrush (*Artemisia filifolia*) and annual vegetation.
