Final Reclamation Inspection

Operator: NOBLE ENERGY INC - 100322

Location ID: 418282

Inspection Photos
Location Name: Cannon H #35-21
Location ID: 418282

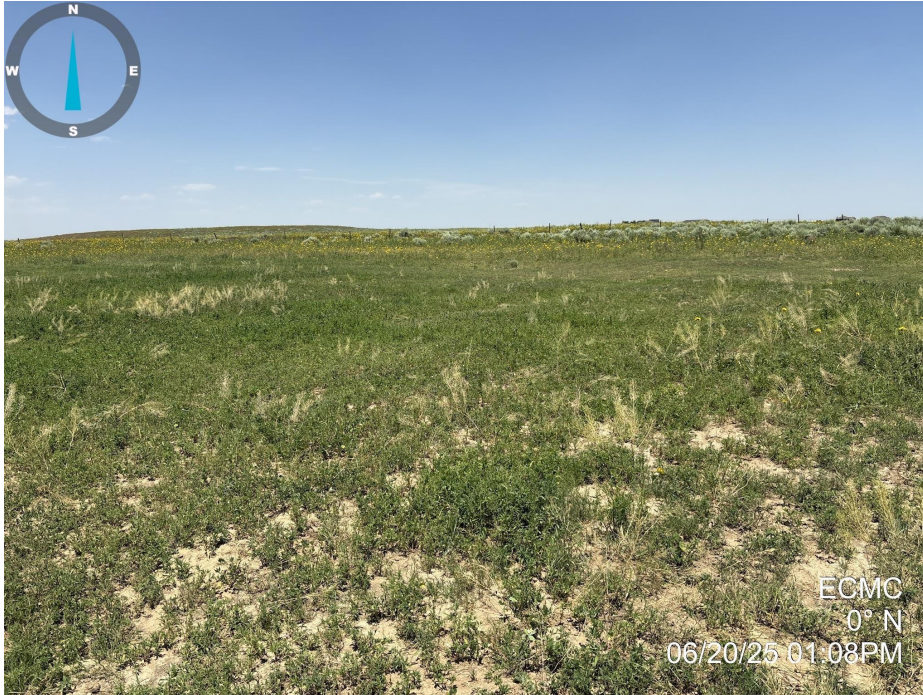
Photo 1. Photo taken from the well location, facing North. Photo illustrates that final reclamation activities have taken place, with evidence of drill row seeding, but vegetation has not established to Rule 1004 standards.

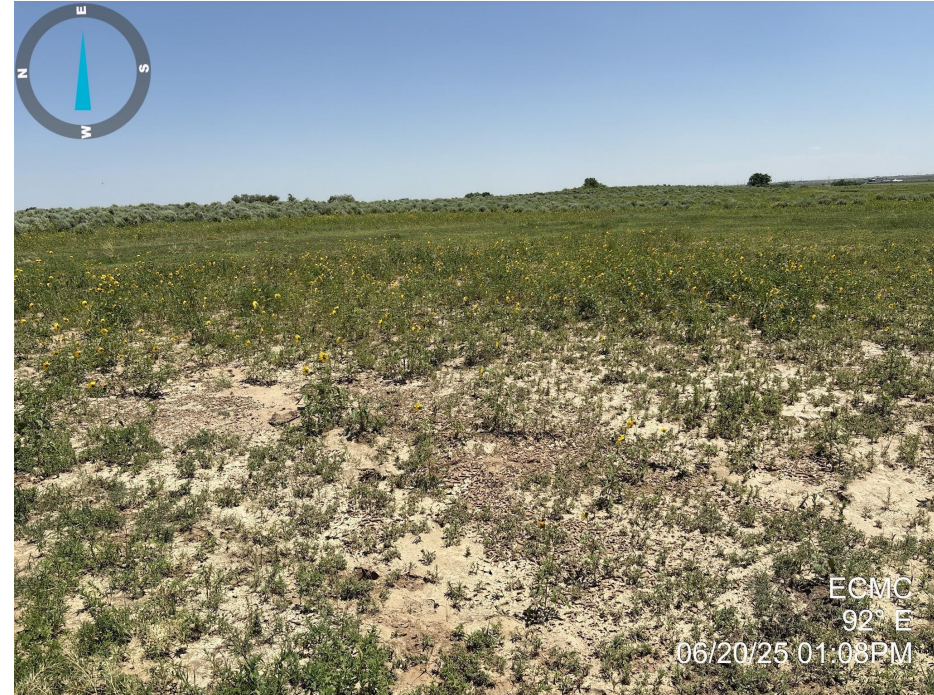
Photo 2. Photo taken from the well location, facing East. See comments under Photo 1.

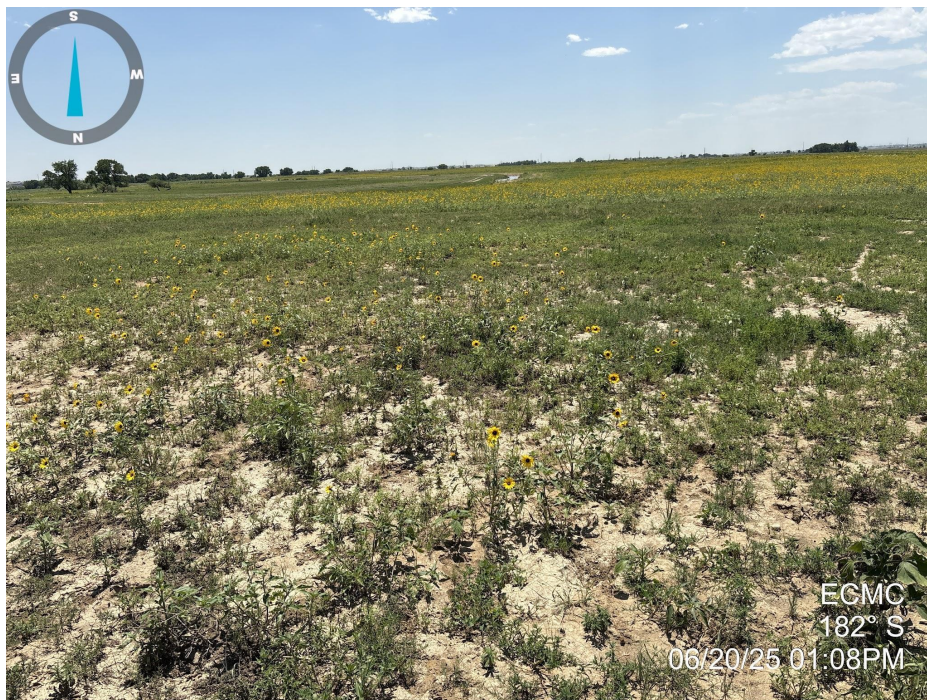
Photo 3. Photo taken from the well location, facing South. See comments under Photo 1.

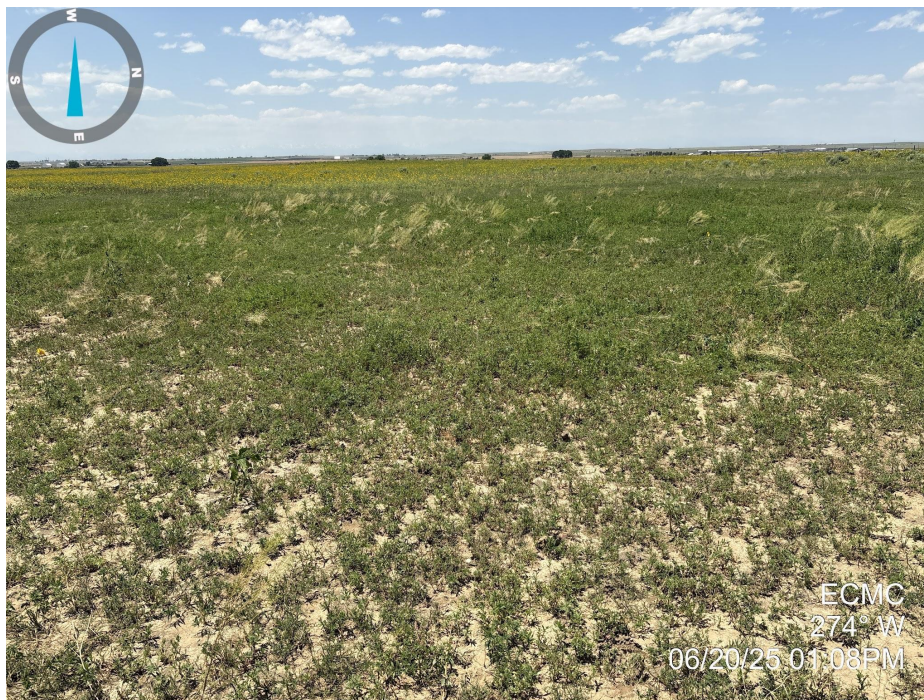
Photo 4. Photo taken from the well location, facing West. See comments under Photo 1.

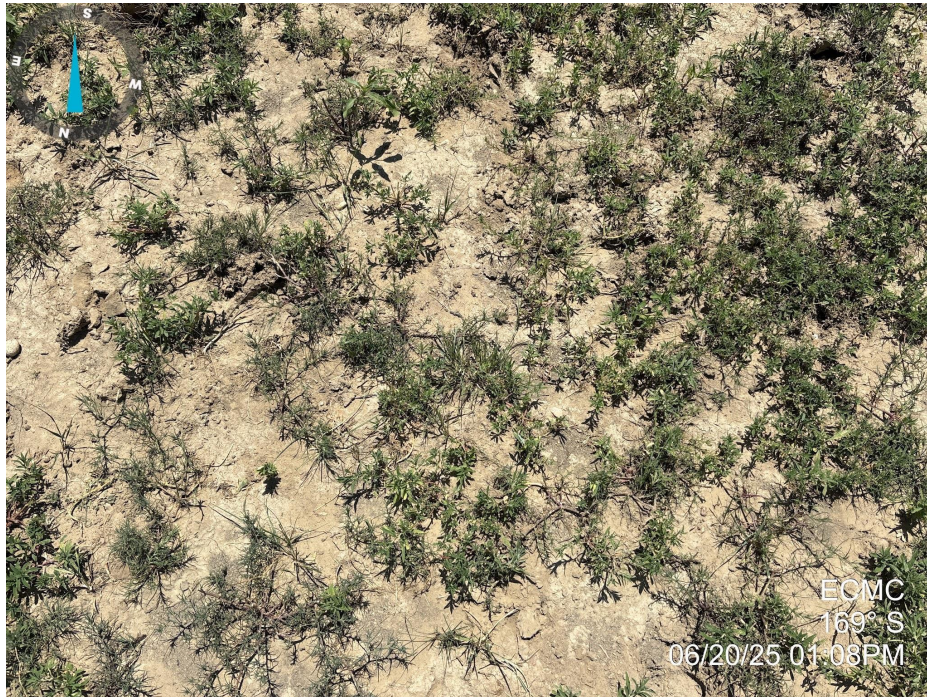
Photo 5. Photo taken of the ground cover at the well location. Photo illustrates weedy annual vegetation including russian thistle (*Salsola tragus*).

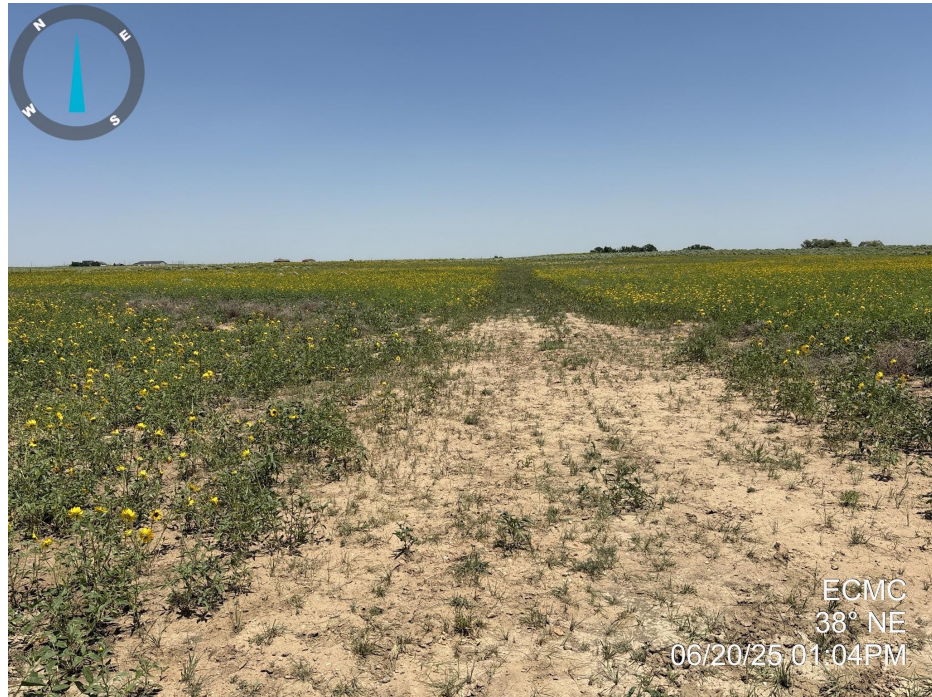
Photo 6. Photo taken of the access road to the well location, facing Northeast. Photo illustrates that final reclamation activities have taken place, with evidence of drill row seeding, but vegetation establishment does not meet Rule 1004 standards.

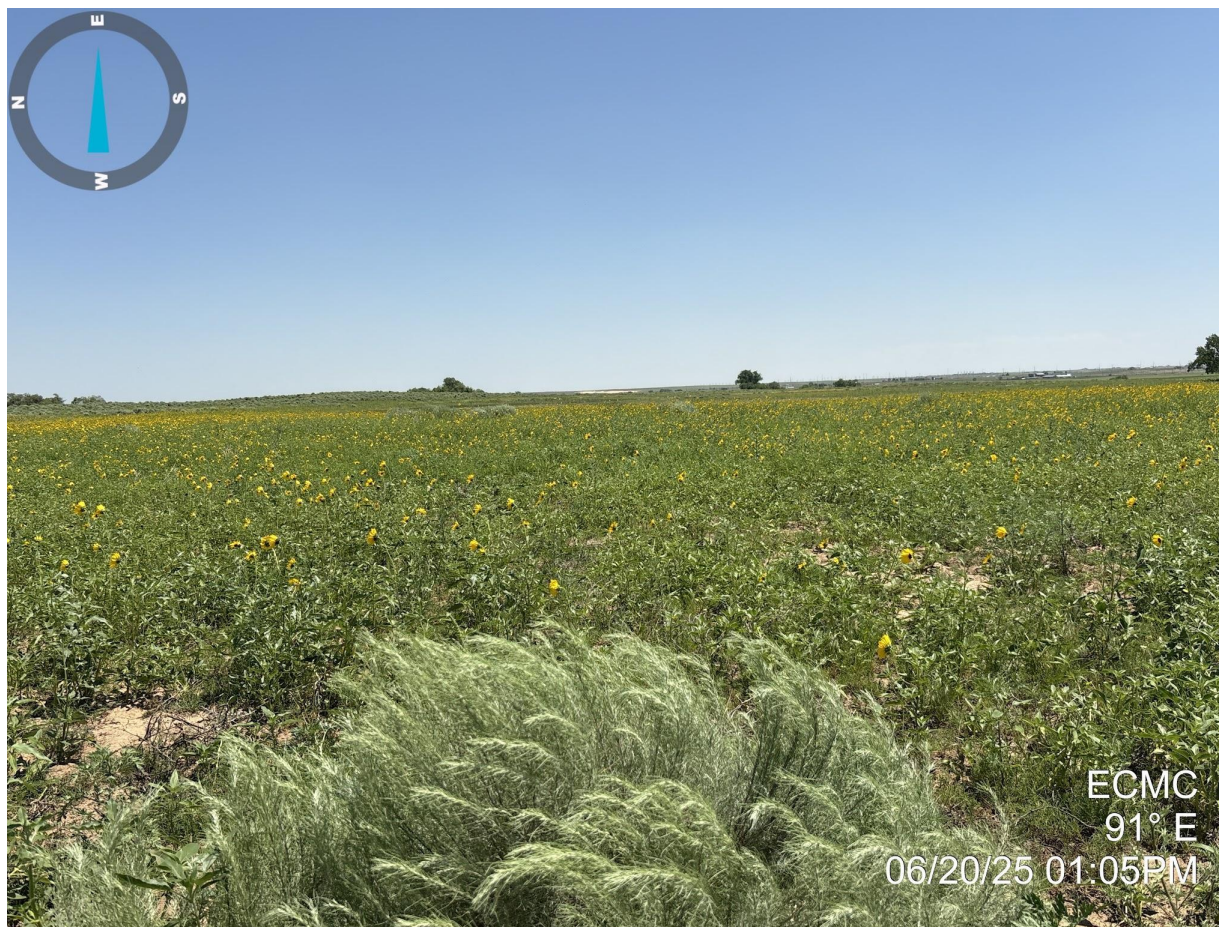
Photo 7. Photo taken of the reference area, located southwest of the well location, facing east. Photo illustrates sand sagebrush (*Artemisia filifolia*) and annual vegetation including prairie sunflower (*Helianthus petiolaris*).
