Final Reclamation Inspection

Operator: NOBLE ENERGY INC - 100322

Location ID: 418276

Inspection Photos
Location Name: Cannon H #35-24
Location ID: 418276

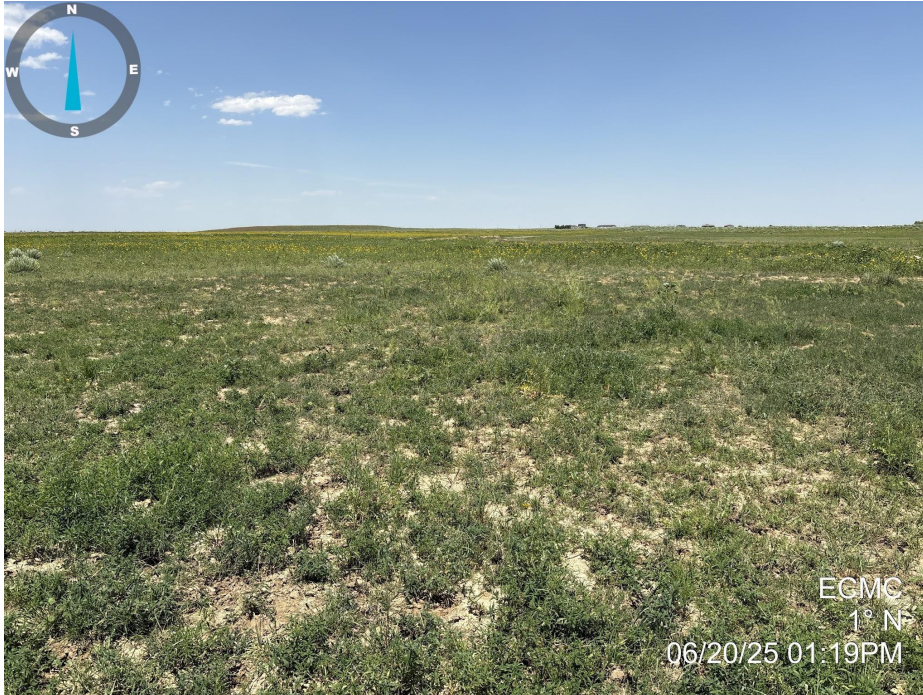
Photo 1. Photo taken from the well location, facing North. Photo illustrates that final reclamation activities have taken place, with evidence of drill row seeding, but vegetation has not established to Rule 1004 standards.

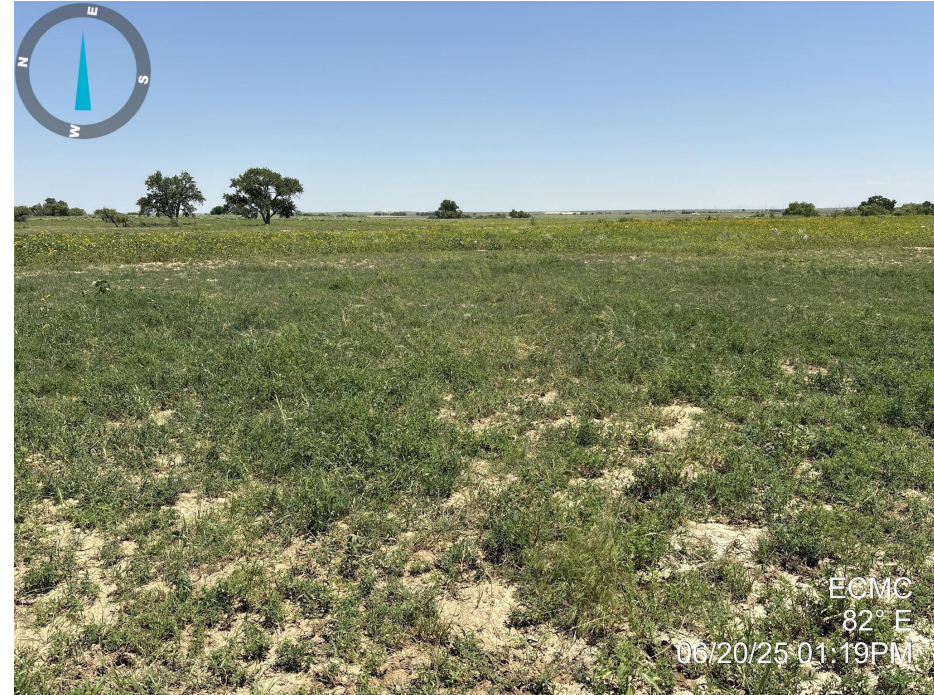
Photo 2. Photo taken from the well location, facing East. See comments under Photo 1.

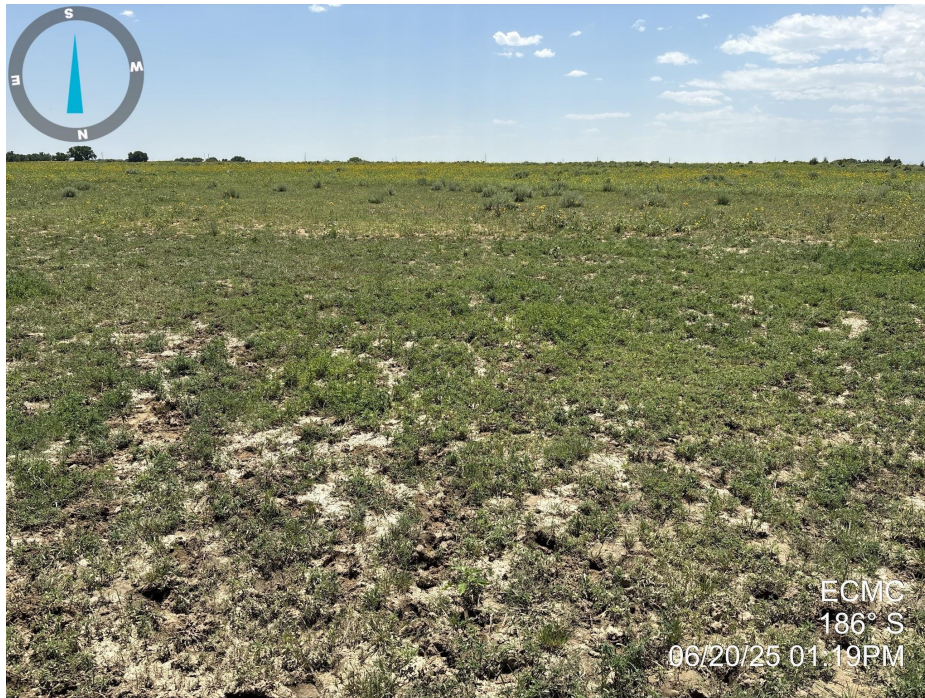
Photo 3. Photo taken from the well location, facing South. See comments under Photo 1.

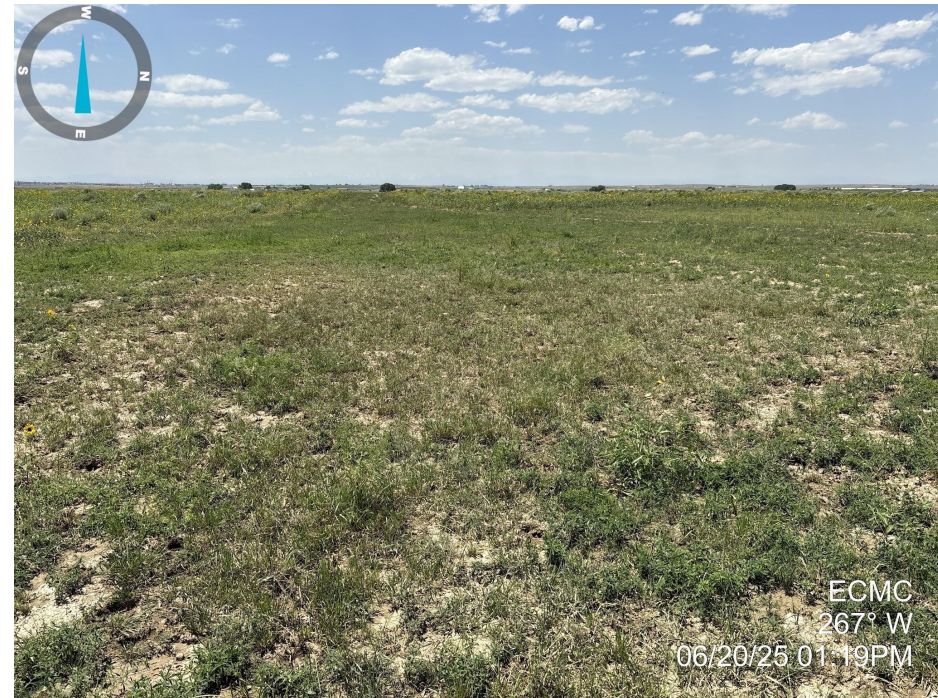
Photo 4. Photo taken from the well location, facing West. See comments under Photo 1.

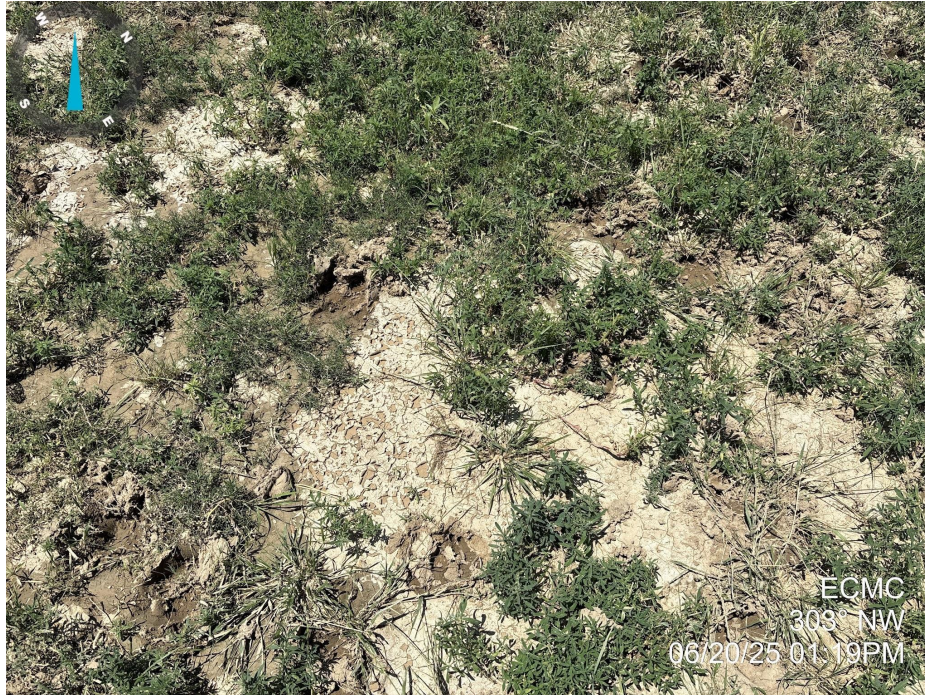
Photo 5. Photo taken of the ground cover at the well location. Photo illustrates weedy annual vegetation including kochia (*Bassia scoparia*).

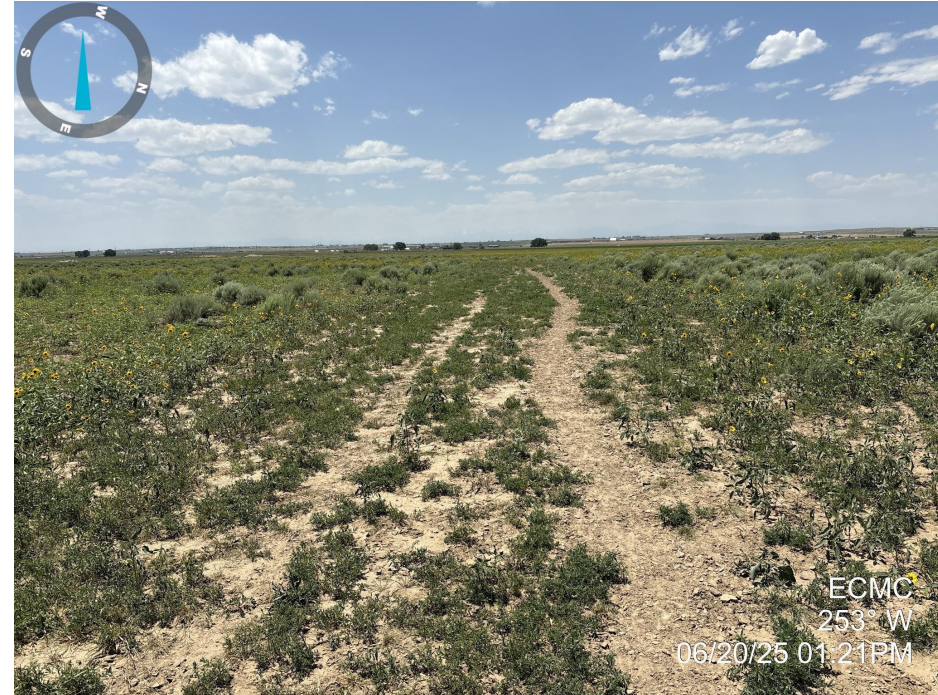
Photo 6. Photo taken of the access road to the well location, facing west. Photo illustrates that final reclamation activities have taken place, with evidence of drill row seeding, but vegetation establishment does not meet Rule 1004 standards.

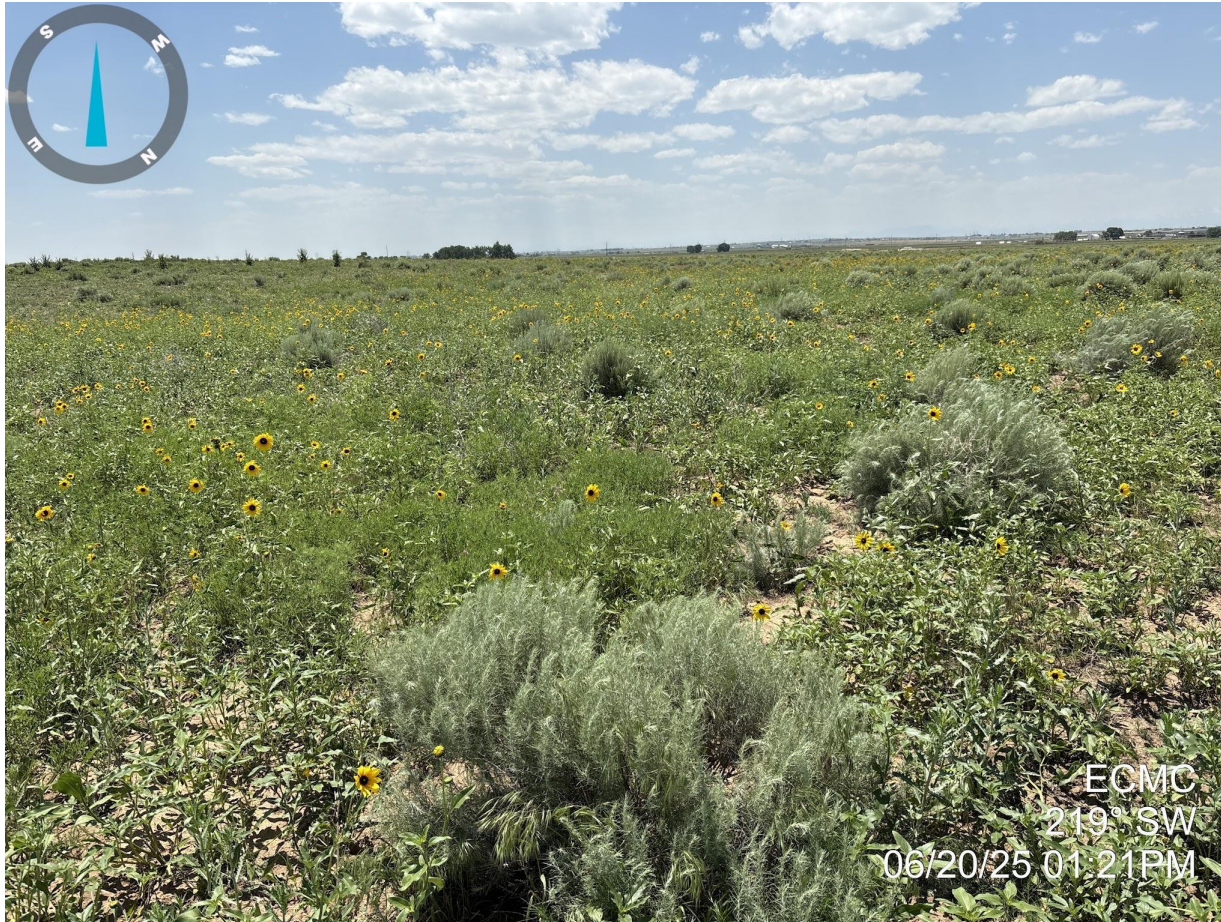
Photo 7. Photo taken of the reference area, located east of the well location, facing southwest. Photo illustrates sand sagebrush (*Artemisia filifolia*) and annual vegetation including prairie sunflower (*Helianthus petiolaris*).
