Final Reclamation Inspection

Operator: NOBLE ENERGY INC - 100322

Location ID: 418280

Inspection Photos
Location Name: CANNON H/35-11 TANK
Location ID: 418280

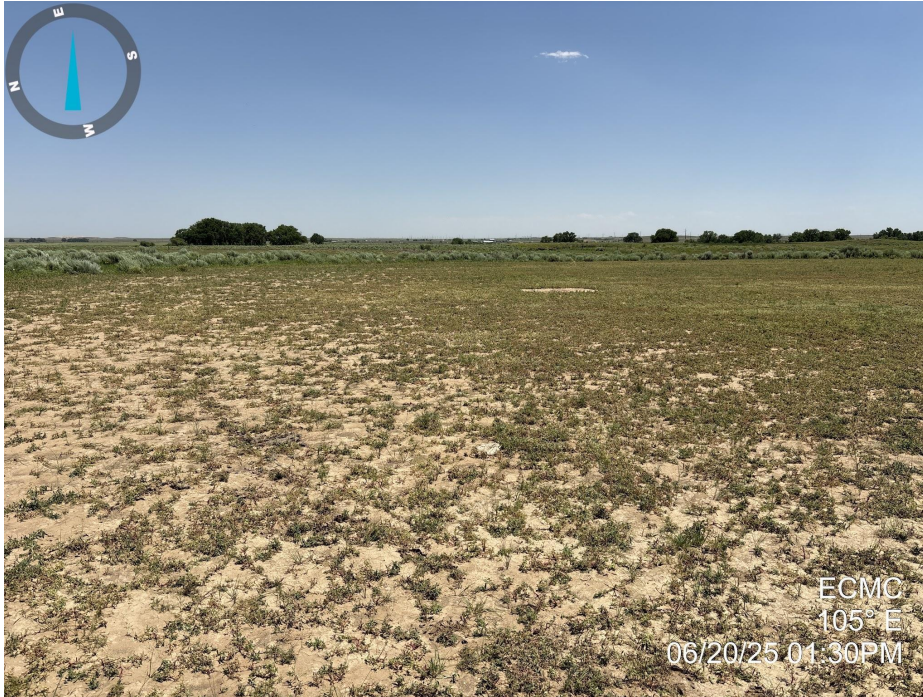
Photo 1. Photo taken of the tank battery location, facing east. Photo illustrates that final reclamation activities have taken place, with evidence of drill row seeding, but vegetation has not established to Rule 1004 standards.

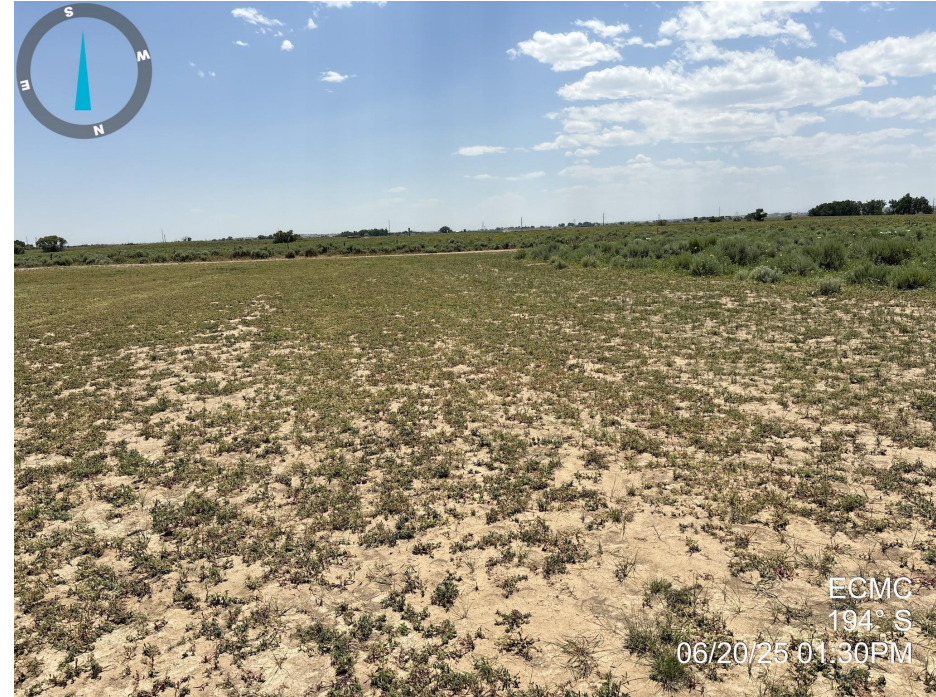
Photo 2. Photo taken of the tank battery location, facing south. See comments under Photo 1.

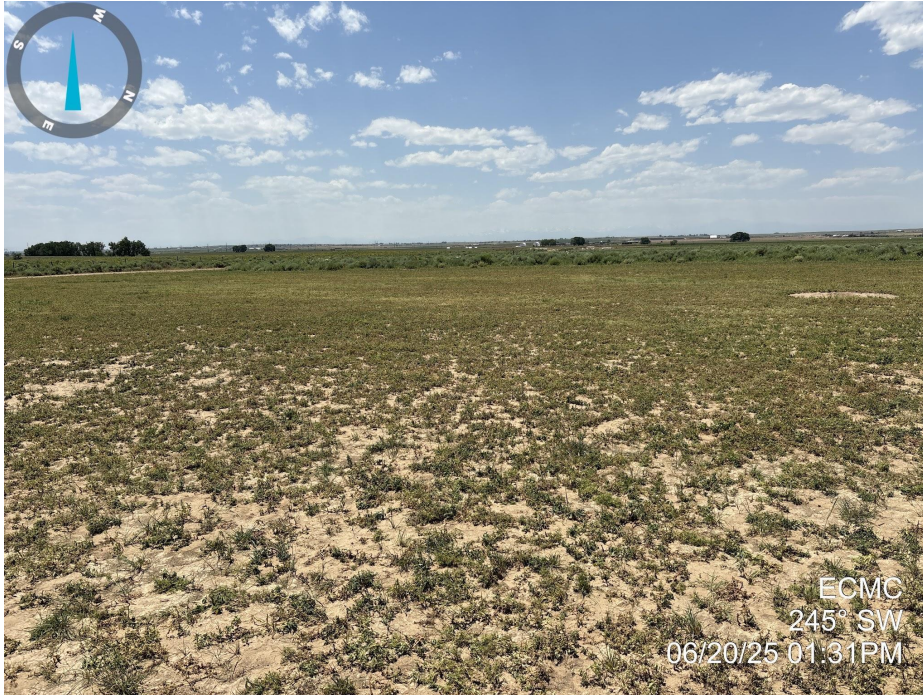
Photo 3. Photo taken of the tank battery location, facing southwest. See comments under Photo 1.

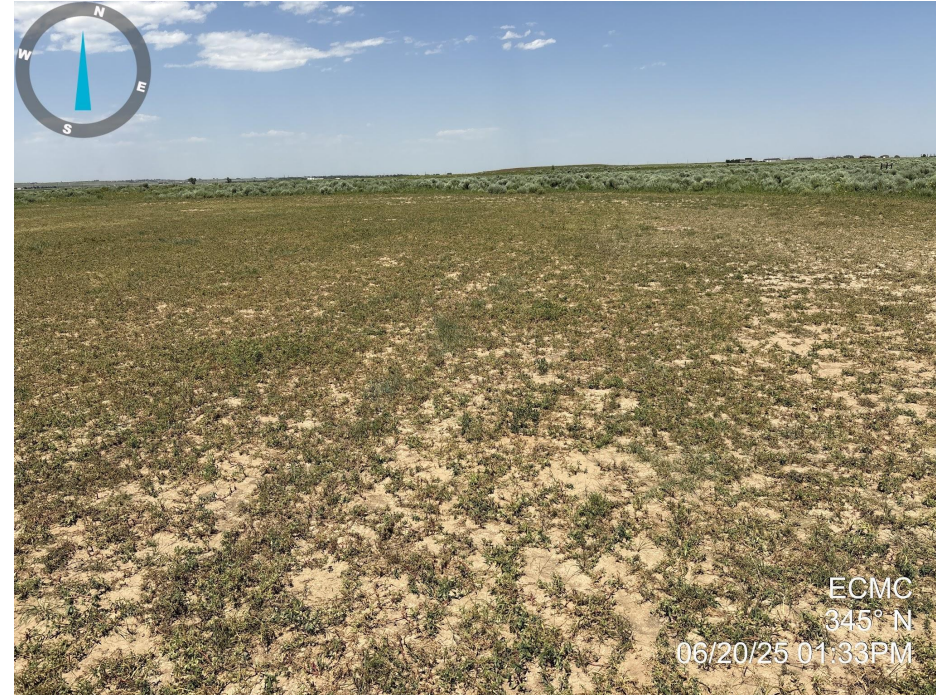
Photo 4. Photo taken of the tank battery location, facing north. See comments under Photo 1.

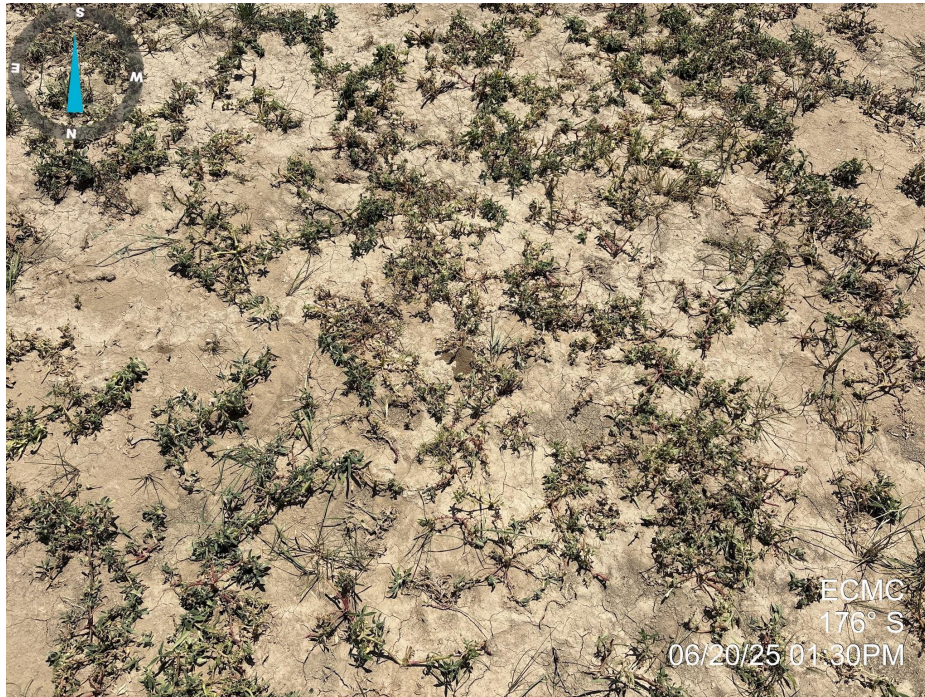
Photo 5. Photo taken of ground cover at the tank battery location. Photo illustrates bare ground and weedy annual vegetation, including russian thistle (*Salsola tragus*).

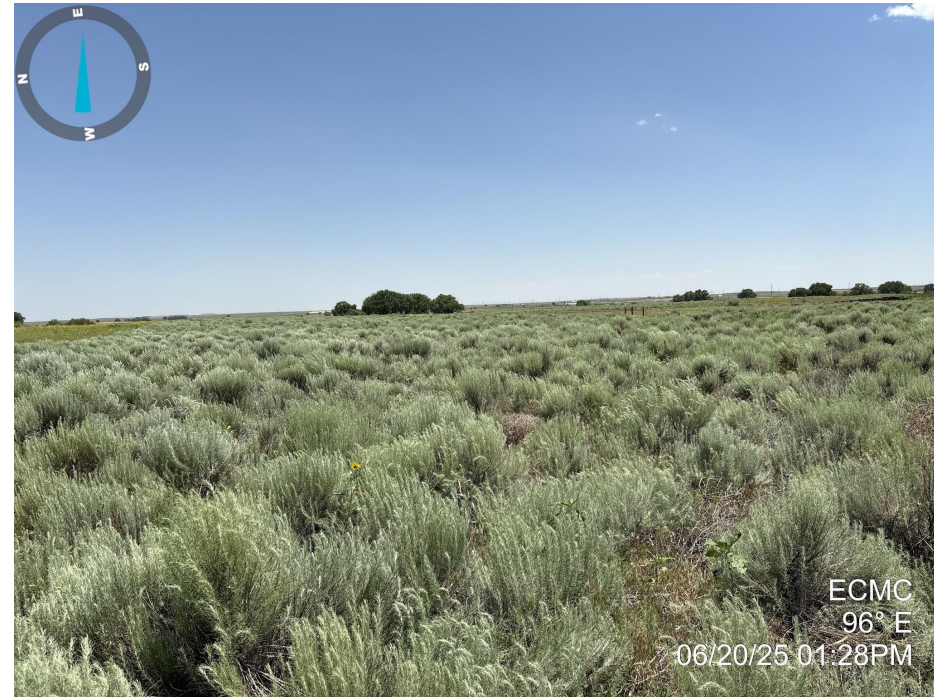
Photo 6. Photo taken of the reference area, located north of the tank battery location, facing east. Photo illustrates the location is dominated by sand sagebrush (*Artemisia filifolia*). .
