# Final Reclamation Inspection

Operator: NOBLE ENERGY INC - 100322

Location ID: 420047

Location Name: DECHANT STATE H/36-19 TANK

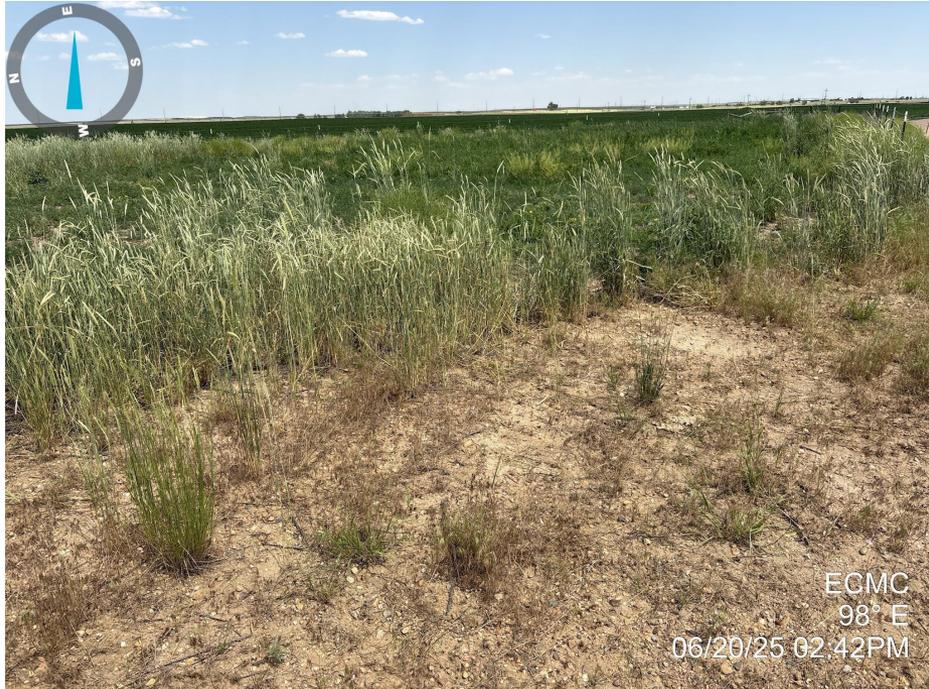
**Photo 1.** Photo taken of the tank battery location, facing east. Photo illustrates that final reclamation activities have taken place, but gravel still remains on a portion of the site and vegetation has not established to Rule 1004 standards. Weedy annual vegetation is present across the location, including cheatgrass (*Bromus tectorum*), a List C Noxious Weed species.

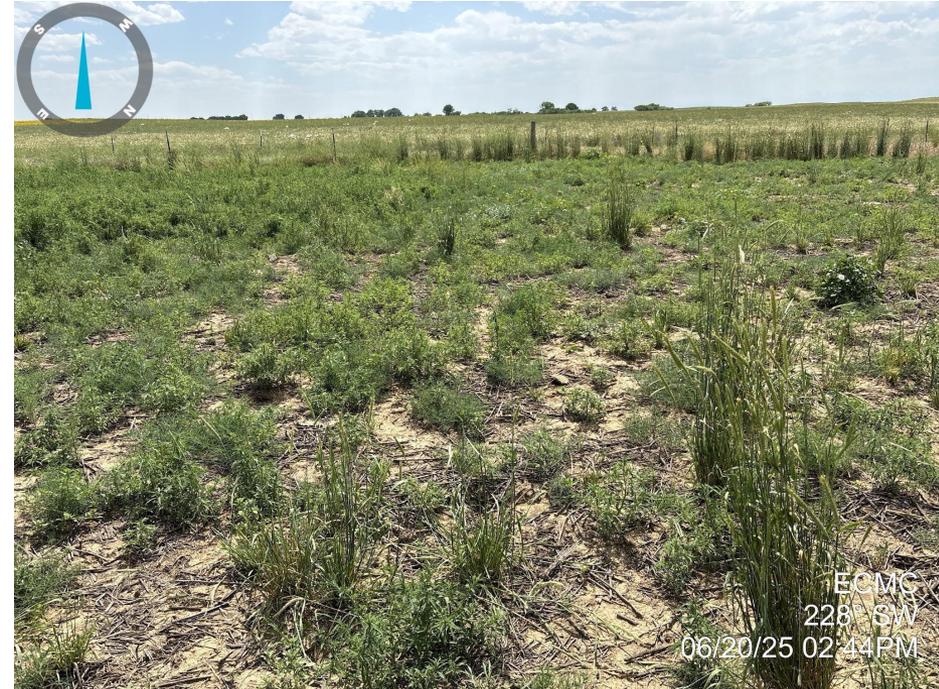
**Photo 2.** Photo taken from the tank battery location, facing southwest. See comments under Photo 1.

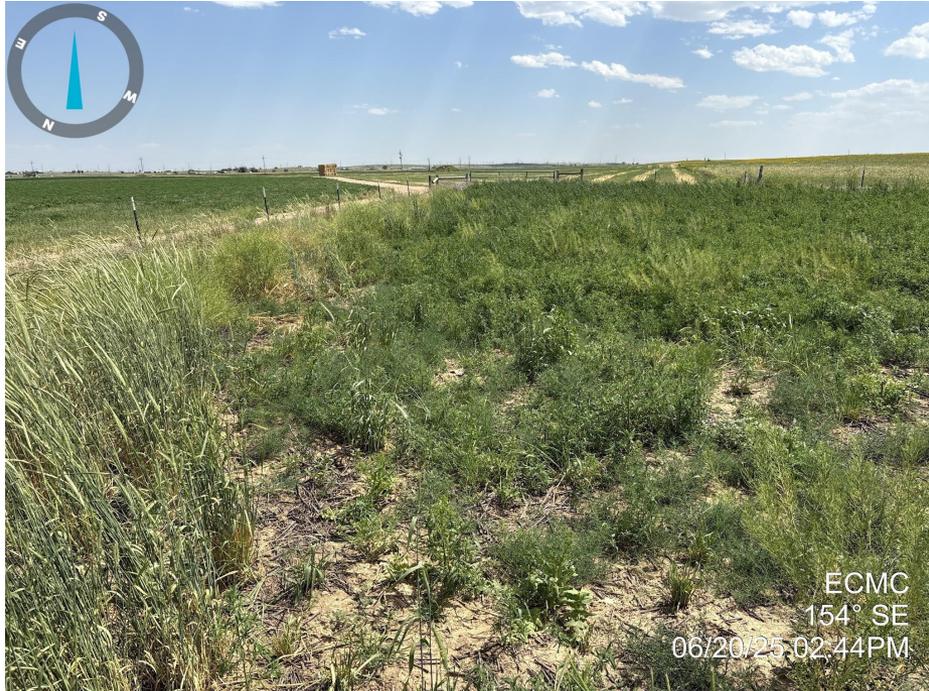
**Photo 3.** Photo taken of the tank battery location, facing southeast. See comments under Photo 1.

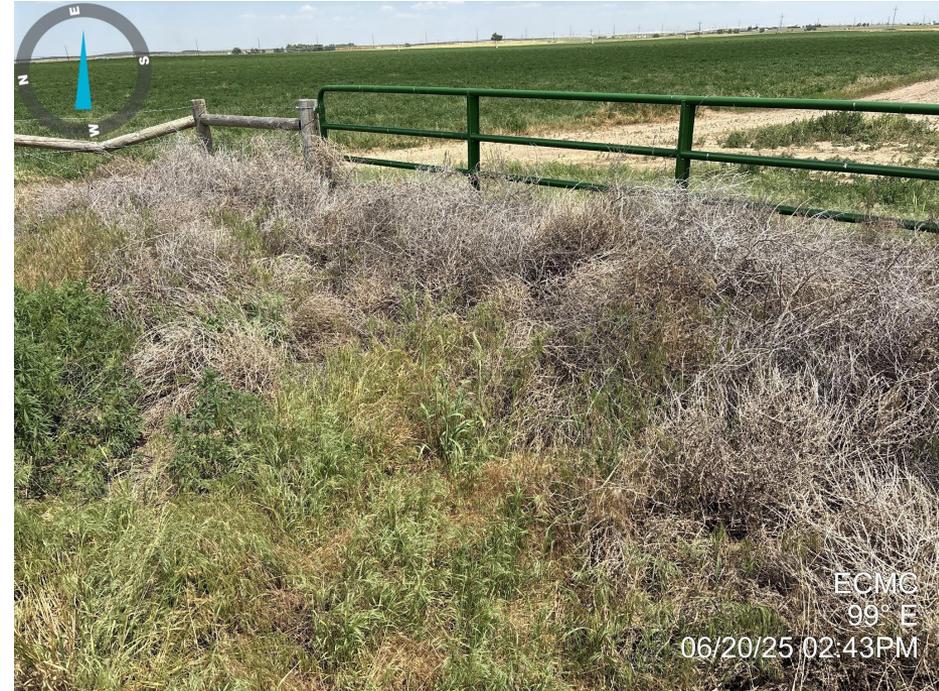
**Photo 4.** Photo taken of the entrance to the tank battery location, facing east. Photo illustrates debris in the form of russian thistle (*Salsola tragus*).

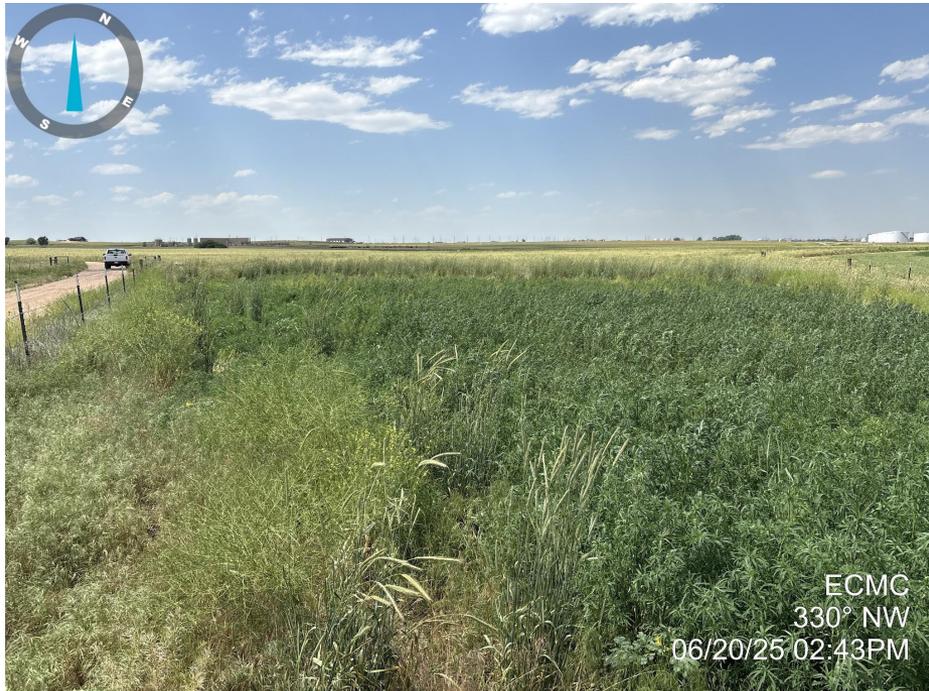
**Photo 5.** Photo taken of the tank battery location, facing Northwest. See comments under Photo 1.

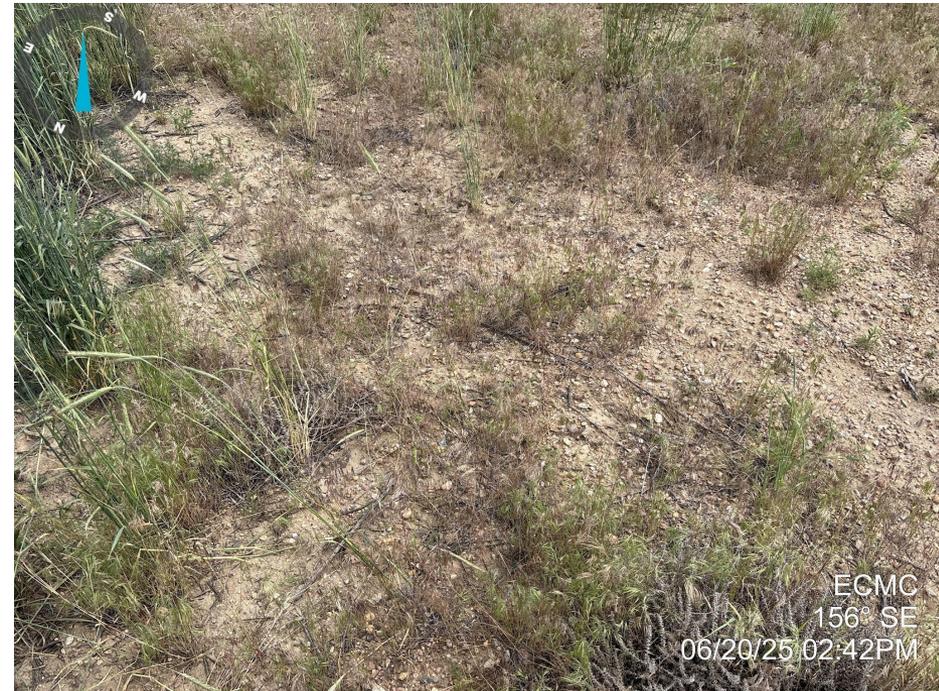
**Photo 6.** Photo taken of ground cover at the tank battery location. Photo illustrates gravel remains on a portion of the site and cheatgrass (*Bromus tectorum*) was observed at the location.

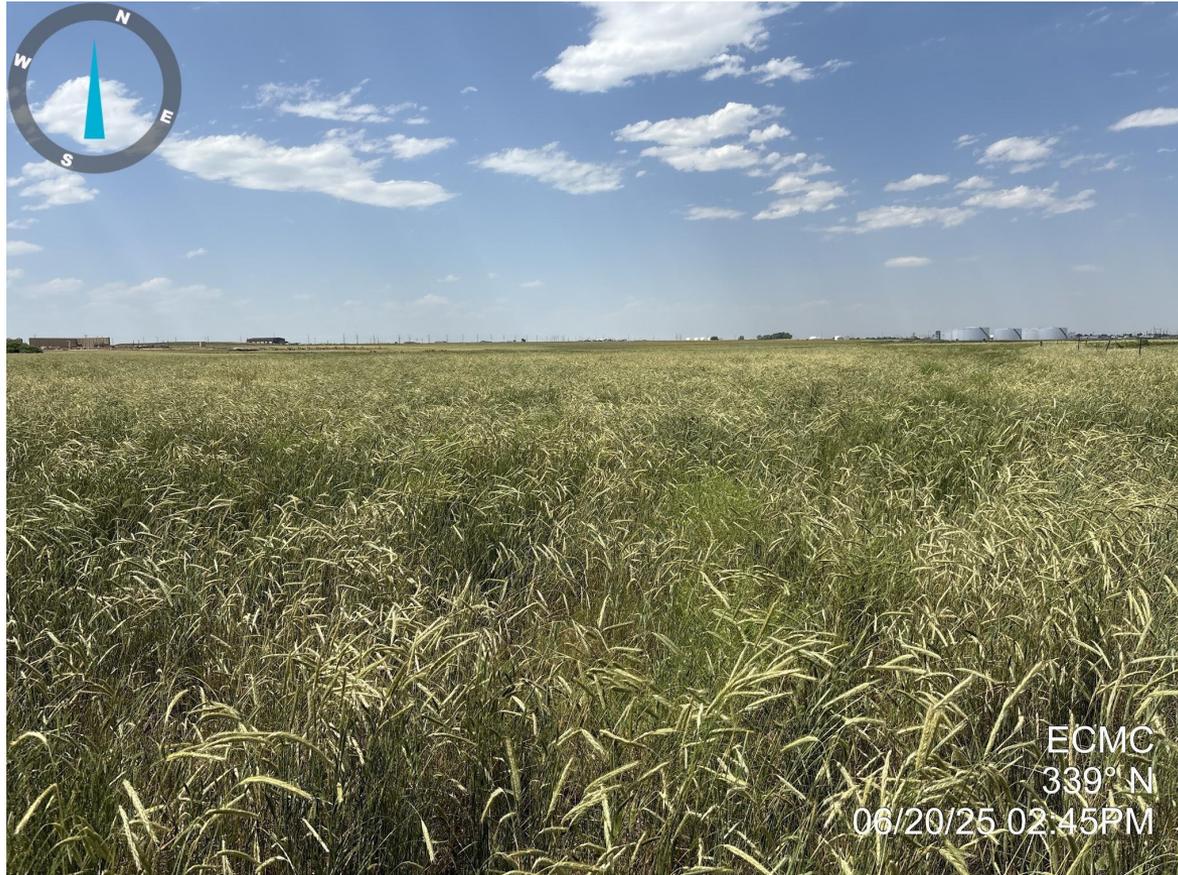
**Photo 7.** Photo taken of the reference area to the tank battery location, located north of the location, facing north. Photo illustrates rye cropland.
