Inspection Photos

Operator: QB ENERGY OPERATING LLC
#10844

Location ID: 334855

Inspection Doc: 719200020

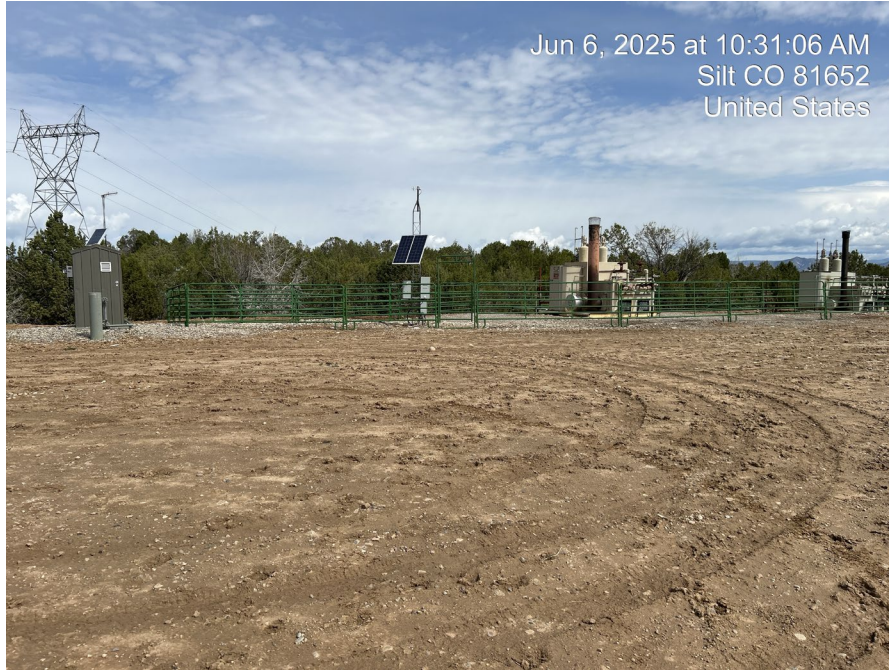
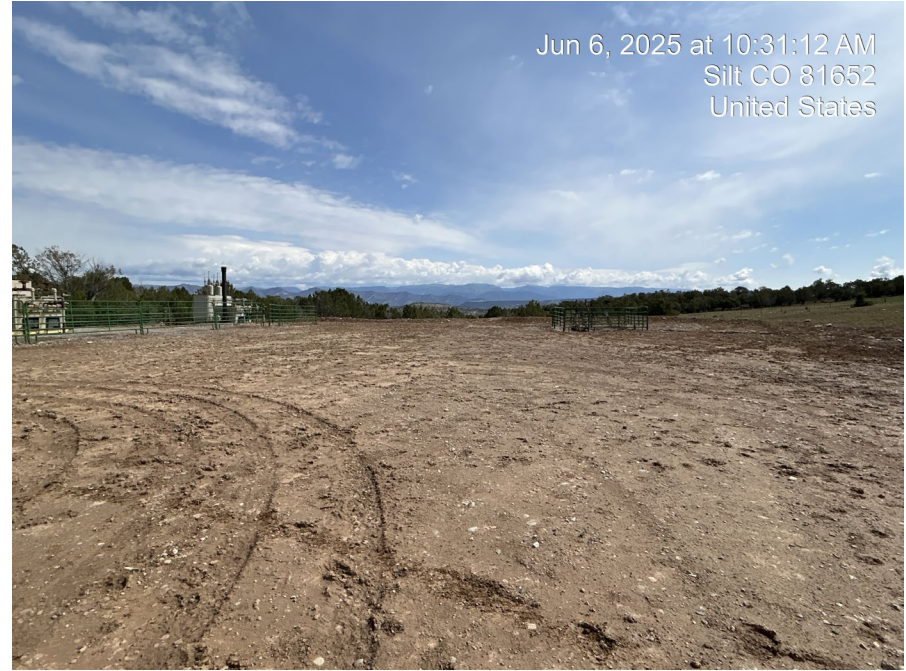
Photo 1: Photo taken from the central portion of the pad, showing an overview of the Location looking northwest and northeast, respectively.

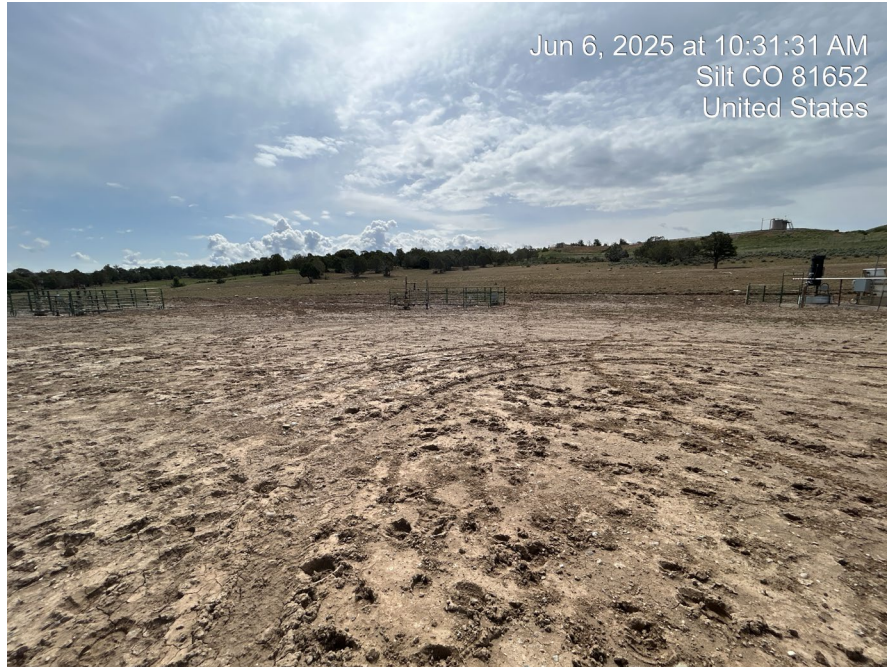
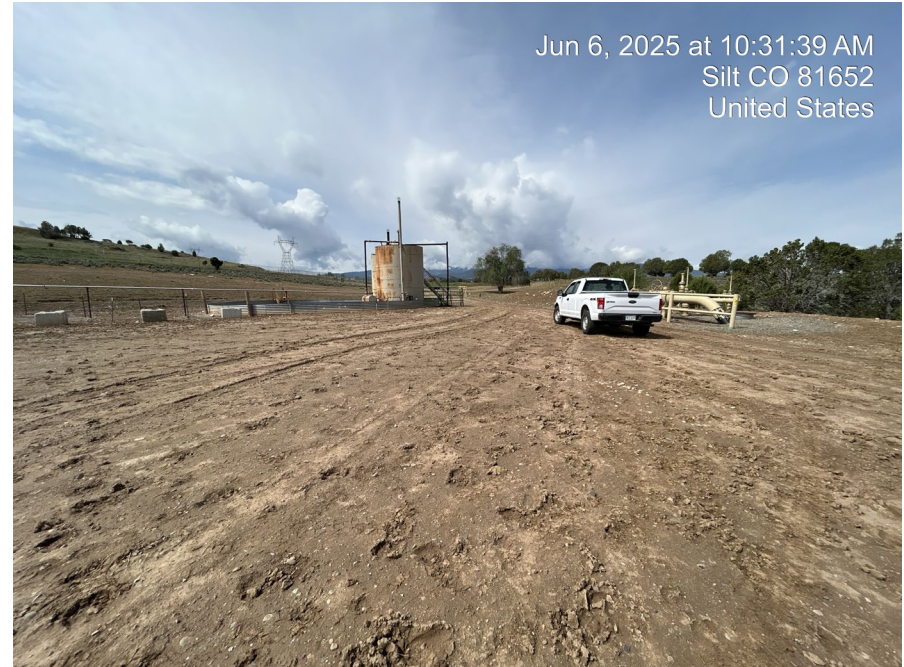
Photo 2: Photo taken from the central portion of the pad, showing an overview of the Location looking southeast and southwest, respectively.

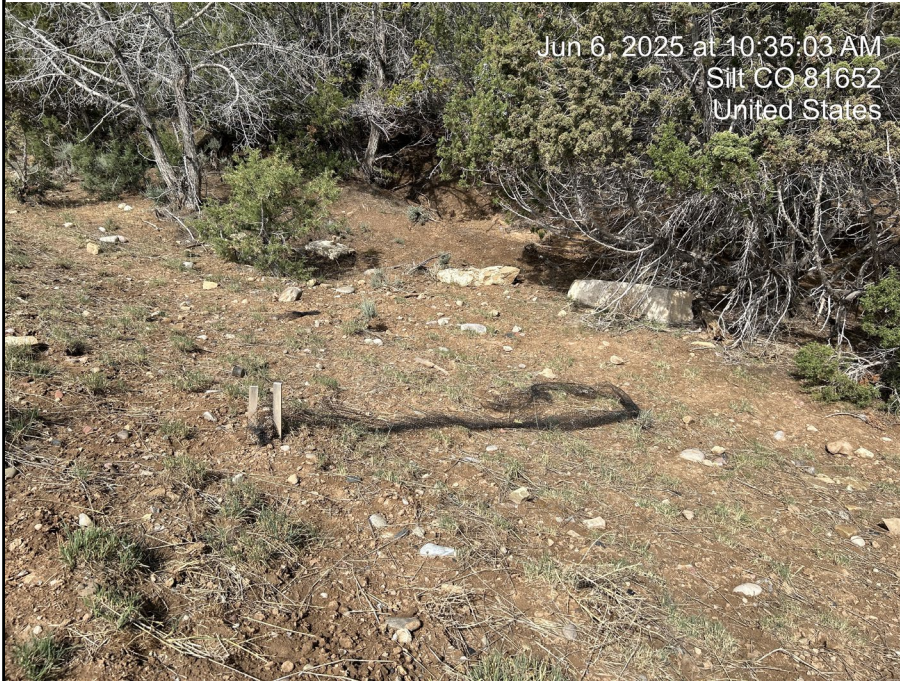
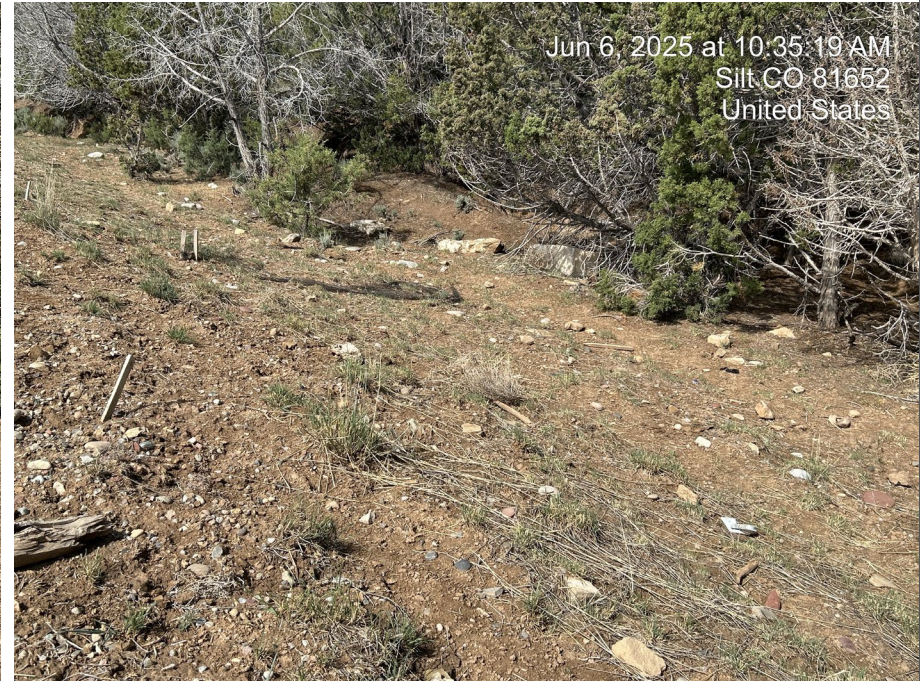
Photo 3: Photo taken from the western portion of the pad. Damaged, non-functional wattles were observed at the Location. Comply with Rule 606.a and remove debris.

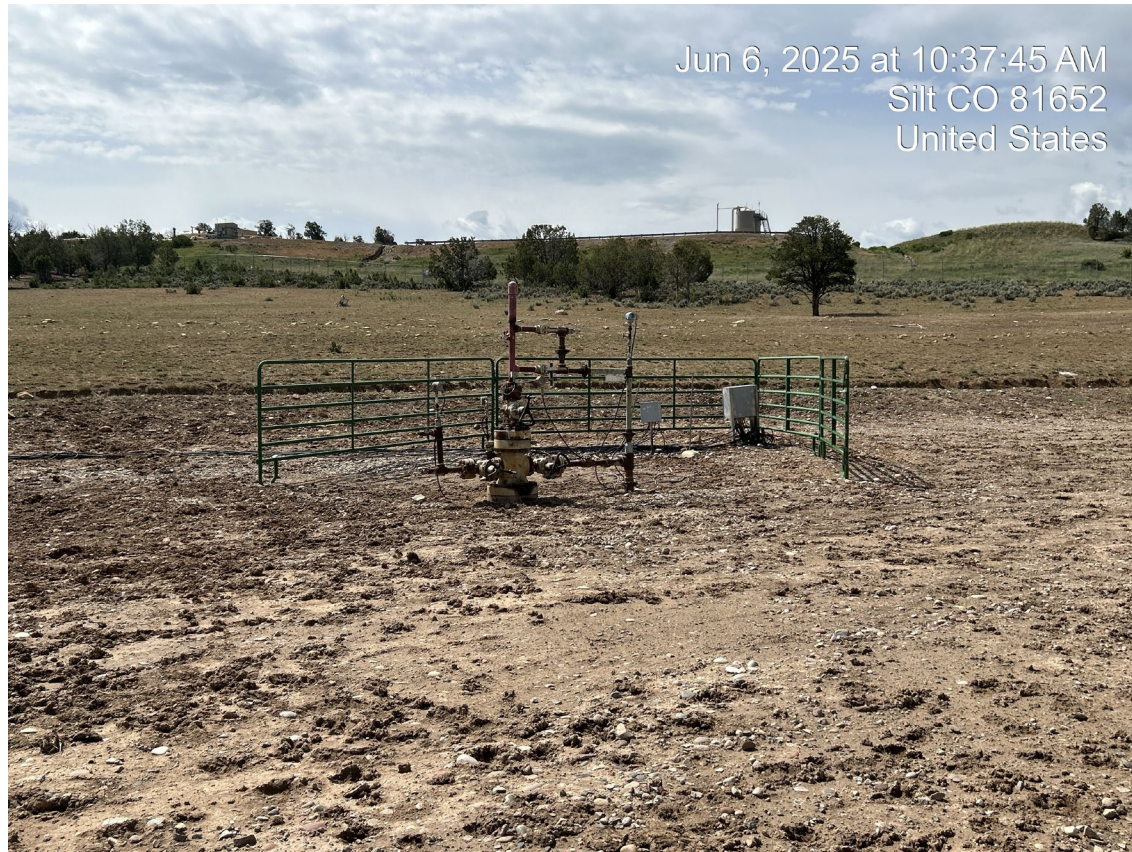
Photo 4: Photo shows fencing around a wellhead is insufficient to keep livestock out. Maintenance is advised.

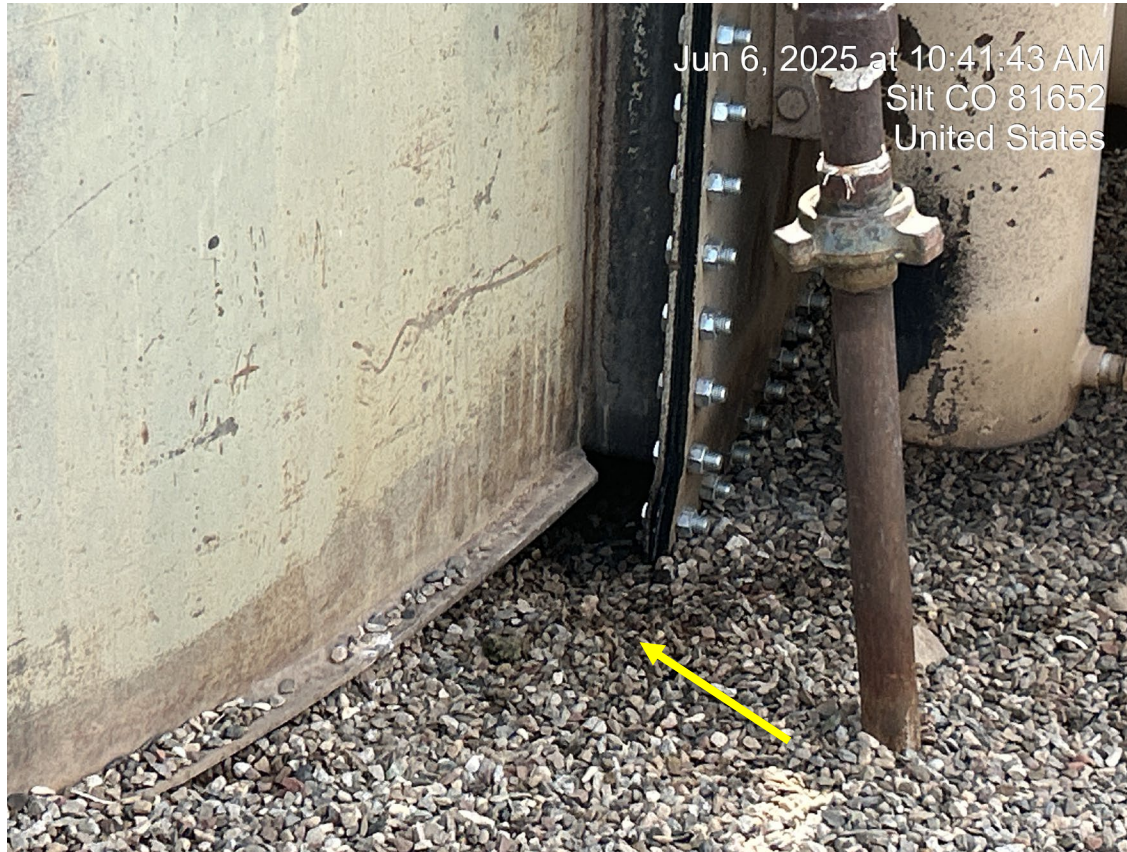
Photo 5: Photo shows a chipmunk burrow at the bottom of a tank battery. Maintenance is advised.

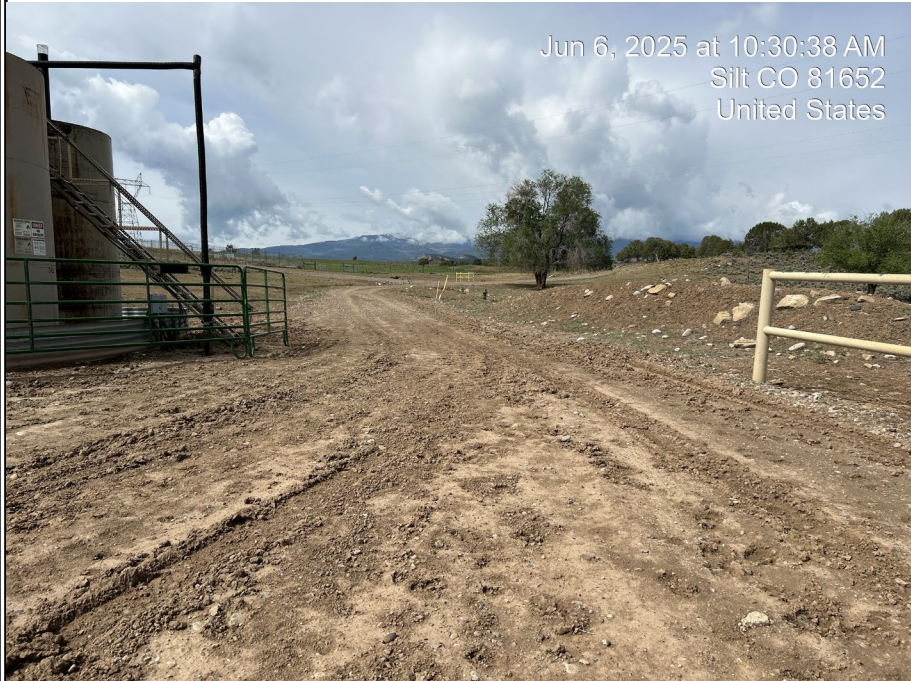
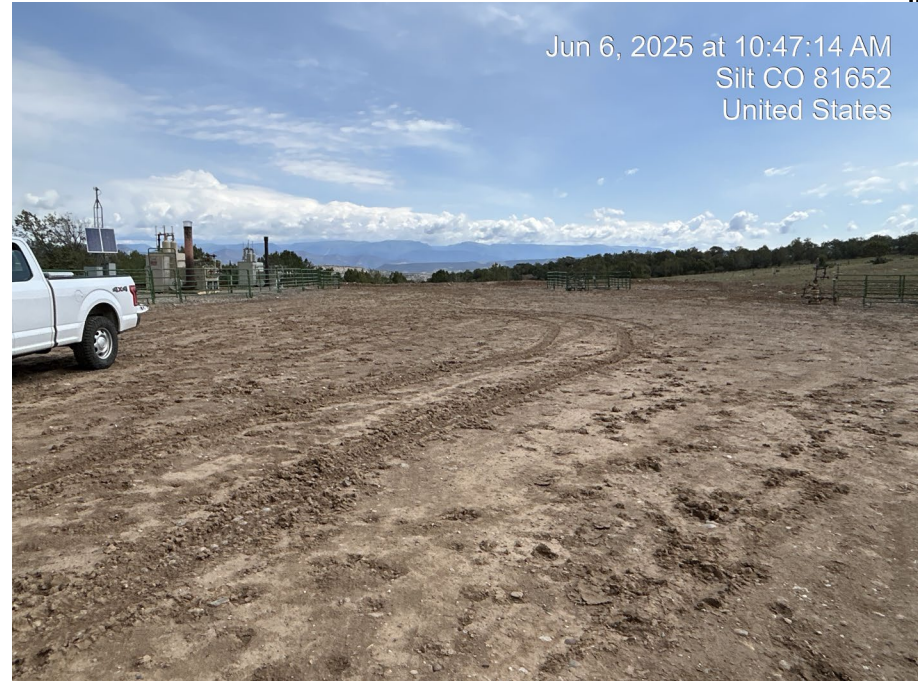
Photo 6: Photo shows sediment tracking across the pad. There are no BMPs in place for tracking/erosion at the site entrance. Stormwater and erosion control BMPs are missing or insufficient at the Location and access road. Comply with Rule 1002.f.
