**Operator: CRESTONE PEAK RESOURCES OPERATING LLC**

**Location Name: OLIVE-62N66W 26SWSW**

**Loc ID: 318688**

**Inspection: 718600727**

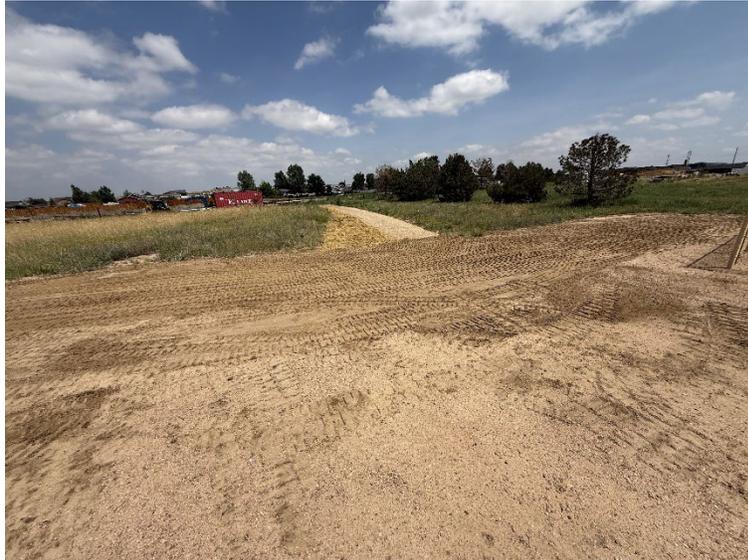
**Exhibit A**

**CA:** The wellbore area does not meet final reclamation standards. The well appears to be located under an unused road. The road dead ends at a fence on the north side of the property. A small depression is present around the wellbore area. See attached pictures. Reclaim the road and wellbore area according to Rule 1004 standards. Remove gravel, decompact to a depth of 18 inches and establish vegetation with total perennial, non-invasive uniform plant cover of at least eighty (80) percent of reference area levels.

**CA Resolution:** Operator has addressed the areas with rutting in the road in order to comply with Rule 1004.
