Final Reclamation and Stormwater Inspection

Location ID: 320116

Well Name: TIPPERARY #1

Inspection Document #: 718600790

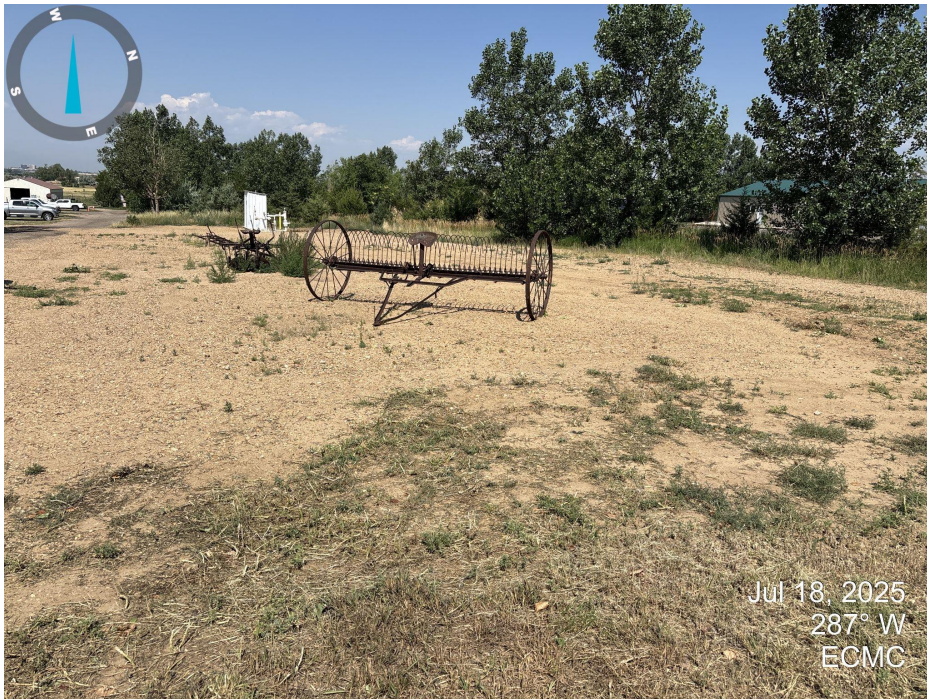
Photo 1. Looking west across tank battery location. Decorative pieces of farm equipment have been placed on location. Gravel remains throughout the tank battery location. Undesirable weeds such as kochia are present on location.

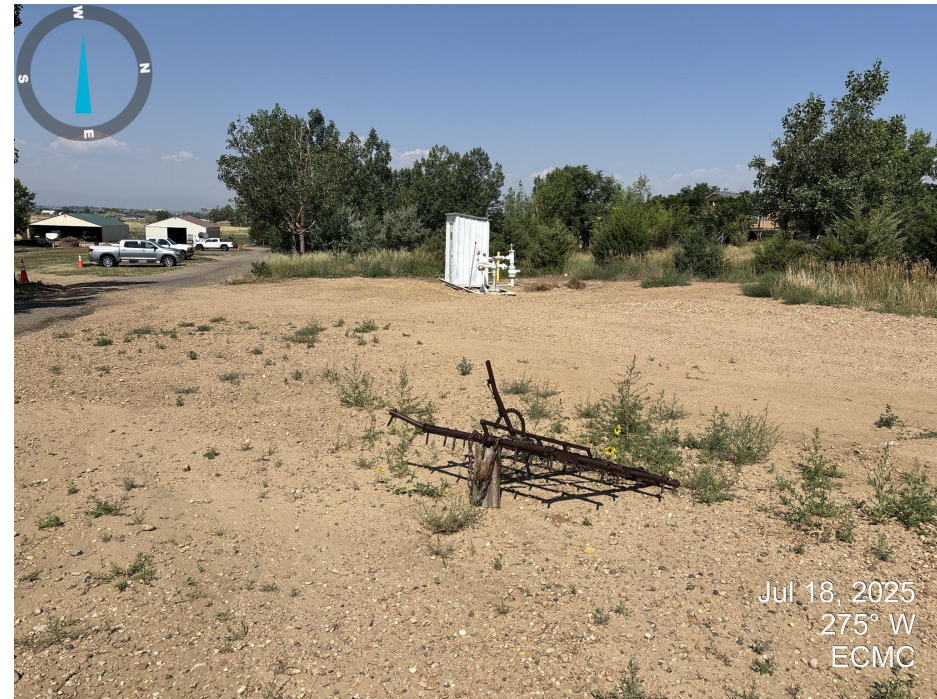
Photo 2. Picture taken at the center of location looking west. The location has not been reclaimed.

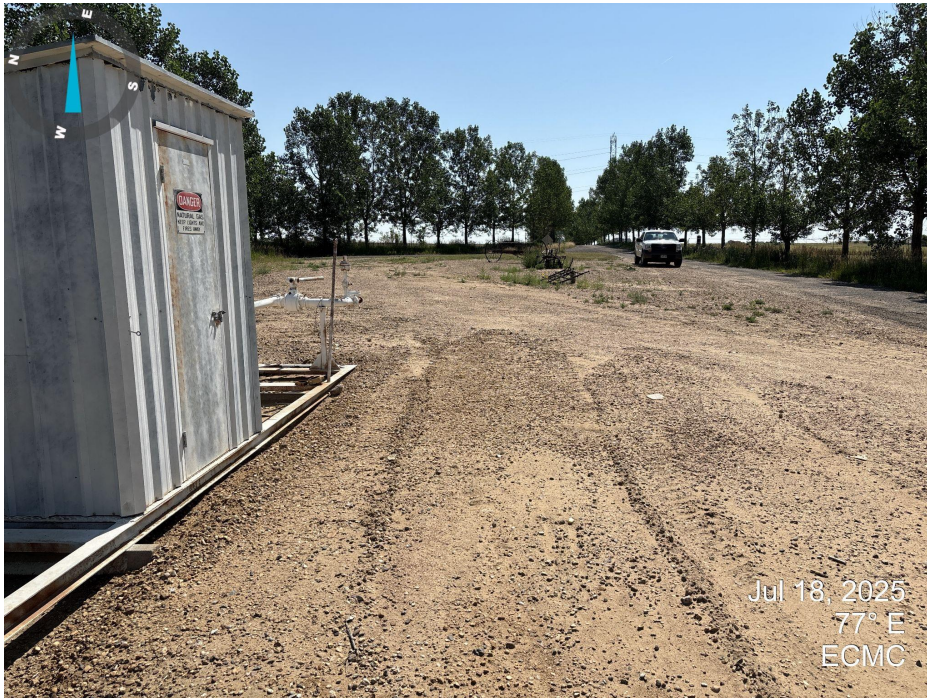
Photo 3. Looking east from the west side of the location. Pipe riser and shed remains on location.

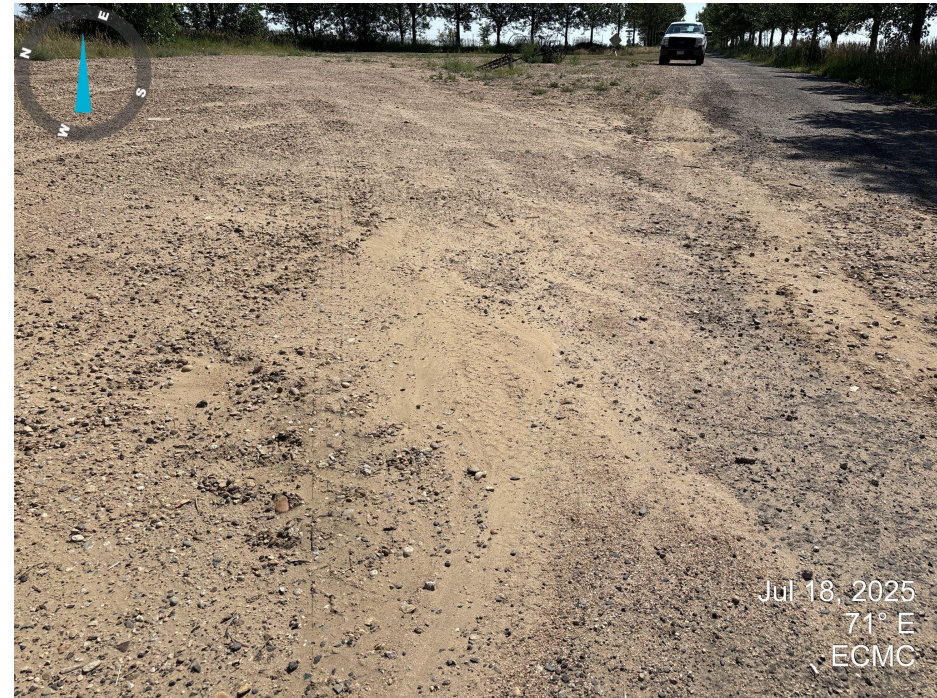
Photo 4. Picture taken on the east side of the location. Stormwater erosion channels are beginning to form on location and sediment is leaving the site.

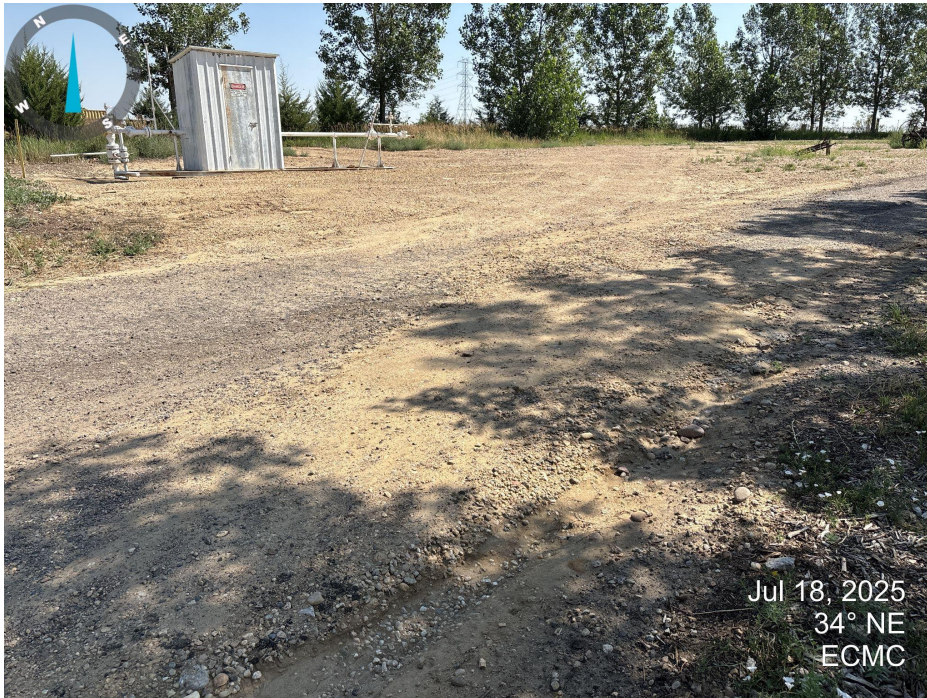
Photo 5. Looking north across the west side of location. Sediment and gravel washing over the road.

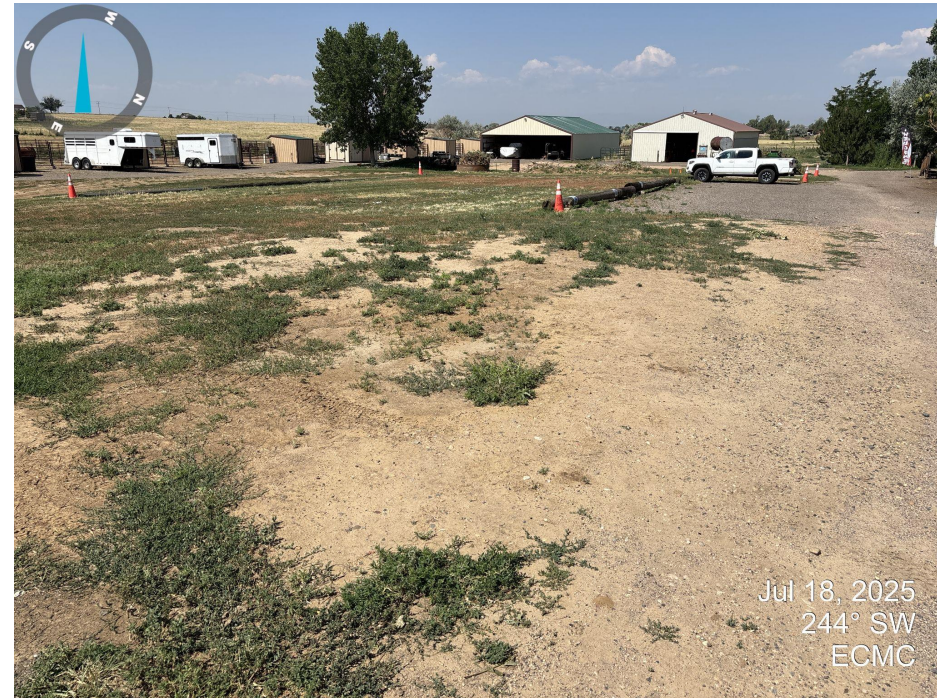
Photo 6. Looking west across the wellbore. Bare soil is present at the wellbore. Vegetation is primarily undesirable weedy vegetation such as kochia.
