Final Reclamation and Stormwater Inspection

Location ID: 320496

Well Name: TIPPERARY #34-8

Inspection Document #: 718600792

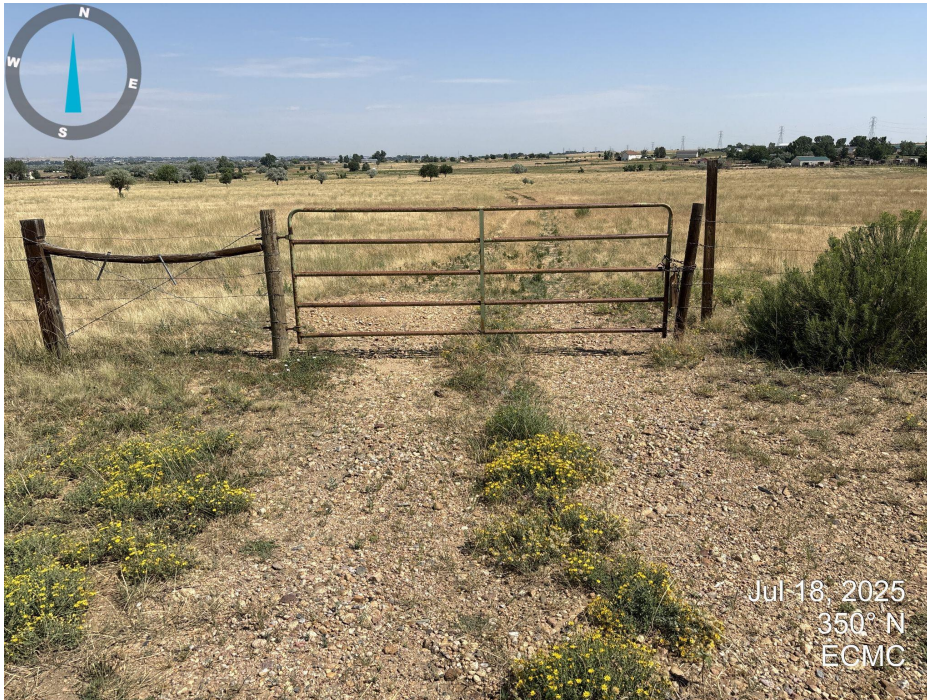
Photo 1. Looking north down access road. Gravel remains at the entrance of the access road.

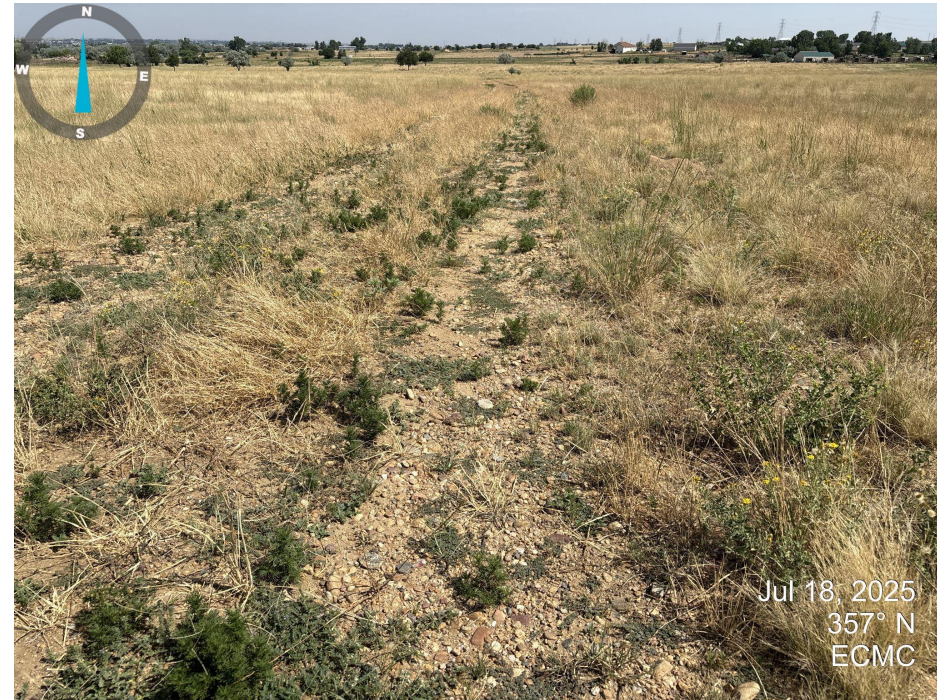
Photo 2. Picture taken on the south end of the access road looking north. Gravel remains on the southern part of the access road. Vegetation establishment is lower on the former access road than surrounding area.

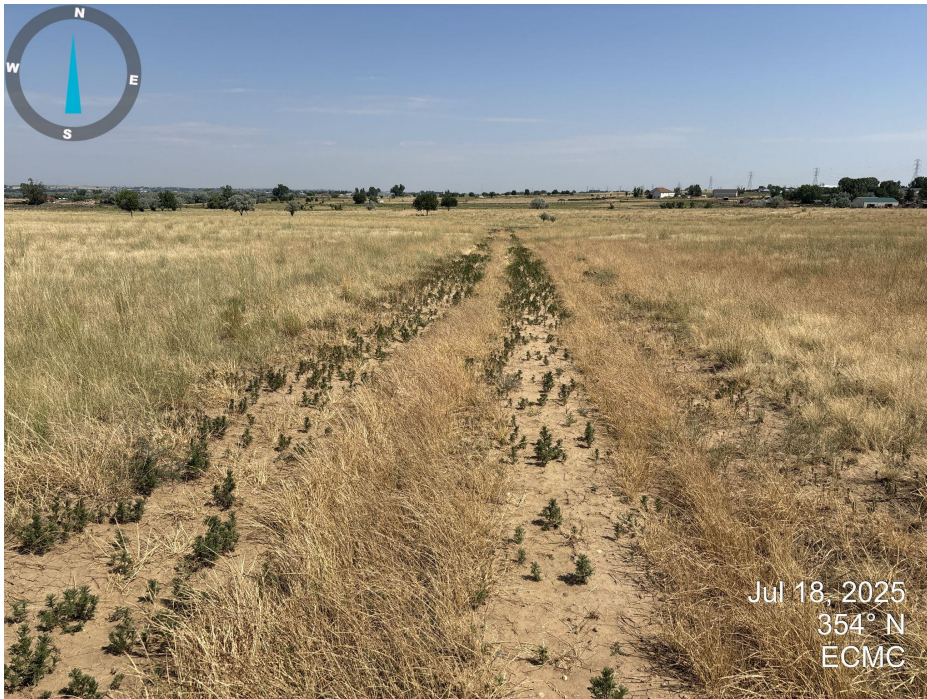
Photo 3. Picture taken at the midpoint of the acces road looking north. There is little desirable vegetation establishment in the former access road.

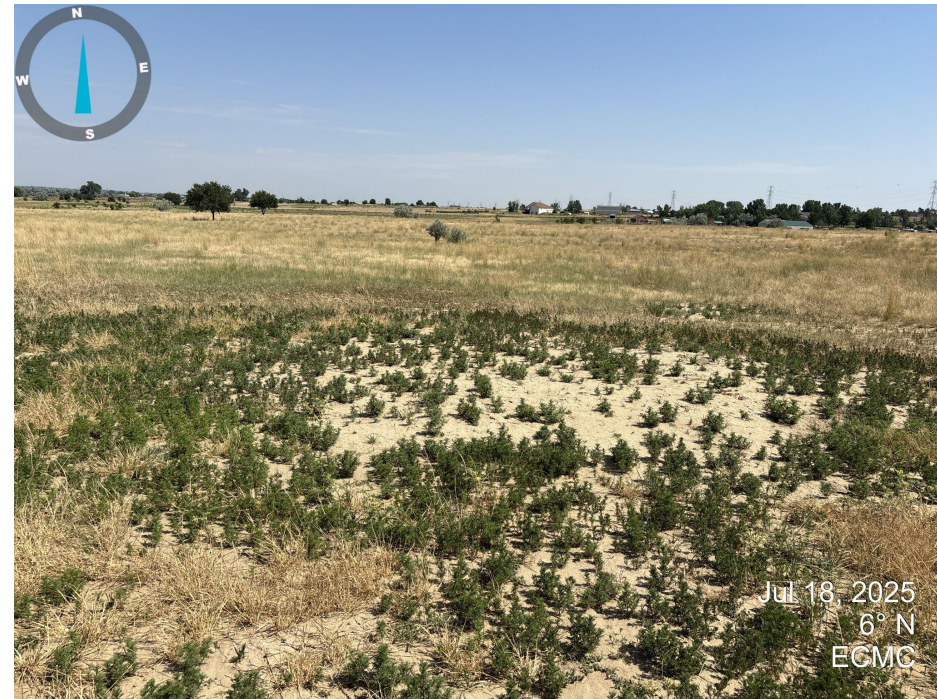
Photo 4. Looking north across the wellbore are. An approximate 30 ft area around the wellbore has very limited establishment of desirable perennial vegetation. There is some desirable vegetation establishment around the perimeter of the location.

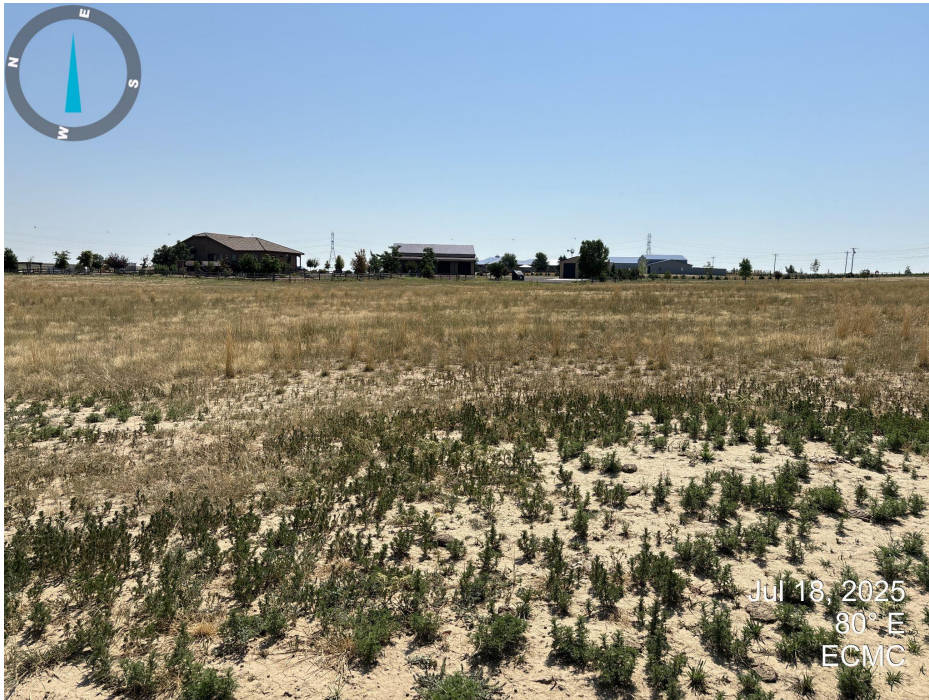
Photo 5. Looking east from wellbore. There is some desirable vegetation establishment around the perimeter of the location.

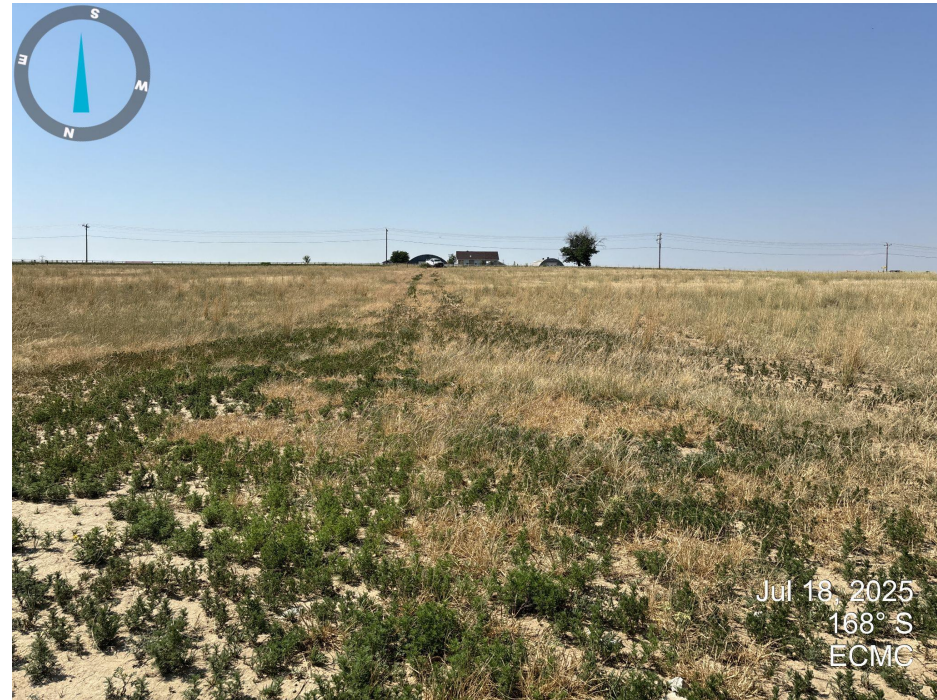
Photo 6. Looking south from wellbore. See photo 4 comments.

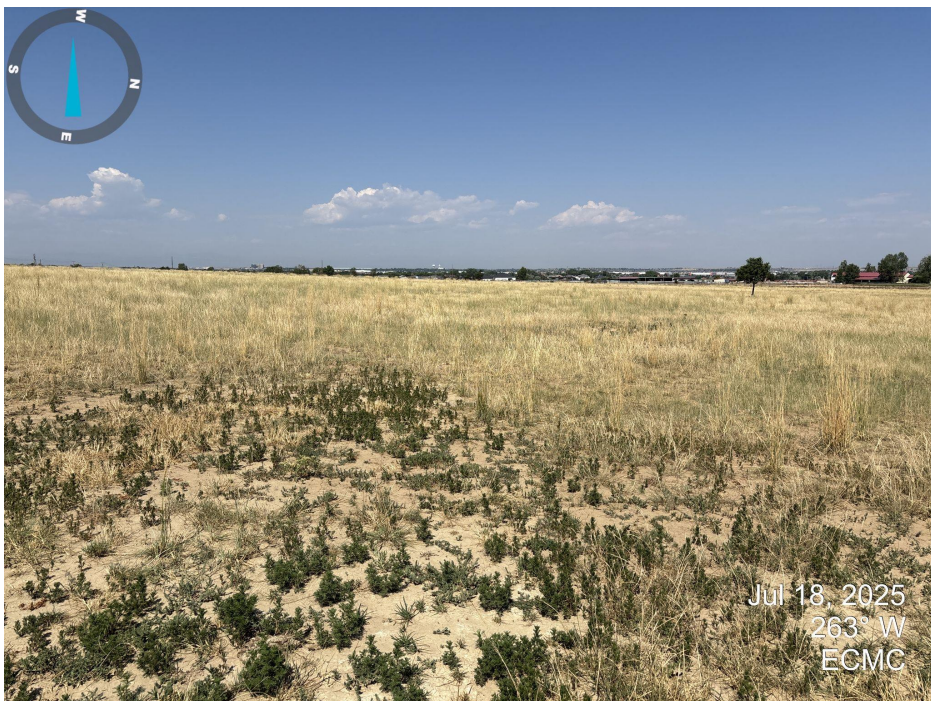
Photo 7. Looking west from wellbore. See photo 4 comments.

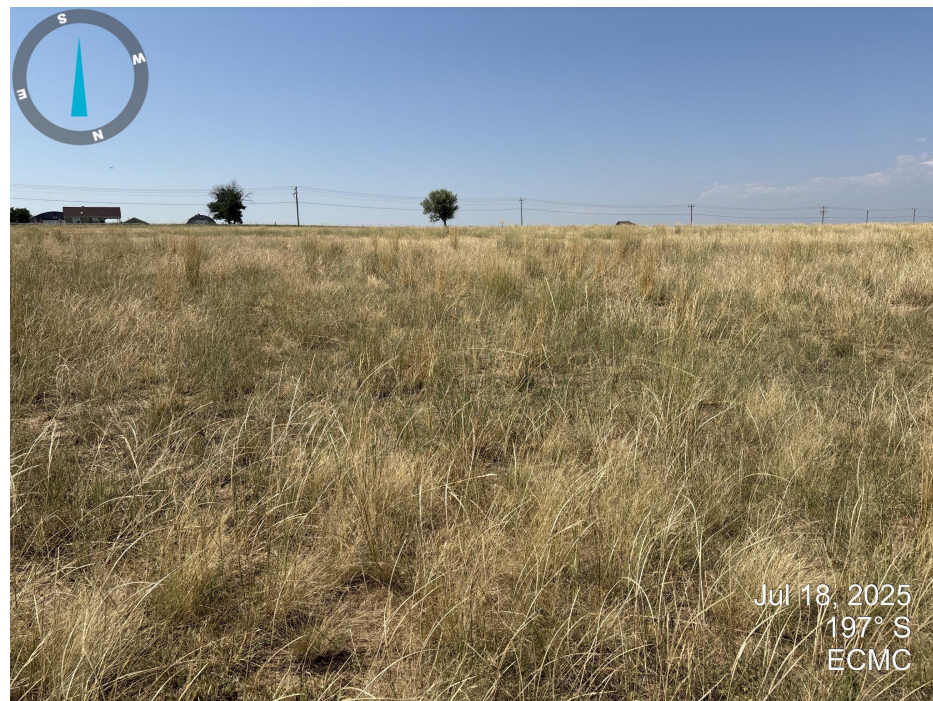
Photo 8. Reference vegetation to the west of location.
