Final Reclamation Inspection

Operator: NOBLE ENERGY INC - 100322

Location ID: 417842

Inspection Photos
Location Name: CANNON/X02-27 TANK
Location ID: 417842

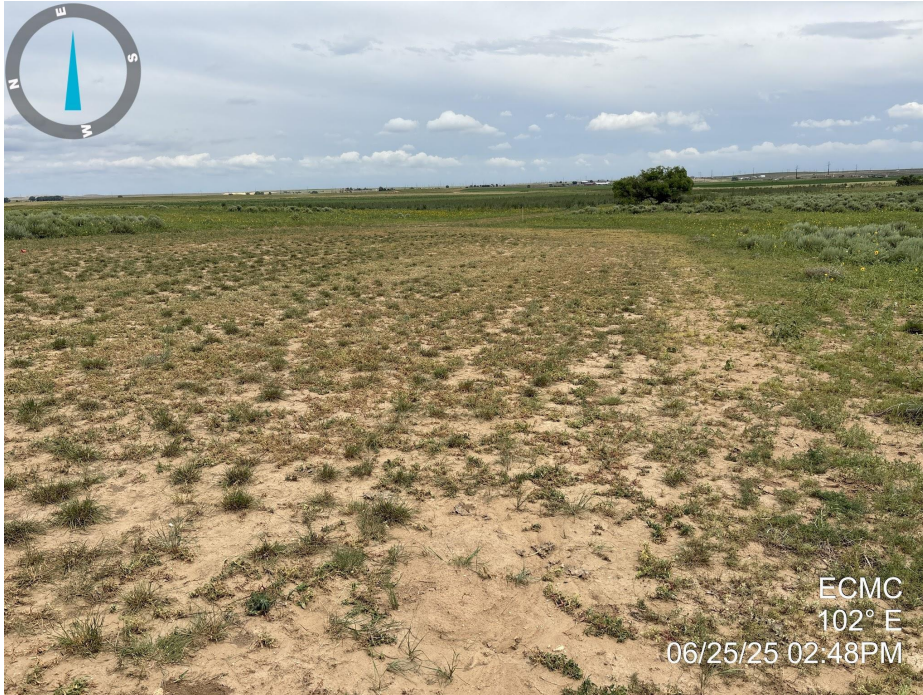
Photo 1. Photo taken of the tank battery location, facing east. Photo illustrates that final reclamation activities have taken place, with evidence of drill row seeding, but vegetation establishment does not meet Rule 1004 standards.

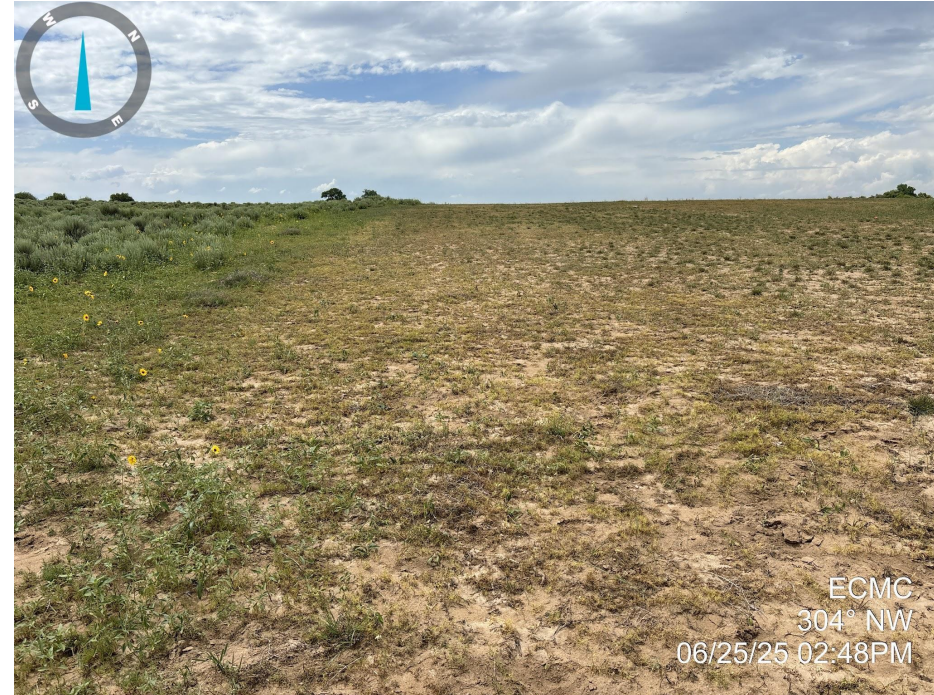
Photo 2. Photo taken of the tank battery location, facing northwest. See comments under Photo 1.

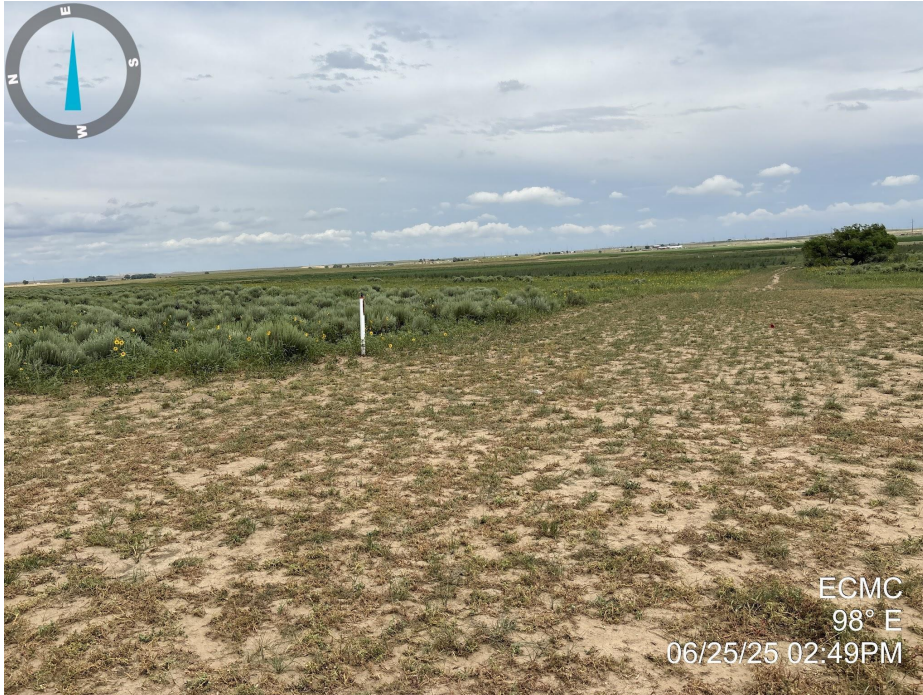
Photo 3. Photo taken of the tank battery location, facing east. Photo illustrates that midstream equipment remains on location.

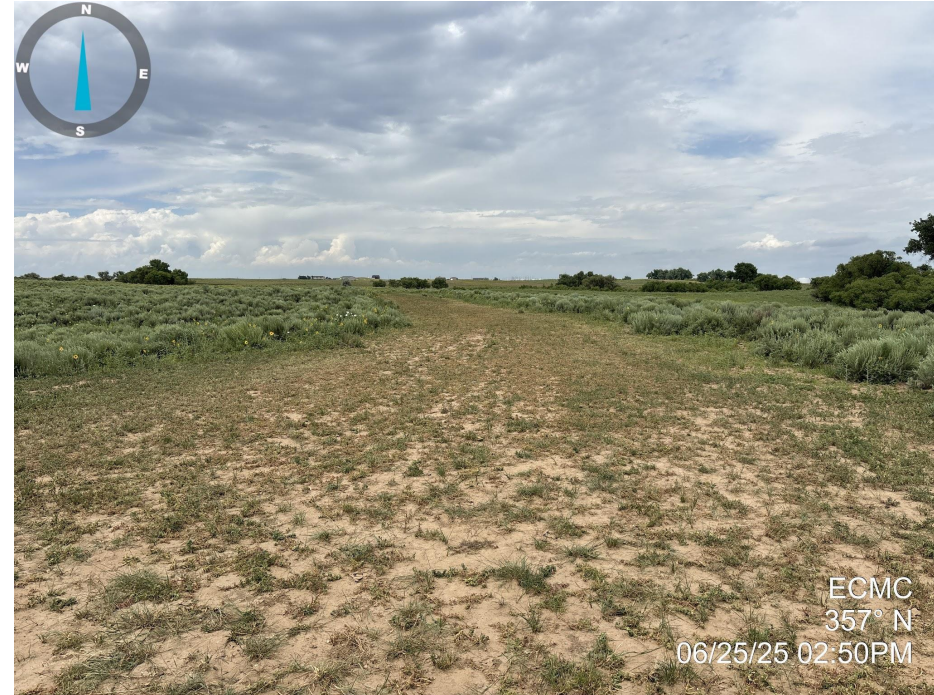
Photo 4. Photo taken from the tank battery location, facing north. See comments under Photo 1.

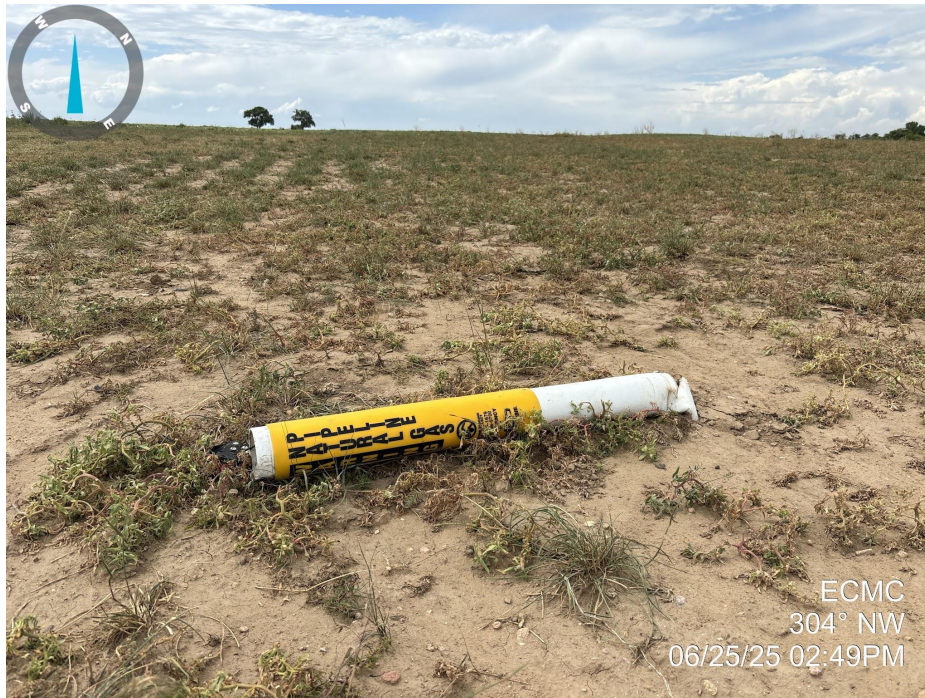
Photo 5. Photo taken of midstream equipment that remains on location and is in disrepair.

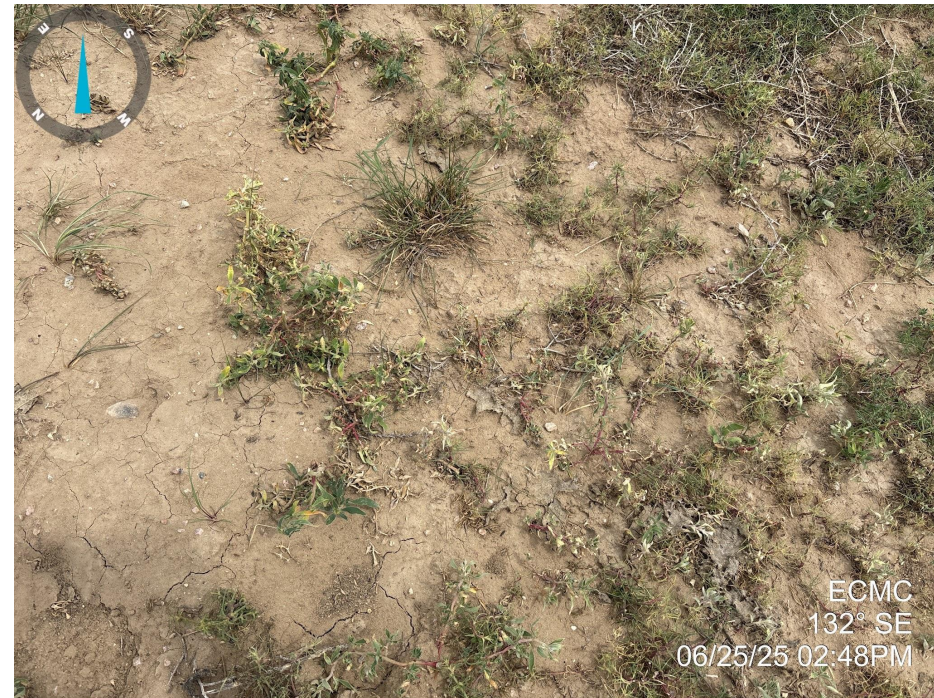
Photo 6. Photo taken of ground cover at the location. Photo illustrates bare ground and weedy annual vegetation including russian thistle (*Salsola tragus*).

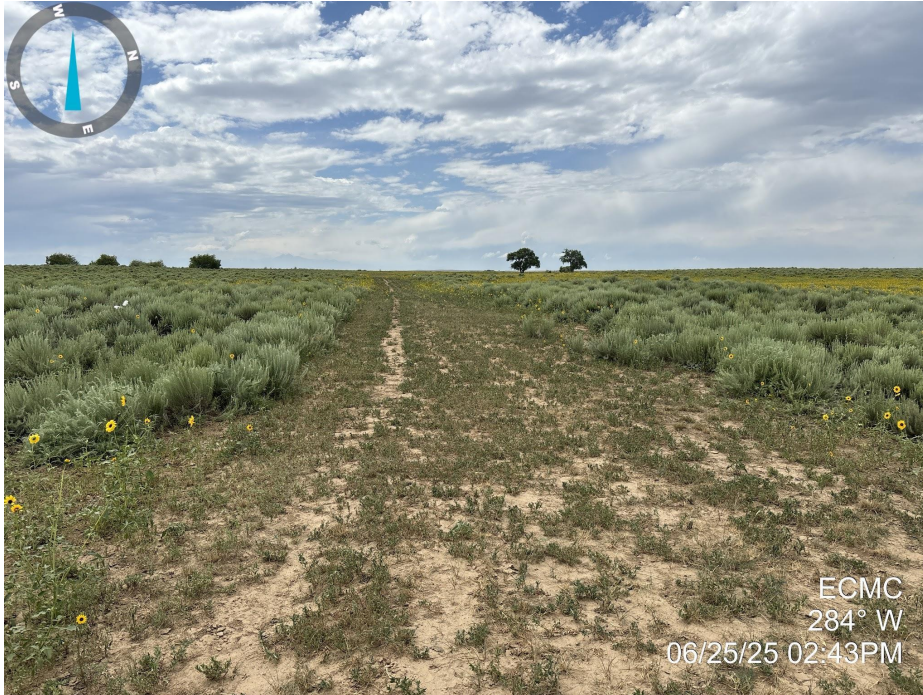
Photo 7. Photo taken of the access road to the tank battery location, facing west. Photo illustrates that final reclamation activities have taken place, with evidence of drill row seeding, but vegetation has not established to Rule 1004 standards.

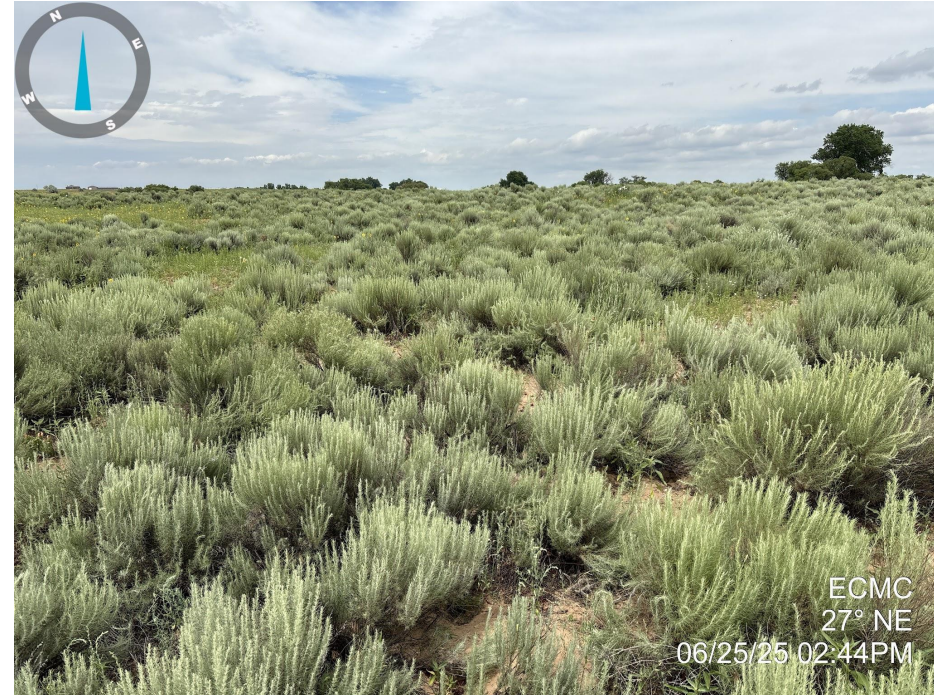
Photo 8. Photo taken of the reference area to the well location, northwest of the location, facing northeast. Photo illustrates the site is dominated by sand sagebrush (*Artemisia filifolia*).
