## **Appendix B**

### **Phase II Pit Status Evaluation Forms and Photographs**

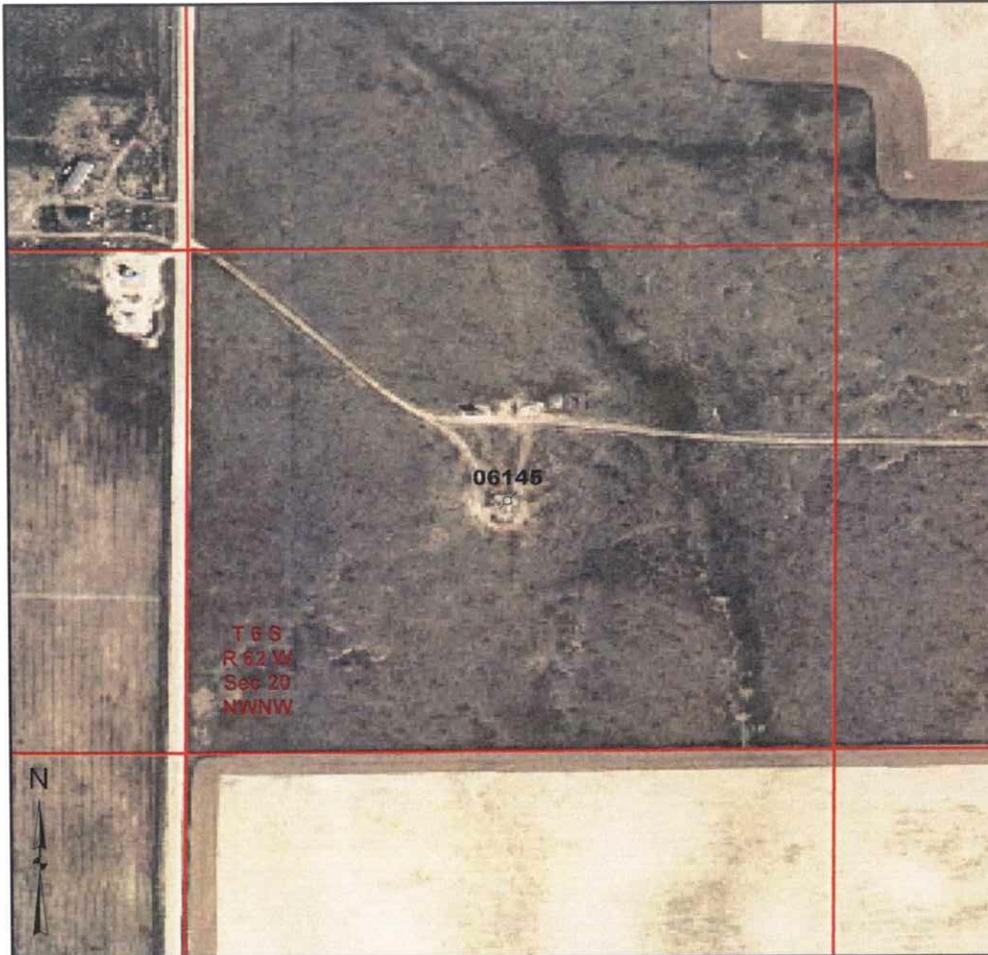
Pit Name: WHITEHEAD 11-20

Notes: No final site inspection forms online from 2008 (post PA'D)  
Field Inspection 6-3-2008: Site has been P&A'd; reclamation complete.

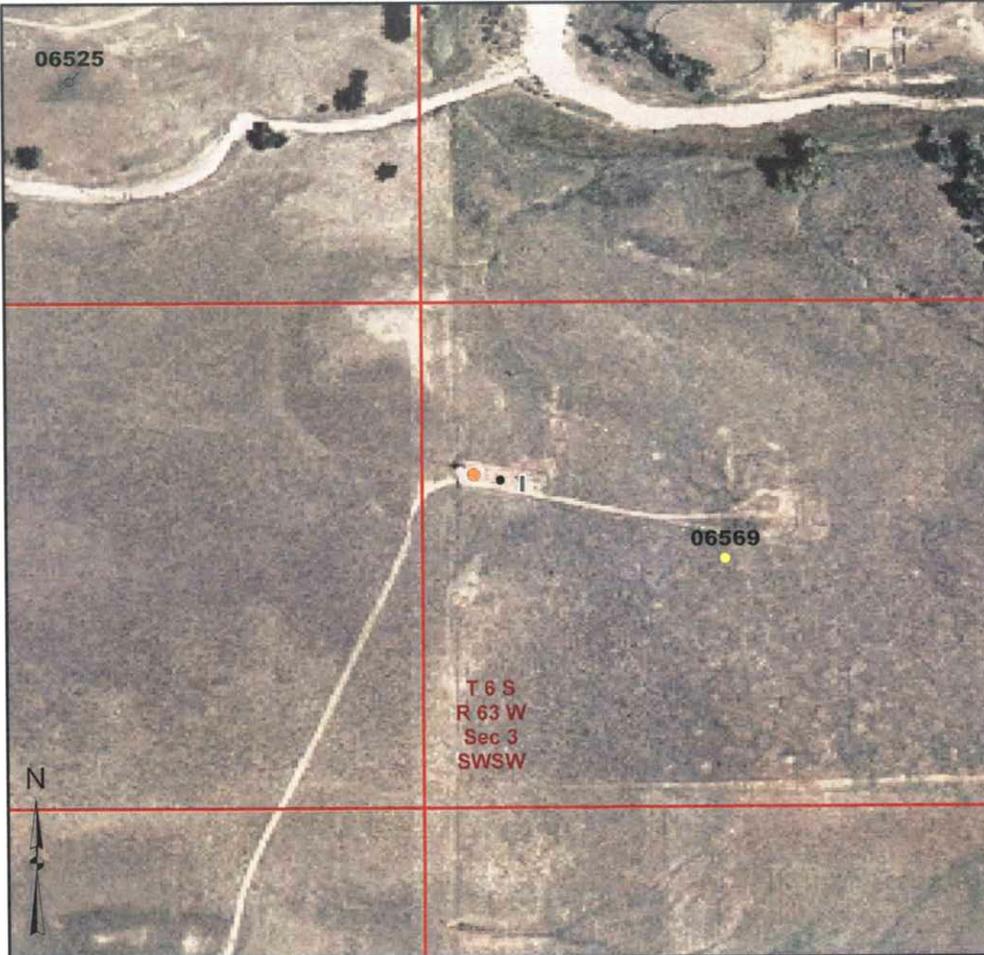
Pit Name: BIRD ELBERT CO 3-13

Notes: LIF (1987) skim pit. FIR (#200124272 9-13-07)  
Field Inspection (6-3-2008): Found steel culvert within battery tank site fence, 100% OCVD

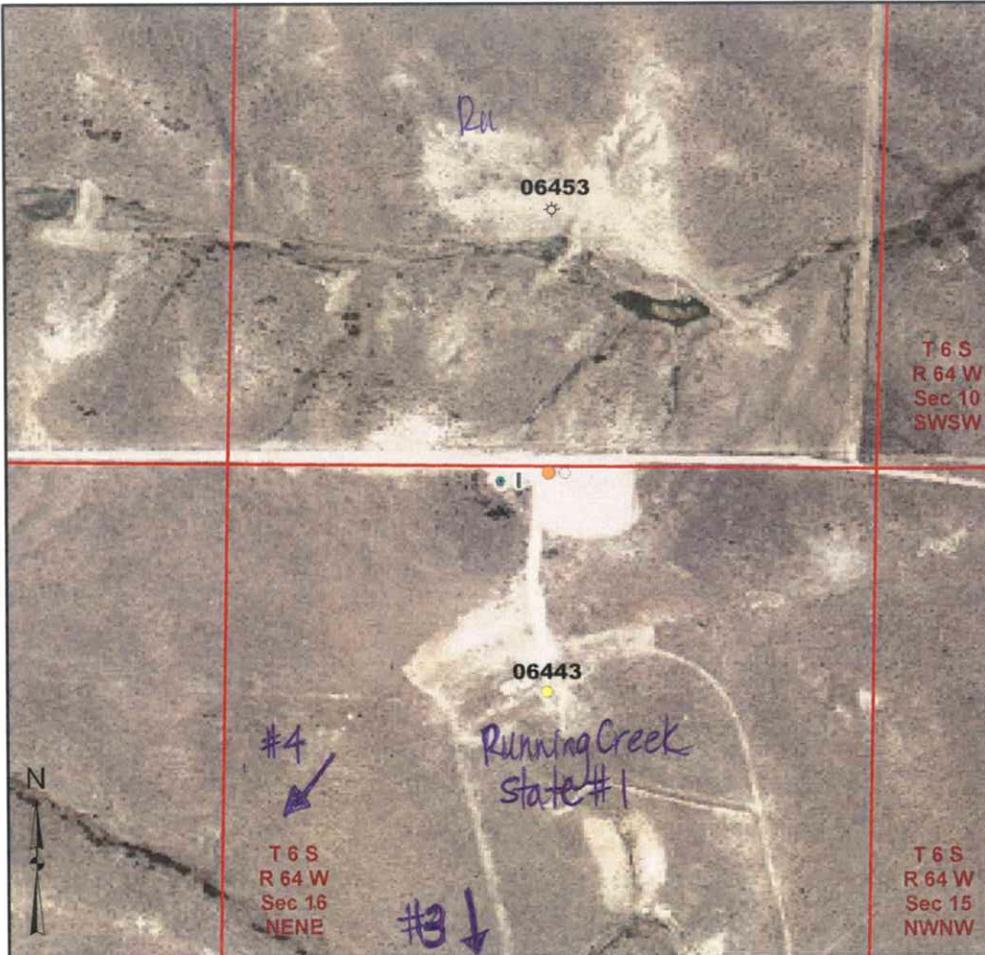
Pit Name: RUNNING CREEK STATE 1,3,4

Notes: *Common Use w/ Pit # 115175, 115176, 115178.*

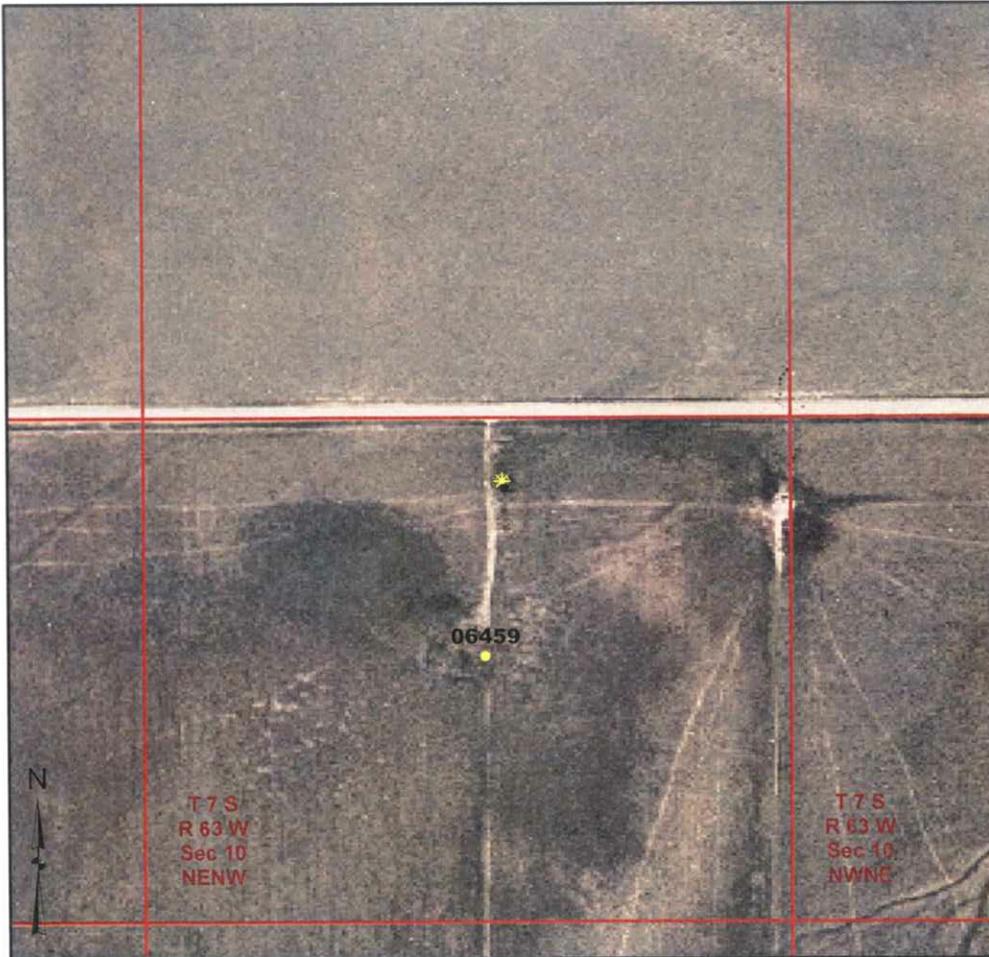
Notes: No lease inspections for Facility ID#111797. NOVA #119754 (2004) indicates well maintain TA status until 4-20-2010.  
 Field Visit 6-4-2008: Earthen Pit & Culvert found. Heavily oil saturated soils & pit cover/berm unsatisfactory.

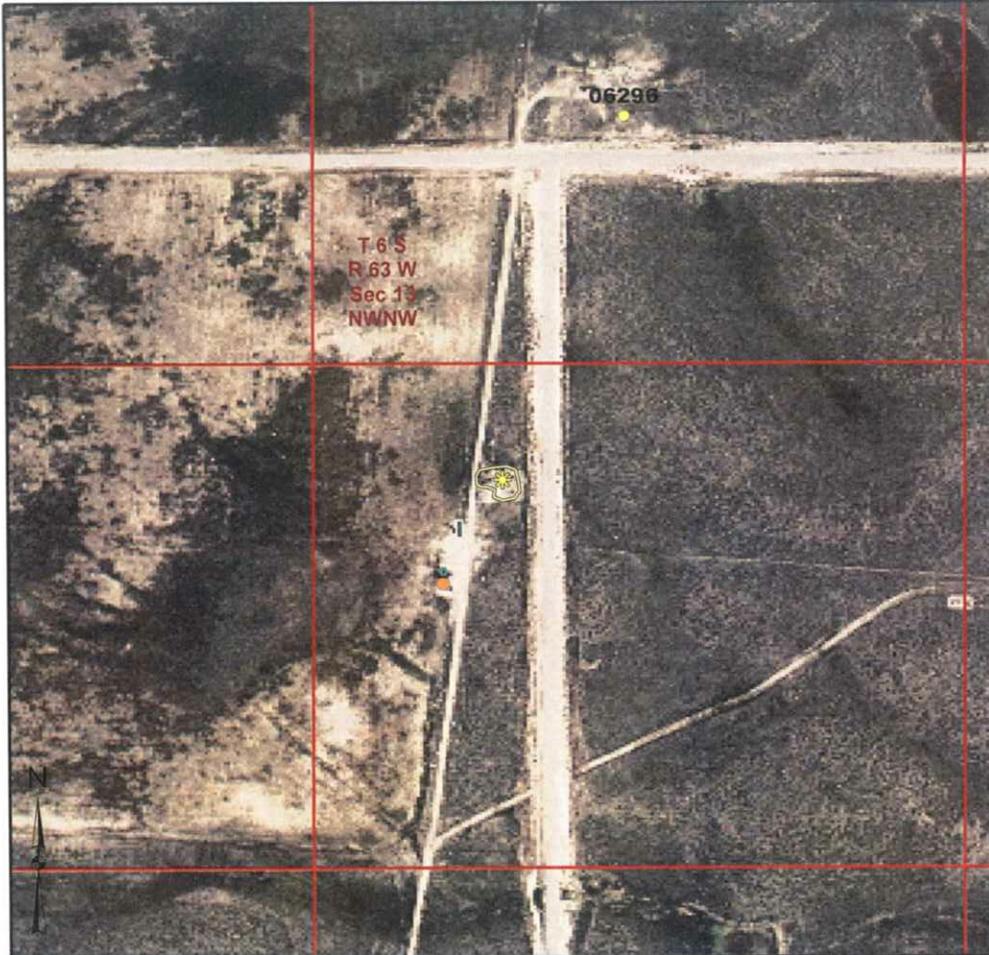
Pit Name: MORRIS 13-4 & 14-8

Notes: Common Use battery site for Morris 13-4 & 14-8  
 Field Visit 6-3-2008: Pit area has been turned/aerated. Battery Site Using fiberglass tank for water storage. Pit remediation recommended.

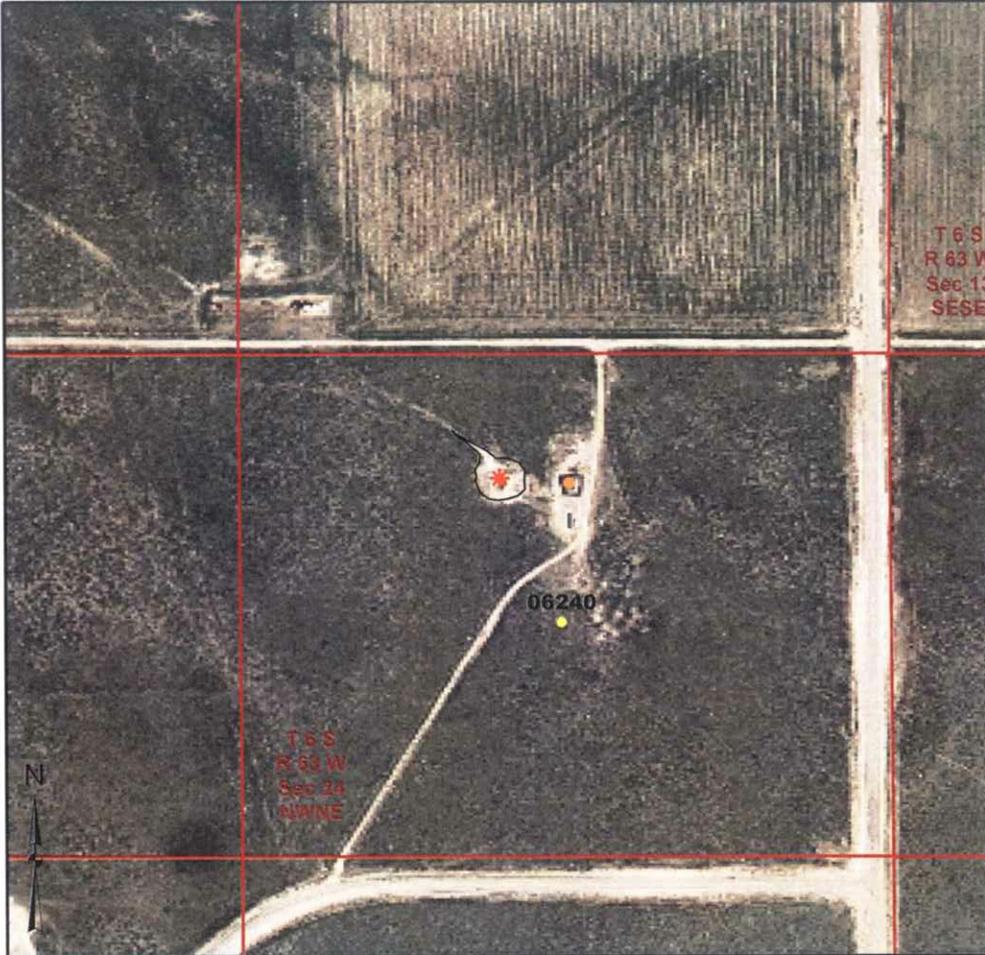
Notes: WSIF (1997) "screened earthen pit, fencing falling down" FIR (9-12-07)  
"Remove oil sat. soil; pits still open"  
Field Visit 6-3-2008: PIT IS BACKFILLED; RESEEDING RECOMMENDED.

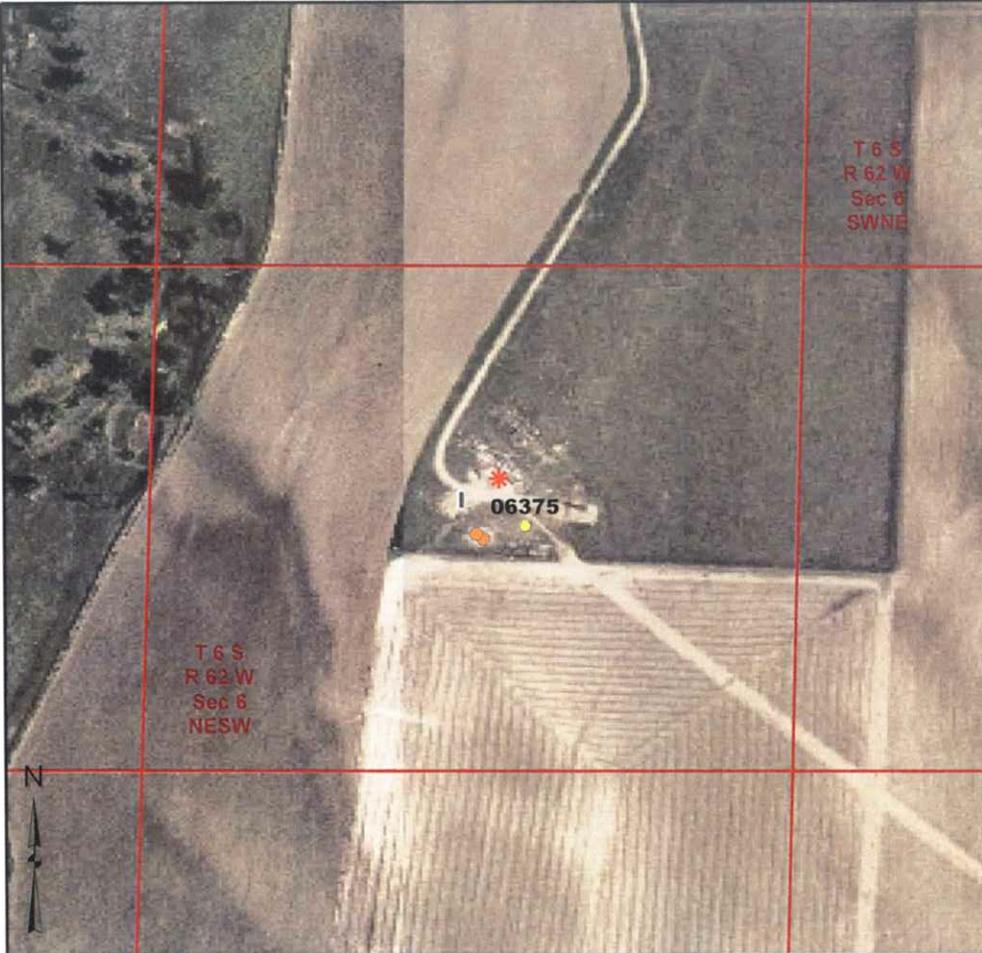
Facility ID: 115084  
 Pit Name: MILLER 6-11

*FIELD VISIT 6-4-2008 : PIT BACKFILLED, SITE NOT CLEAN. Debris Found.*

*Recommend Remediation*
